Technical Site Study Assessment

Draft Progress Report

Cora Kelly Elementary School
3600 Commonwealth Ave.

George Mason Elementary School
2601 Cameron Mills Rd.

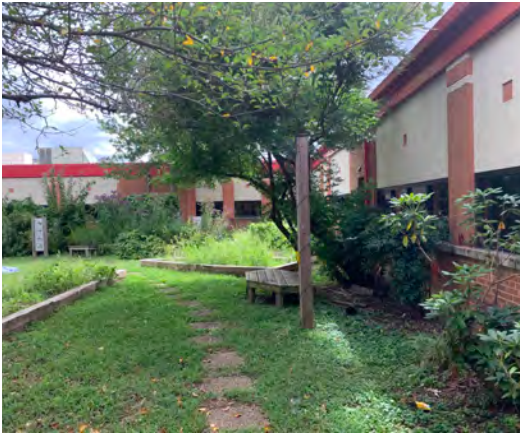
CK-1

While ramps are present at some building entrances, no ramp handrails are compliant with current ADA or building code standards (CK-6, CK-7). Also, most play areas are not connected to accessible paths, and no accessible play equipment was observed (CK-1, CK-2, CK-4, CK-5).

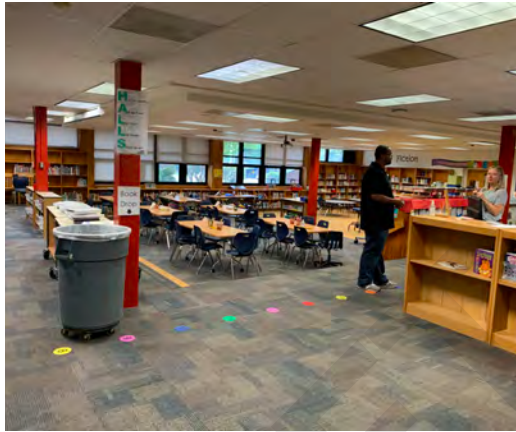
CK-8

Studio27 also observed many plumbing fixtures and facilities at Cora Kelly that are not ADA accessible. This includes water fountains in the corridors (CK-9), sinks in classrooms (CK-10), and bathroom in classrooms (10). The majority of the Library is not accessible because of the sunken 'pit' design of the central area (CK-8).
