**FROM: JOINT CITY-SCHOOLS FACILITY INVESTMENT TASK FORCE
Lynn Hampton, Chair, Mignon Anthony¹, Elliott Branch, Micheline Castan-
Smith, Marshall Cook, Dwight Dunton, Amy Liu, Dave Millard, Eric Wagner**

SUBJECT: TASK FORCE FINAL REPORT (DELIVERABLE 2 OF 2)

A2 Services, Inc. Facility Survey of City of Alexandria - City Hall

A2 Services, Inc.
Facility Survey of the City of Alexandria – Public Safety Center

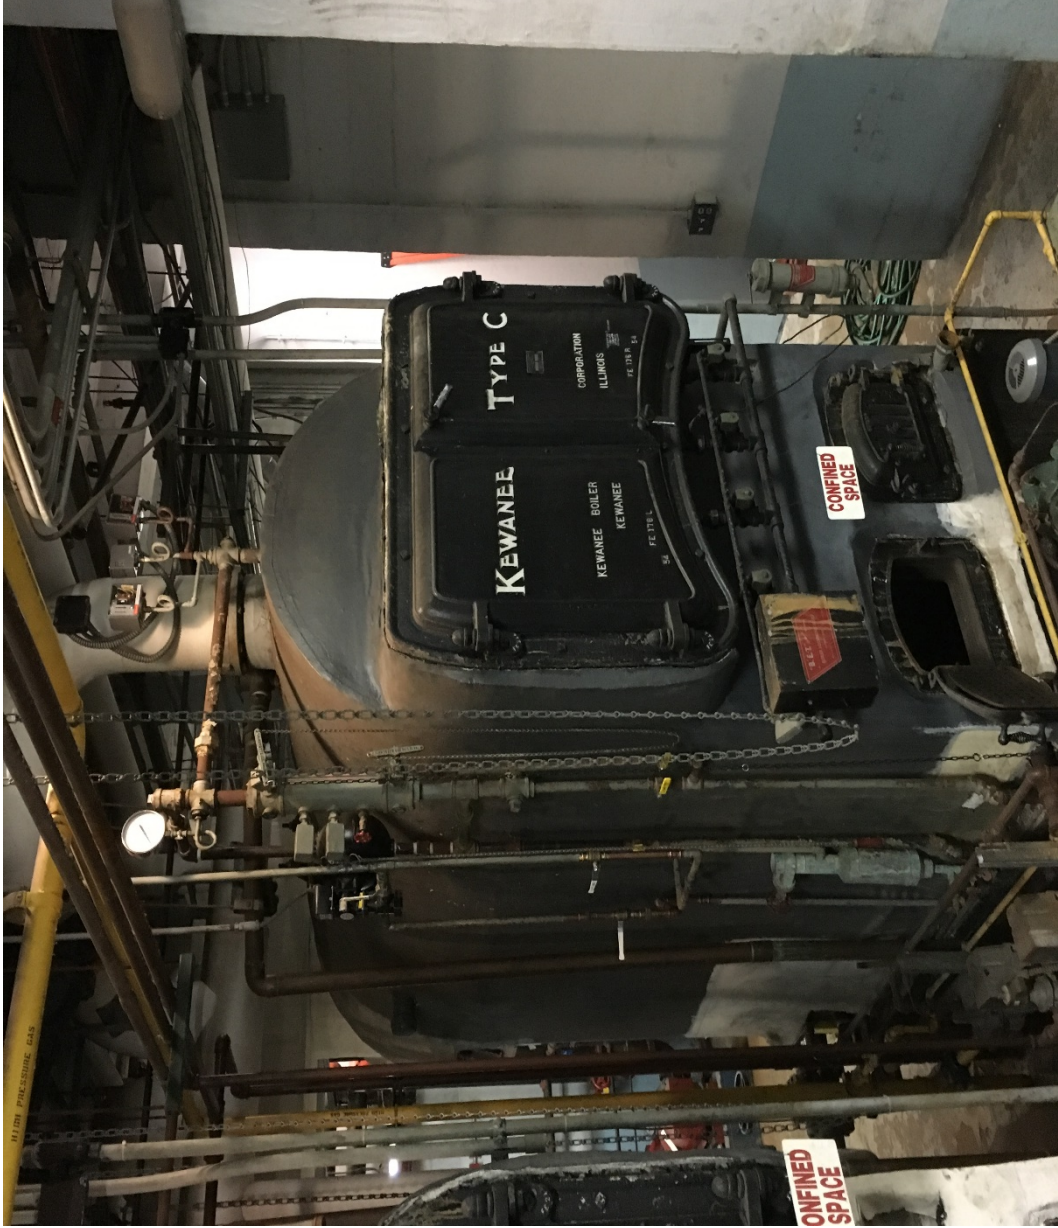
Finding # 1 Photo. This picture is of one of the old brick set fire tube boilers. These units are in poor condition.

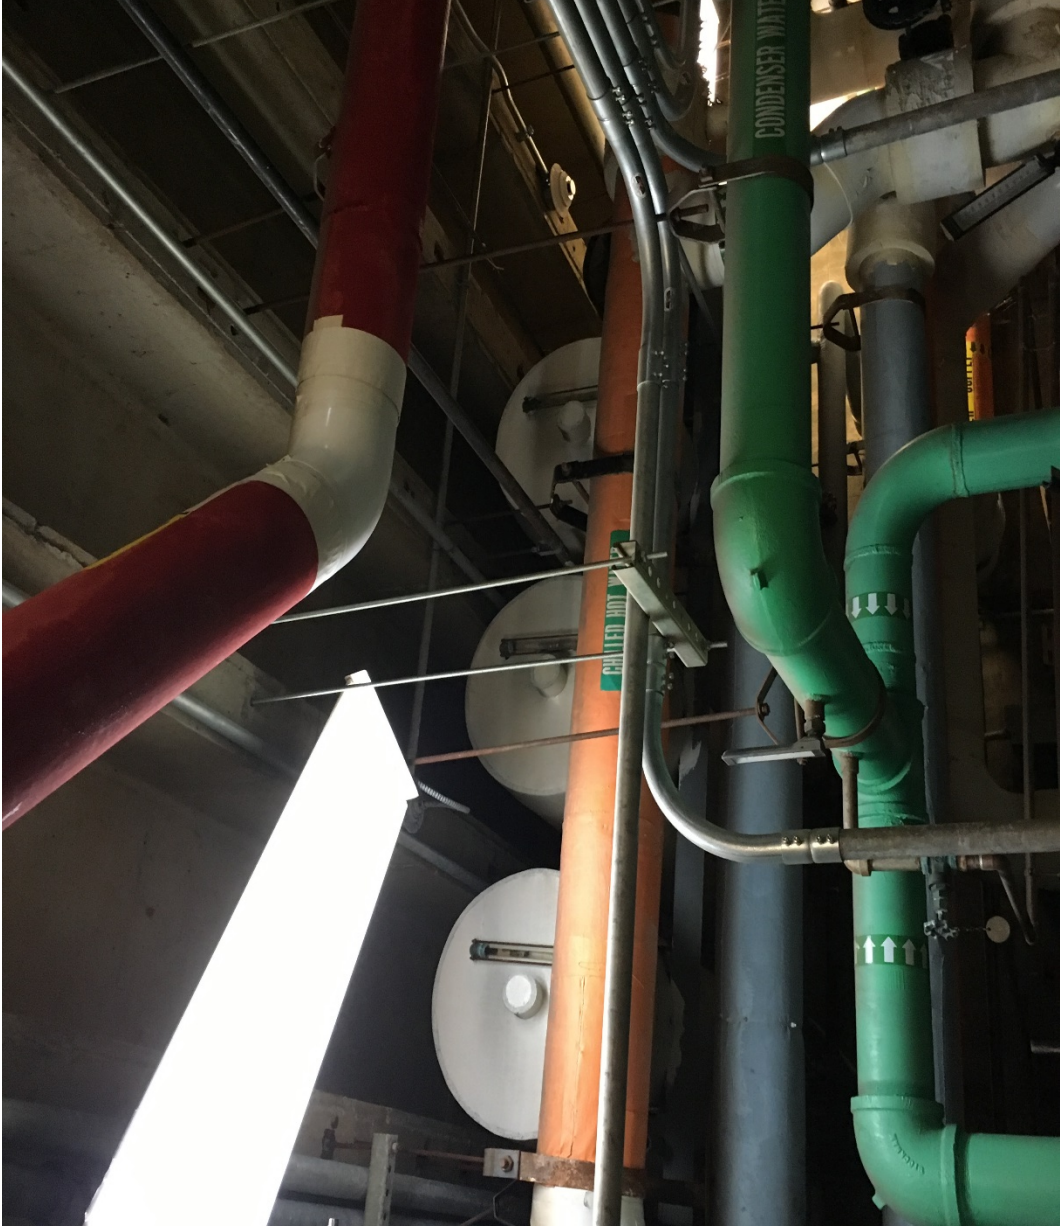
Finding # 2 Photo. The 3 tanks shown in this picture are the closed system expansion tanks. These need to be repaired and the proper air cushion established to allow the systems water to expand and contract without changing the system pressure.

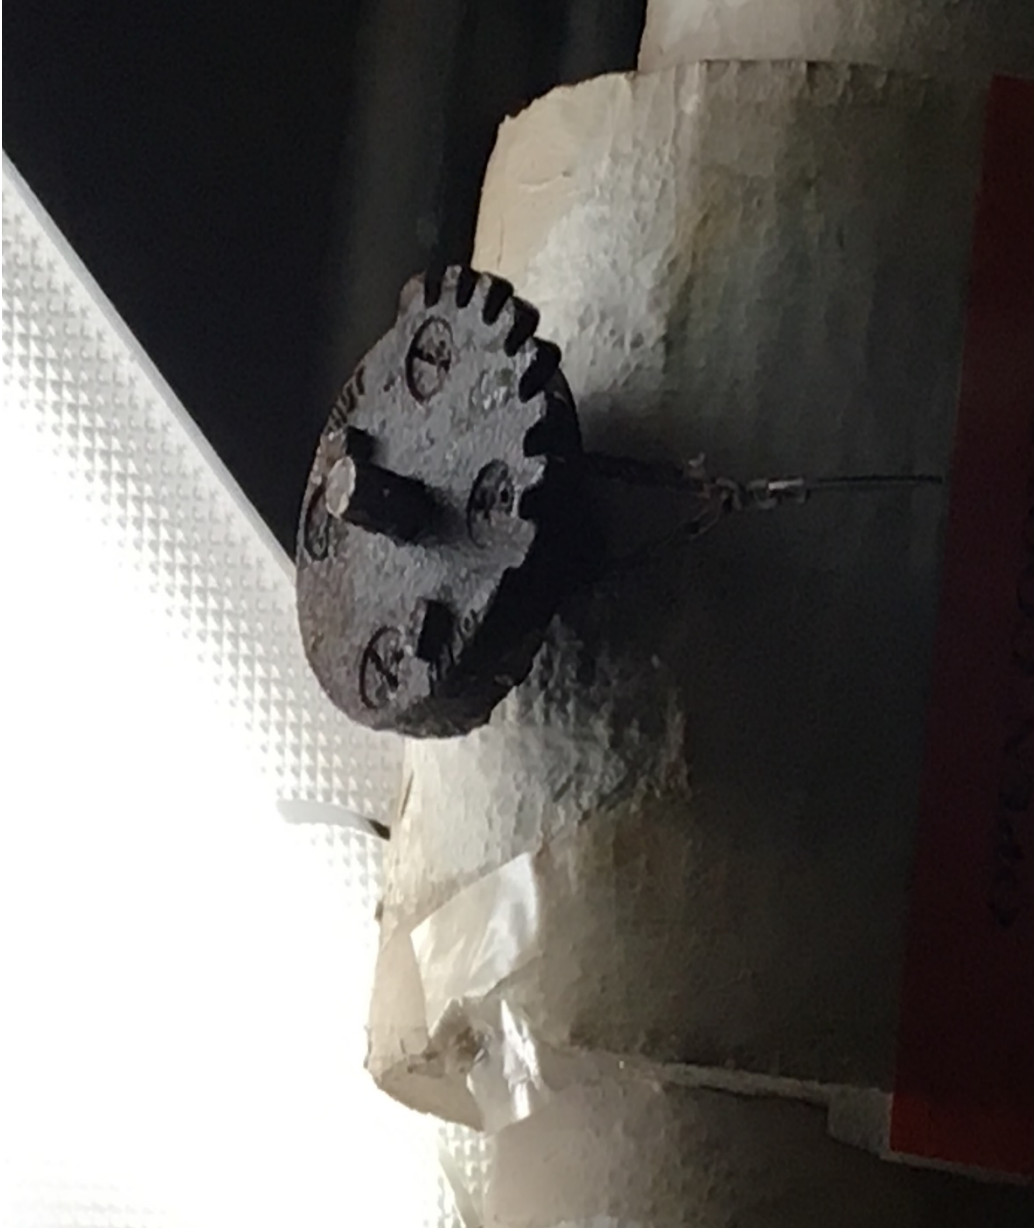
Finding # 3 Photo. This picture is an example of one valve which needs to be replaced.

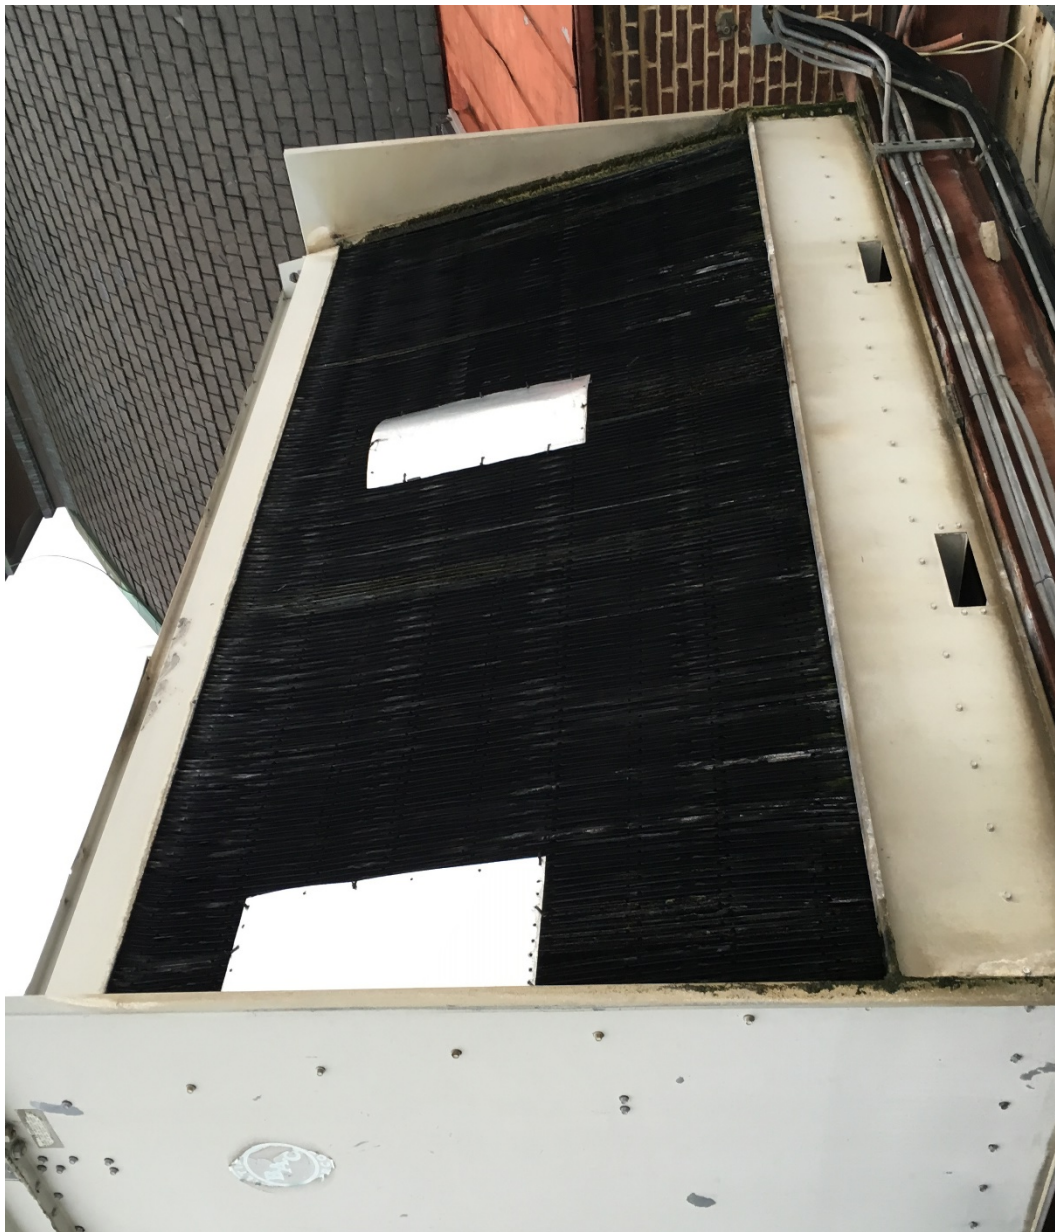
Finding # 4 Photo. This picture notes the temporary sheet metal repair to the cooling tower fill.

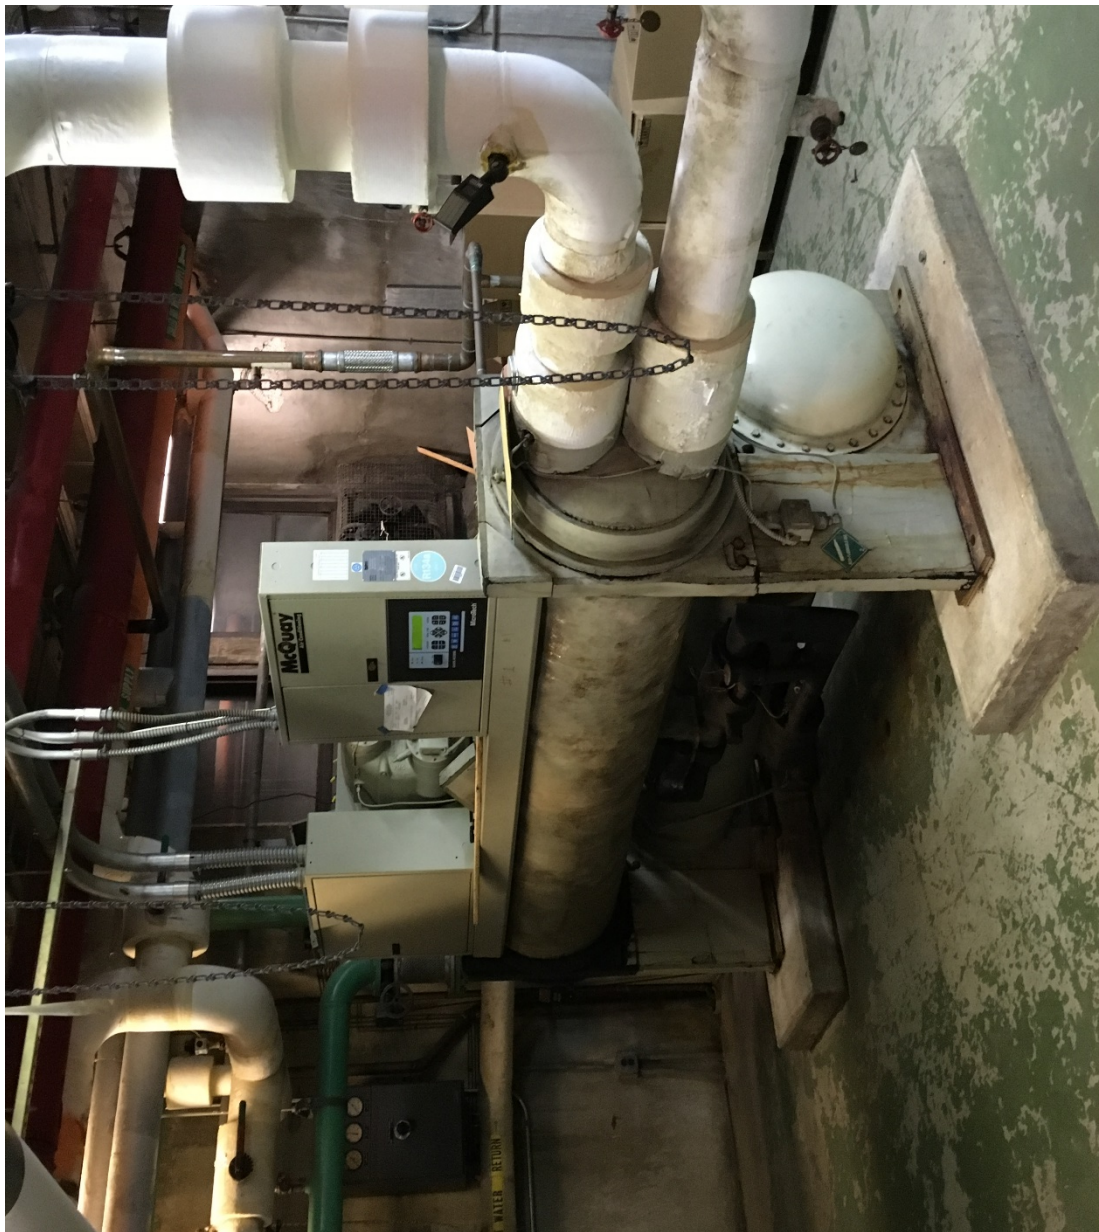
Finding # 5 Photo. This picture notes one of the R-22 centrifugal chillers.

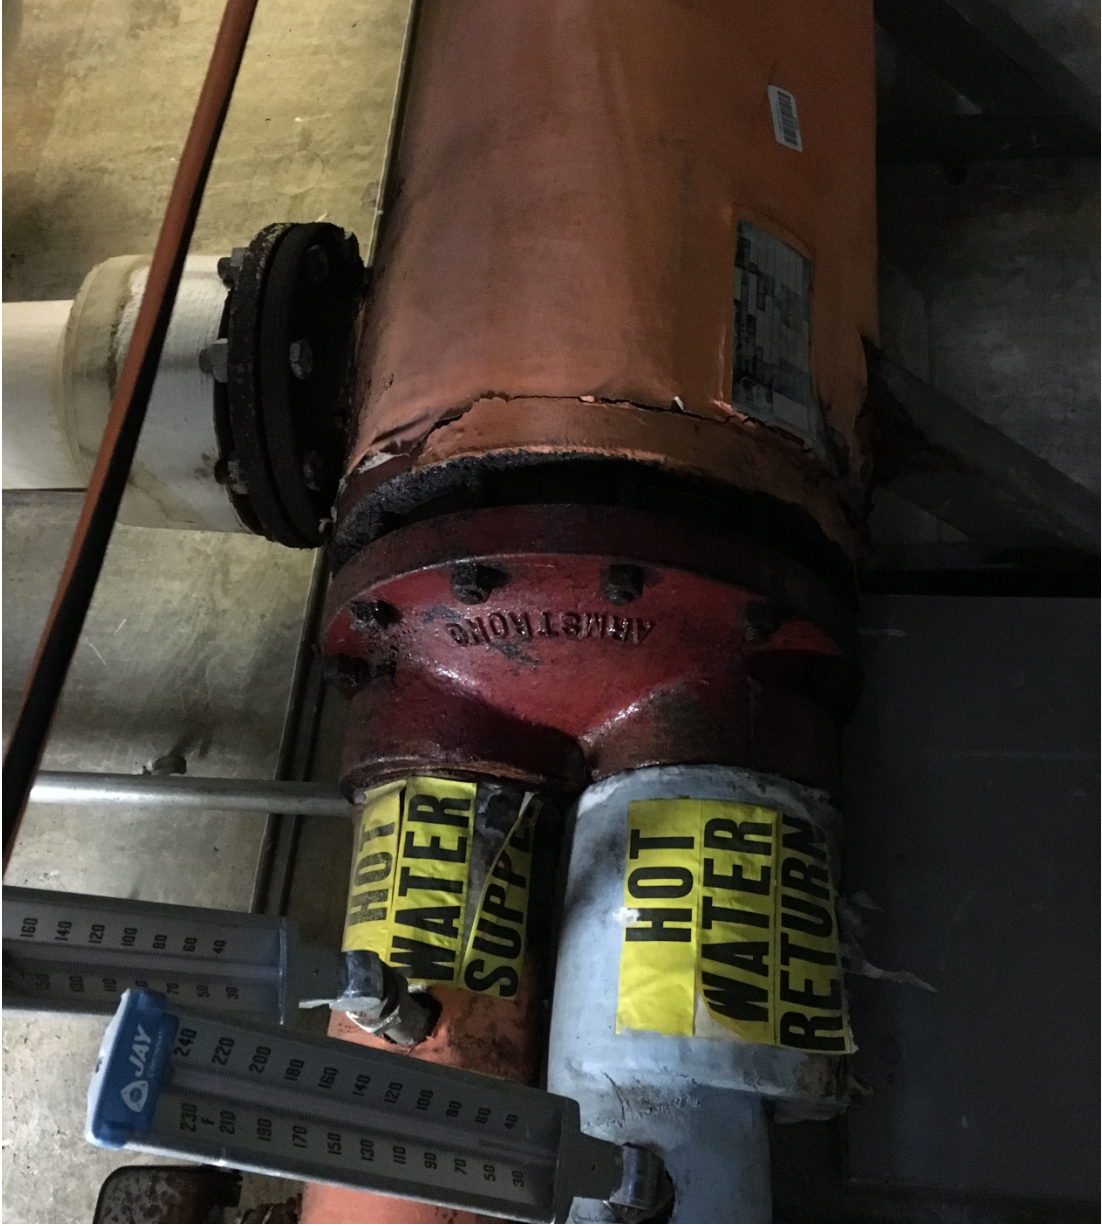
Finding # 7 Photo. This picture is of the heat exchanger which heats the whole building. The head is leaking while in operation and should be repaired.

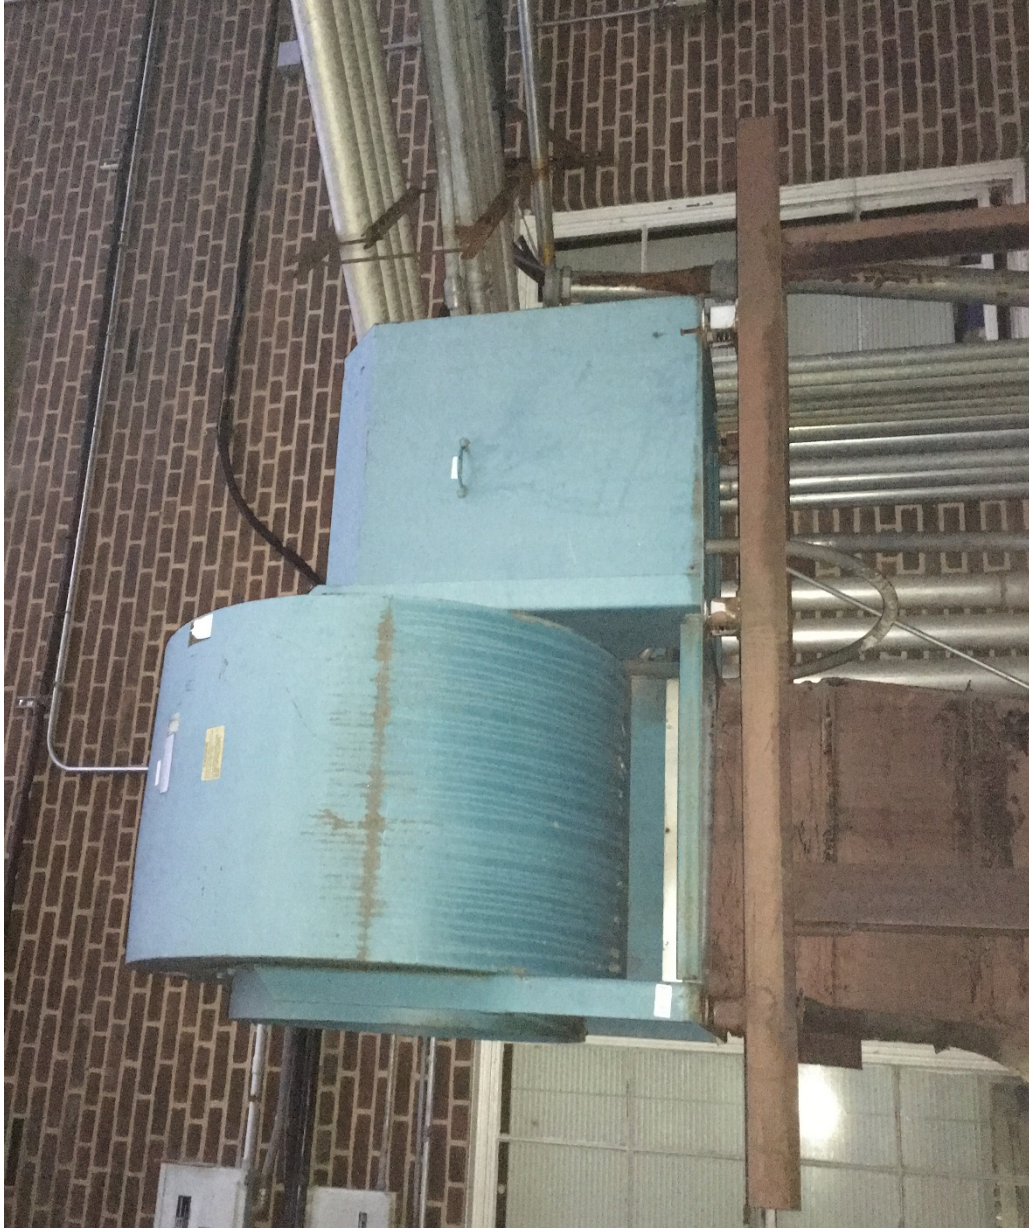
Finding # 9 Photo. This picture is of the second OA fan which most likely causes more issues. It simply dumps unfiltered cold air into the building.

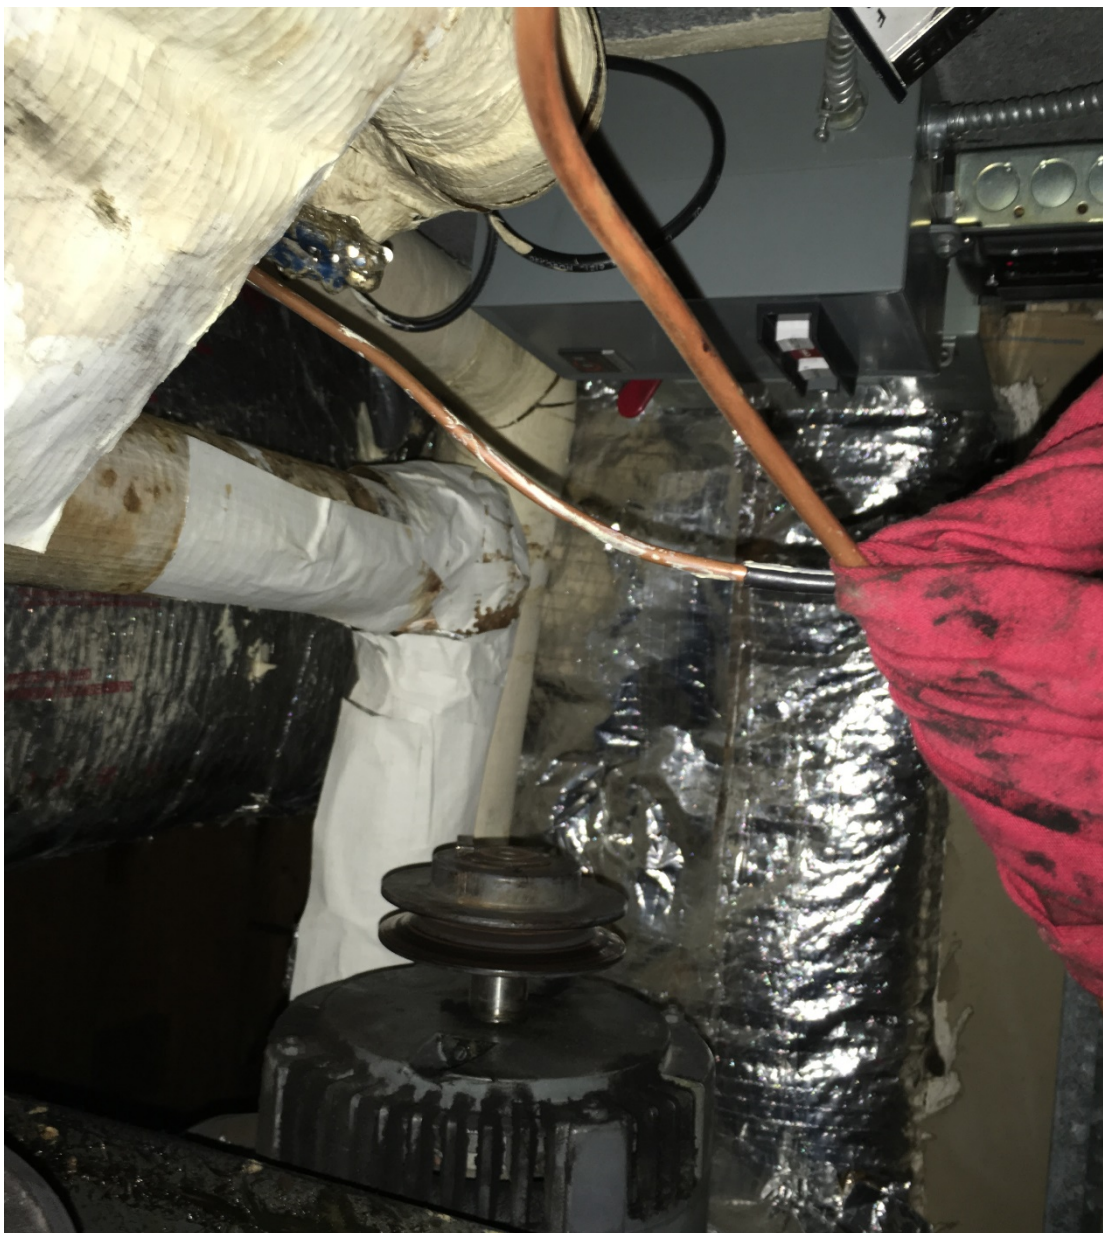
Finding # 10 Photo. This picture is of the air handler in the print shop which the fan bearings have failed. It is very hard to access.

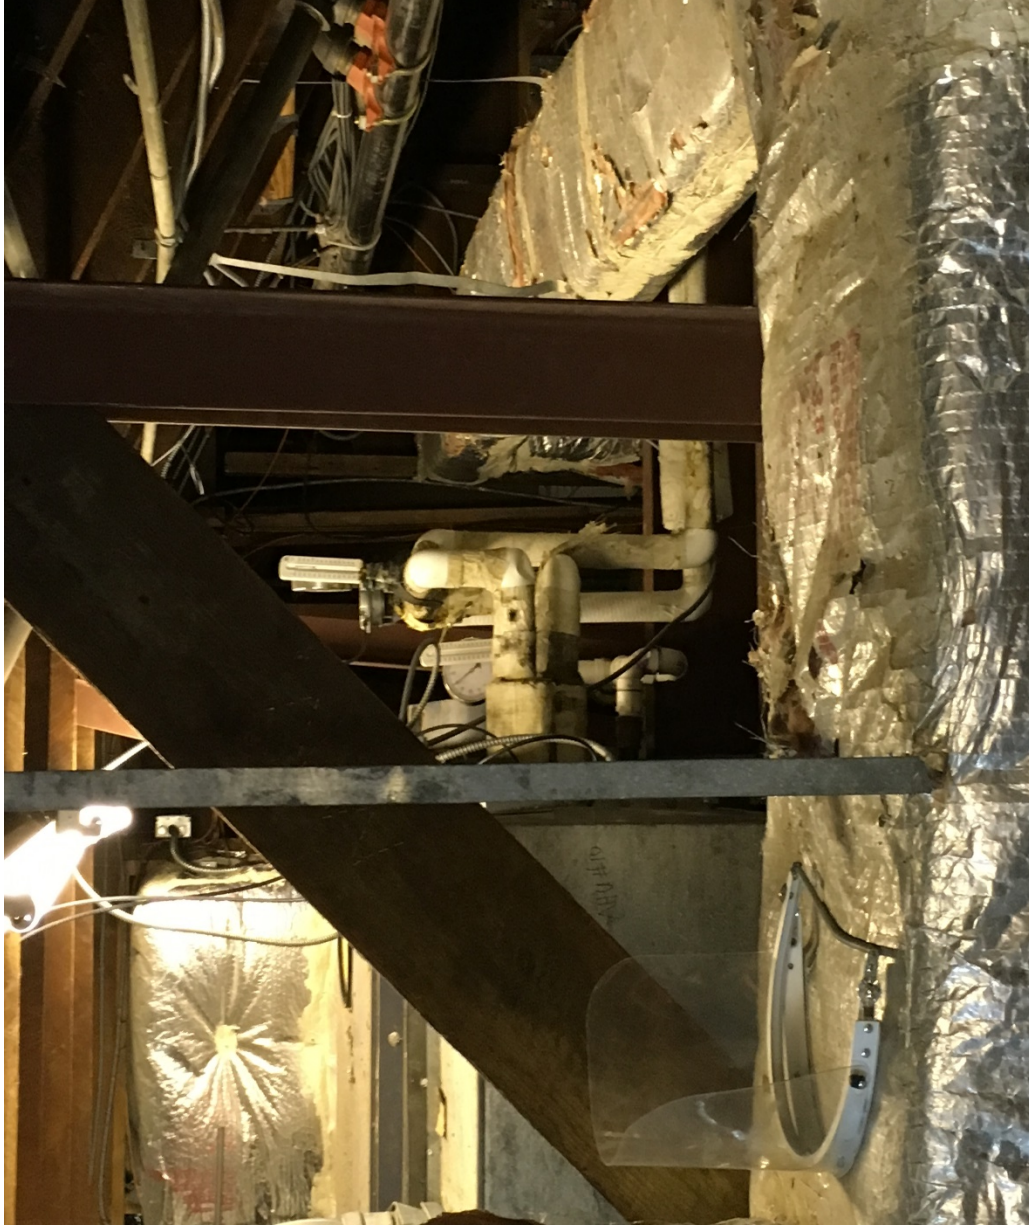
Finding # 11 Photo. This picture is of one of the attic air handlers with damaged duct work insulation. This will cause condensate leaks in summer.

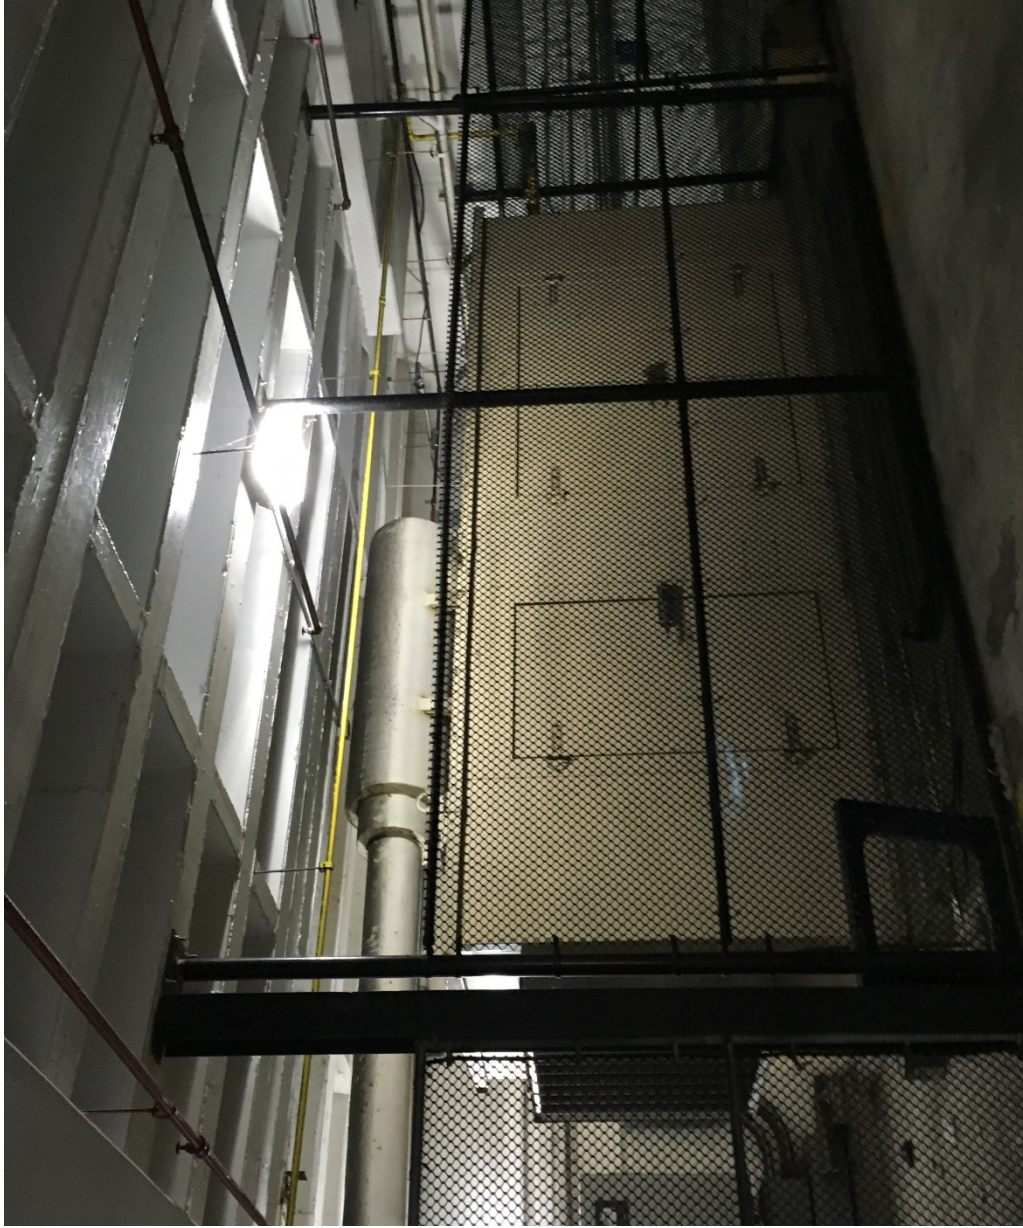
Finding # 16 Photo. A2 recommends that the emergency generator transfer switches be transferred and tested under load at least every 2 months. This picture is of the emergency generator.

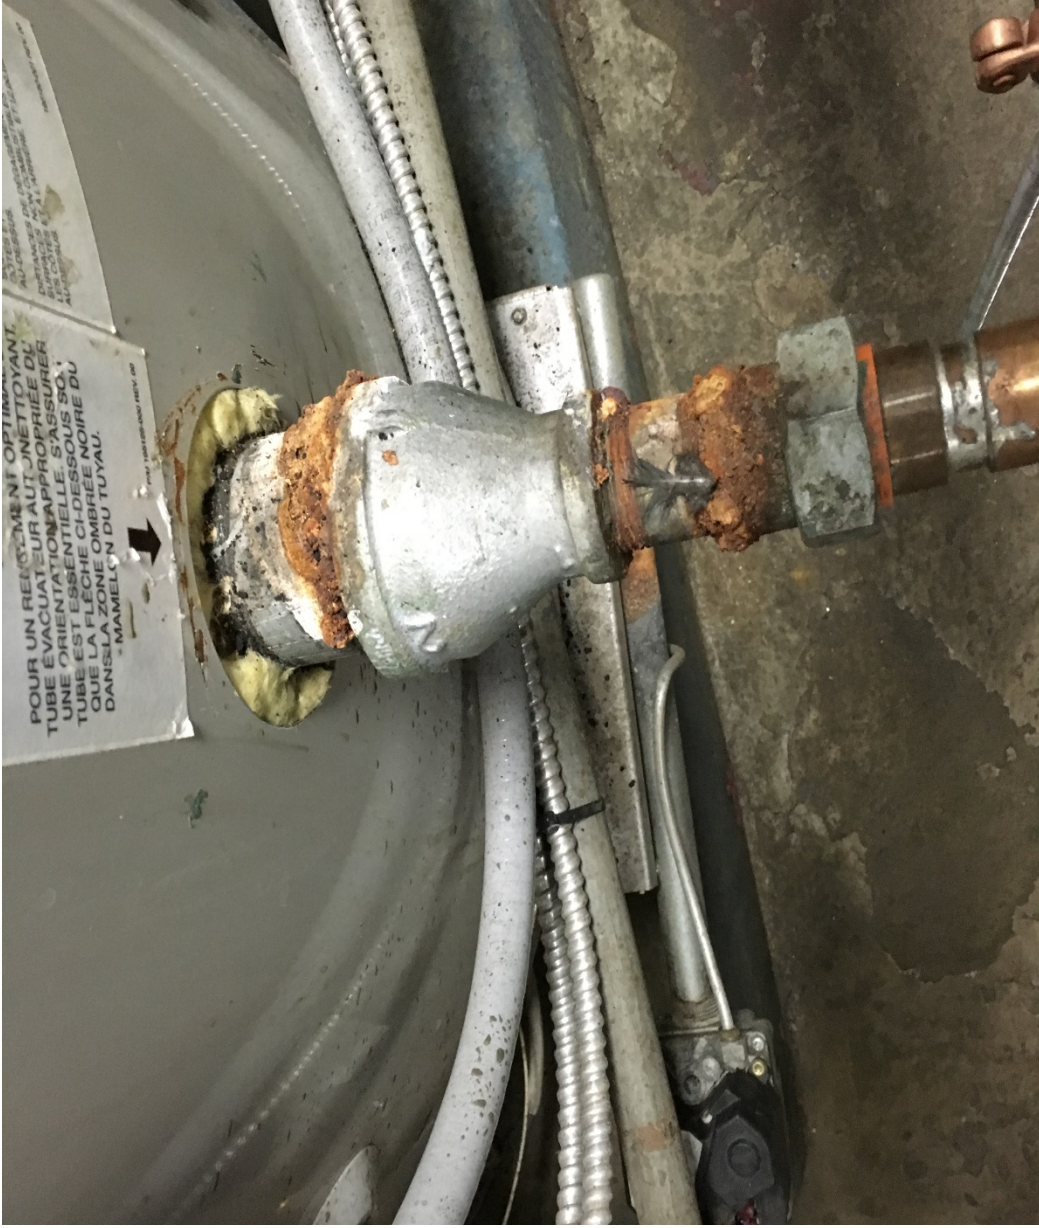
Finding # 18 Photo. This picture notes the corroded inlet water fittings to the domestic water heater in the boiler room.

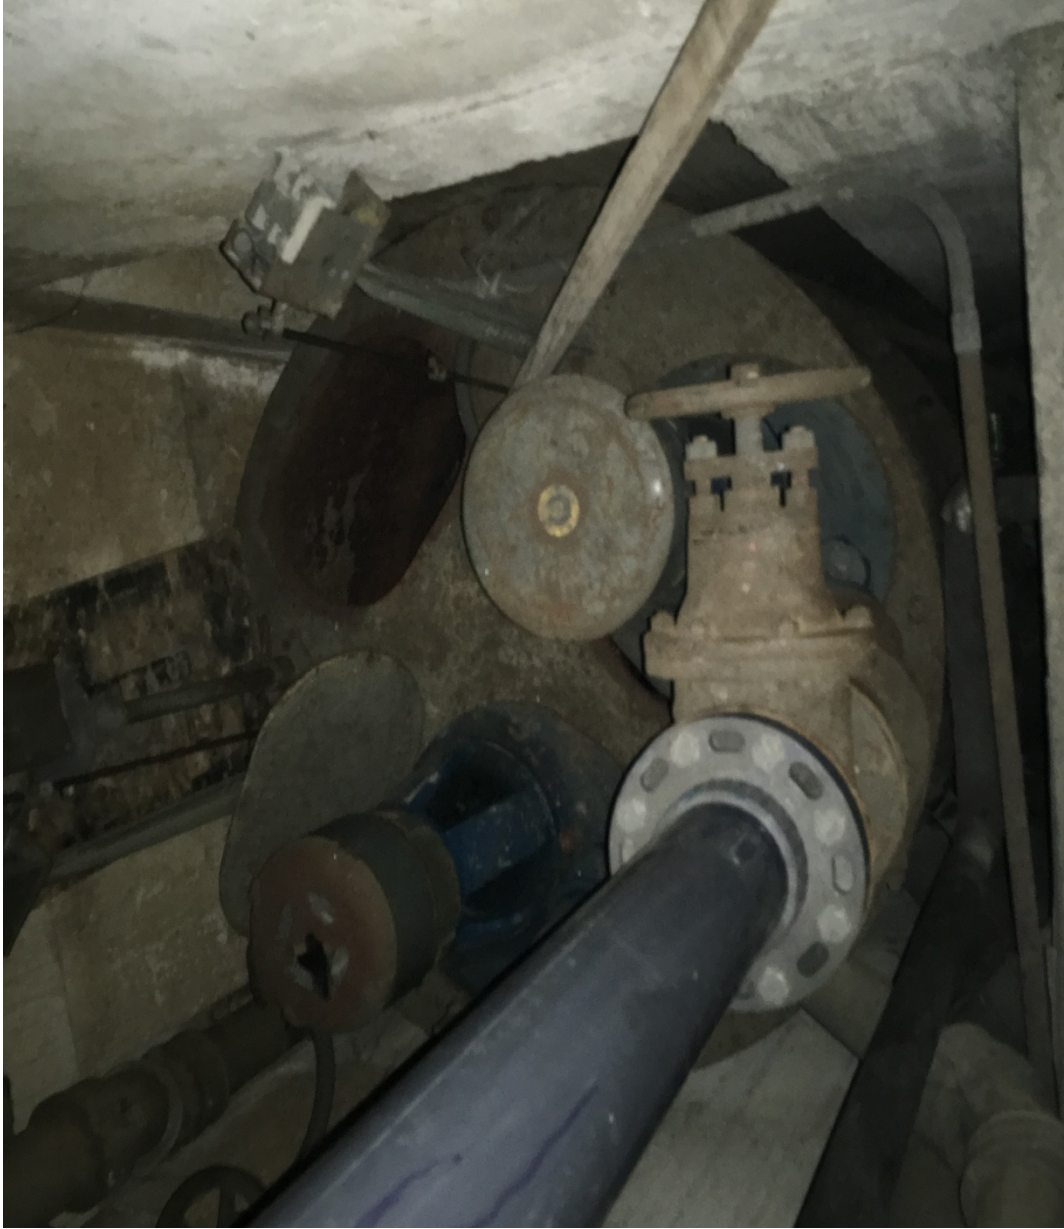
Finding # 20 Photo. This picture notes the old shaft driven sump pumps which are noisy. If they fail the garage could flood.

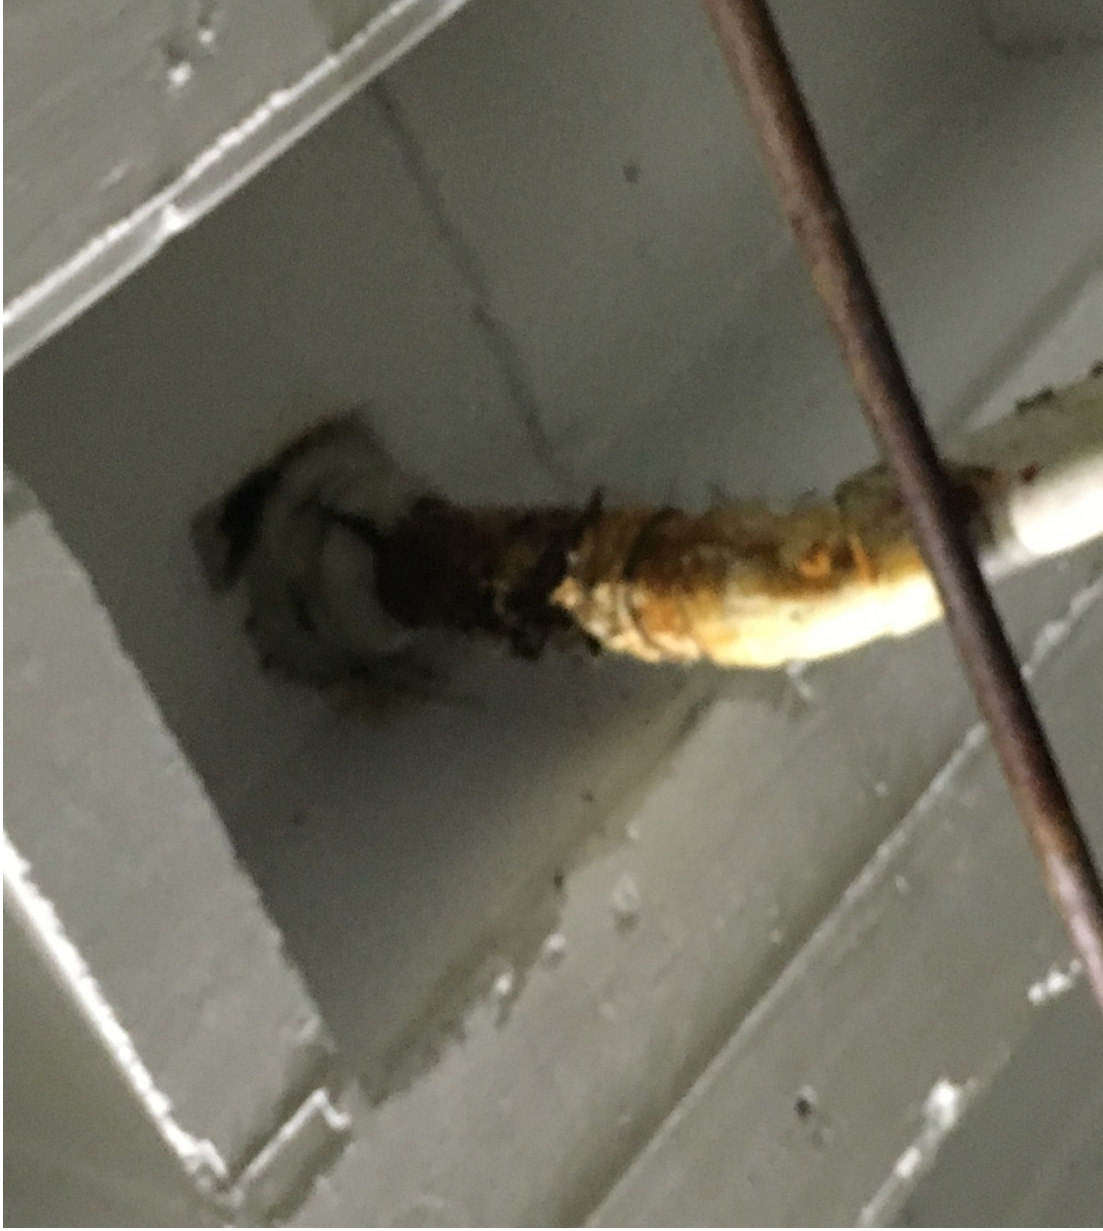
Finding # 23 Photo. This picture is of one planter drain which is leaking into the garage.

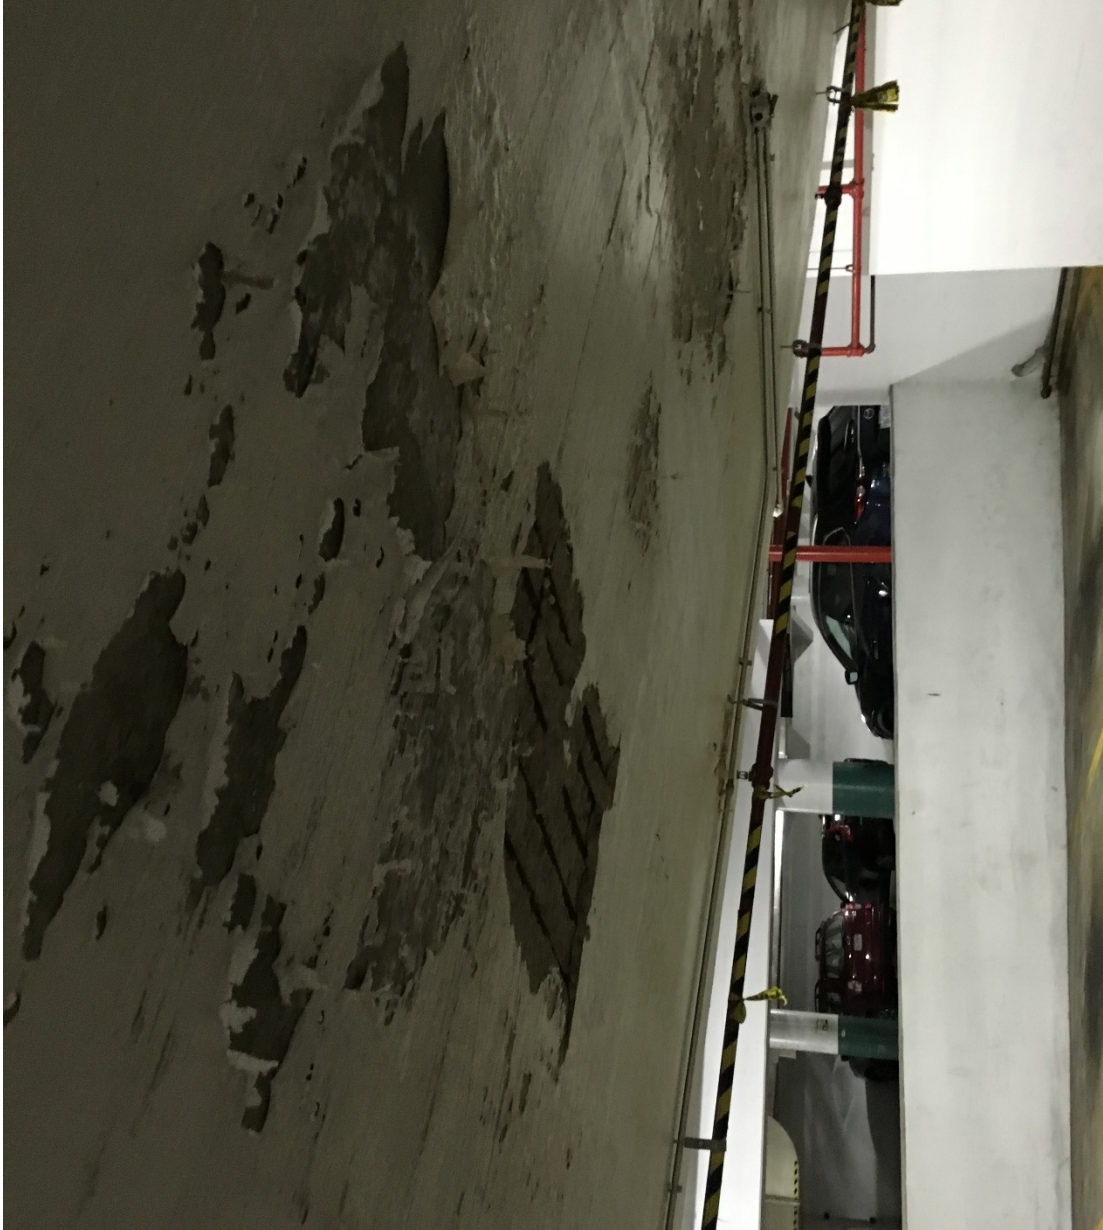
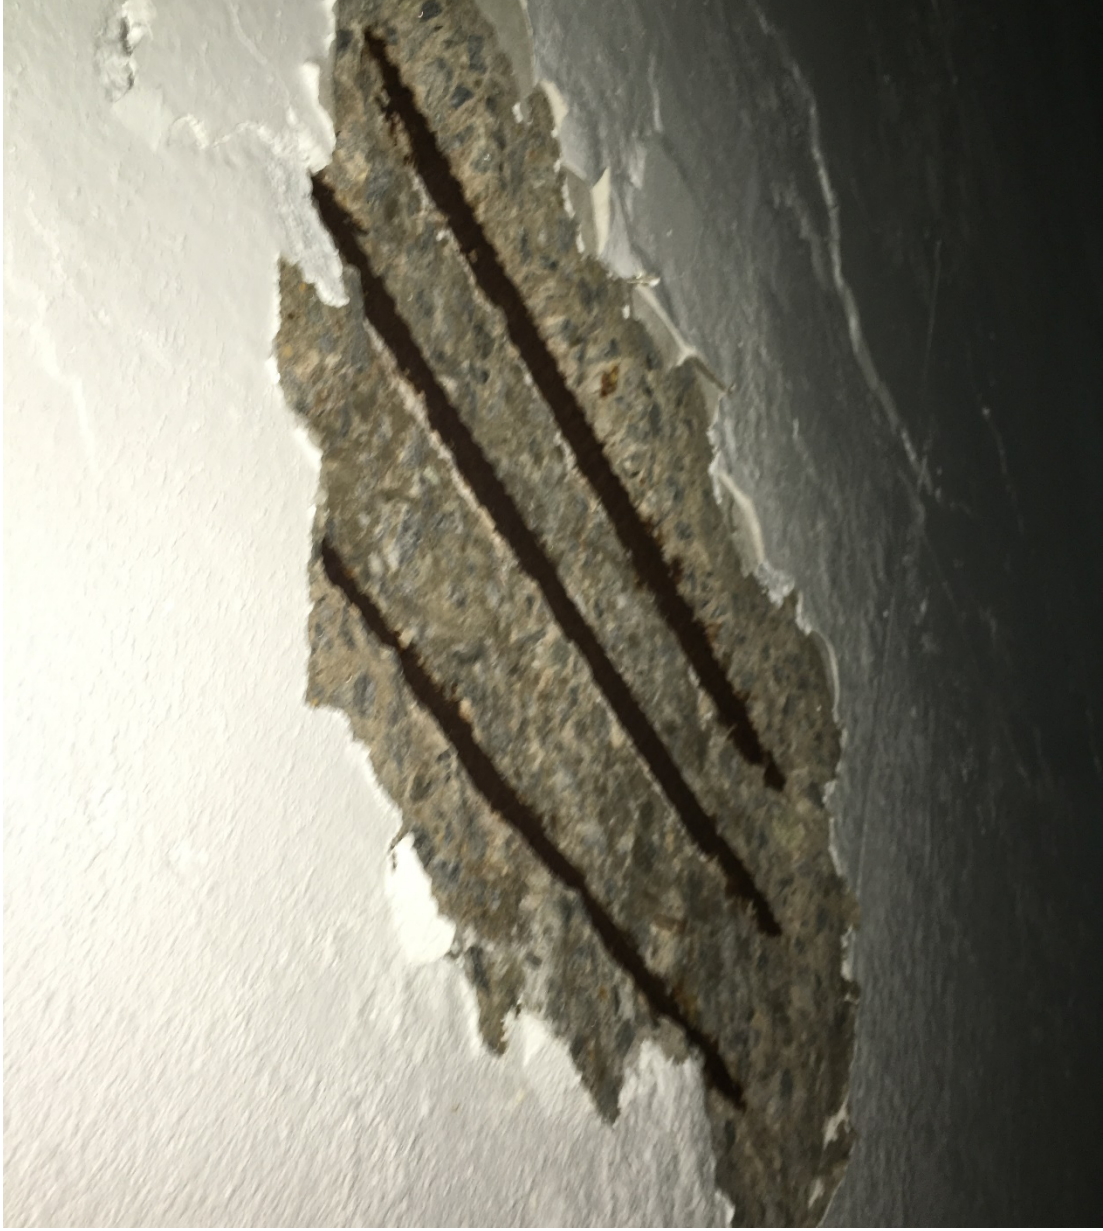
Finding # 24 Photo. This picture is one example of structural damage in the garage from water infiltration.

Finding # 24 Photos Continued. This picture is another example of structural damage in the garage.

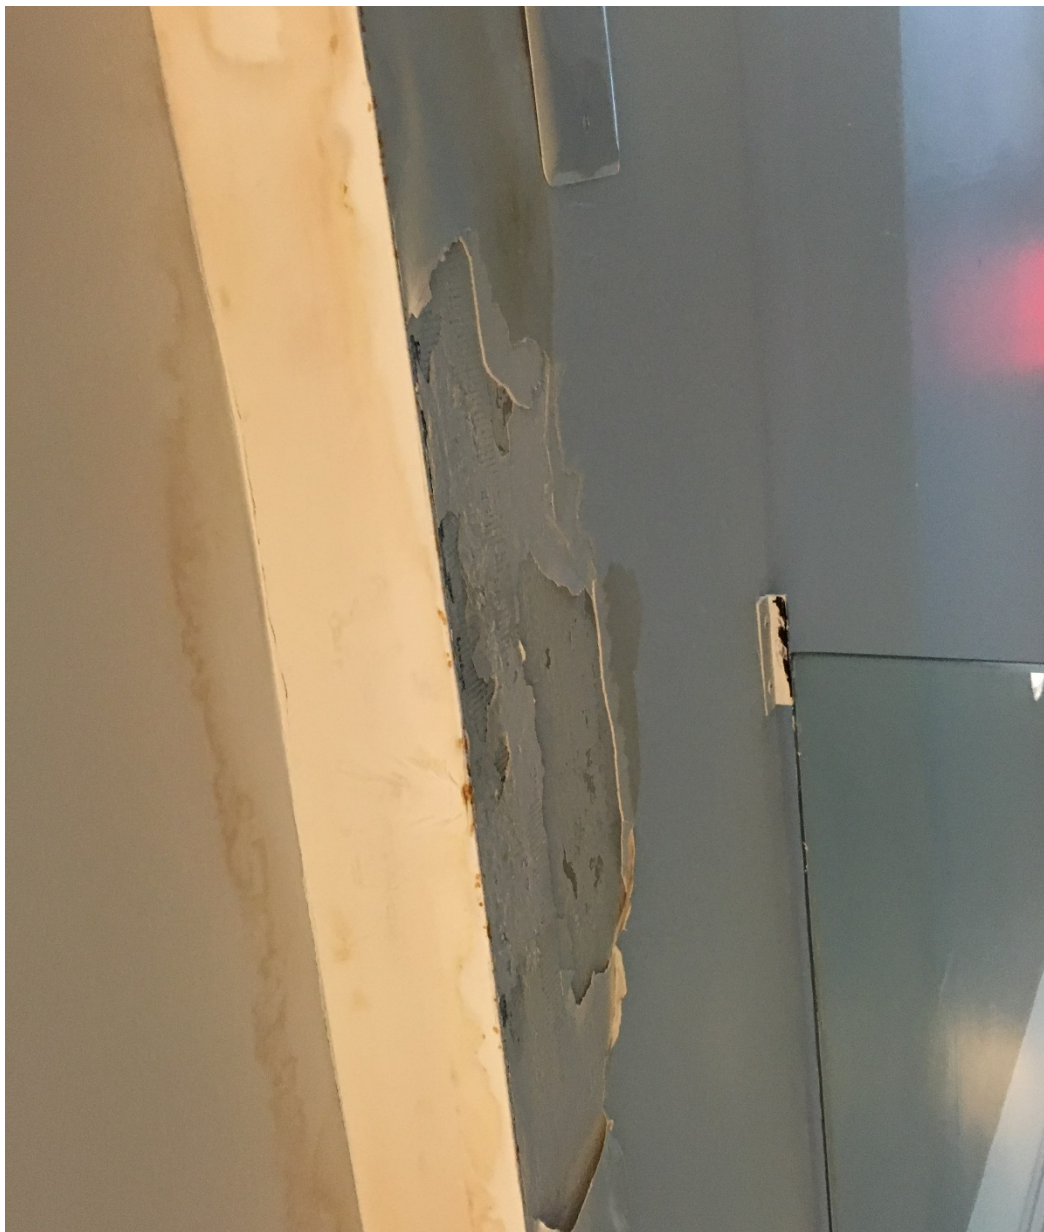
Finding # 26 Photo. This picture notes the water damaged dry wall bulk head outside room 3230. This is from a roof leak.

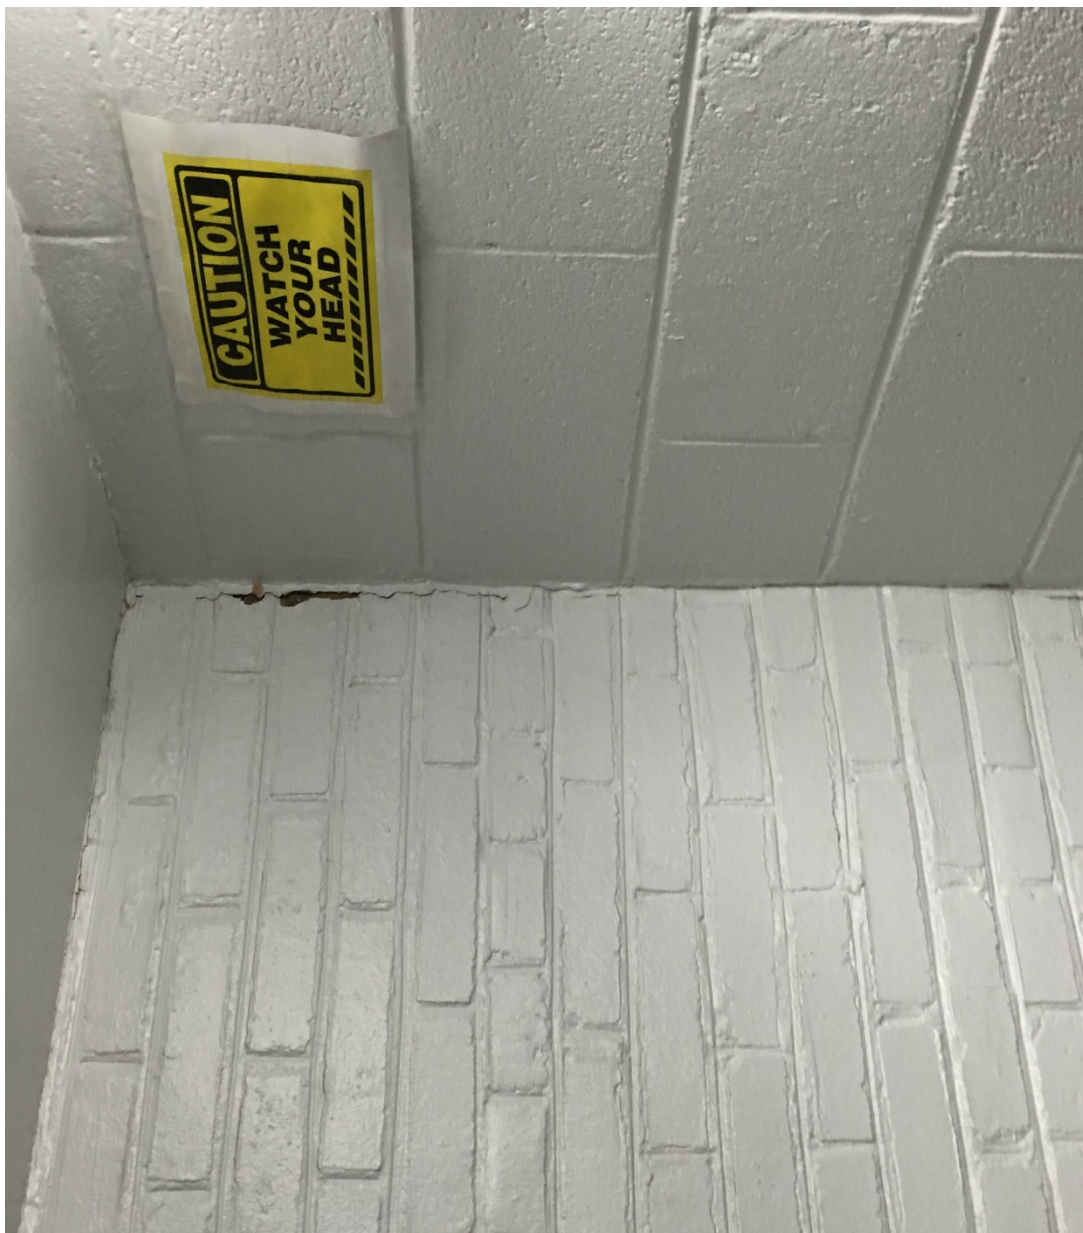
Finding # 27 Photo. This picture notes the crack between the block and the brick walls where water is entering stairway #1.
