**FROM: JOINT CITY-SCHOOLS FACILITY INVESTMENT TASK FORCE
Lynn Hampton, Chair, Mignon Anthony¹, Elliott Branch, Micheline Castan-
Smith, Marshall Cook, Dwight Dunton, Amy Liu, Dave Millard, Eric Wagner**

SUBJECT: TASK FORCE FINAL REPORT (DELIVERABLE 2 OF 2)

A2 Services, Inc. Facility Survey of City of Alexandria - City Hall

A2 Services, Inc.
Facility Survey of the City of Alexandria – Public Safety Center

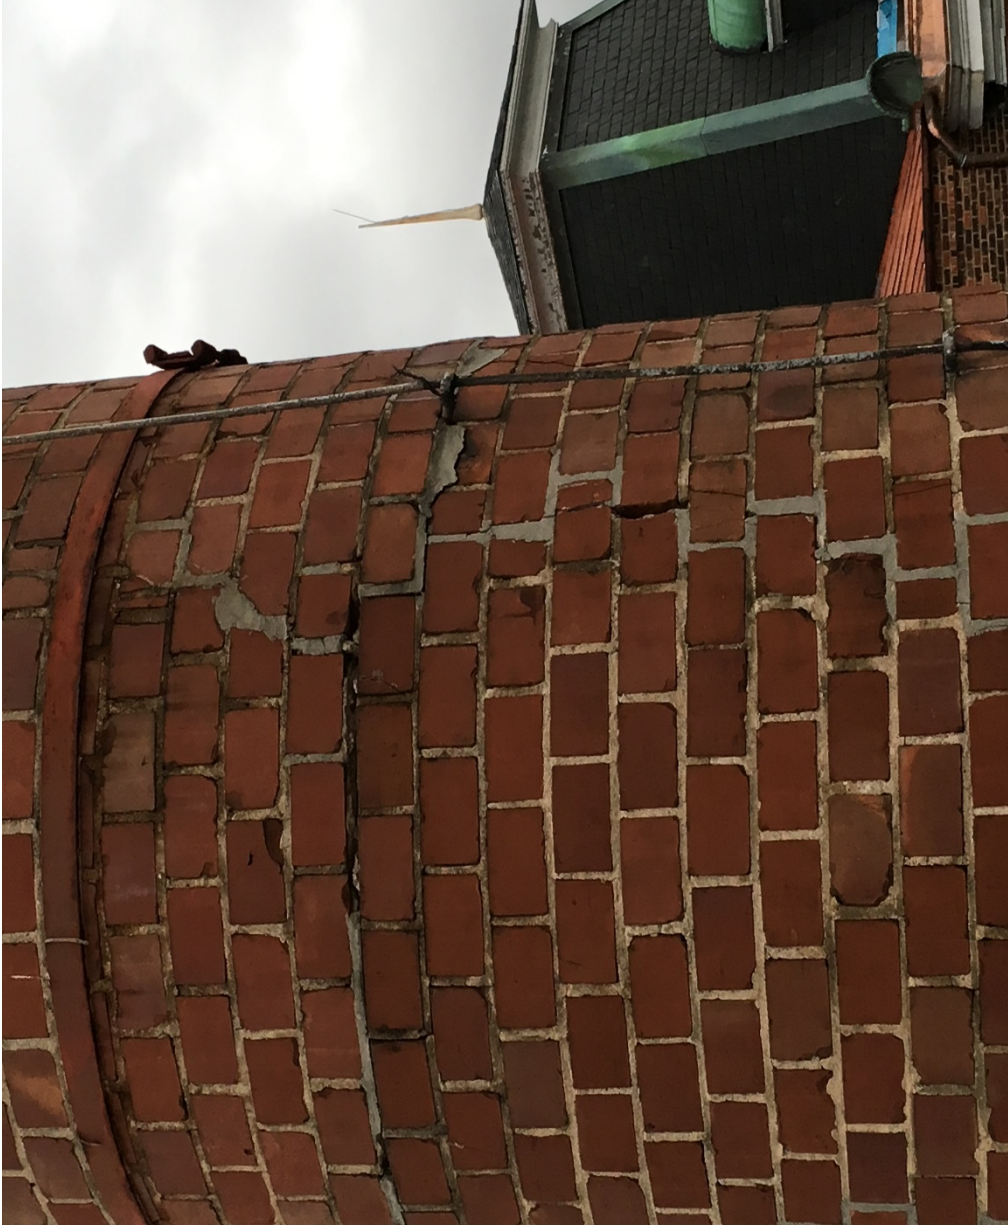
Finding # 28 Photo. This picture notes the structural damage to the brick chimney.

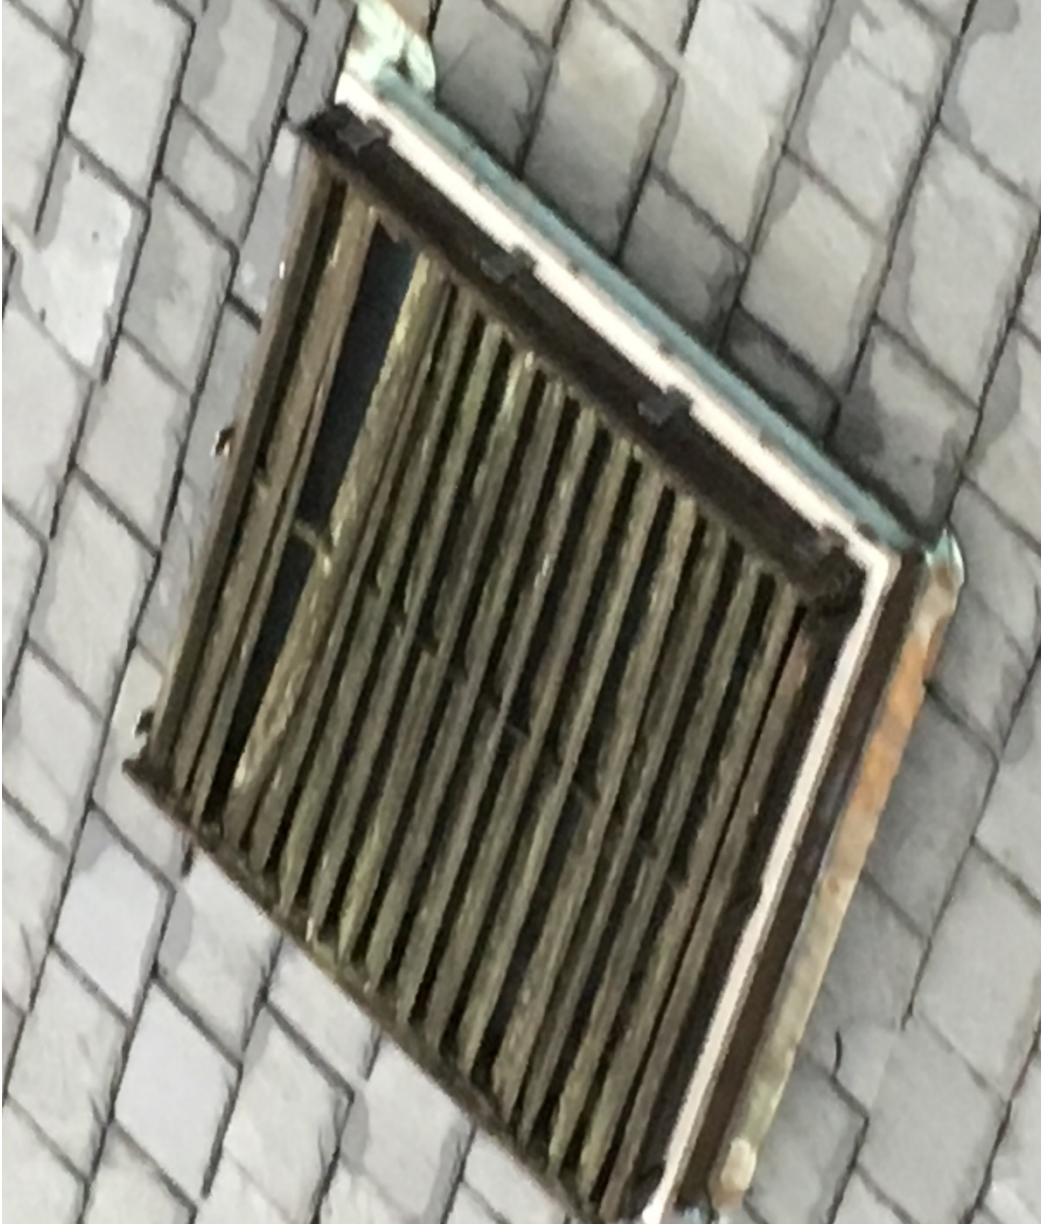
Finding # 29 Photo. The picture notes the rotten wooden louver which will need to be replaced.

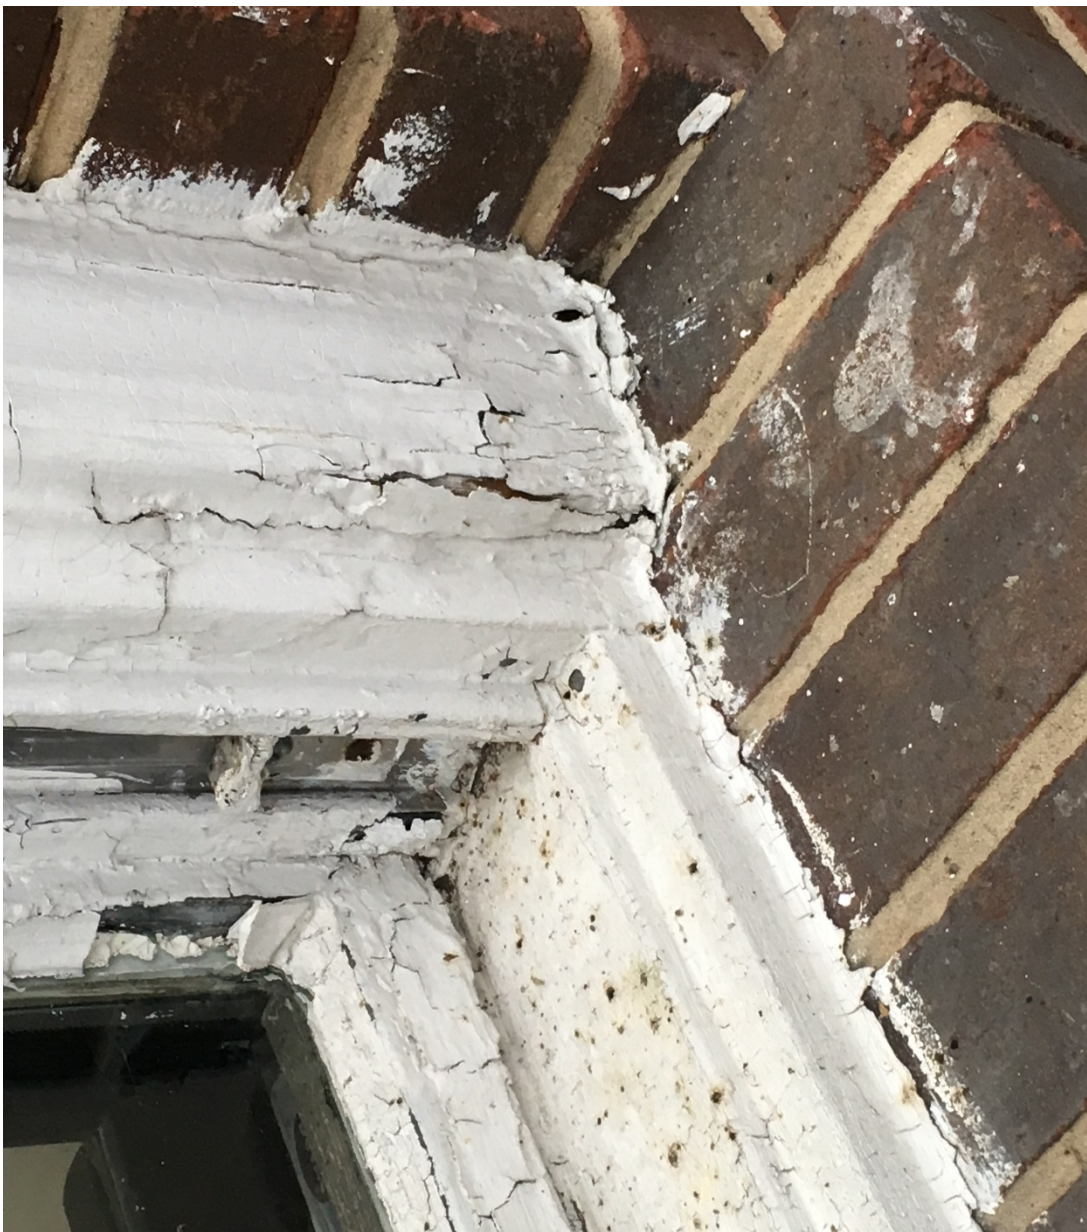
Finding # 30 Photo. This picture is an example of the damaged windows wood work.

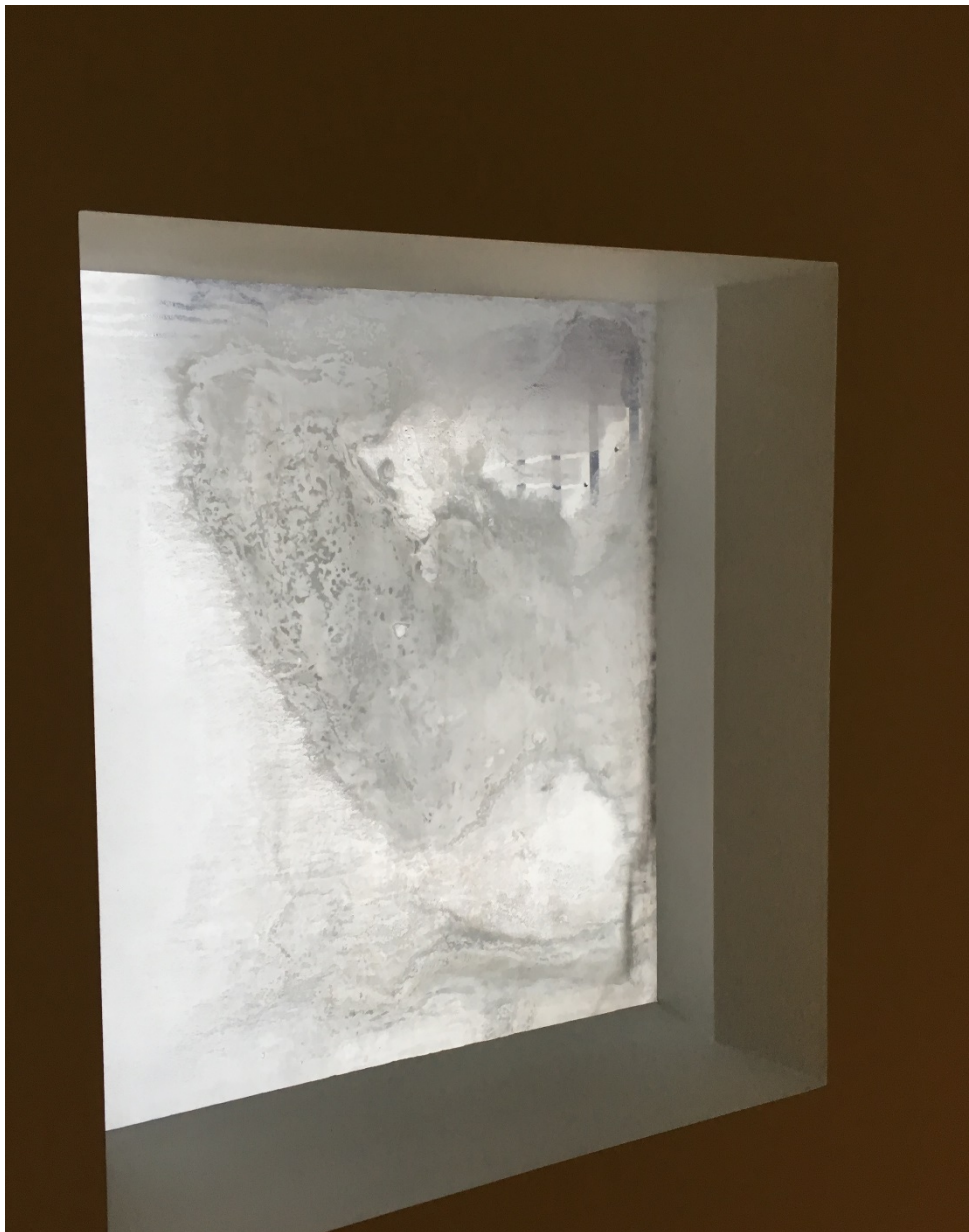
Finding # 31 Photo. This picture is one of the leaking skylights on the 5th floor.

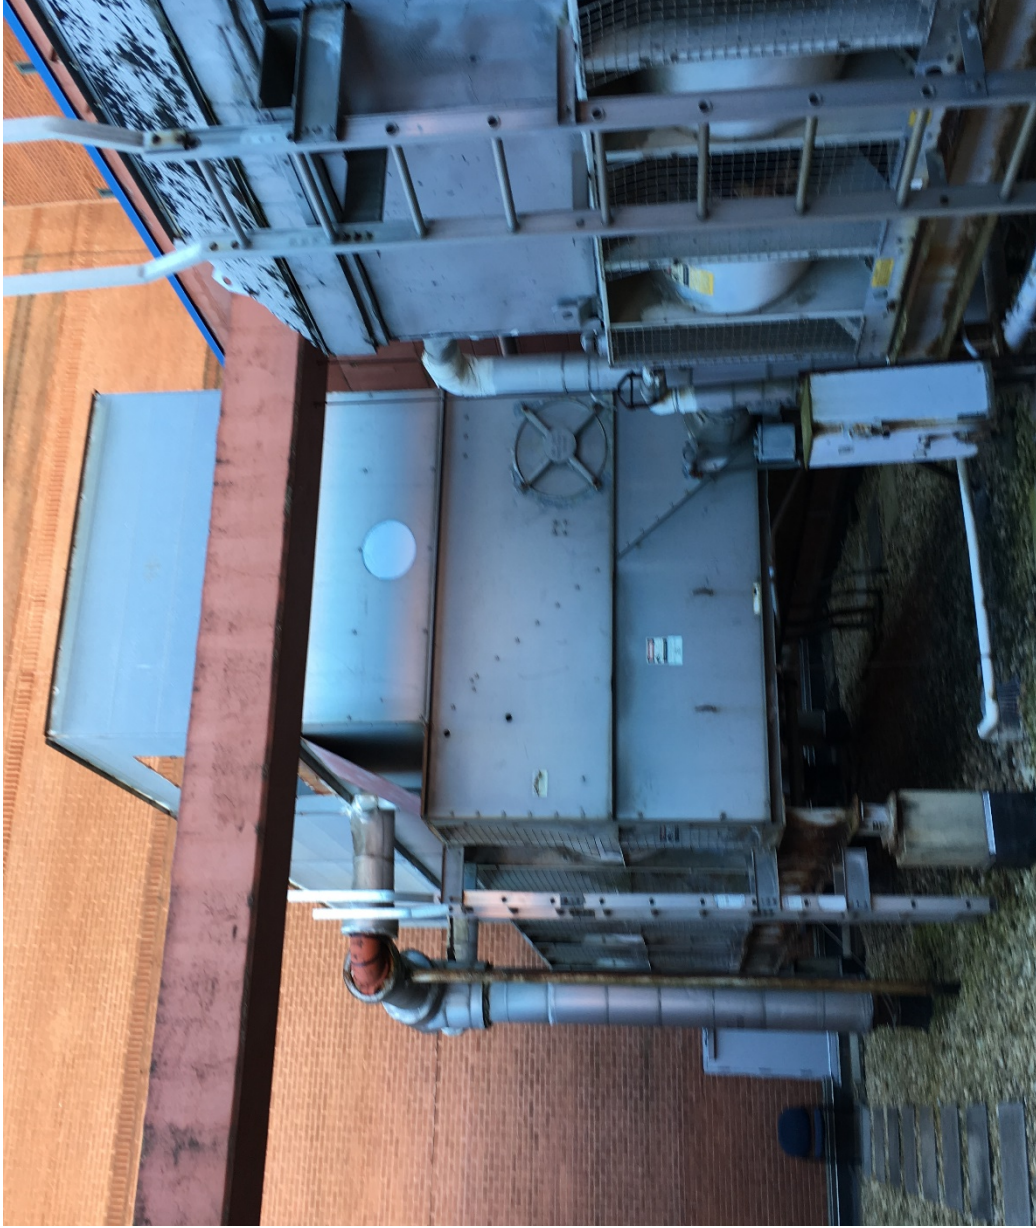
Finding # - 3 Equipment abandoned in place. This picture is of an abandoned in place cooling tower on the roof.

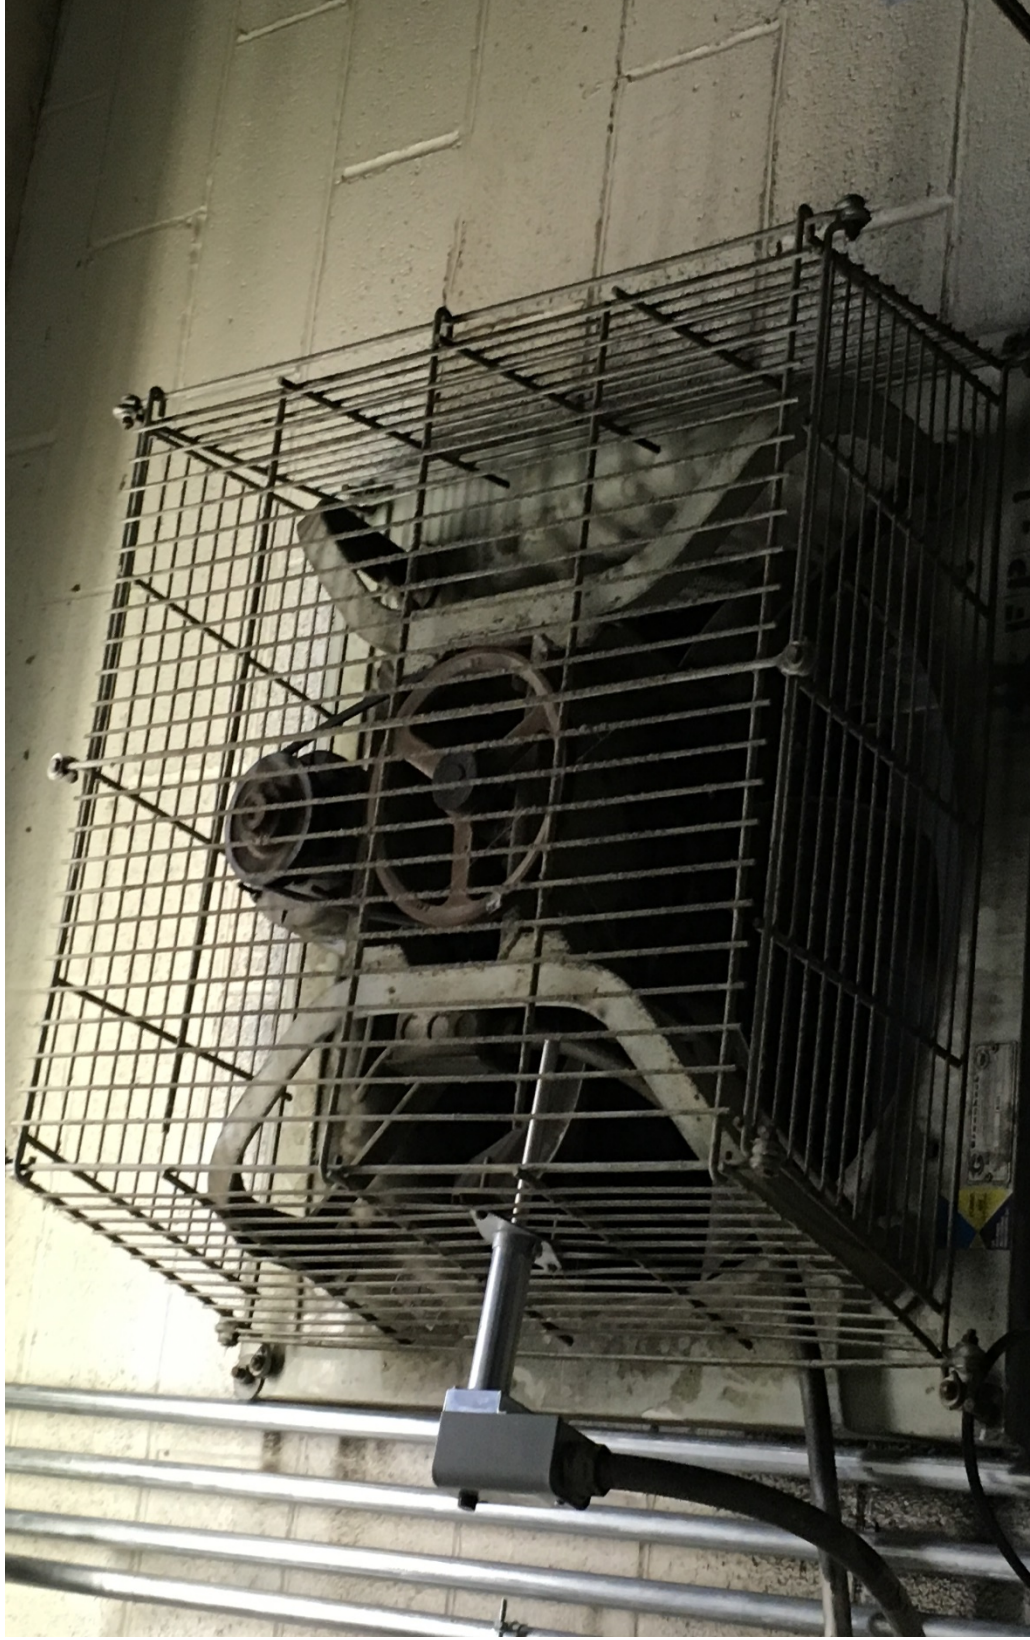
Finding # - 3 Equipment abandoned in place continued. This picture is a wall mounted exhaust fans left in place. There is also a damper assembly related to this fan.

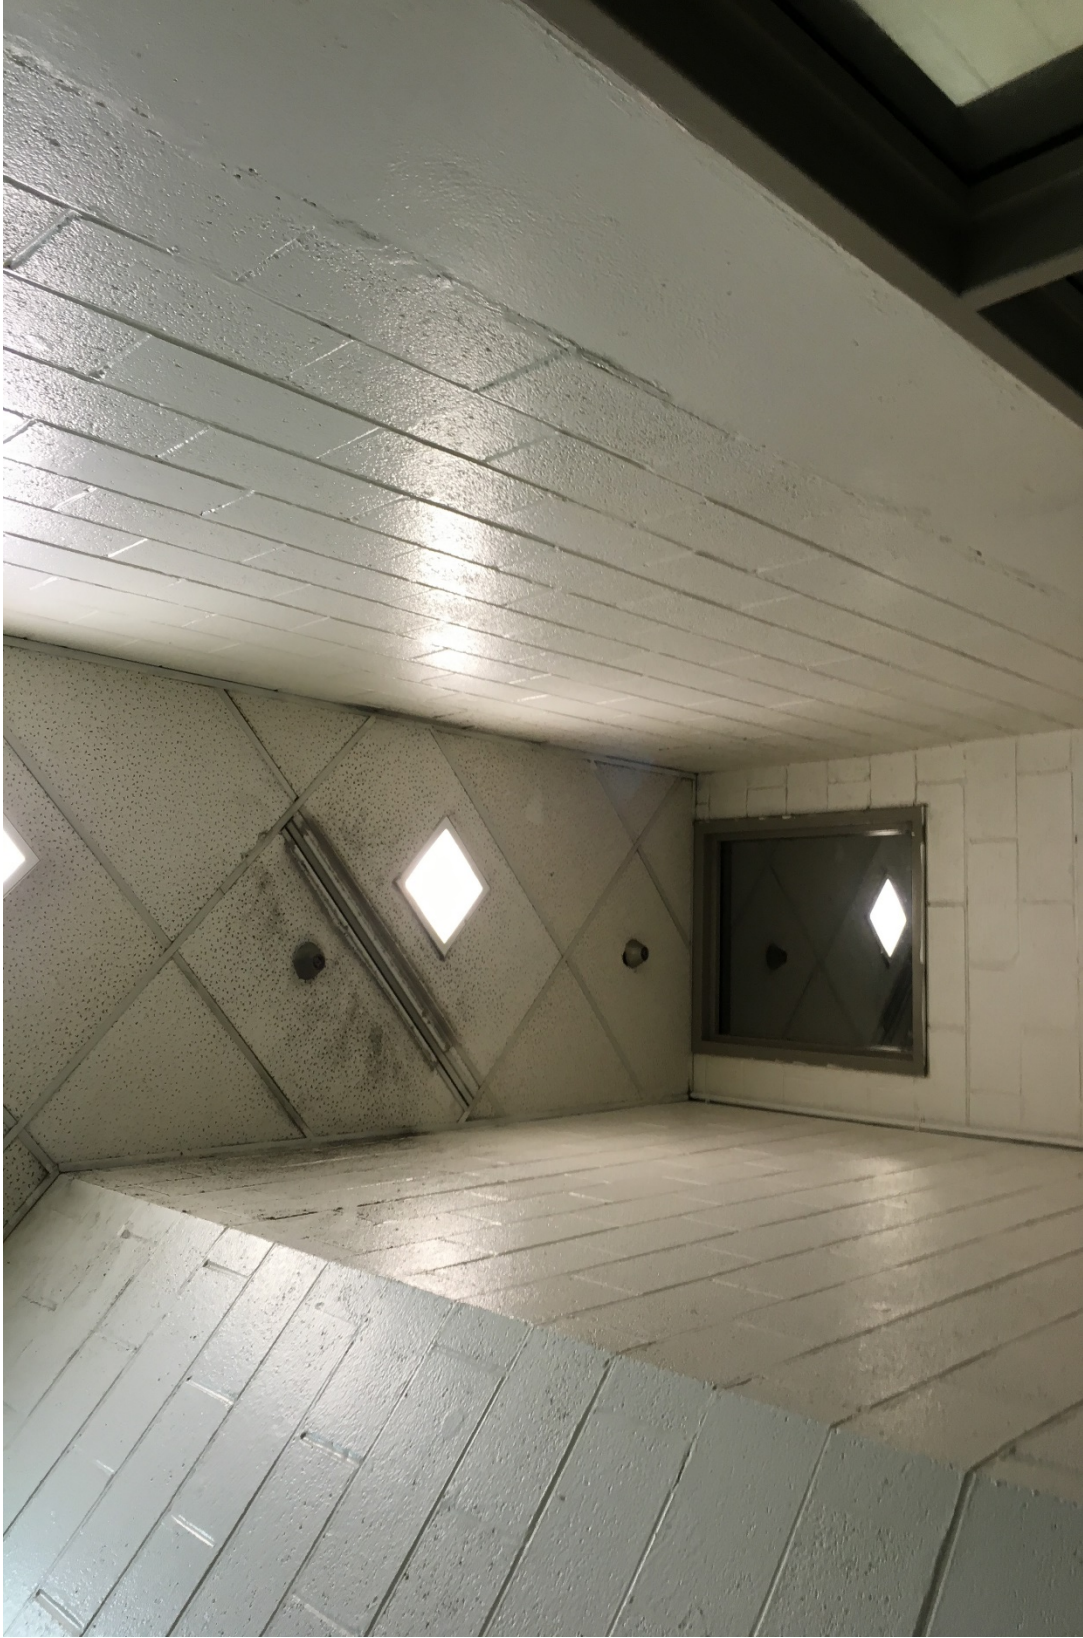
Finding # - 4 This picture is an example of how hard the ceiling diffusers, ceiling tile and light fixtures are to reach.

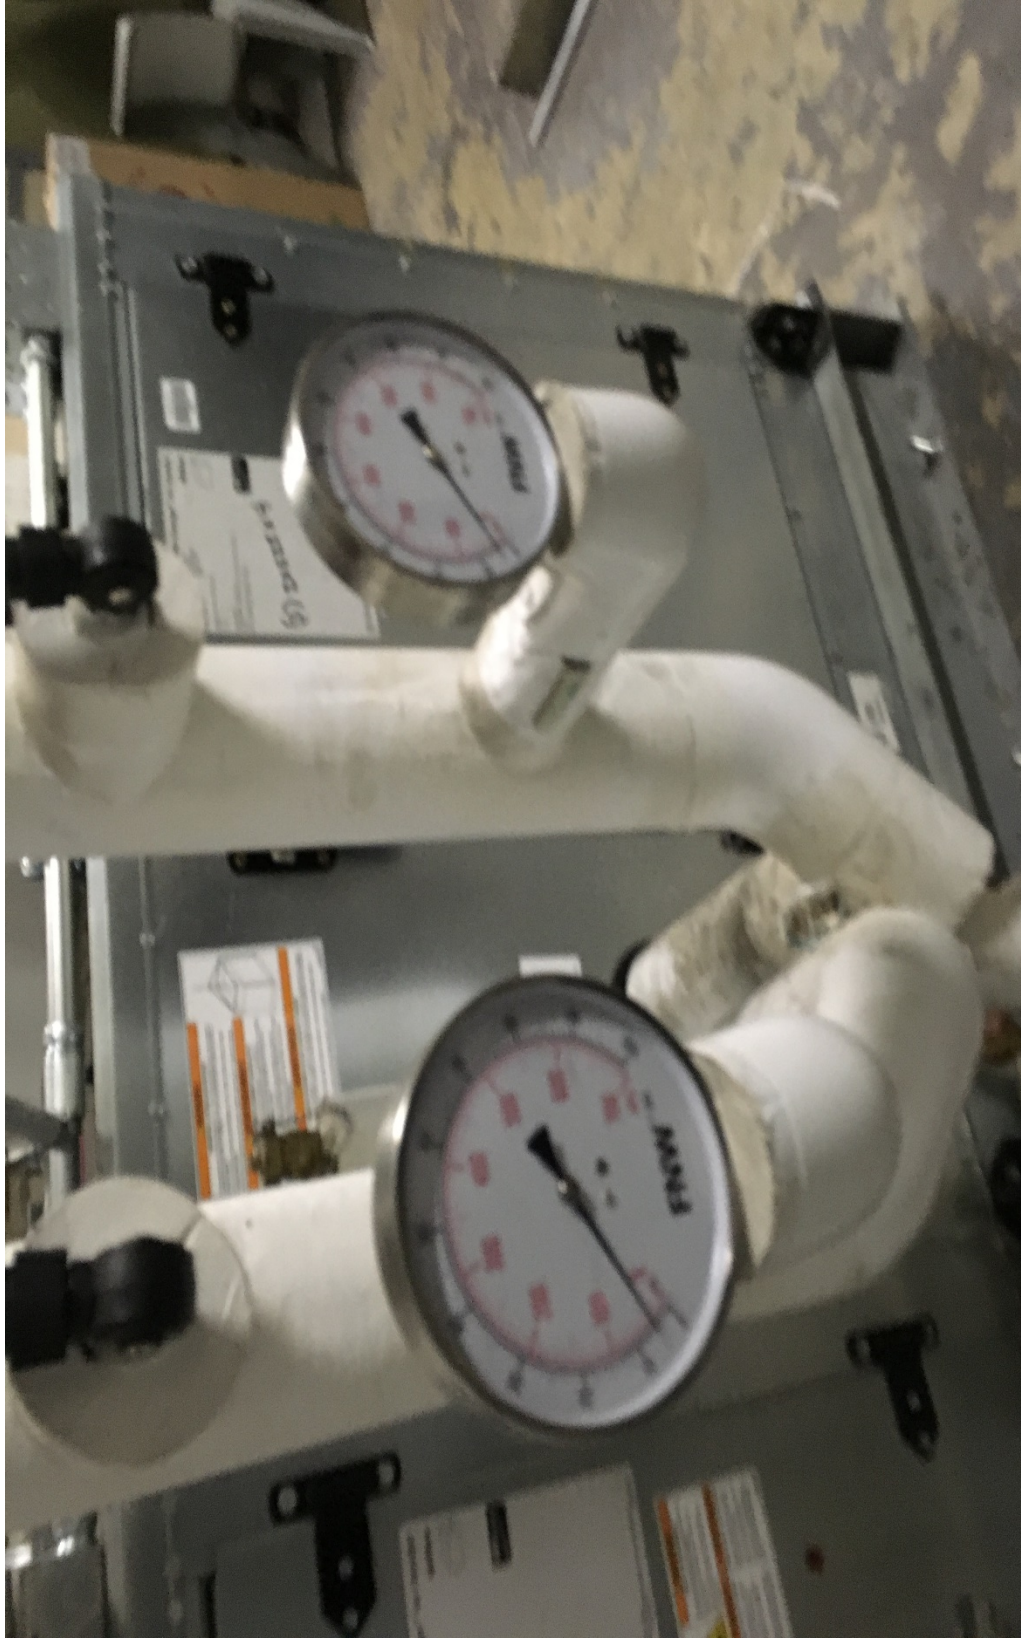
Finding # - 5 This picture notes the chilled water flow problems at the jail penthouse air handlers. Section R-3. The picture while blurred indicates that the pressure gauges are reading 5 PSIG and less. This should be reading up around 20 PSIG.

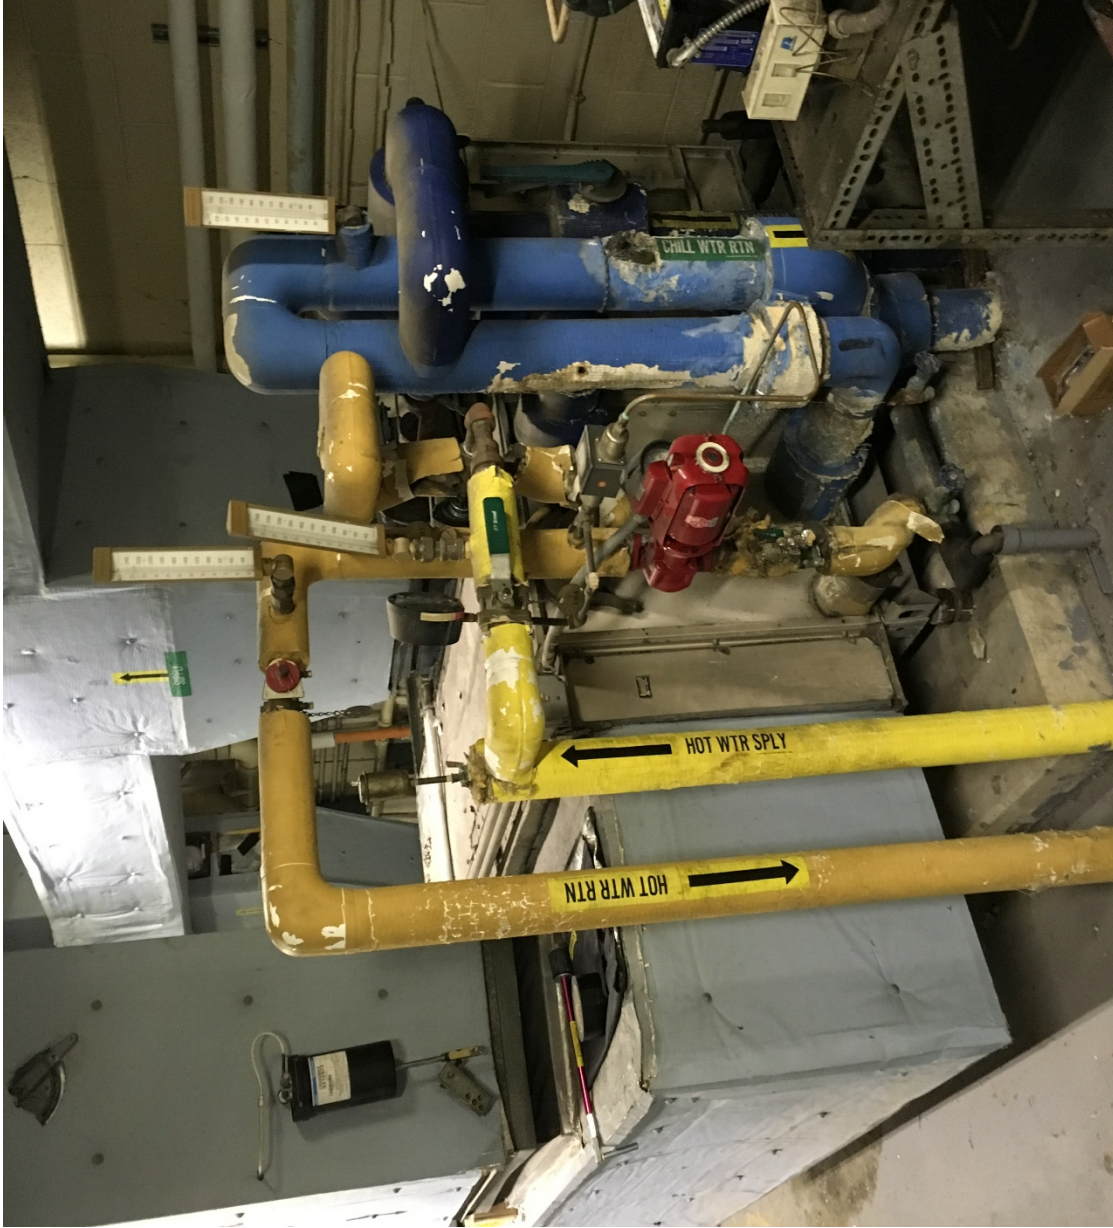
Finding # - 7 Section R-2 air handlers which are in poor condition.

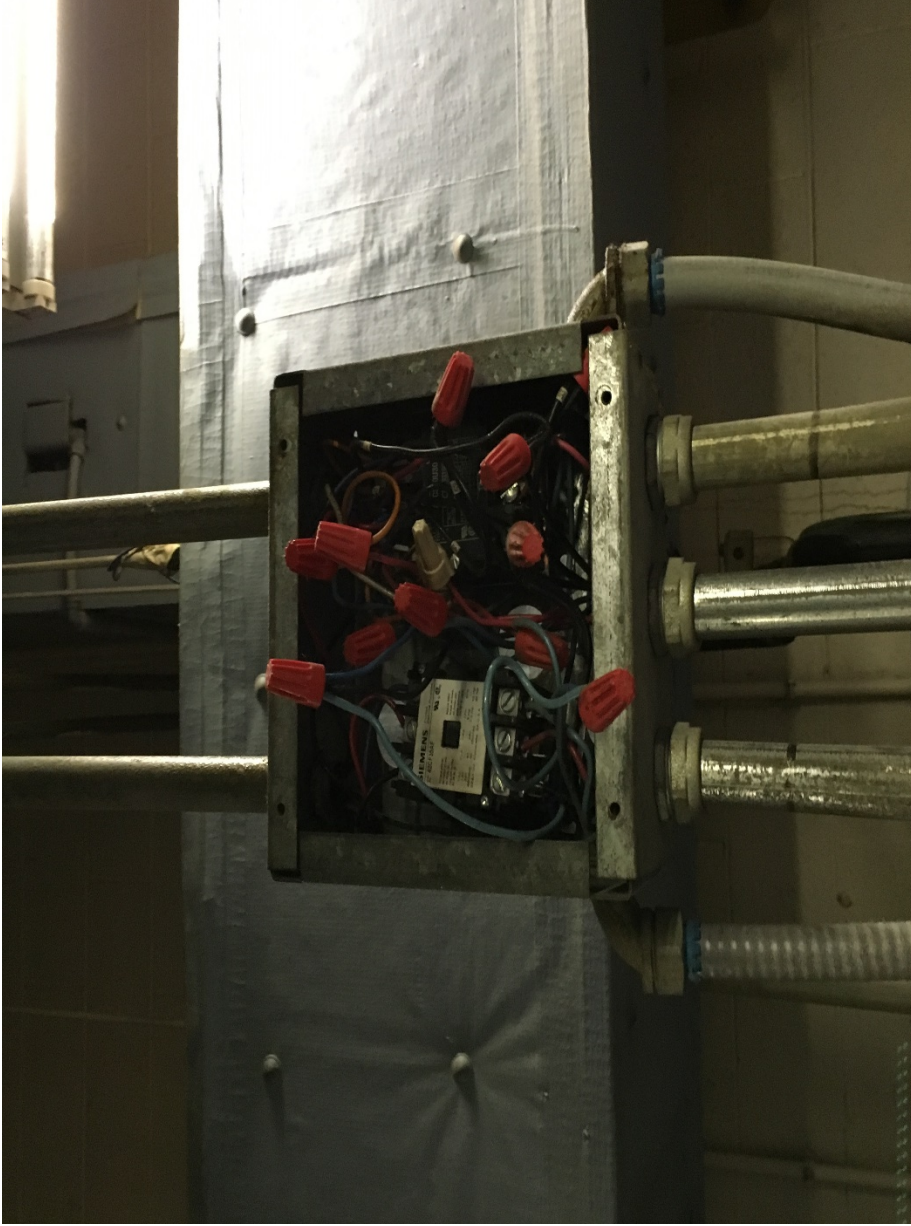
Finding # - 8 This picture is one example of the poor repair work being completed by the contractor maintaining this equipment, (i.e. no landing or mount in the control box).

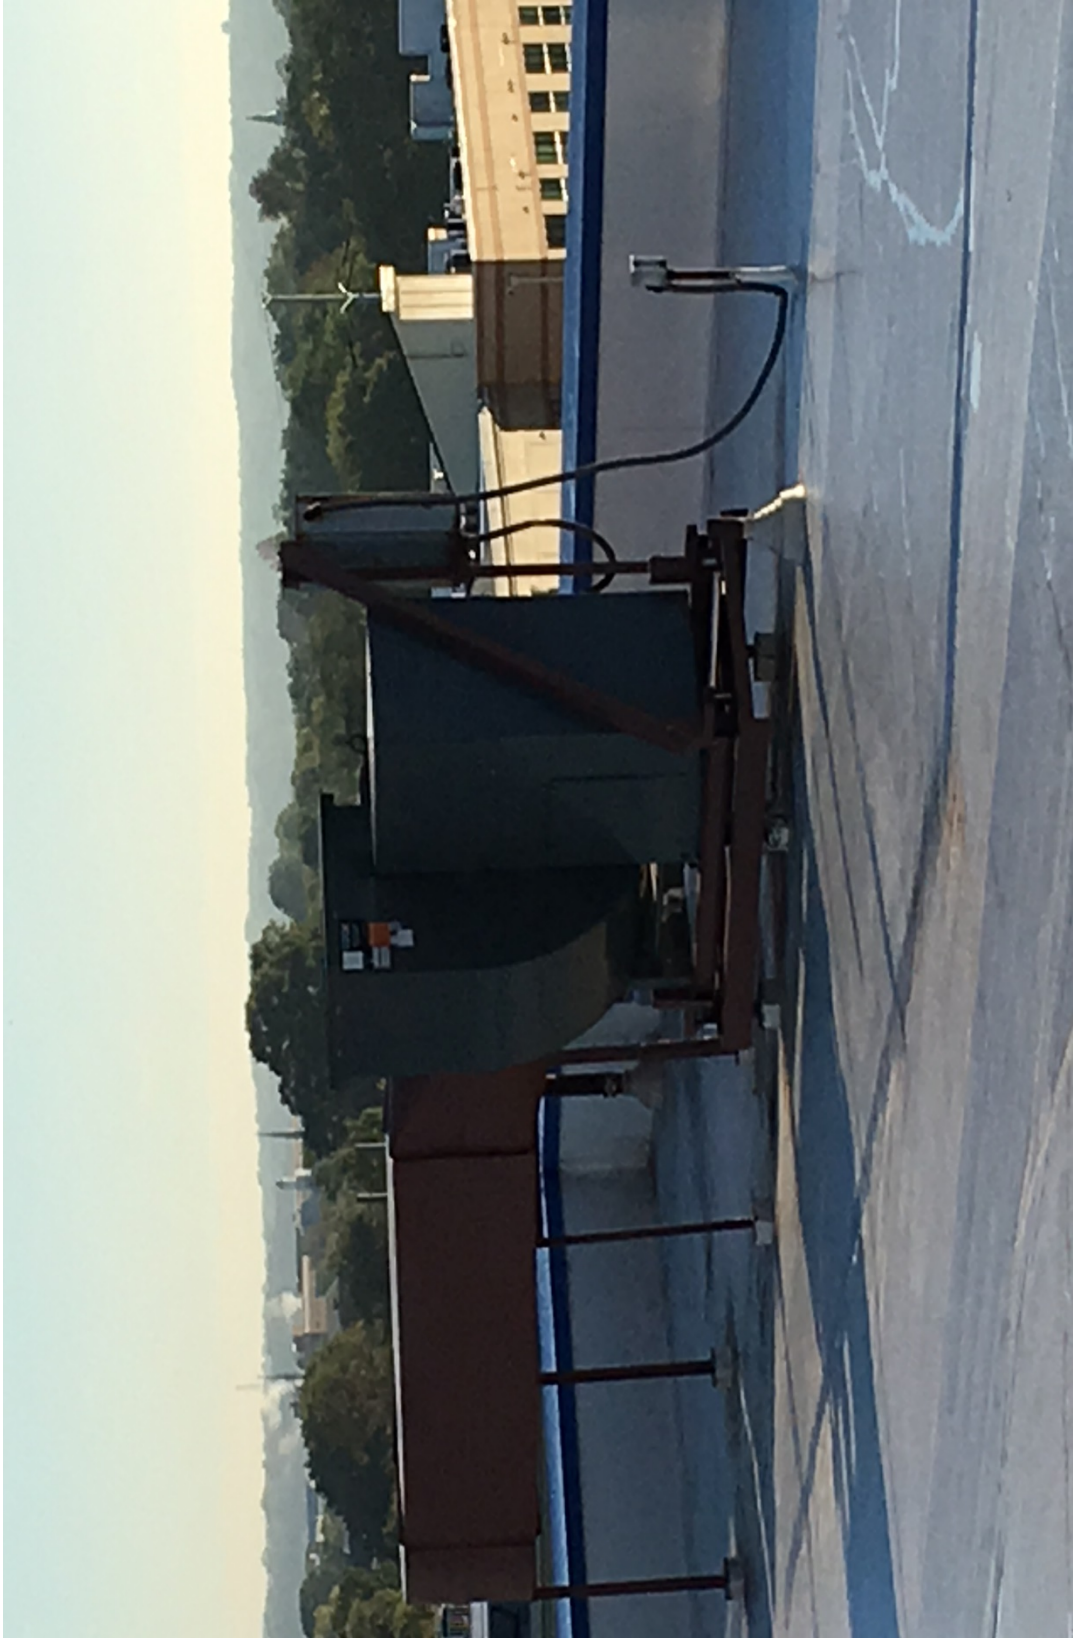
Finding # - 9 This picture is of exhaust fan that serves the kitchen hood system. The belt is loose and needs to be repaired.

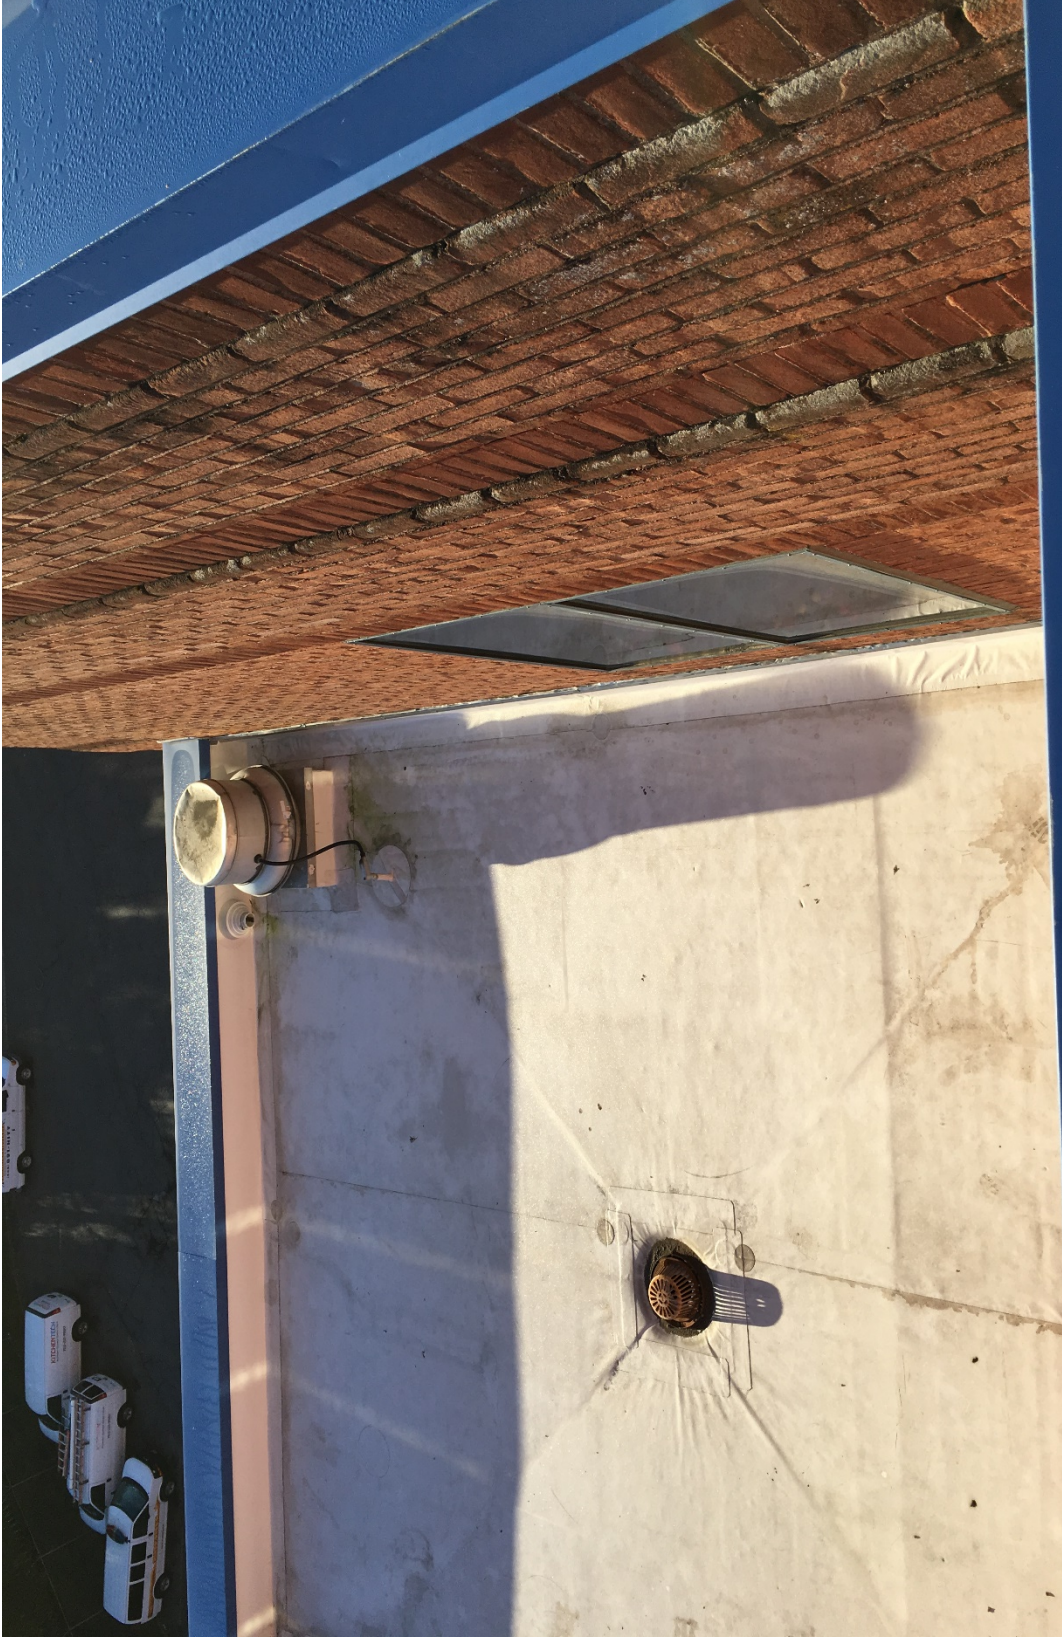
Finding # - 10 This exhaust should have an OSHA approved safety ladder installed to allow safe access to service the fan.

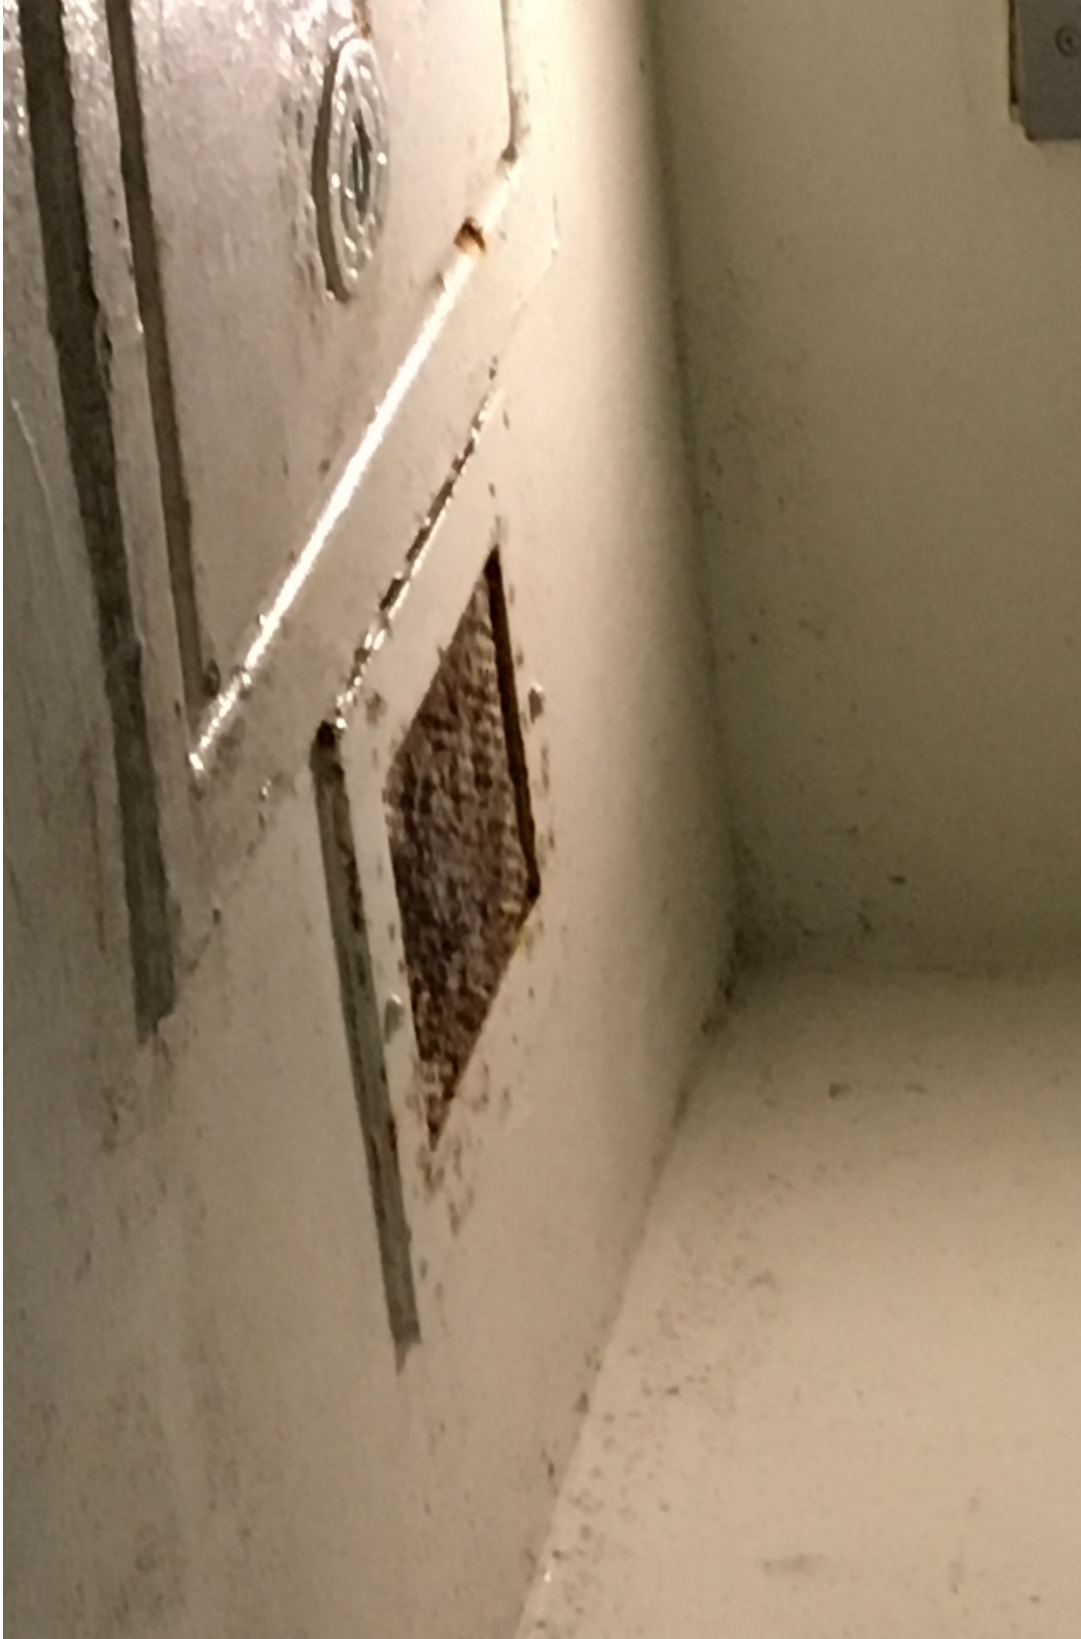
Finding # - 11 Numerous exhaust grills in the jails housing area shower stalls should be replaced.

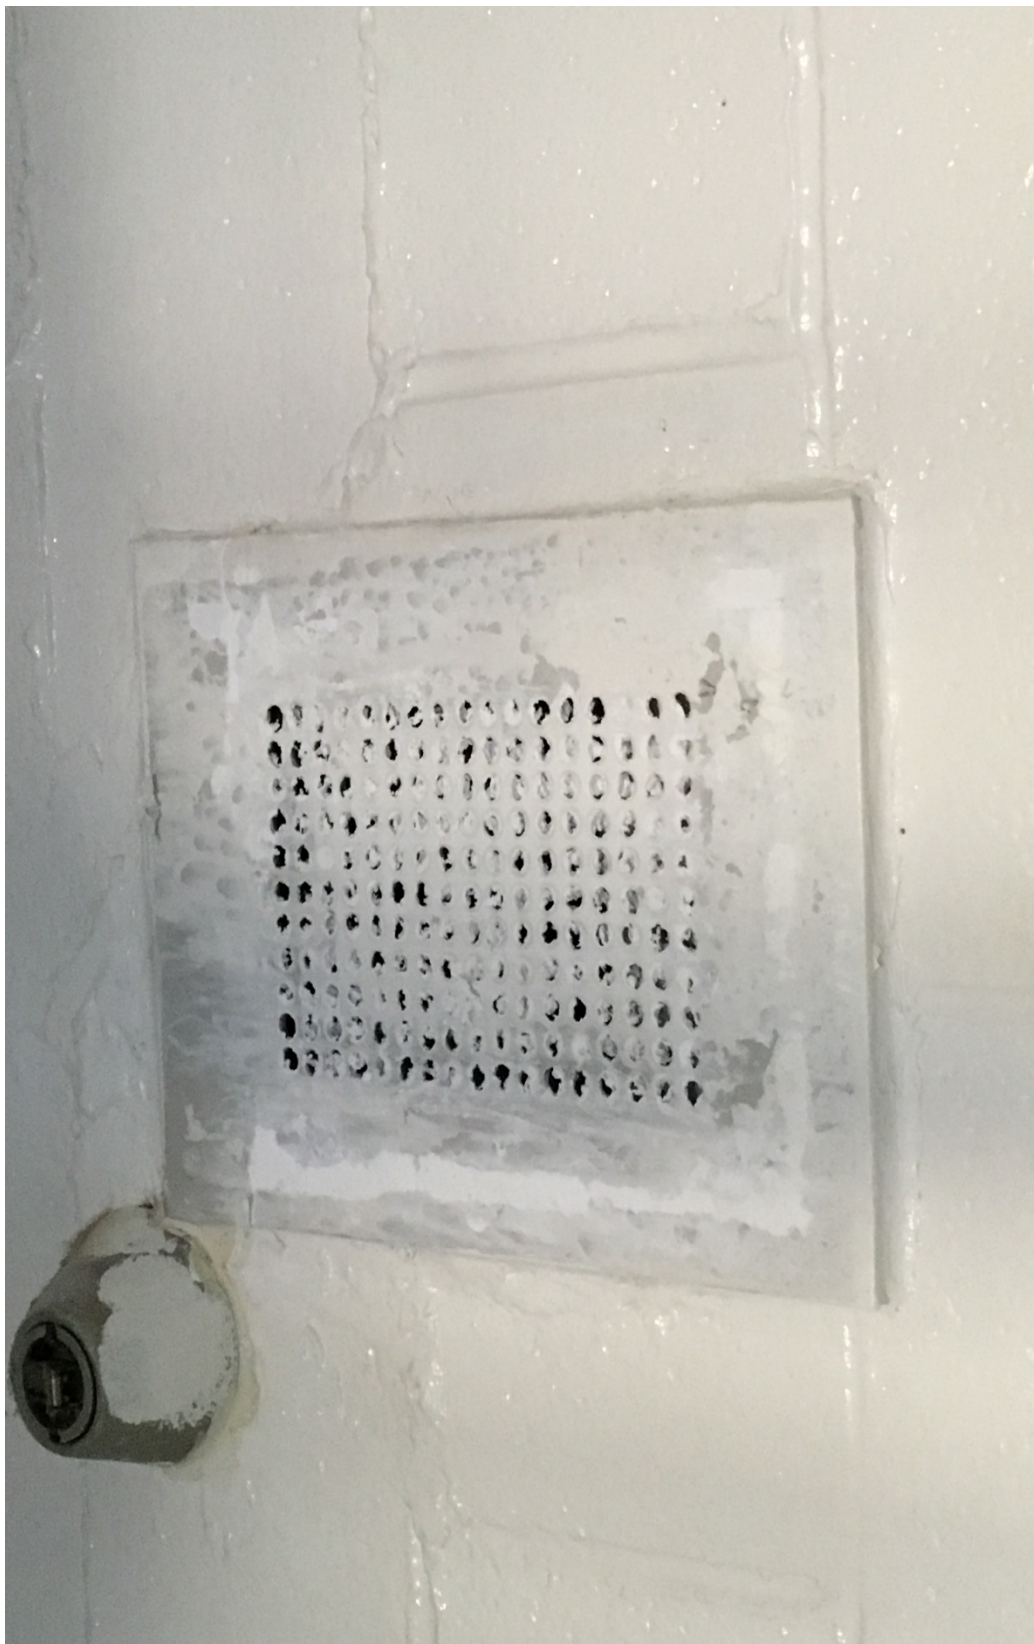
Finding # - 12 Numerous supply grills in the jail cells need to be replaced with the inmates have damaged them.

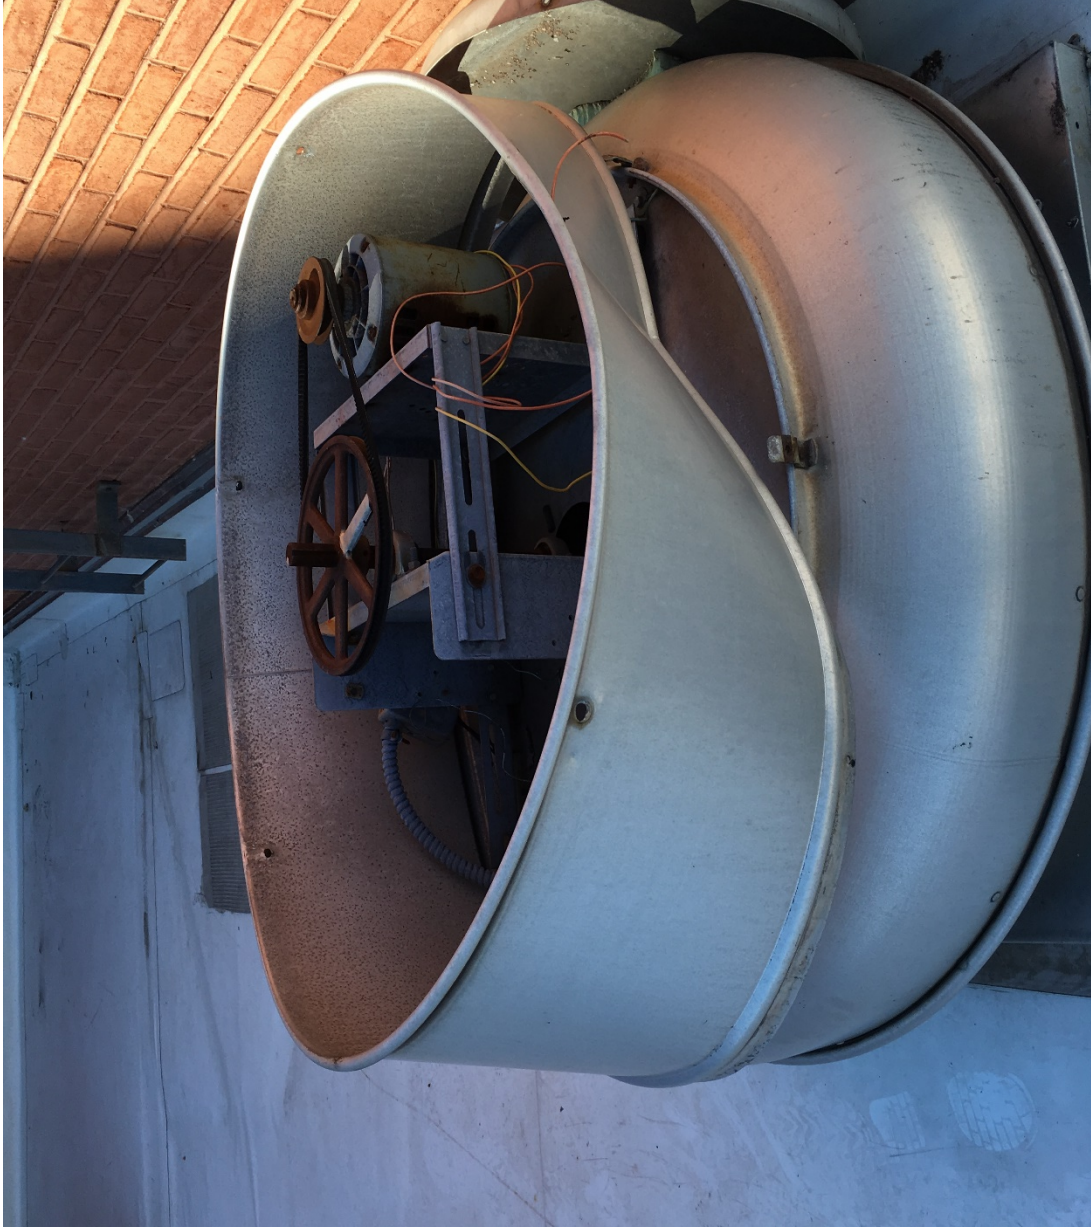
Finding # - 13 One roof top exhaust fan has failed. It should be repaired then put back into service.
