**FROM: JOINT CITY-SCHOOLS FACILITY INVESTMENT TASK FORCE
Lynn Hampton, Chair, Mignon Anthony¹, Elliott Branch, Micheline Castan-
Smith, Marshall Cook, Dwight Dunton, Amy Liu, Dave Millard, Eric Wagner**

SUBJECT: TASK FORCE FINAL REPORT (DELIVERABLE 2 OF 2)

A2 Services, Inc. Facility Survey of City of Alexandria - City Hall

A2 Services, Inc.
Facility Survey of the City of Alexandria – Public Safety Center

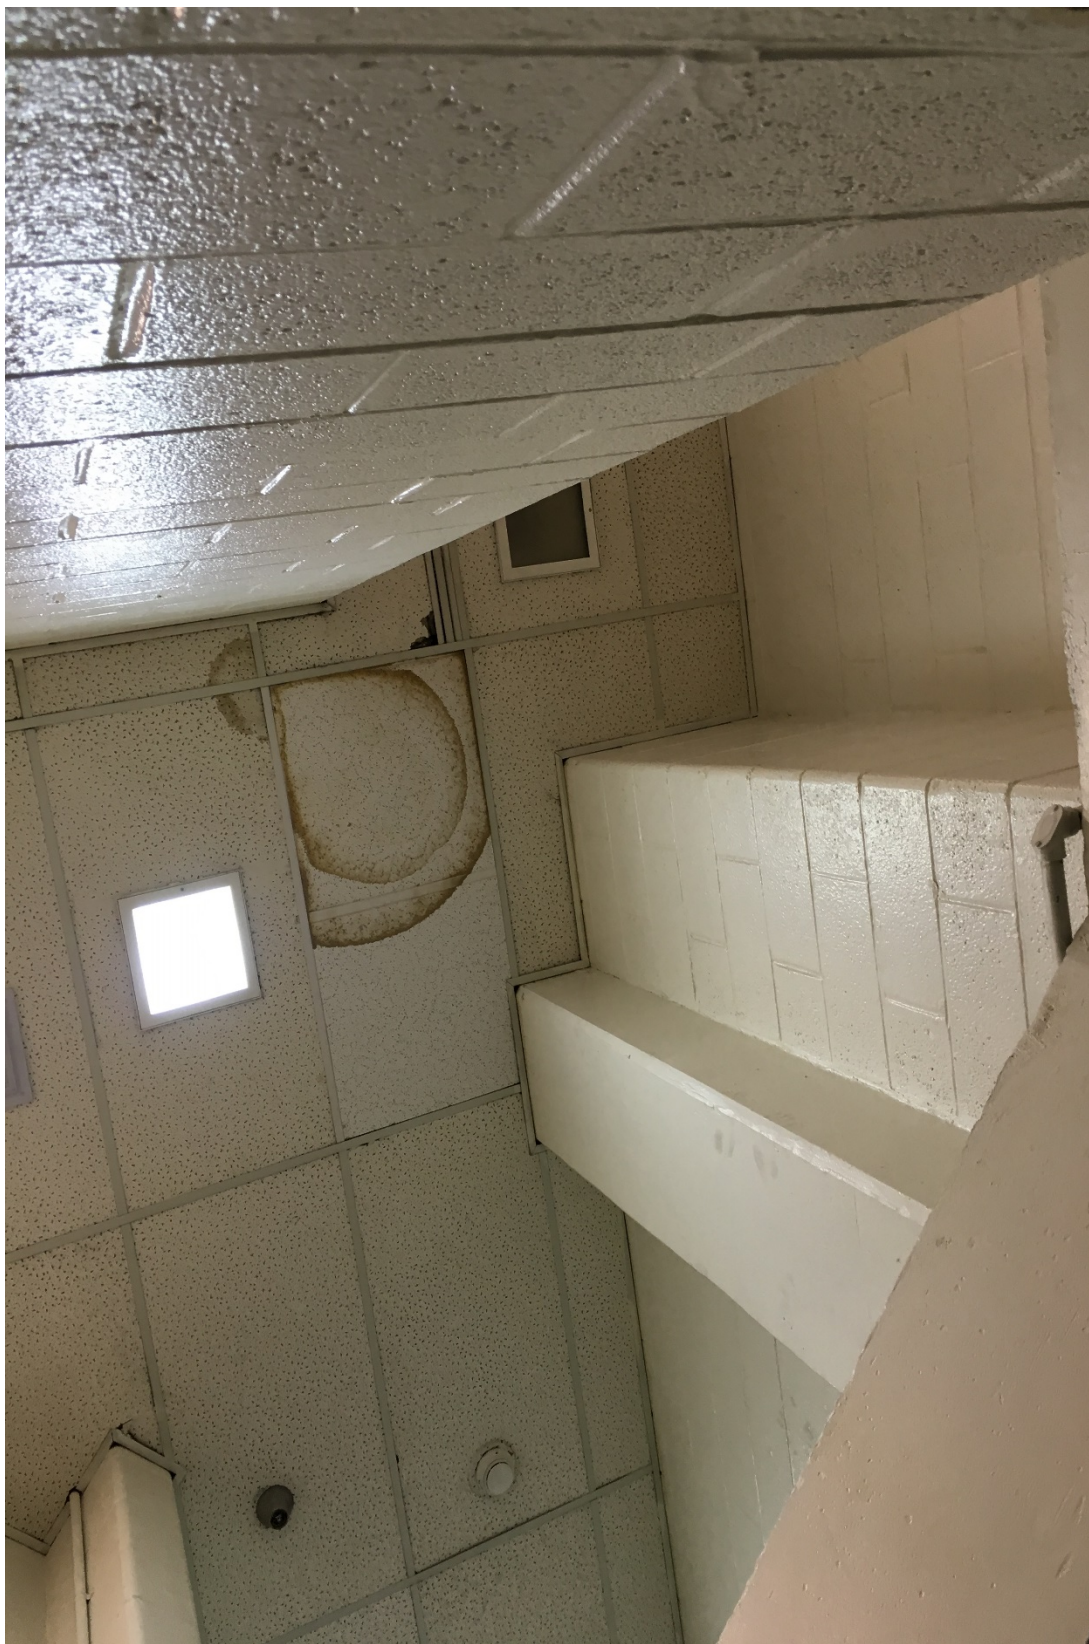
Finding # - 16 This picture is an example of ceiling access to light fixtures, ceiling tile and diffusers. This is in a stairwell.

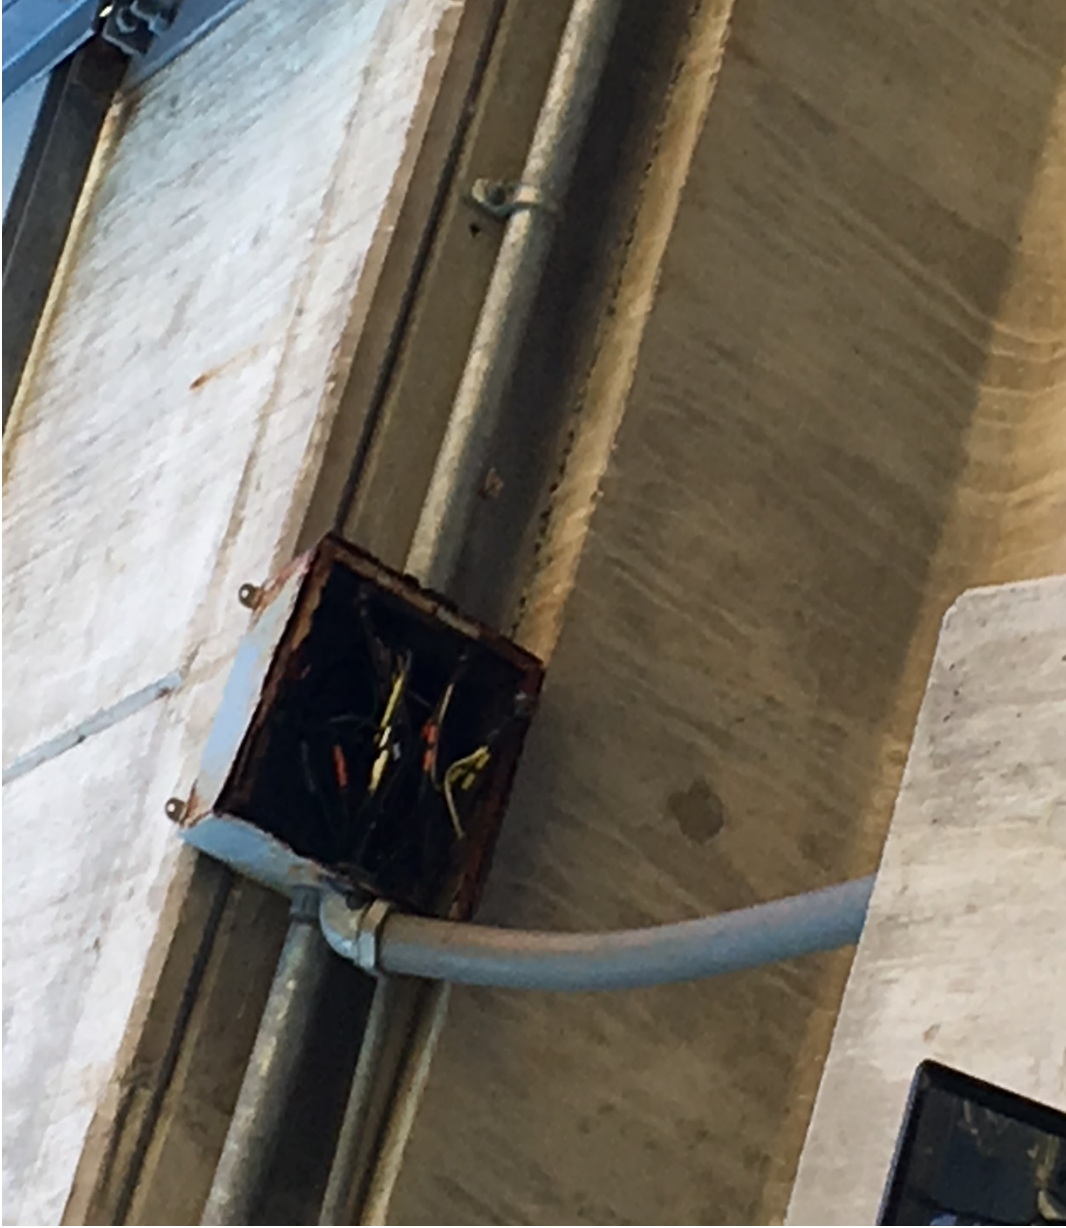
Finding # – 17 This picture shows the rusted away electrical piping and junction boxes which are rusting away. This electrical service feeds the parking area lights under the beltway access ramp and will require a bucket truck.

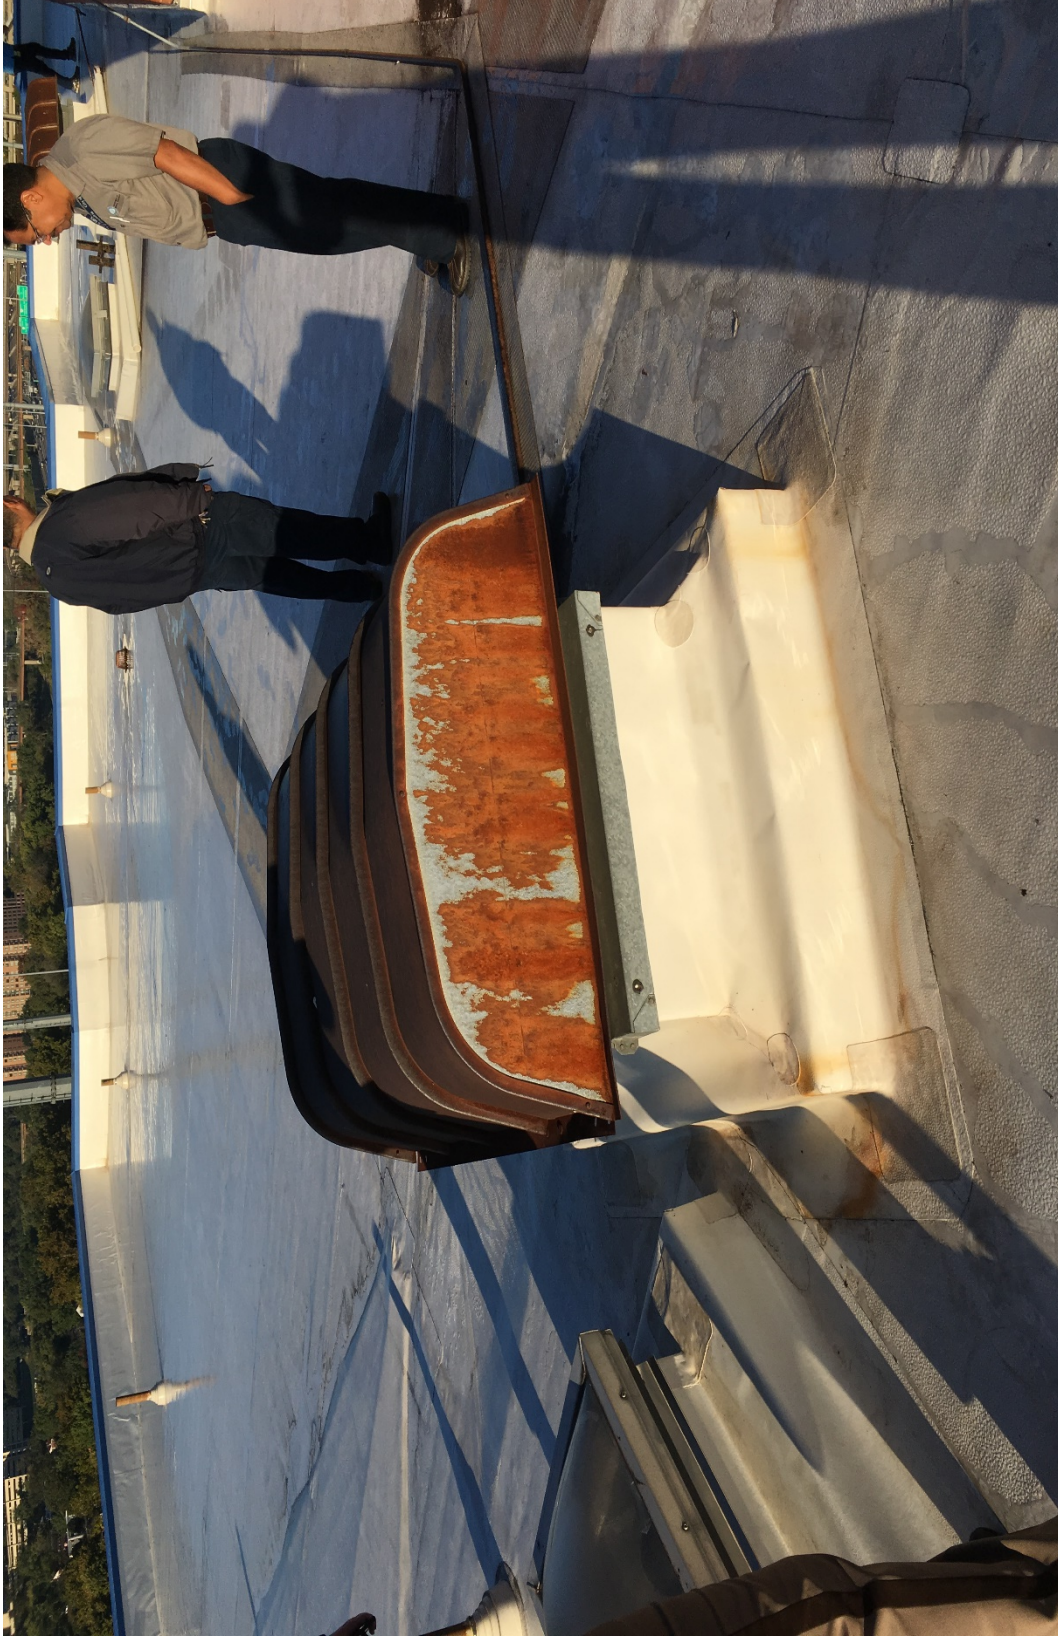
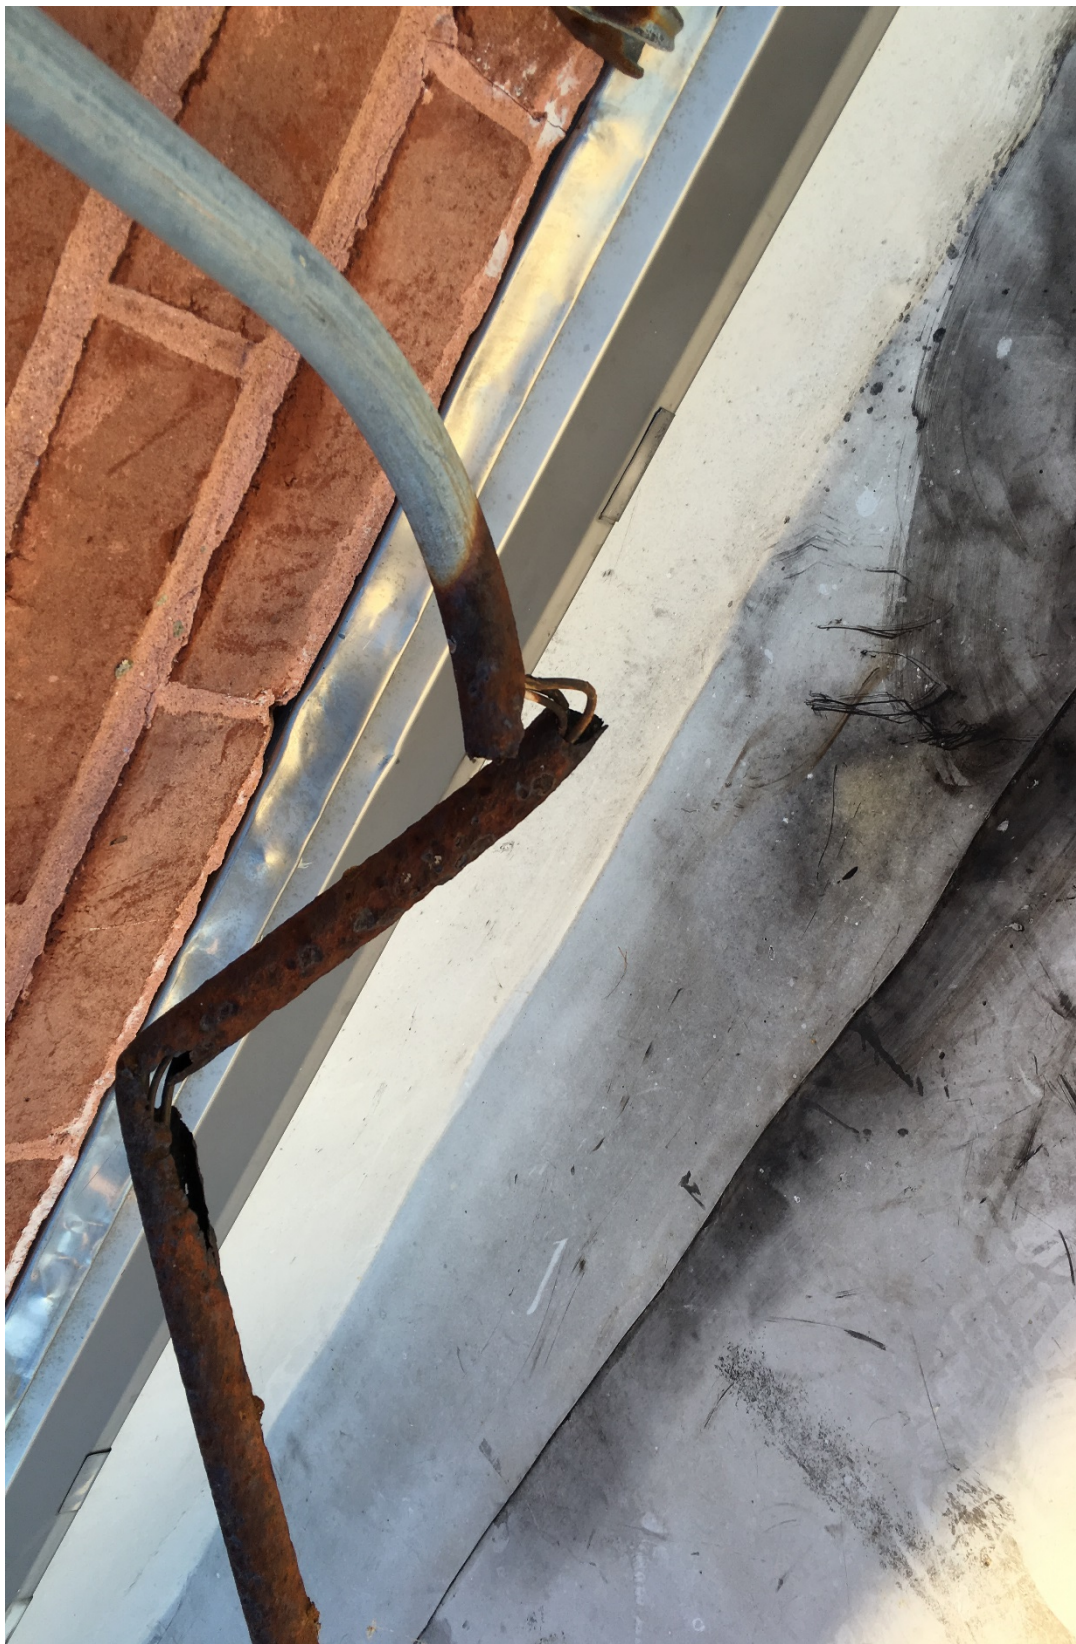
Finding # - 18 This picture is of the building vent dampers where the power wiring and conduit should be repaired.

Finding # - 18 continued. This picture is of the damager power wiring and conduit to the damper assembly.

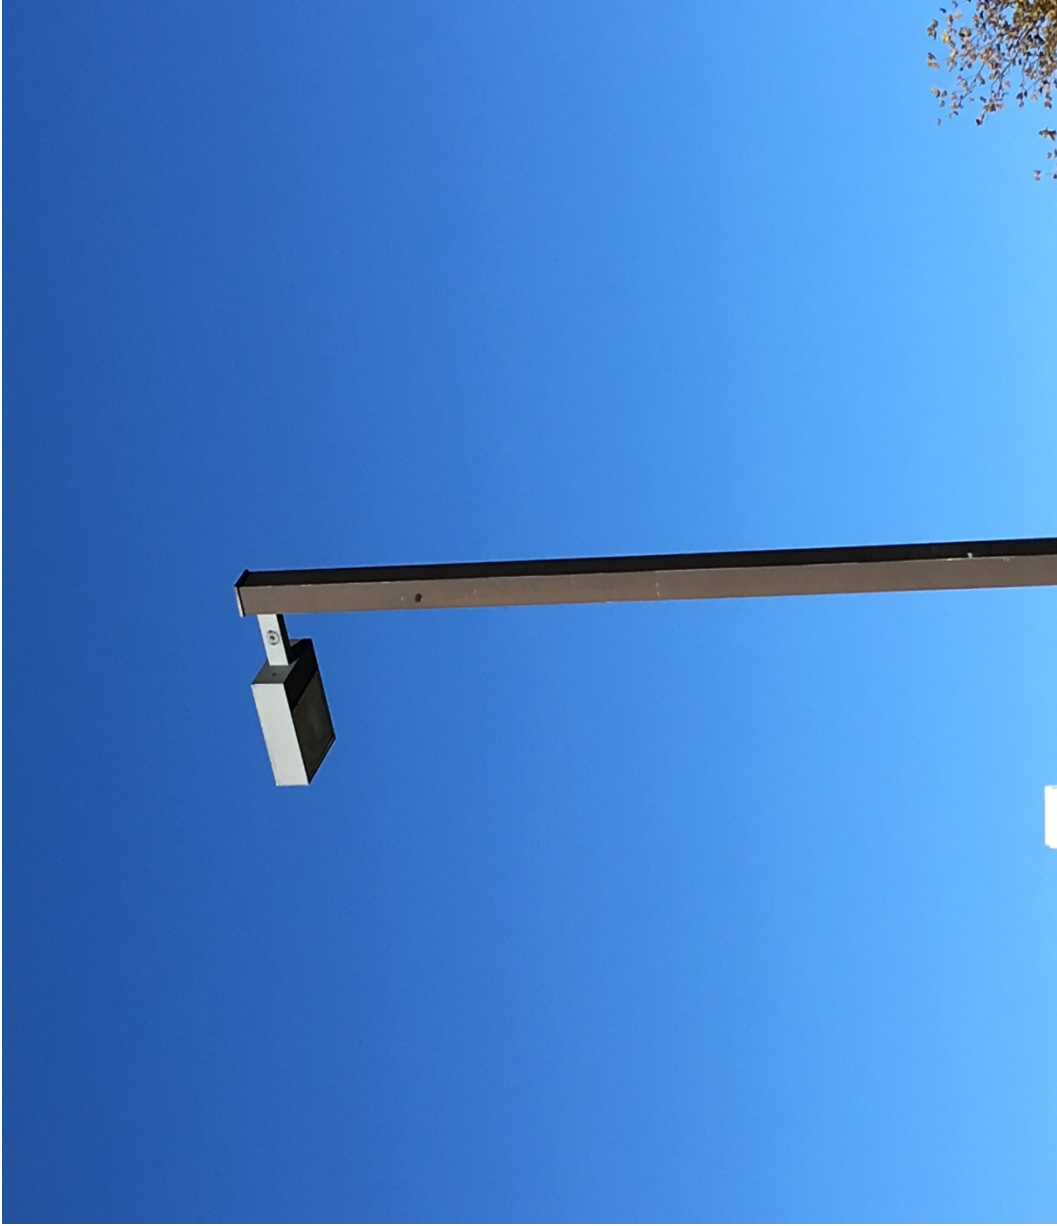
Finding # - 19 This picture is of one the exterior pole light which cannot be accessed for repairs or re-lamping without an outside contractor using a bucket truck.

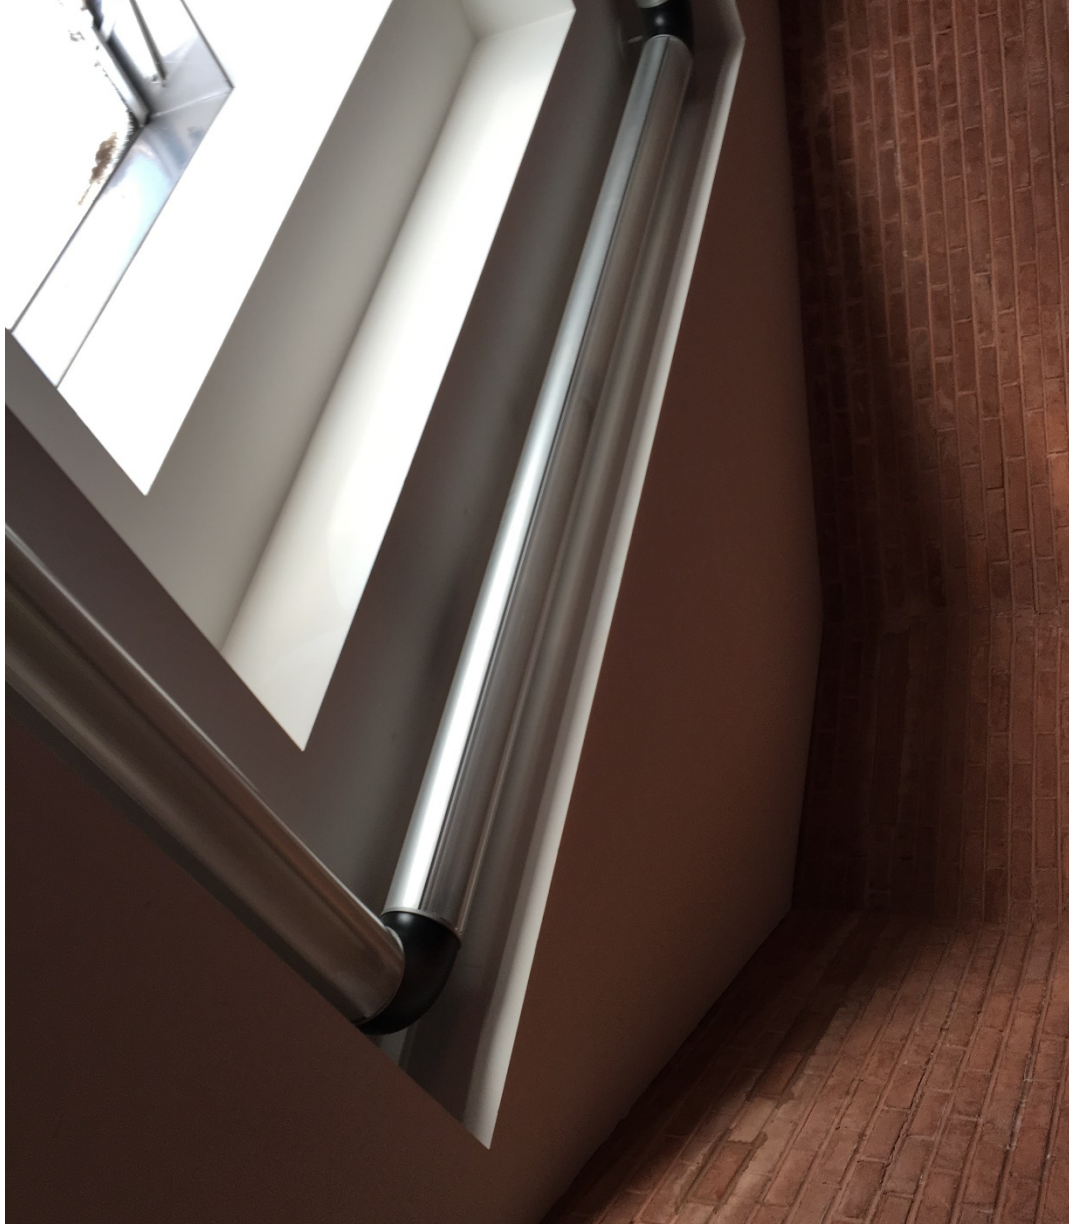
Finding # - 20 This picture is one of the lights in the sheriff's office stairwell which cannot be accessed to change the bulbs or repair the fixtures.

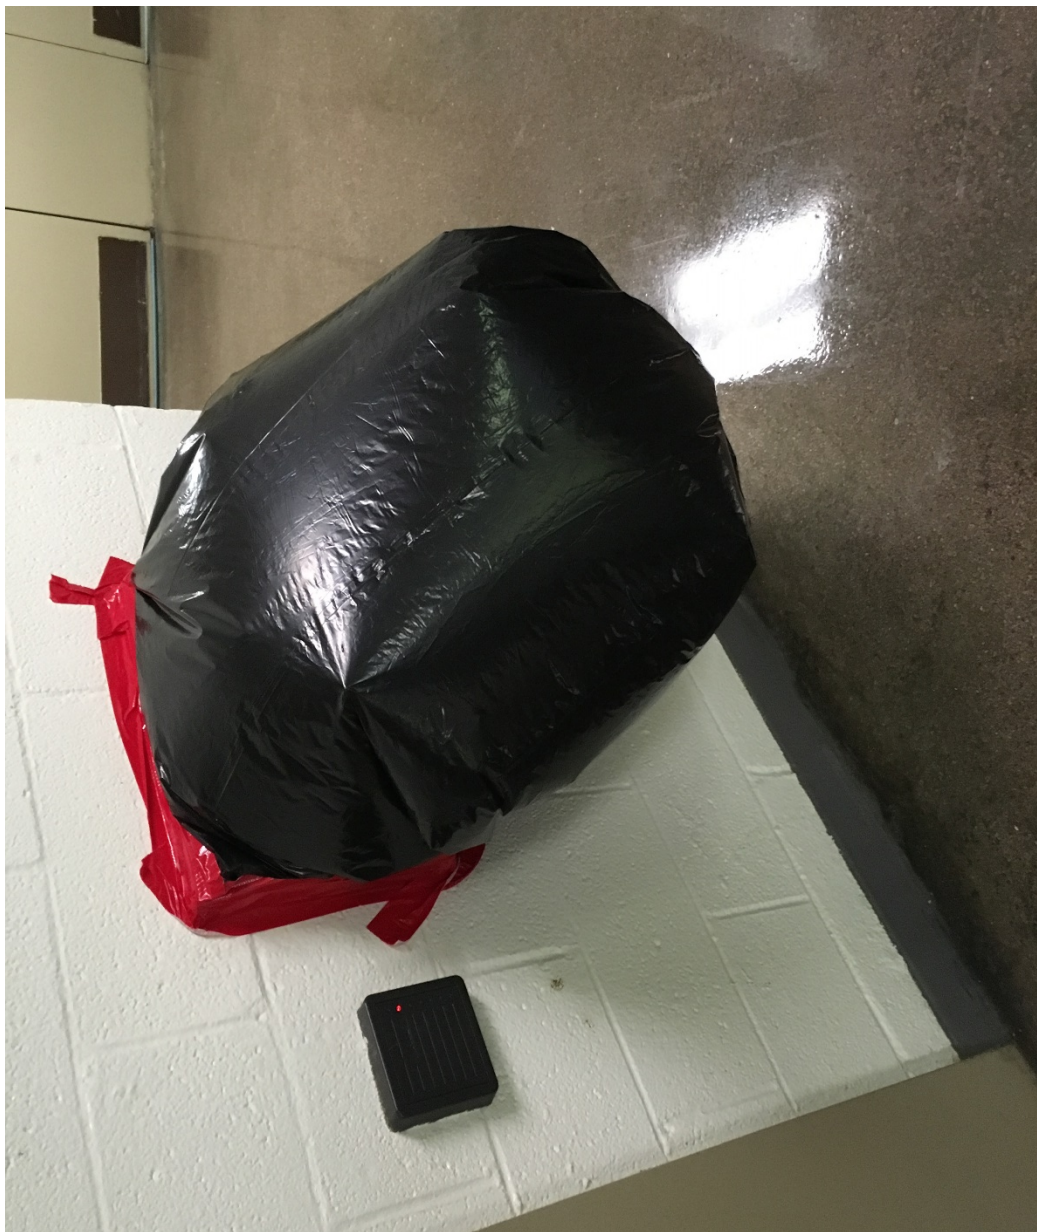
Finding # - 23 This picture is of the water fountain in the jail which will need the block wall cut away for repairs.

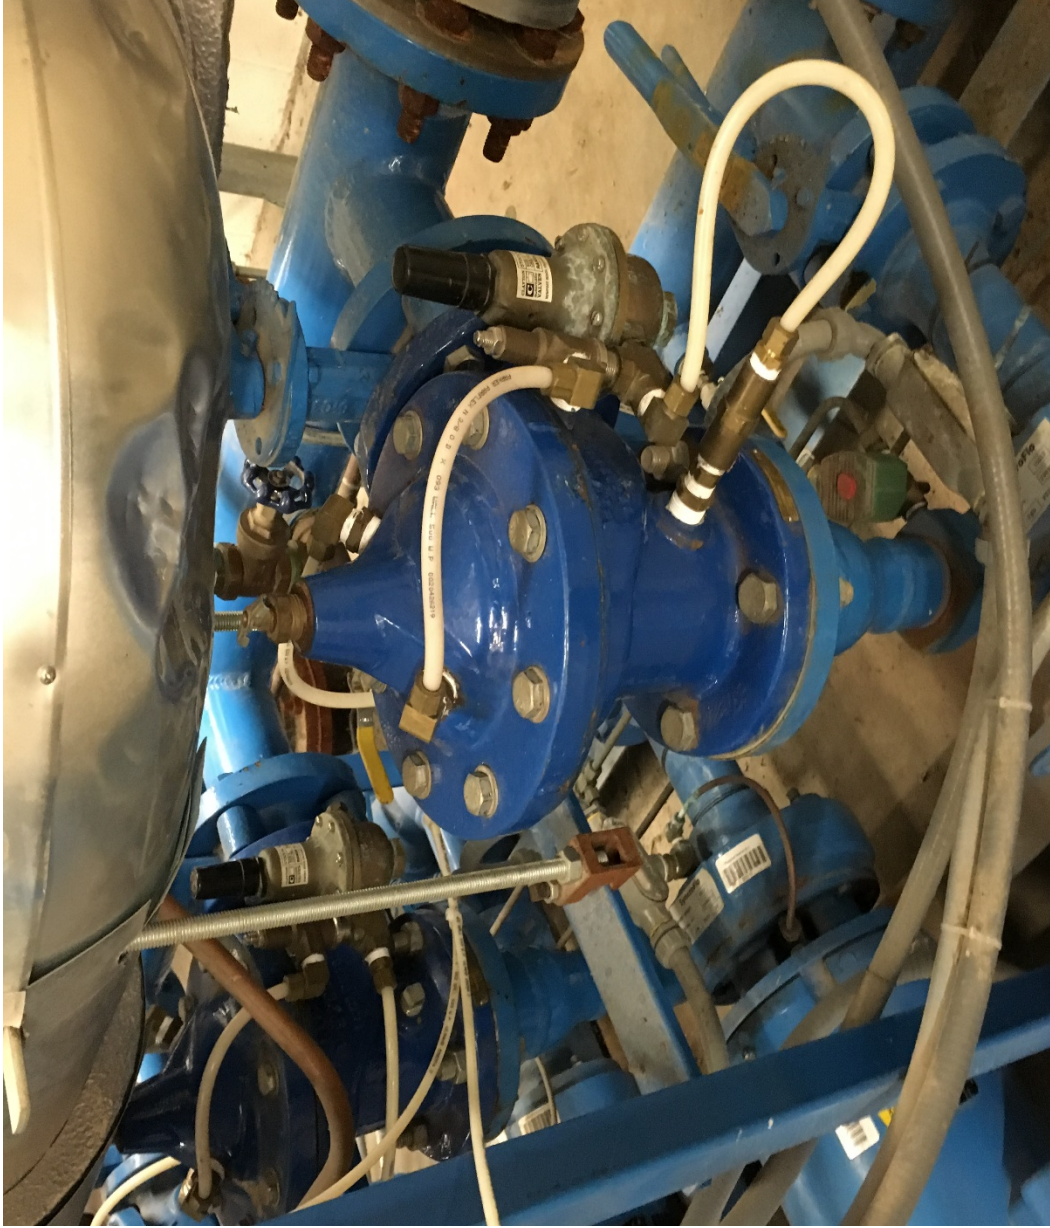
Finding # 24 A2 recommends consideration of installing VFDs on the domestic water booster pumps.

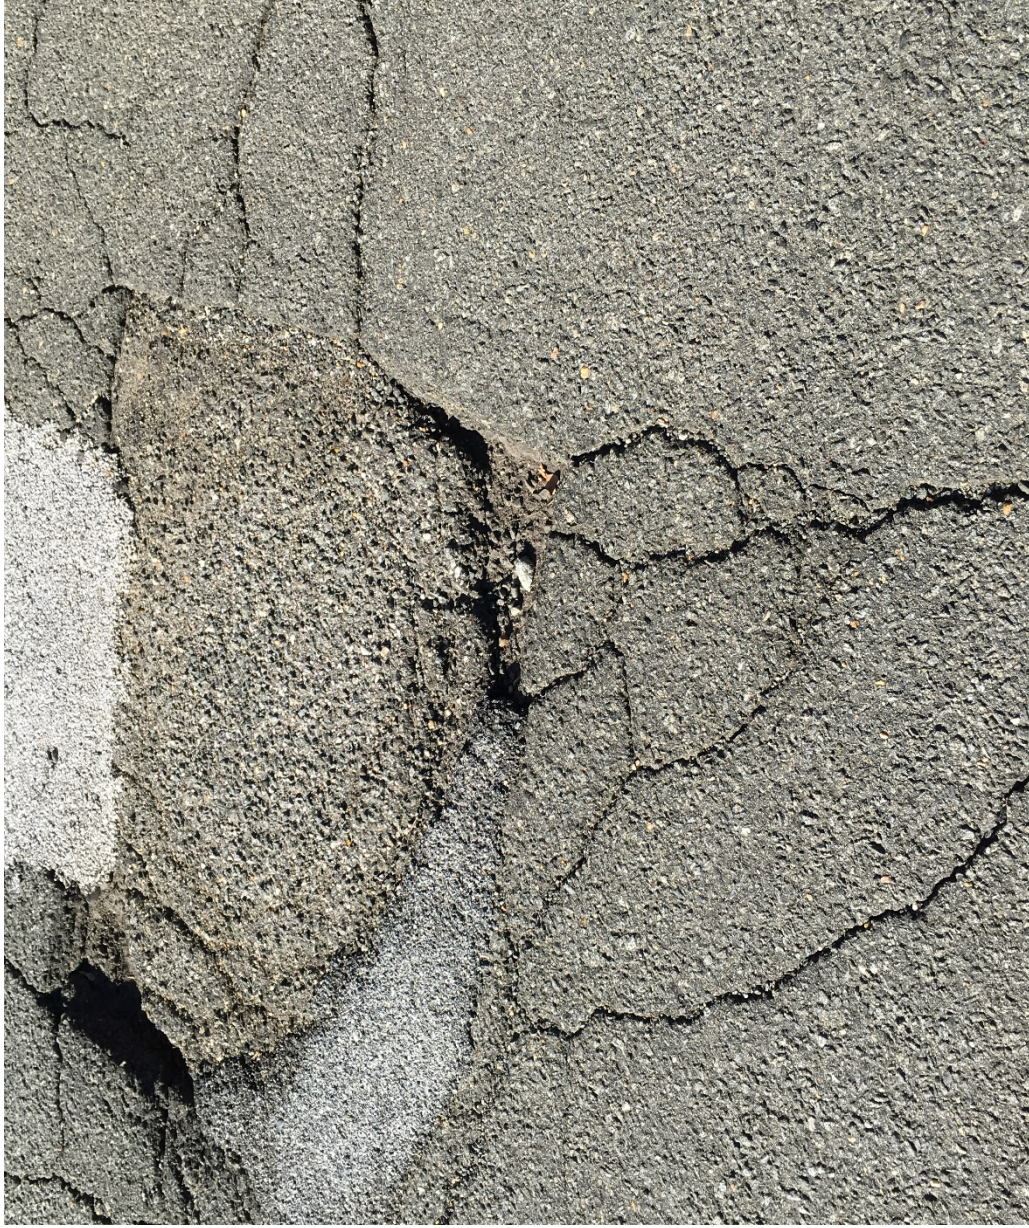
Finding # - 25 This picture is one example of asphalt damage in the parking areas and driveways. There are many areas with damage similar to this condition.

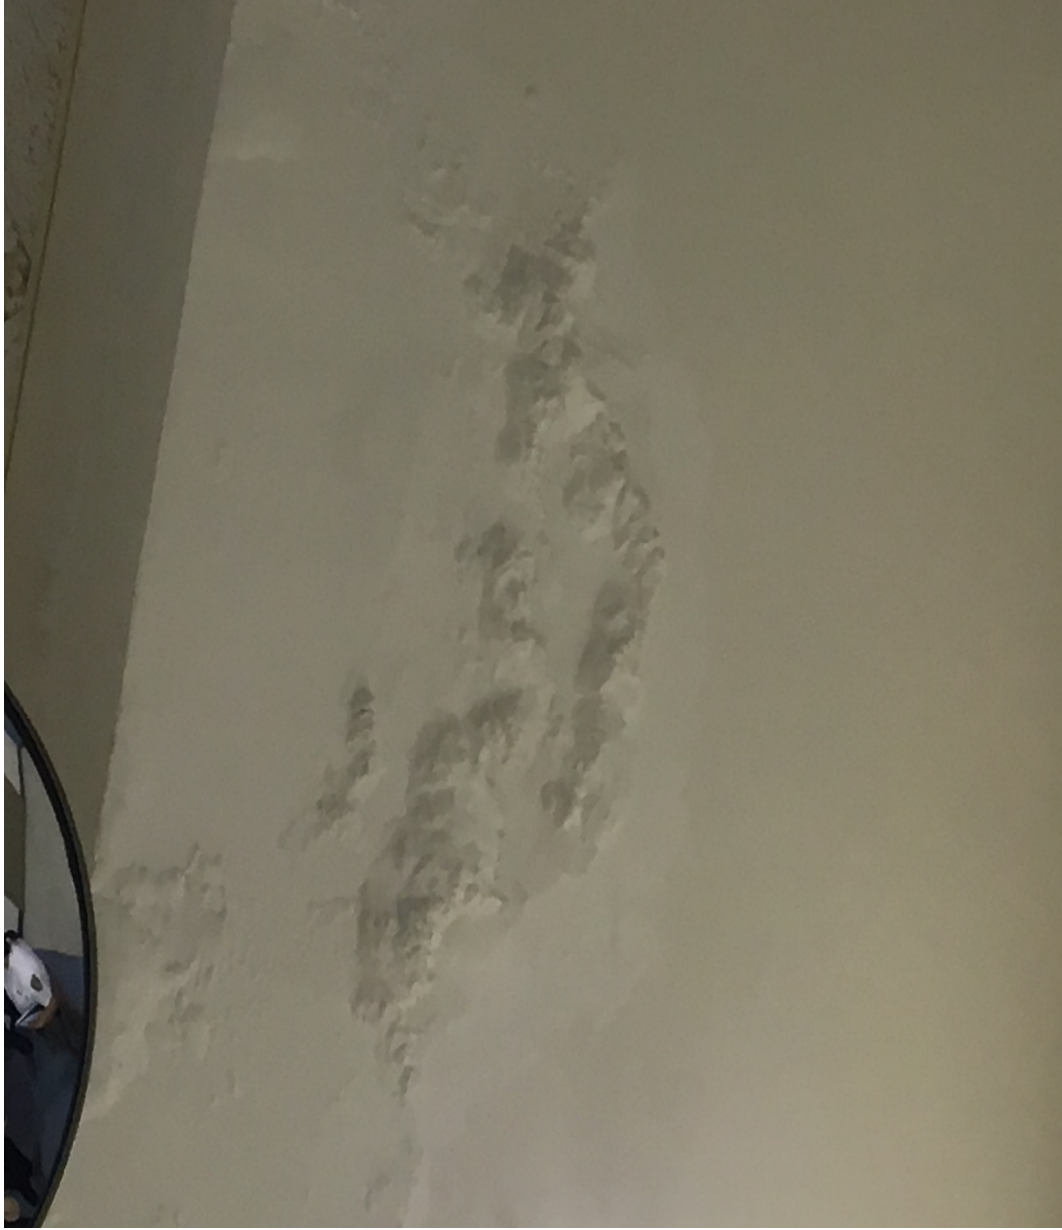
Finding # - 26 This picture denotes water damaged on the concrete slab in 3CF which appears to be caused by a leak from the roof or areas above.

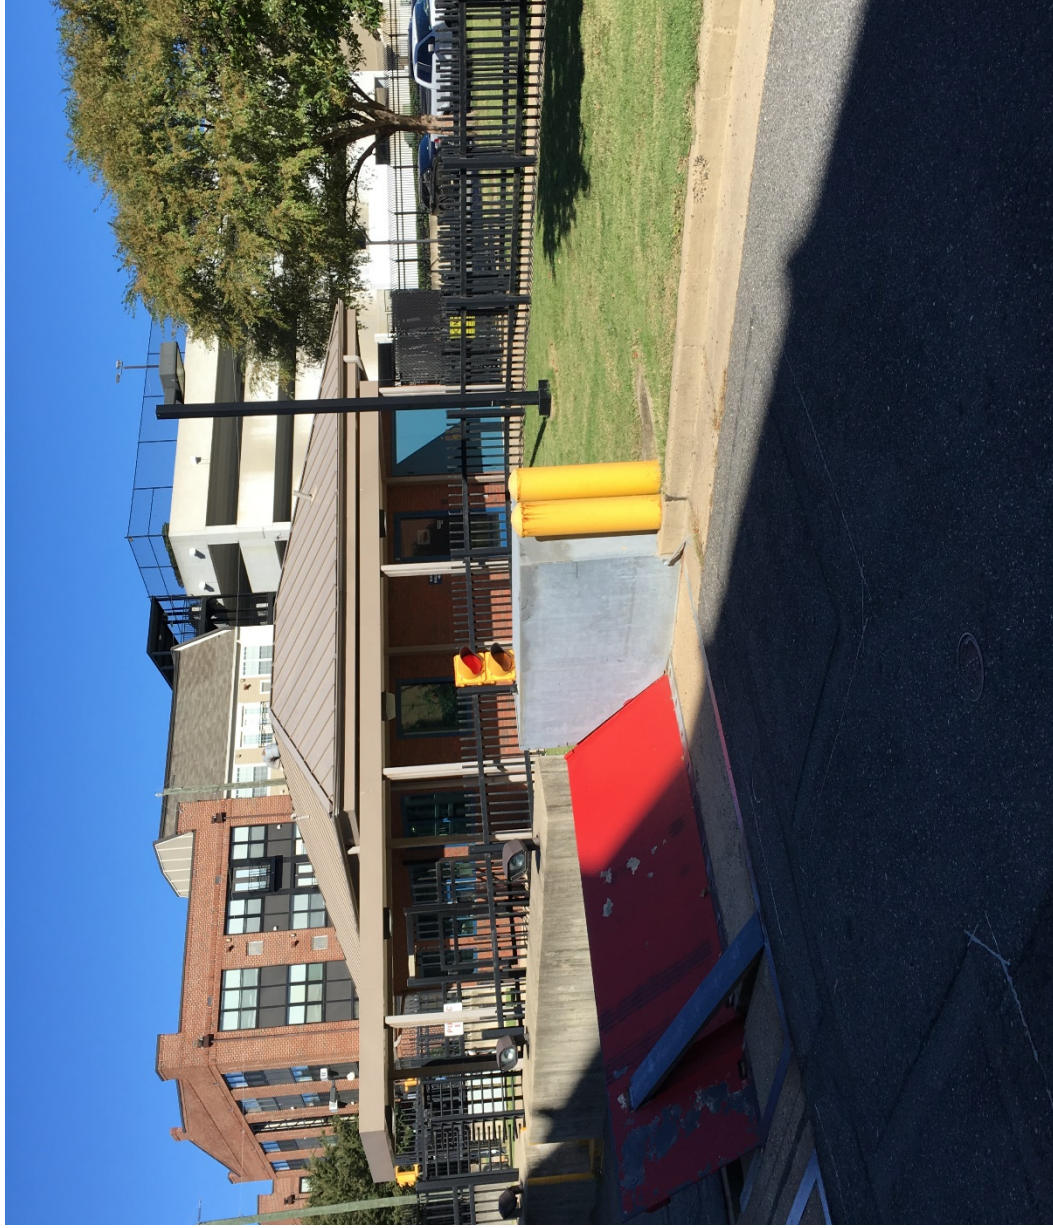
Finding # - 27 The heavy gates and security fencing at the entrances and around the facility are in need of repairs.

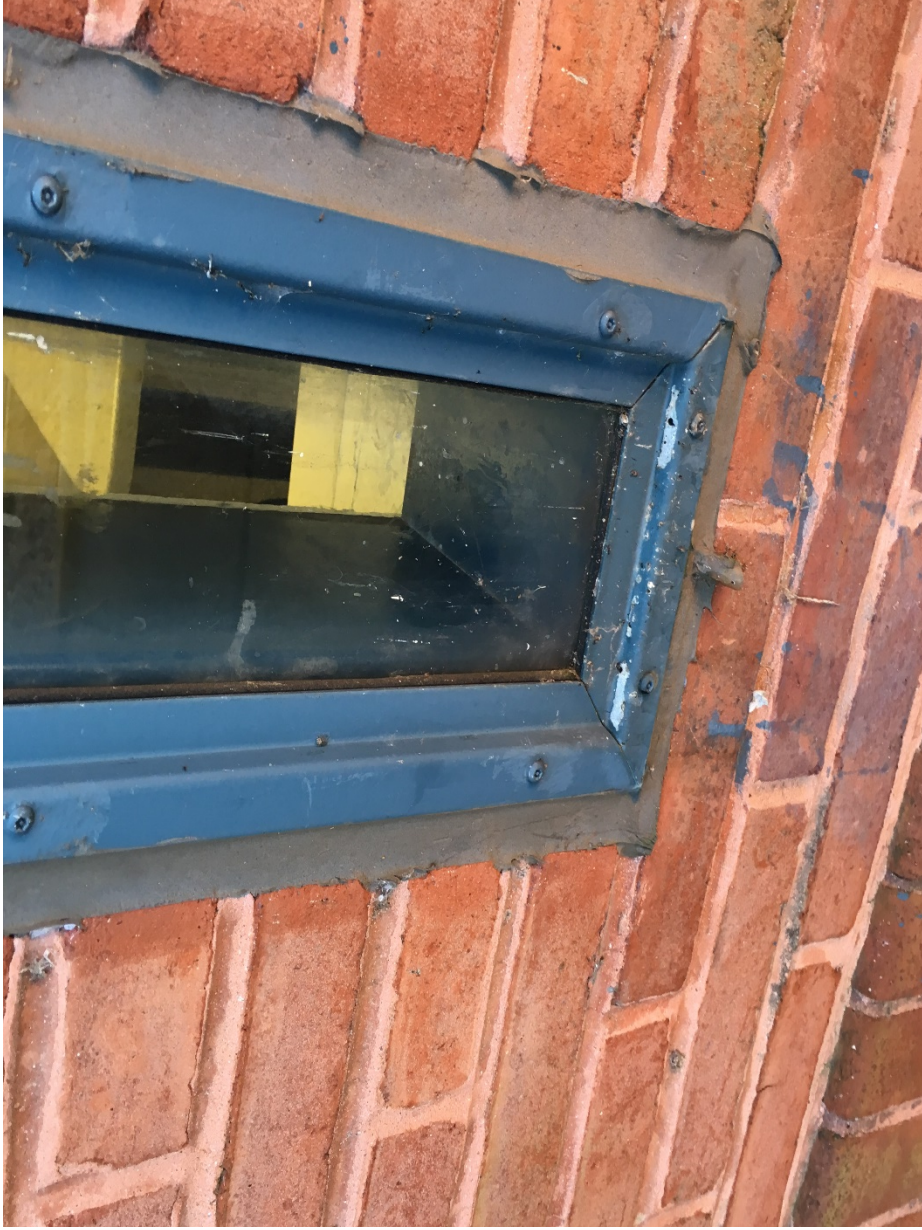
Finding # - 29 The jail and sheriff's office windows are in poor condition in several areas.

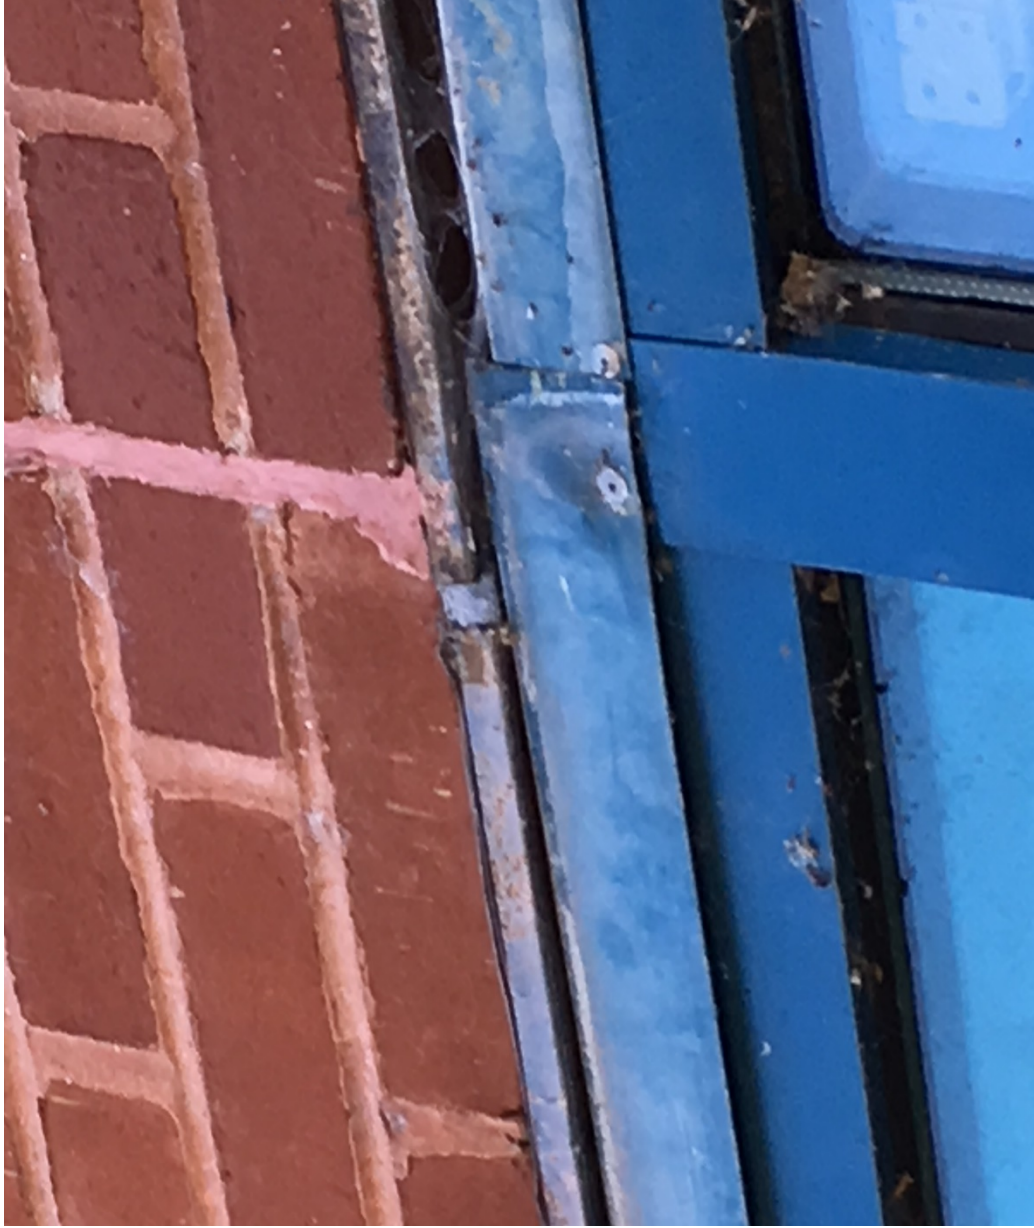
Finding # - 30 This picture notes one section of windows at the north side of the sheriff's office which needs to be caulked to stop water infiltration.

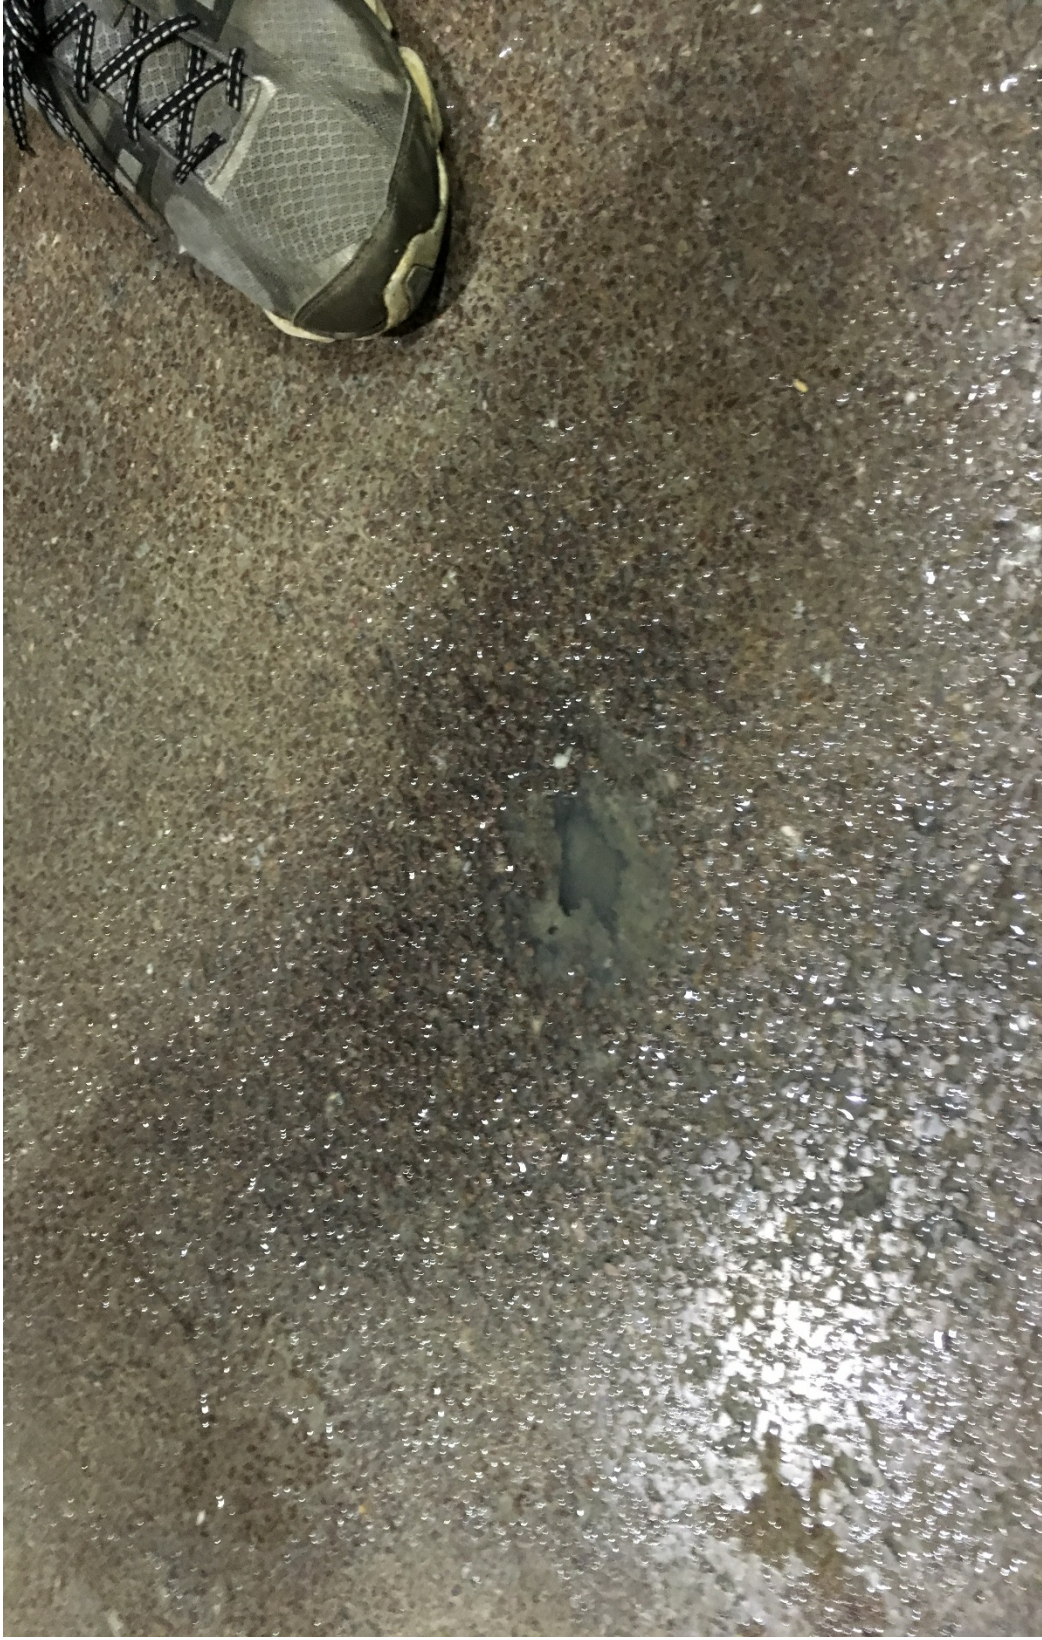
Finding # - 32 This picture is of the epoxy /coating used in the shower stall areas floors which is in need of repair or replacement.

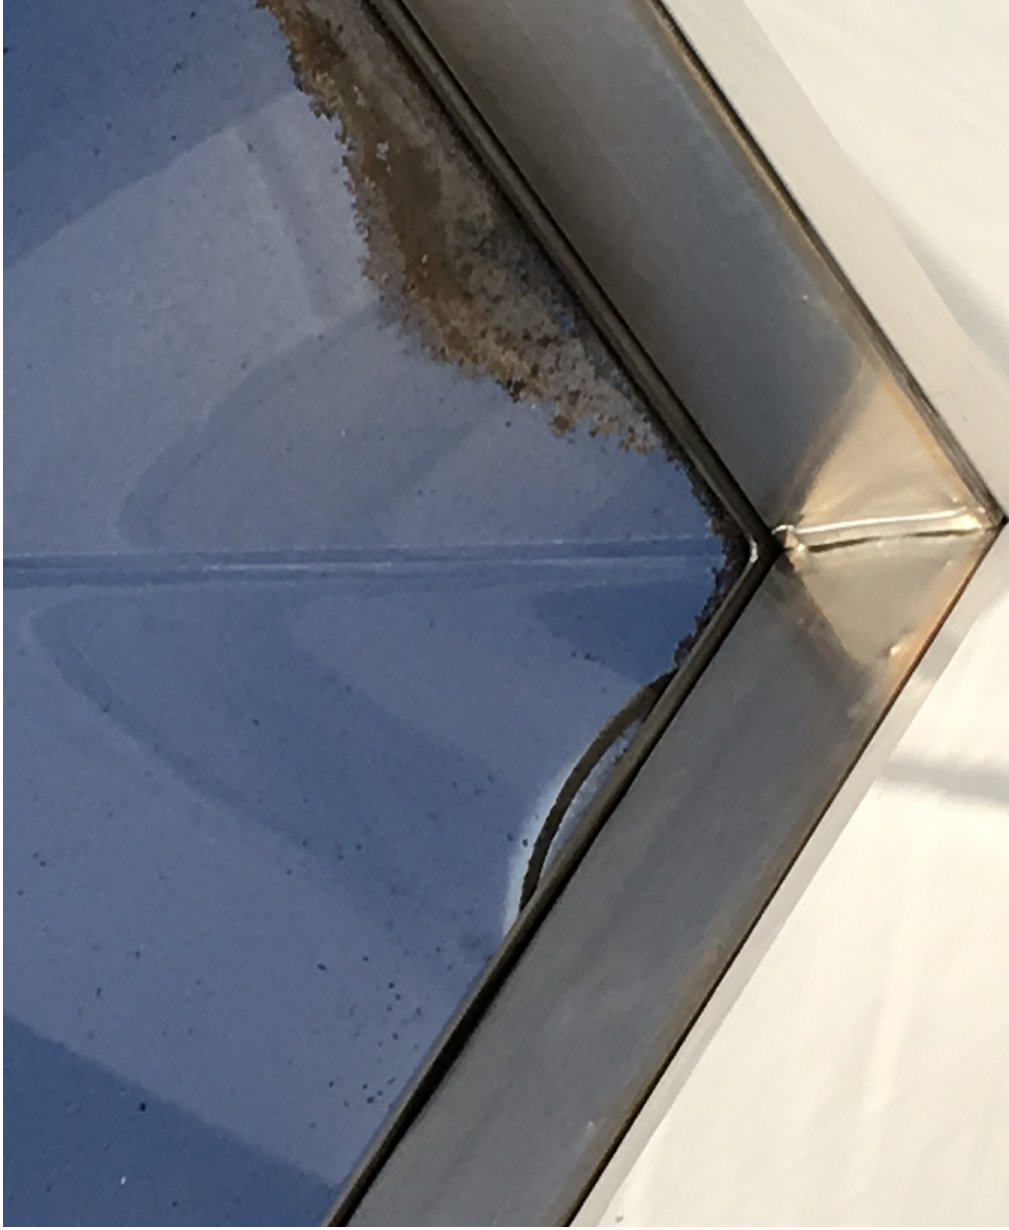
Finding # - 33 This picture is of sheriff's office stairwell skylights which show signs of leaking.
