Patrick Henry Elementary School

4643 Taney Ave, Alexandria, VA 22304

Existing Facilities Assessment

Alexandria City Public Schools

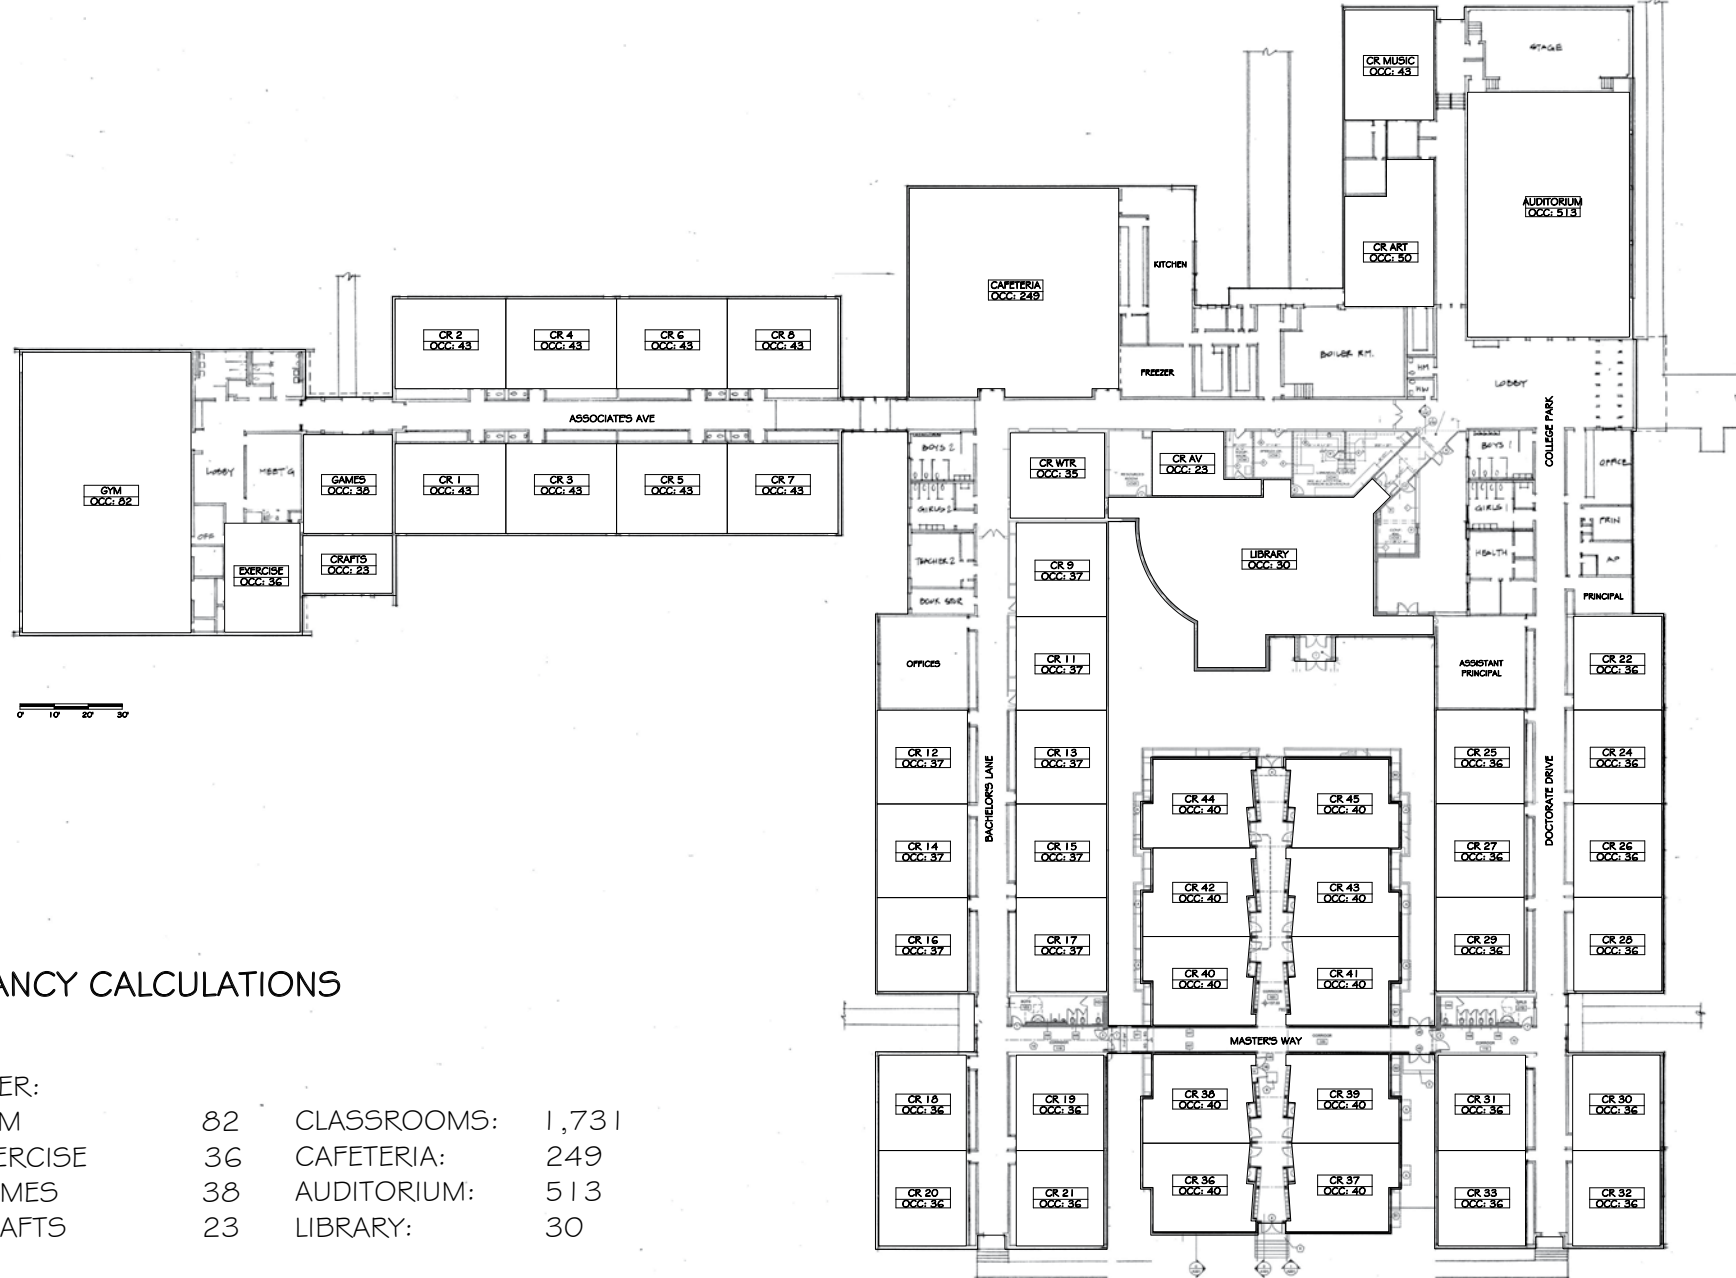
SK-02

For the maximum allowable school and recreation center occupancy load- see the attached Occupancy Diagram, SK-02.

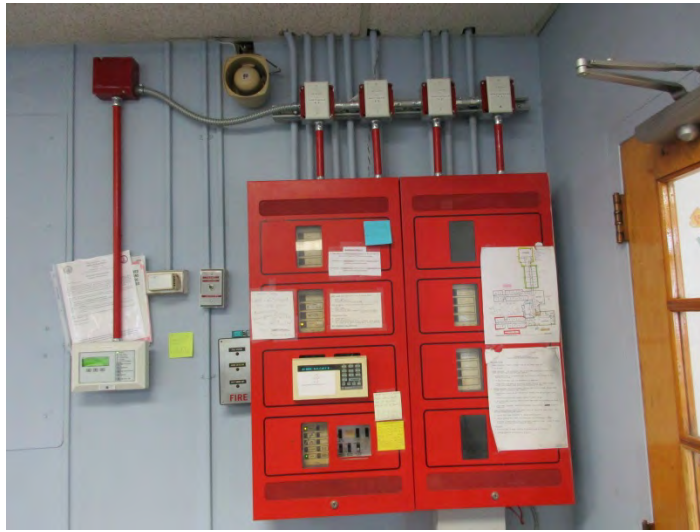
The fire alarm system is outdated and does not meet the current code requirements. Classrooms are not equipped with audio and visual devices and the audio and visual devices in the corridors do not meet the current code requirements.

Outdated building fire alarm system.

2. Upgrade Fire Alarm
 - a. The system is outdated. We recommend that the existing fire alarm system be replaced.
3. Service Rooftop Units
 - a. All of the rooftop units (RTUs) have exceeded their expected lifespan. If the RTUs are serviced by a qualified contractor and the necessary recommended repairs are made the lifespan would be extended.

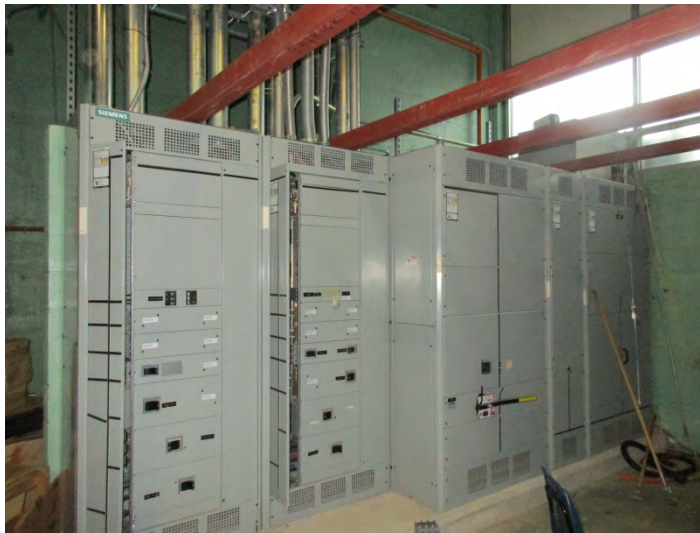
Electrical panelboards in boiler room in good condition.

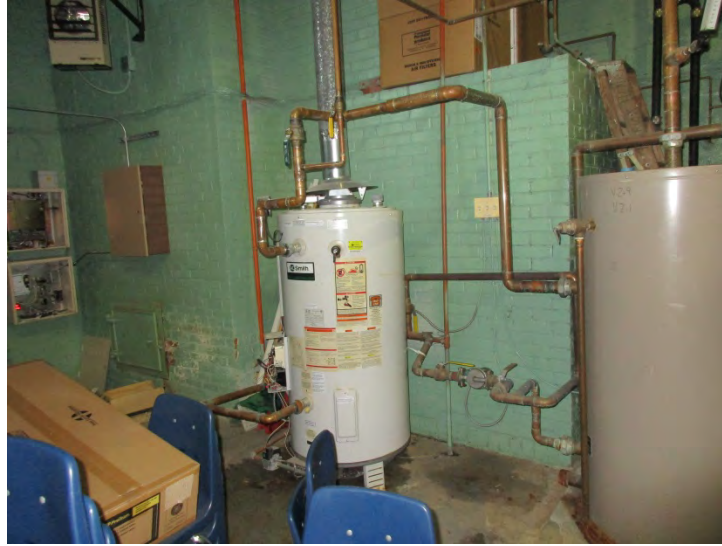
The building has a 3” cold water service and a single water heater coupled with a supplemental storage tank. Some of the water distribution piping is routed in the old steam tunnels under the building. It appears that most of the hot water and cold water pipes are insulated. All lavatories are equipped with approved tempering valves. Plumbing fixtures are in fair to poor condition. Most of the roof drain domes are missing and blocked roof drains are causing pools to form on the roof. Gas supply piping on the roof is missing multiple supports.

Single domestic water heater with supplemental tank

6. Pipe Insulation
 - a. Pipes without insulation can remain. We recommend supplemental tankless water heaters be installed in or near the bathrooms to provide water.

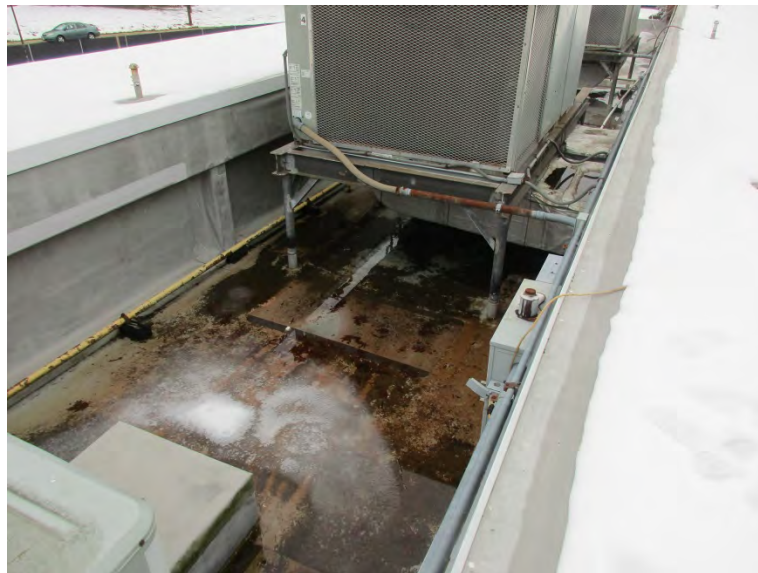
Pool of water surrounding RTU supports on roof.

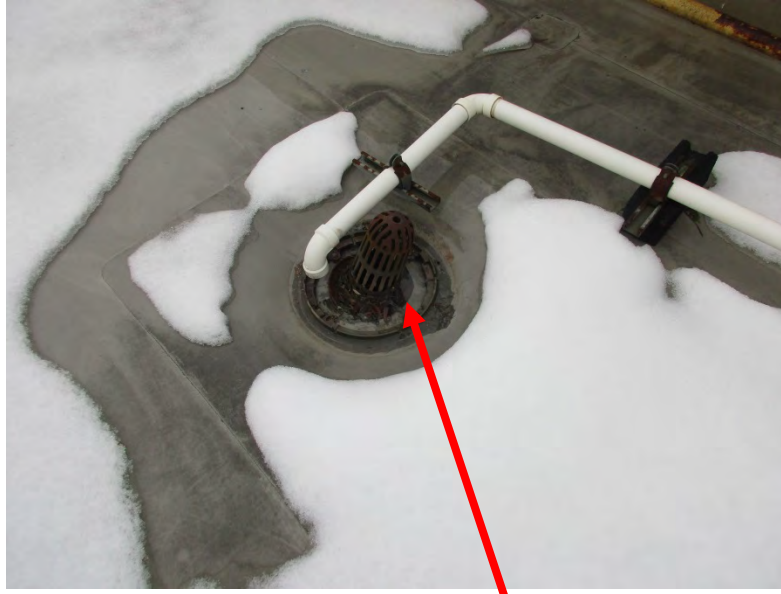
Broken roof drain dome.

4. Replace/Service Roof Drains
 - a. Replace, service, and restore all roof drain domes. Patch roof as needed – see architectural report.
5. Replace/Repair Lighting Fixtures

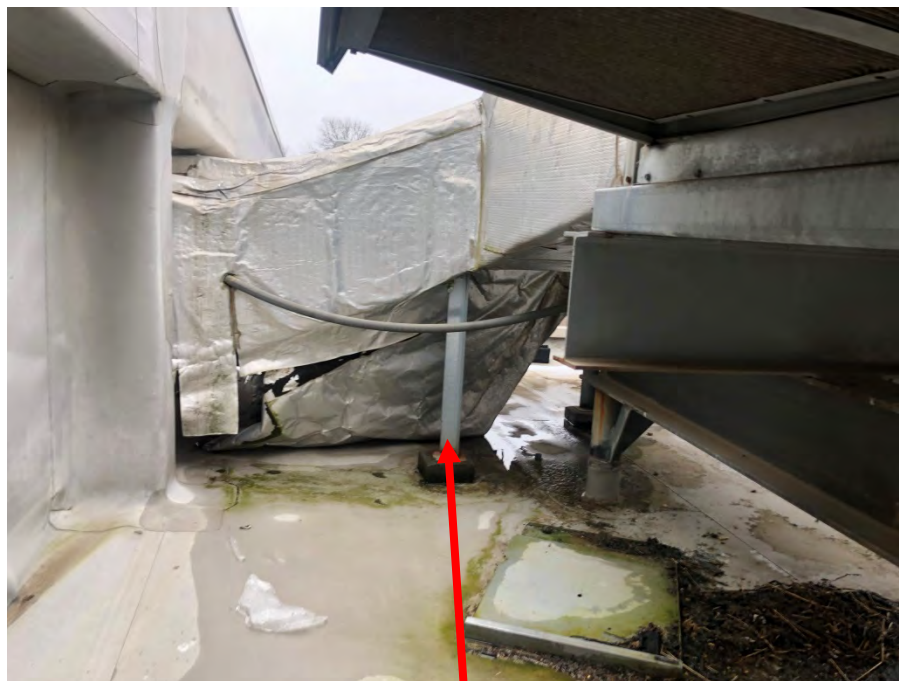
Insulation on exterior duct peeling off.

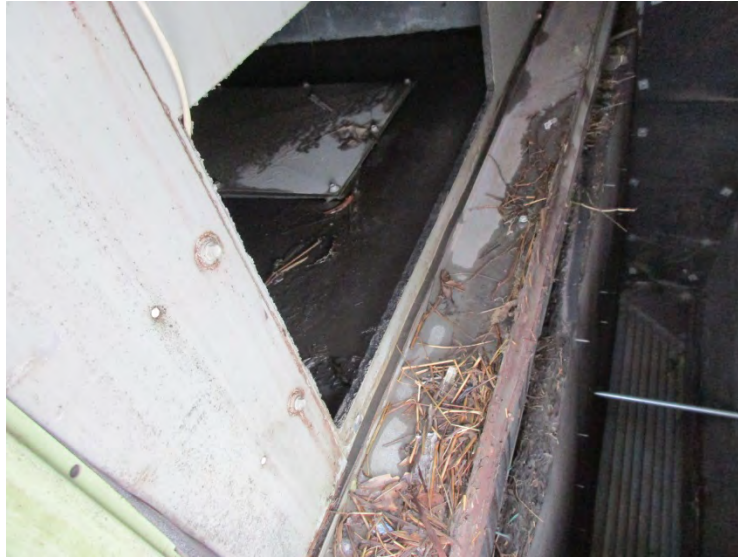
Debris found inside RTU-12.

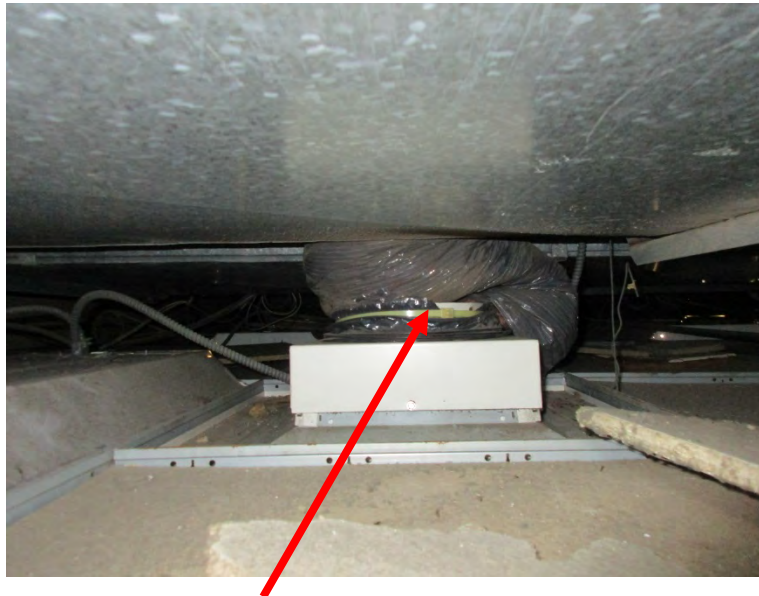
Broken supply flex duct above classroom ceiling.

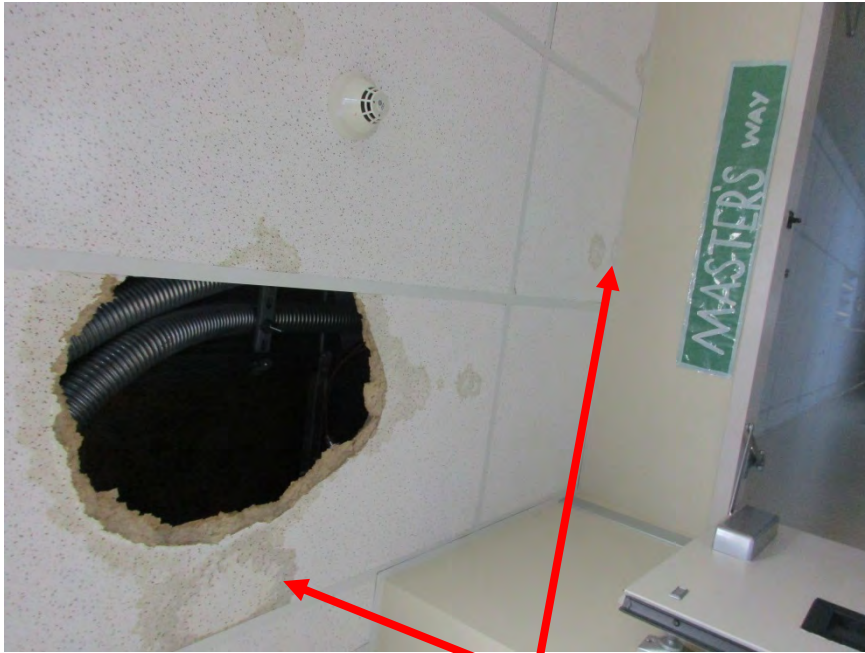
Significant number of ceiling tiles in various spaces had water marks and damages during our site evaluations. The intensity and quality of these marks and damages were much greater near the windows in almost all classrooms. Refer to the attached photos.

Our visits to the building occurred during very dry weather conditions and we were not able to observe any active condensation. However, we believe the tile stains and damages are caused by condensation.

Watermarks found on damaged ceiling tiles.
