ALEXANDRIA CITY PUBLIC SCHOOLS  
COMPREHENSIVE CONDITION AUDITS

- CORA KELLY ELEMENTARY SCHOOL
- FRANCIS C. HAMMOND MIDDLE SCHOOL
- GEORGE MASON ELEMENTARY SCHOOL
- GEORGE WASHINGTON MIDDLE SCHOOL
- MATTHEW MAURY ELEMENTARY SCHOOL
- TRANSPORTATION FACILITY

**Final Report - DRAFT**

**August 9, 2019**

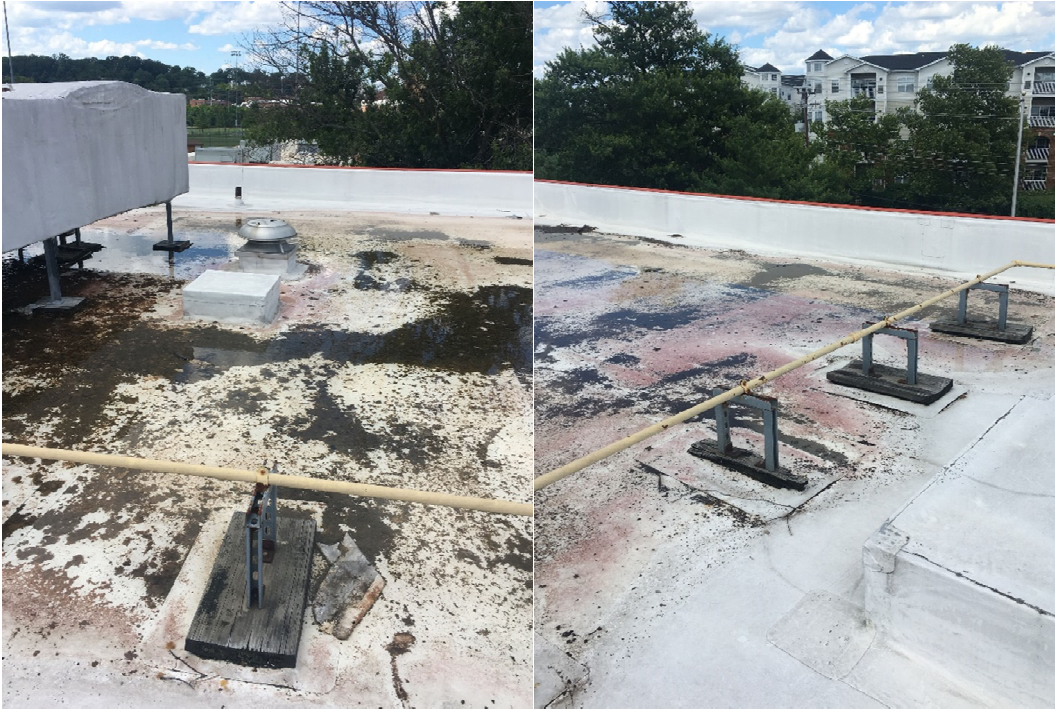
*Figure 8 and 2: Water ponding on the roof causing leaks*

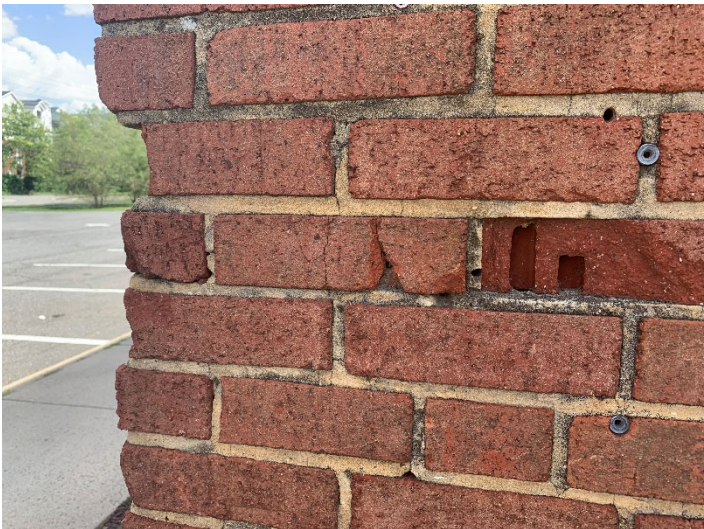
*Figure 3: Joint repair needed*

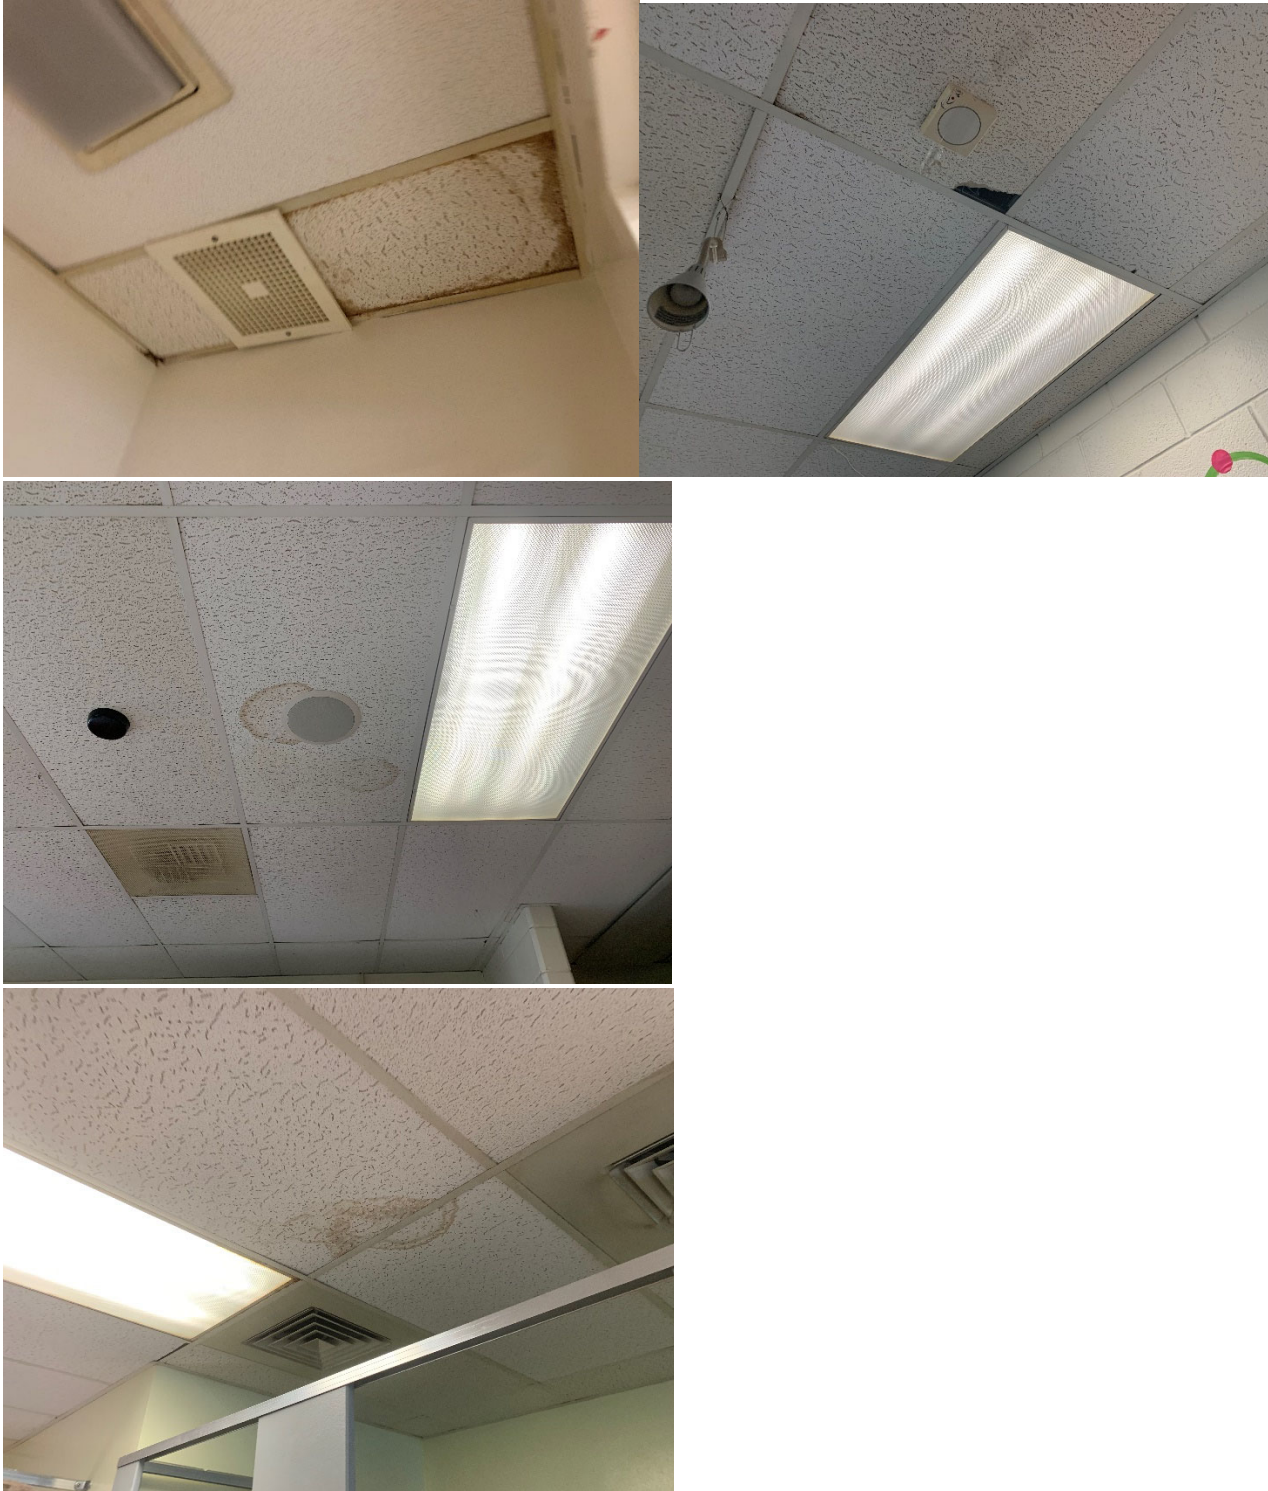
*Figure 5: Leaks and staining on ceiling tiles*

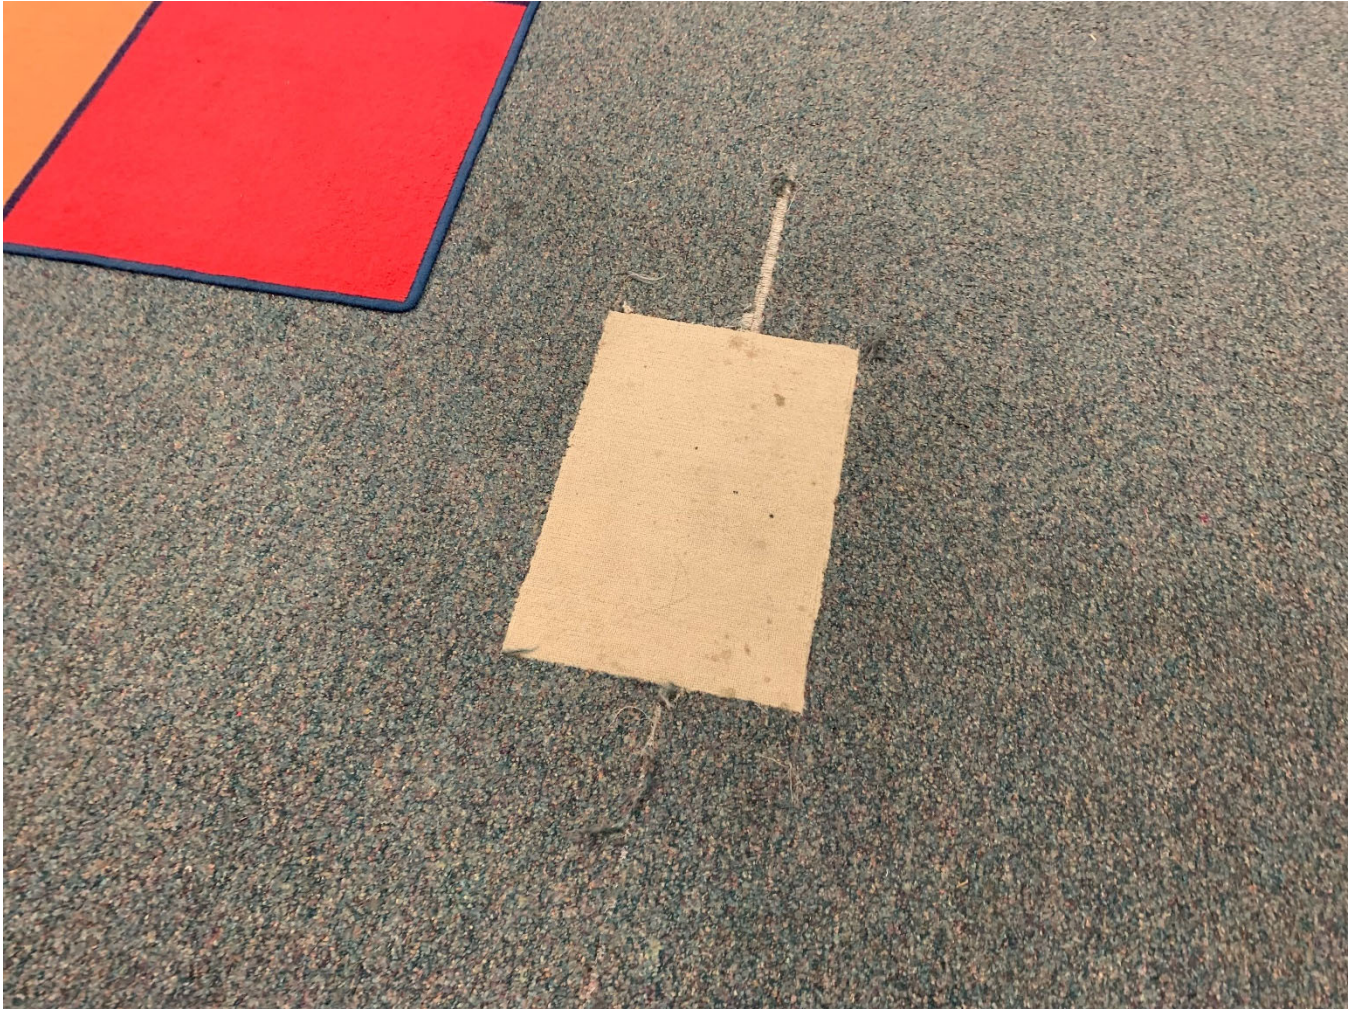
*Figure 6: Carpets need replacement*

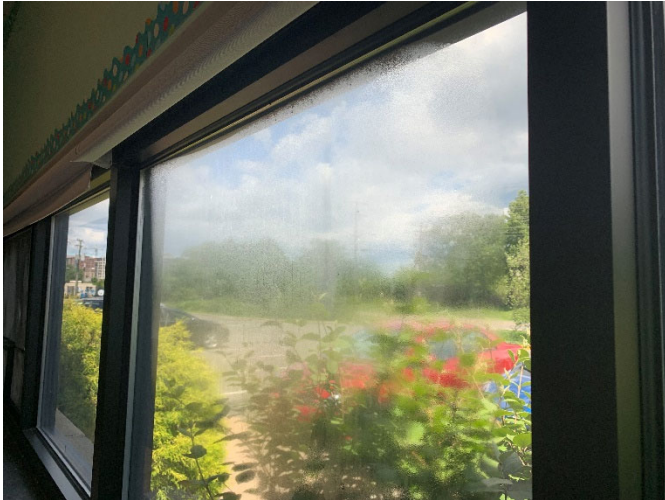
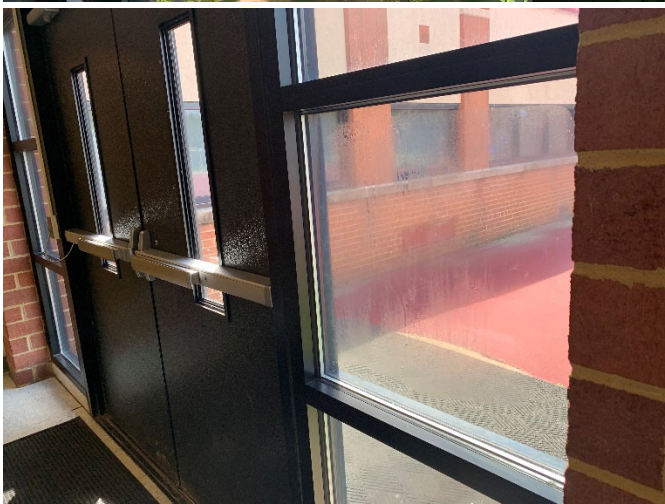
*Figure 7: Window Sweating*

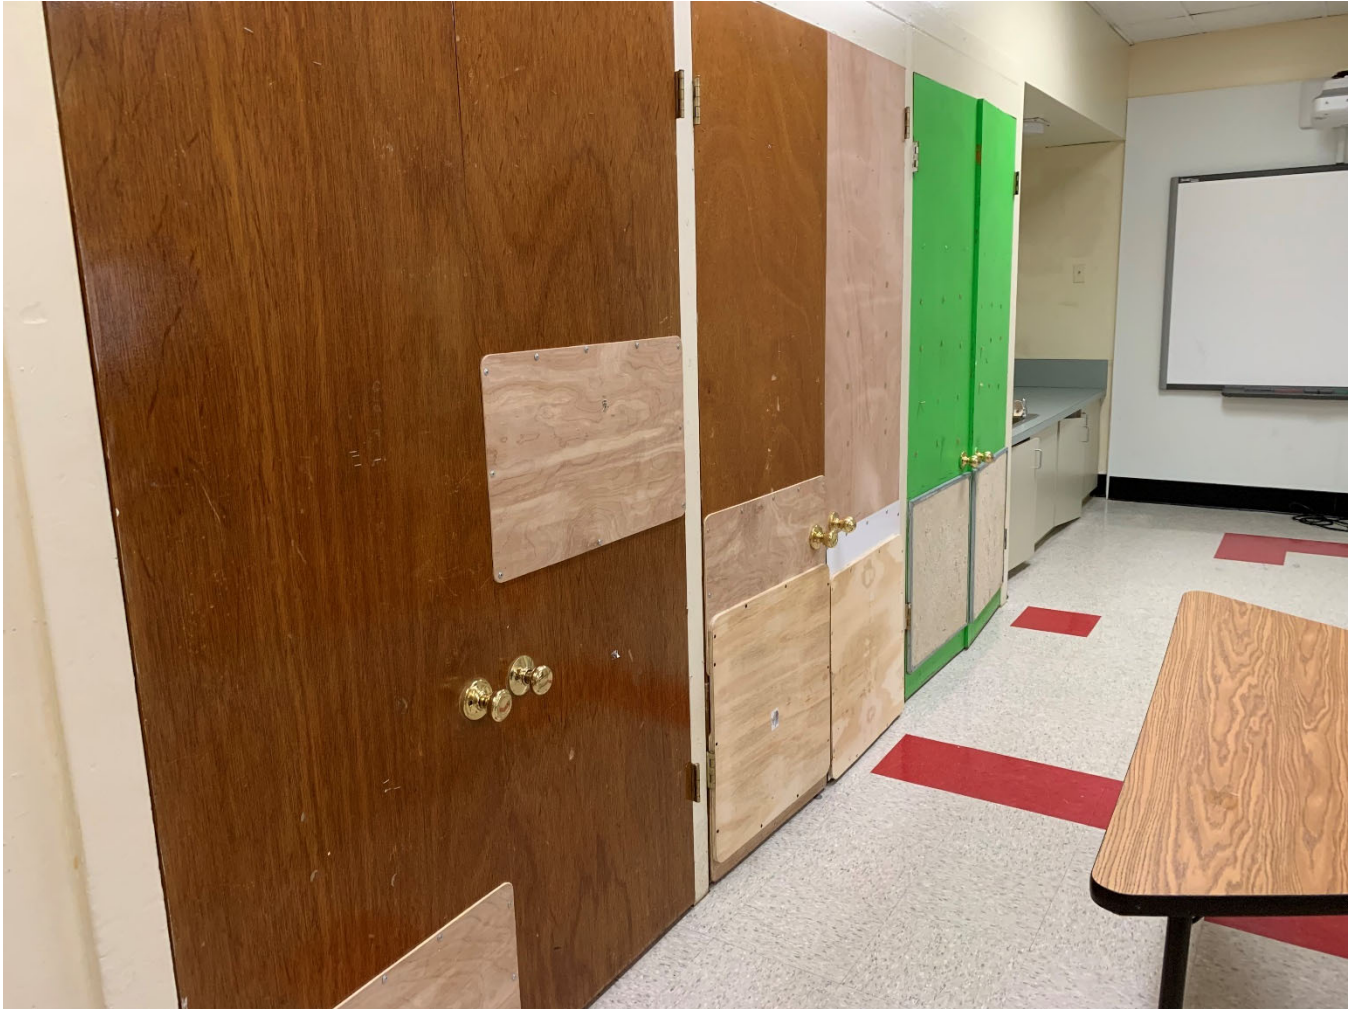
*Figure 9: Furniture laminates damaged*

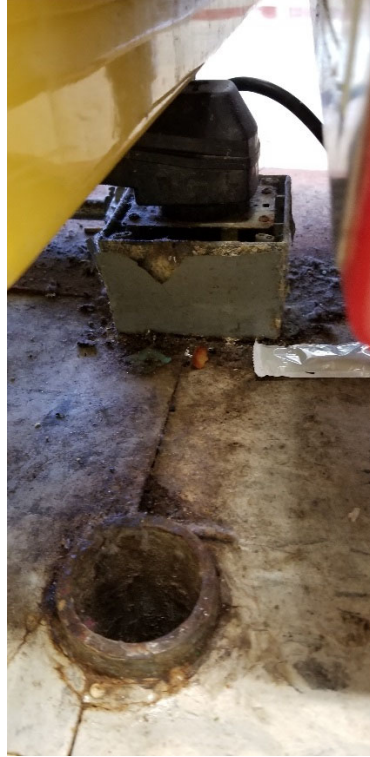
*Figure 12: Cafeteria Service Counter – Floor Outlet Missing Cover Plate*

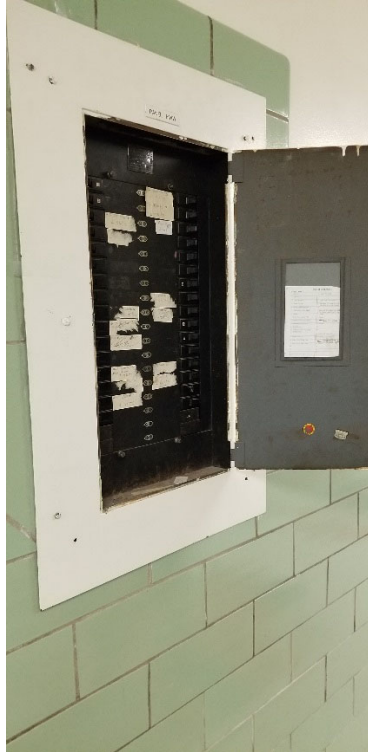
*Figure 13: Obsolete Panel 1-WW*

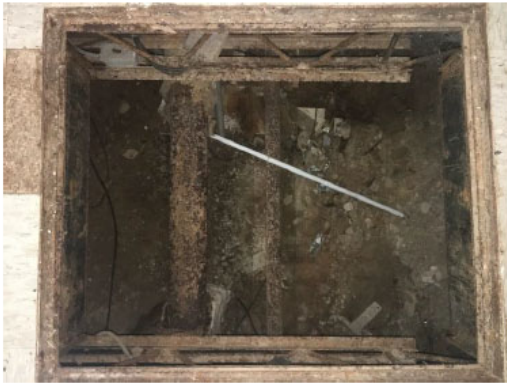
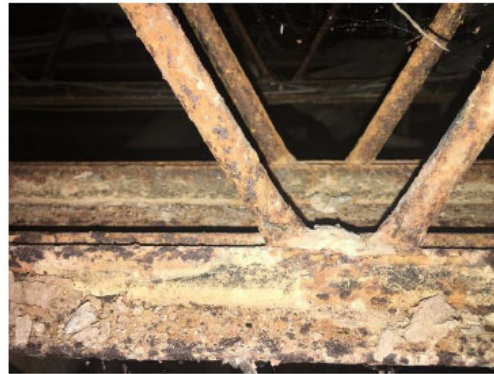
Steel joists in the crawl space beneath Room 2 – STEM Lab, are rusting.

All the visible existing steel joists in the crawl space beneath the STEM lab are rusting, but there are no apparent signs of section loss. Measurements were taken at multiple locations on a badly rusted joist to determine if there were areas of significant material loss, there was not. The flange thickness was consistently 5mm +/- and the rod diameters were consistently 15mm+/-.

The crawl space will need to be repaired to eliminate the humidity and prevent further rusting. The construction specifications should be reviewed to determine if a vapor barrier is required – if so, a vapor barrier should be added to prevent further damage.

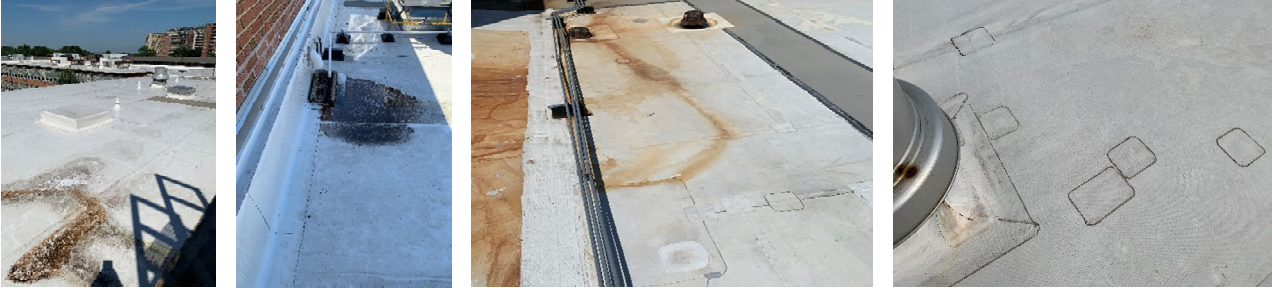
Figure 1. Roof – shown: D wing roof failures and patchwork

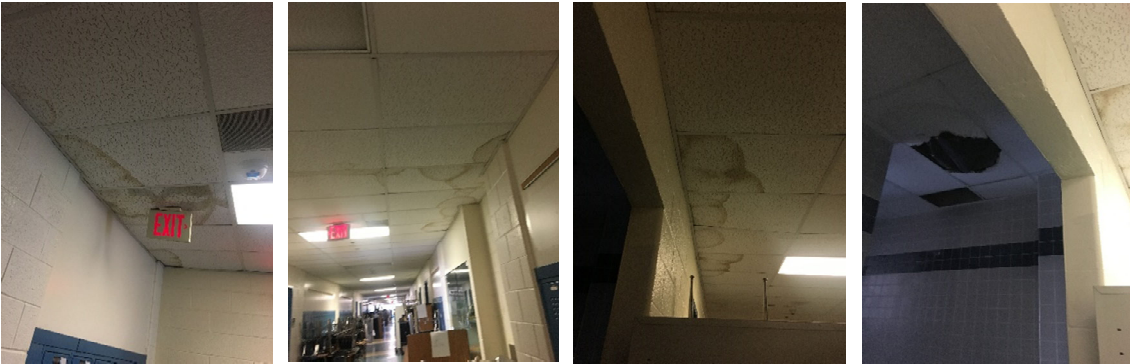
Figure 2. Ceiling stains from roof failure

Figure 3. Condemned 2<sup>nd</sup> floor boys' room

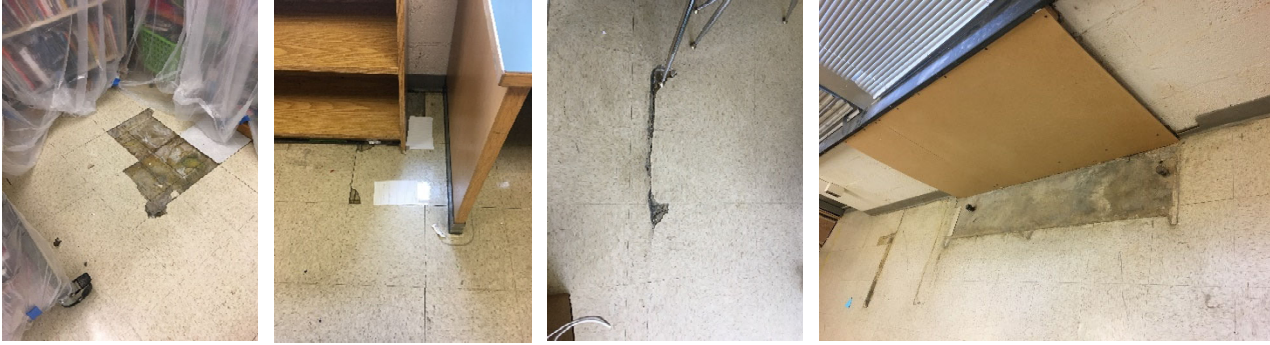
*Classroom flooring wear & rear – refer to matrix*

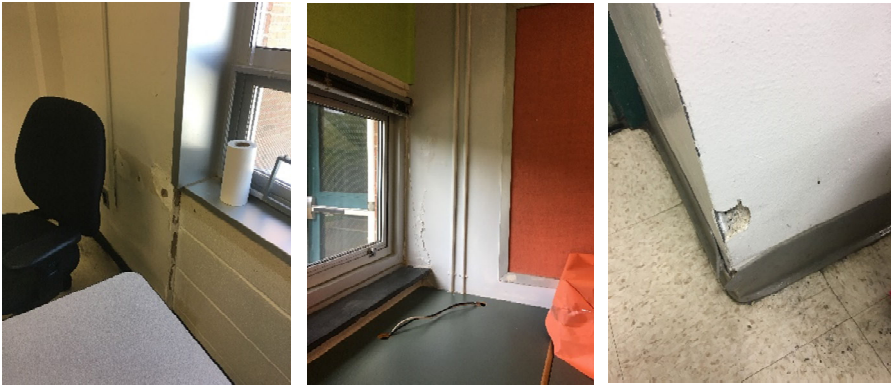
*Classroom wall finish issues – refer to matrix*

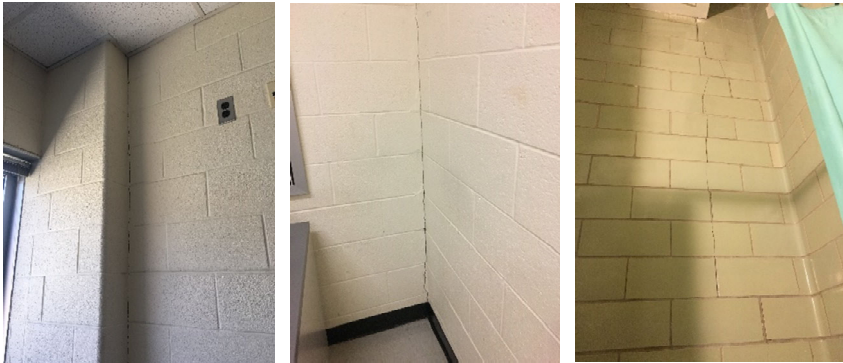
*Interior masonry wall cracks – refer to matrix*

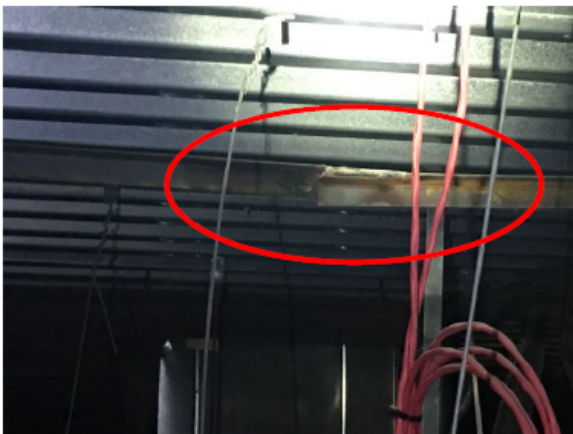
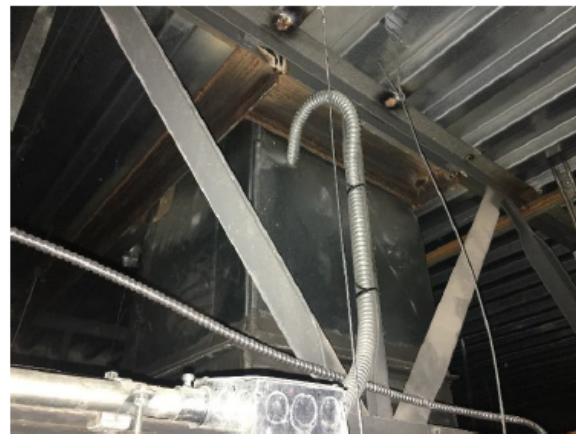
Leaks in the second-floor bathroom of the D-Wing have brought down ceilings and left the bathroom unsafe and unable to be used.

There is minor rusting of some of the steel framing above the bathroom. There are no apparent signs of section loss. Two of the brace angles are very rusted and seem to be failing at the welded joints where there is significant deflection.

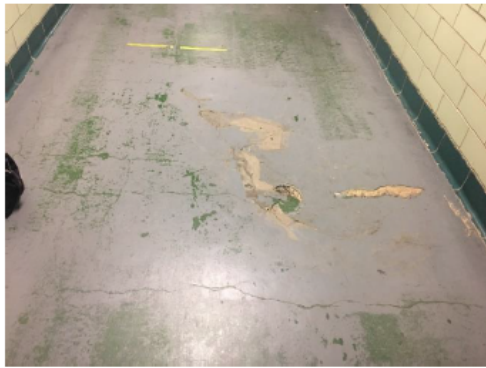
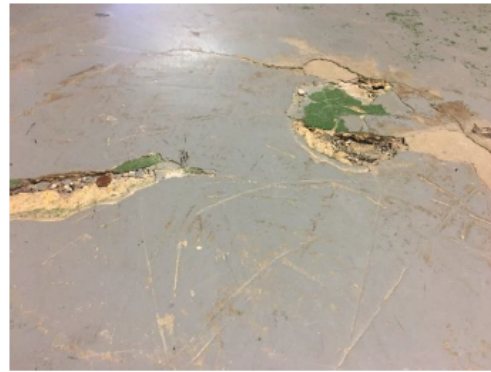
An area of the concrete slab at the lowest level corridor to the locker rooms is damaged.

The concrete slab has some hairline cracking and is spalling in two concentrated areas. The slab appears to have been previously patched. Spalling areas are about 6"x2'-0"x1" deep.

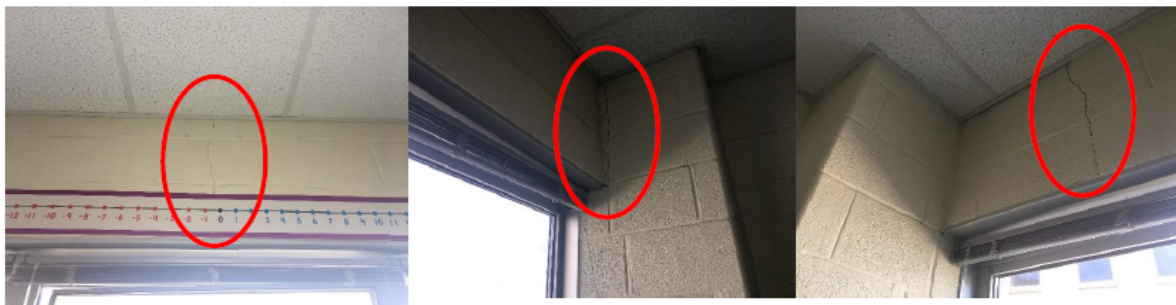
Various spandrels throughout the building have vertical cracks. Shown below are cracks in the spandrel of room D116.

In room D116 (on the first floor) the CMU above the window has vertical cracks in several places. The exterior masonry shows no signs of cracking. There is no cracking elsewhere in room D116, only above the window. The cracks do not present a major concern. The location of the cracks suggests typical deflection and expansion.

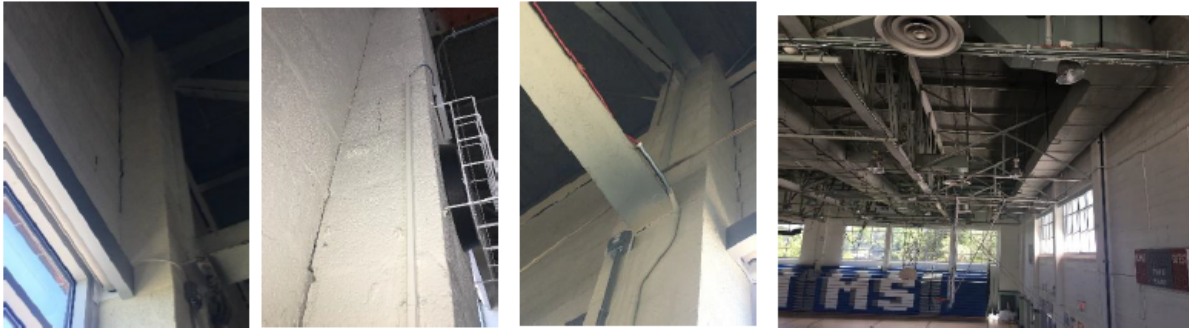
In the gymnasium, columns appear to be separating from the walls.

At each of the four walls in the gymnasium, there are small cracks between the walls and the columns. The size of the cracks varies by column, but the widest crack measured was about 1/2". There also appears to be separation at the wall corners – one corner is separated along its entire length. These cracks do not present a major concern. The location of the cracks suggests that columns and walls are moving separately.

The cracks should be filled with a flexible material. The columns can also be tied back to the walls to prevent them from moving separately and cracking in the future.

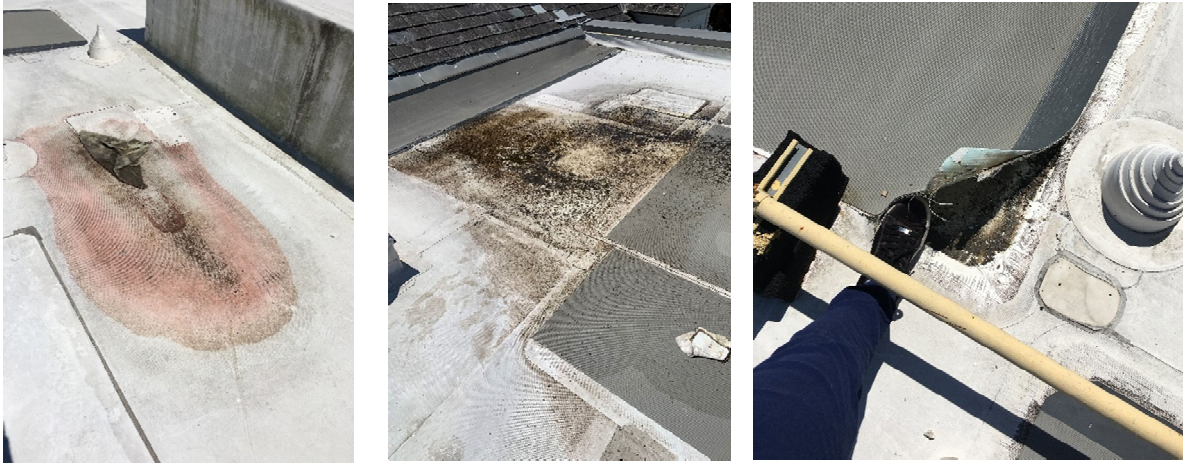
Figure 14 Roof Failures

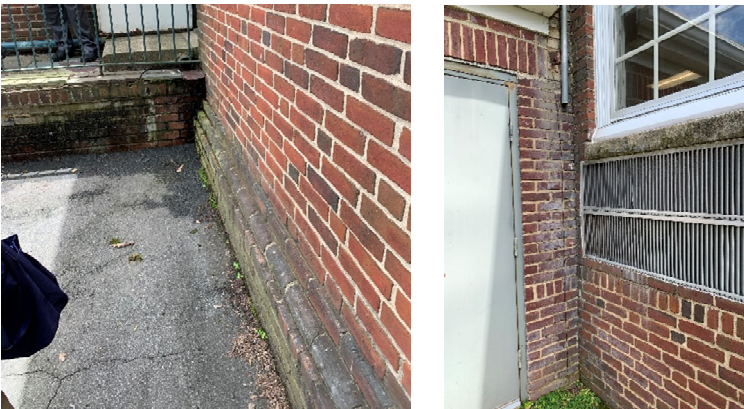
Figure 15 Exterior Wall Moisture and Settlement Cracks

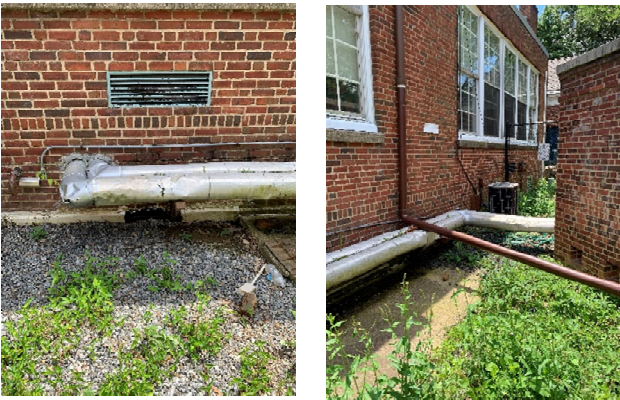
Figure 17 Inadequate Stormwater Drainage

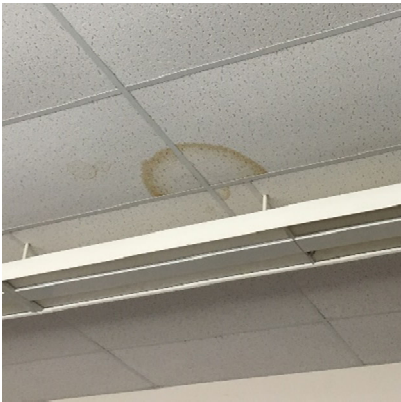
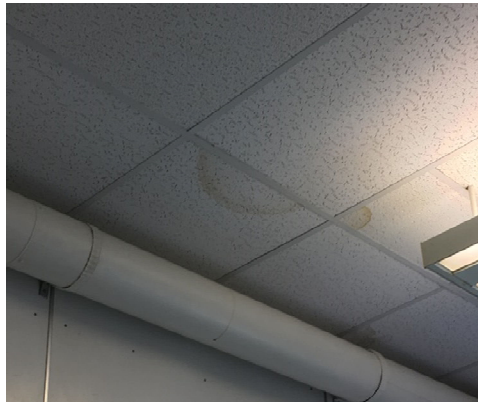
Figure 20 Ceiling Stains

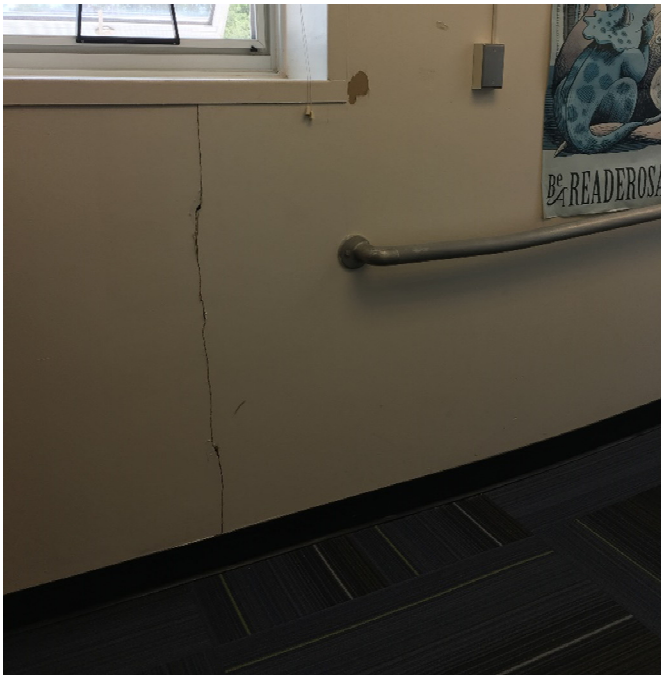
Figure 9 Settlement Crack (seen in Library)

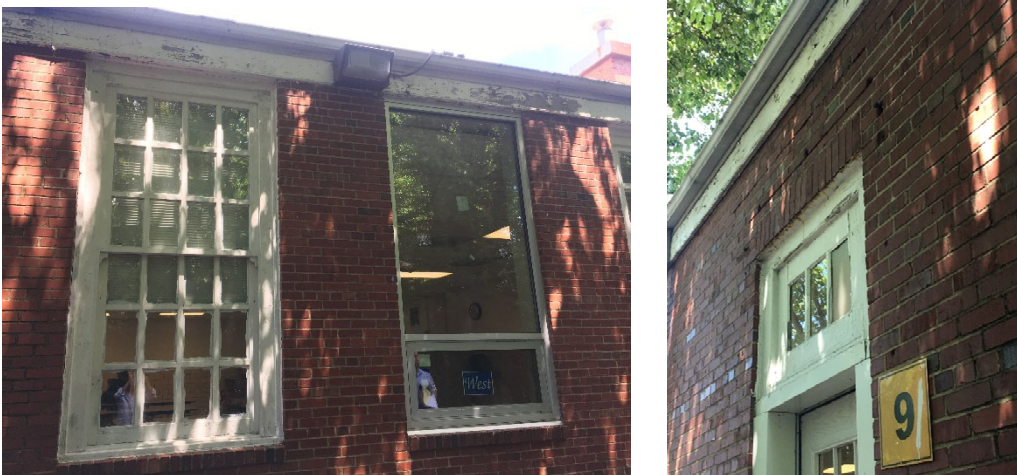
Figure 22 Wood Rot on Windows Due to Moisture

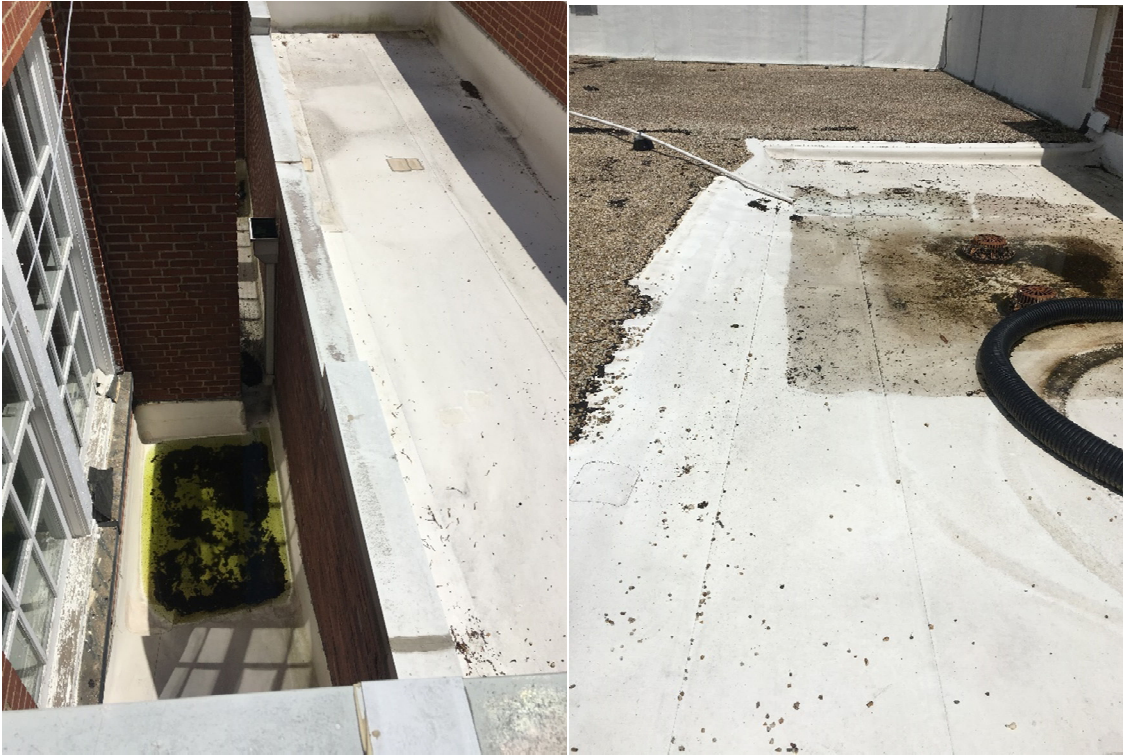
Figure 1: Roof leaks

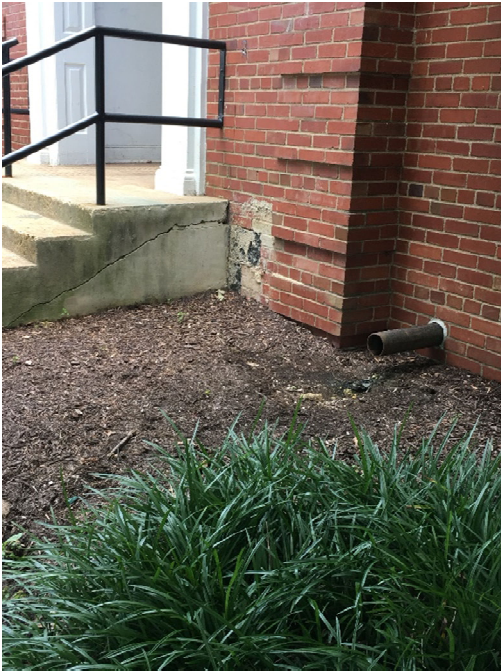
Figure 3: Crack on the entrance steps

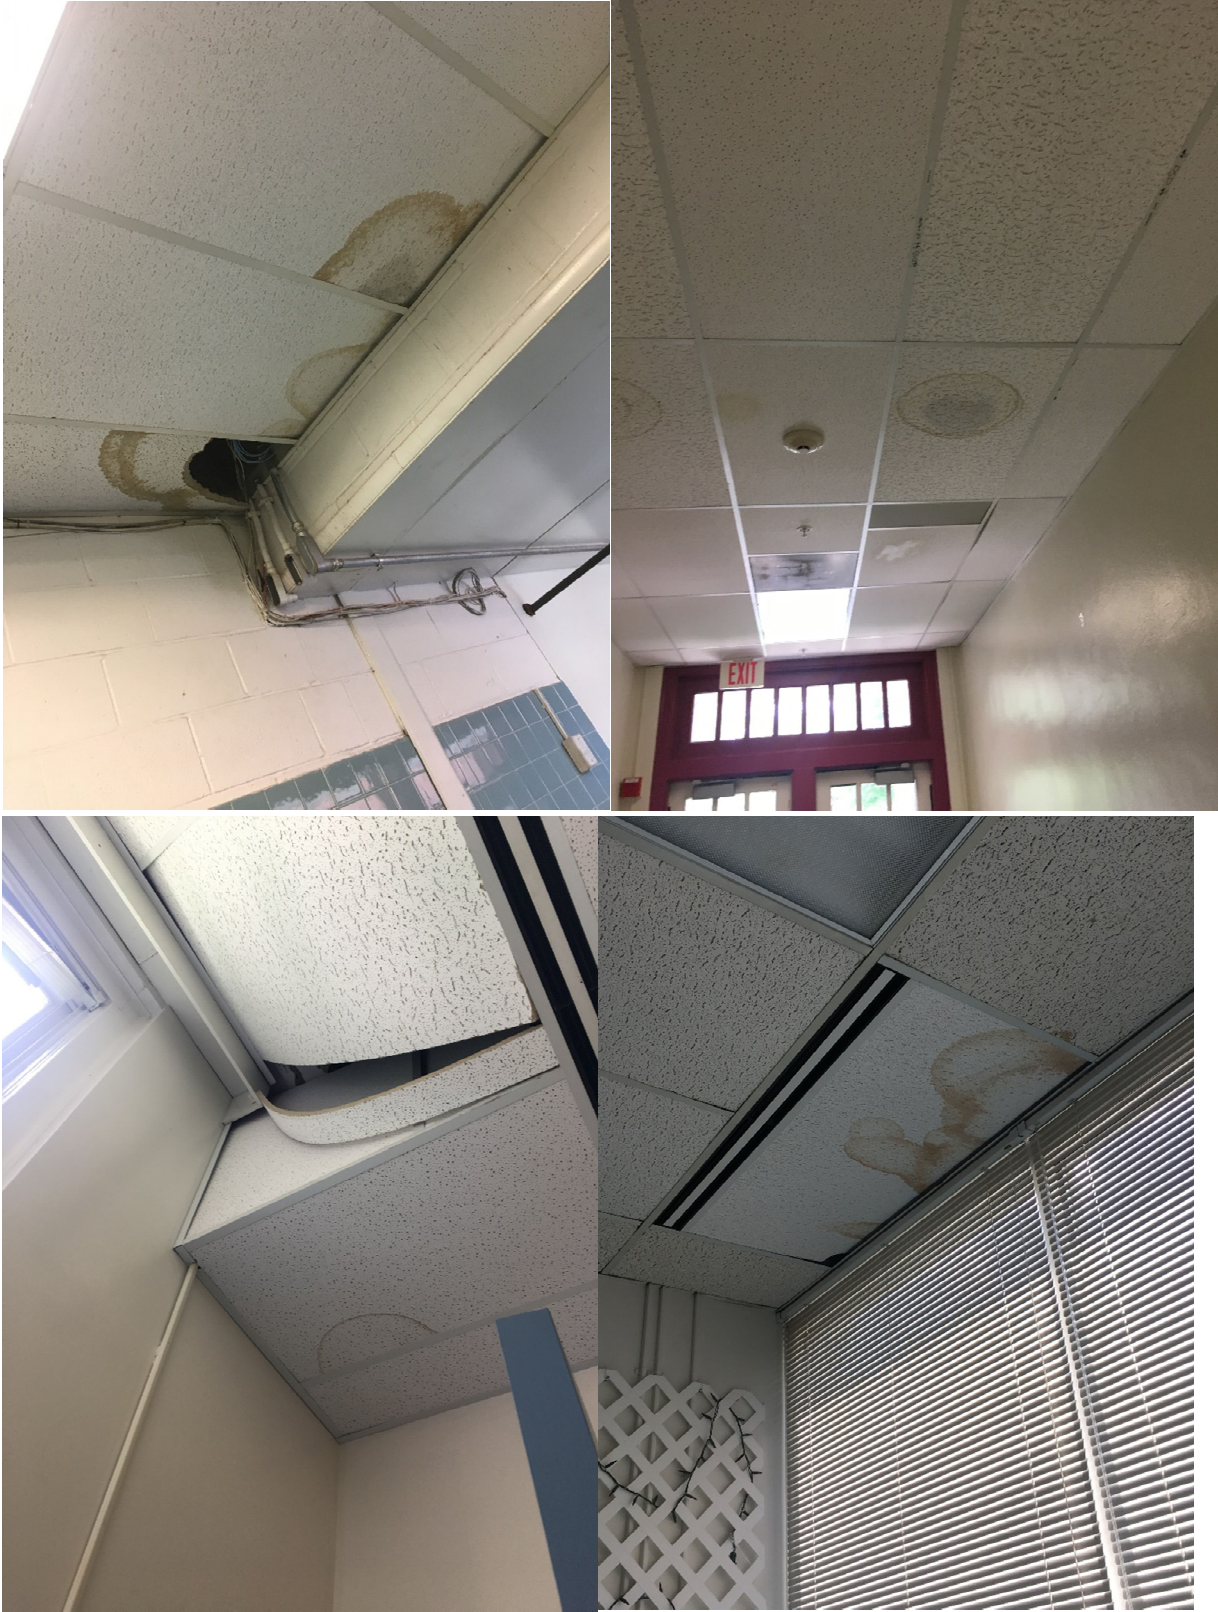
Figure 5: Ceiling stains

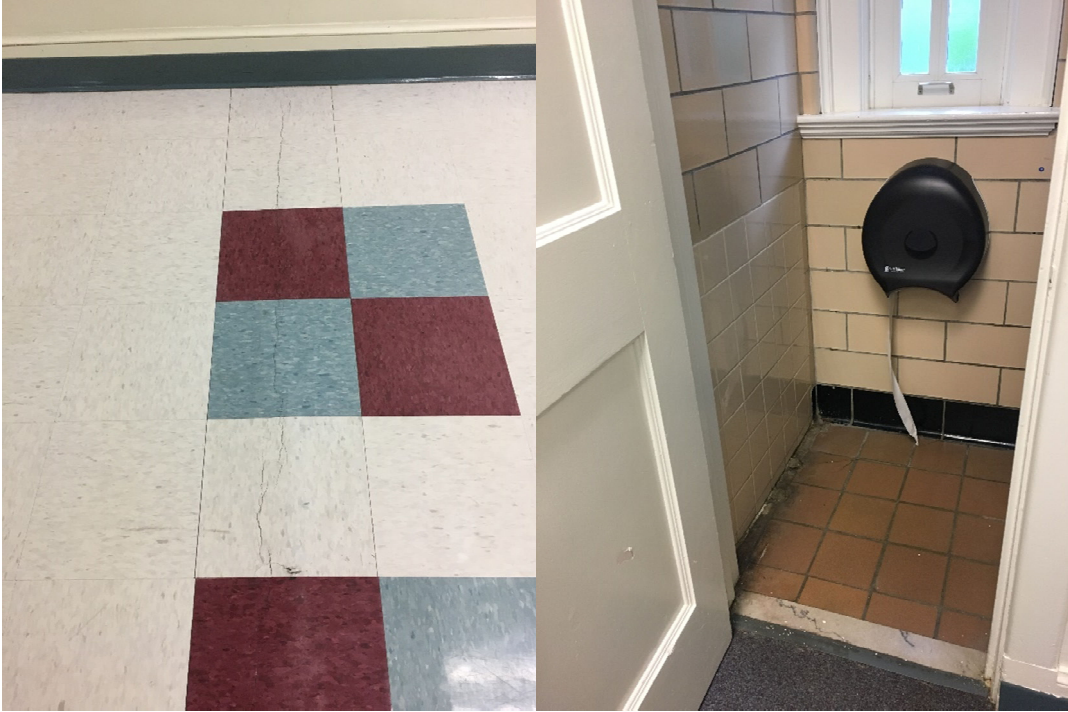
Figure 6: Cracked floor

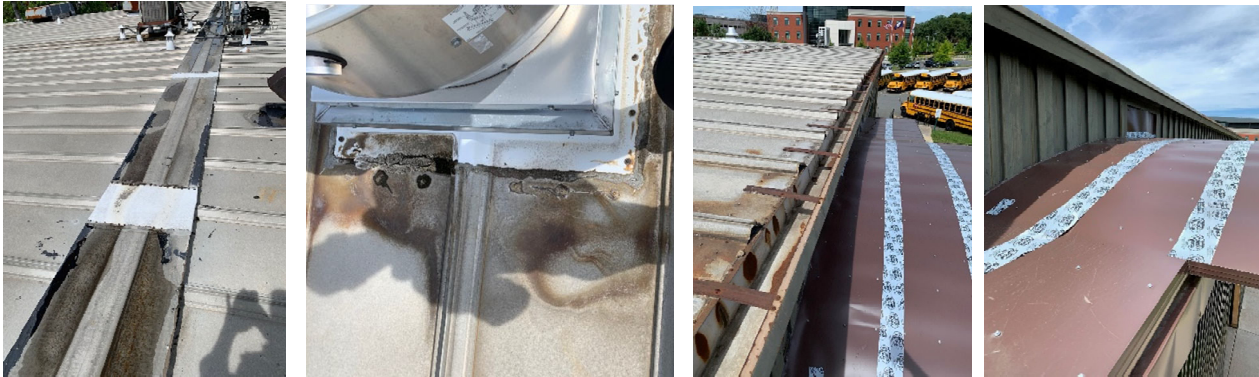
Figure 1. Roof – Leaks, corroded seams and surfaces, gutter detail and incomplete canopy

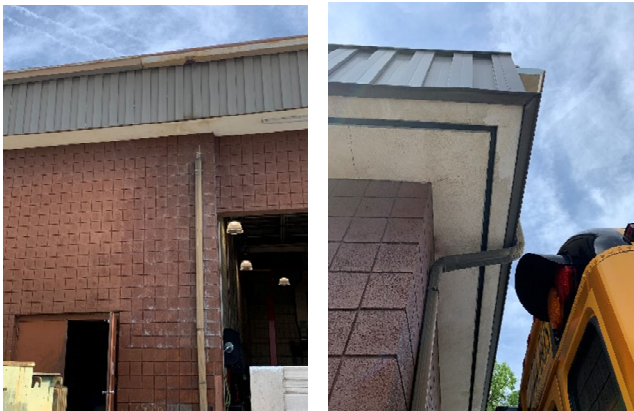
Figure 2. Exterior water damage due to roof drainage failures

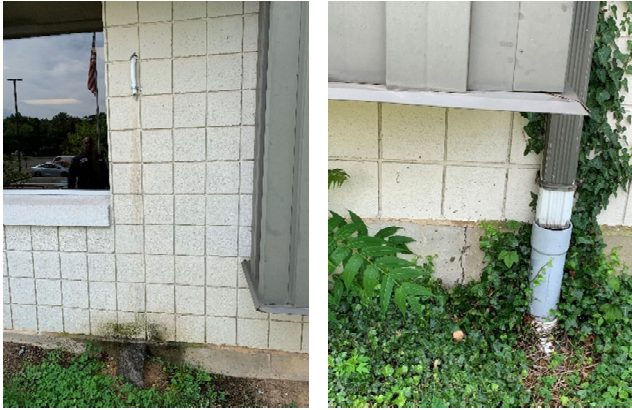
*Figure 3: Examples of water infiltration and subsurface breaches in exterior enclosure*

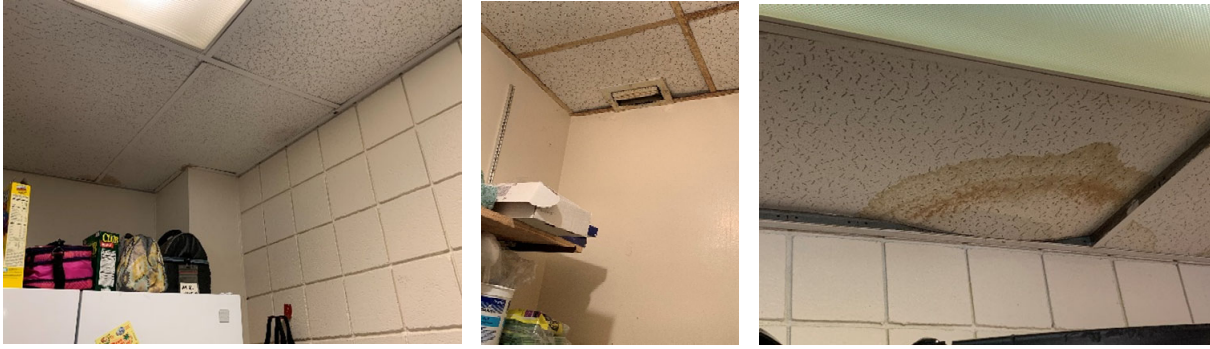
Figure 6: Examples of roof leaks and damaged ceiling tiles throughout upper level

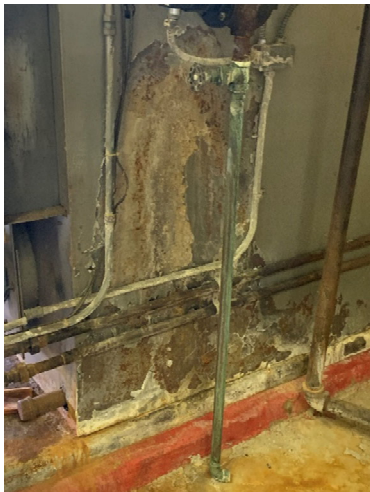
Figure 8: Example of ground water infiltration in utility and bus bays

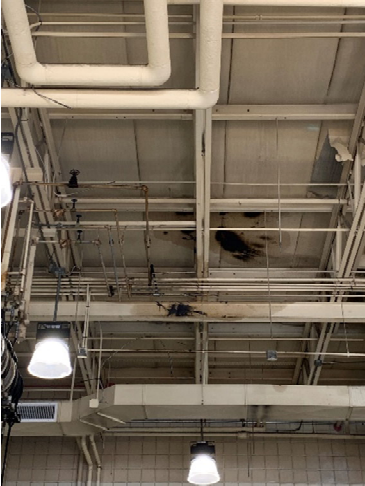
Figure 9: Example of leaks prevalent in high bus bays

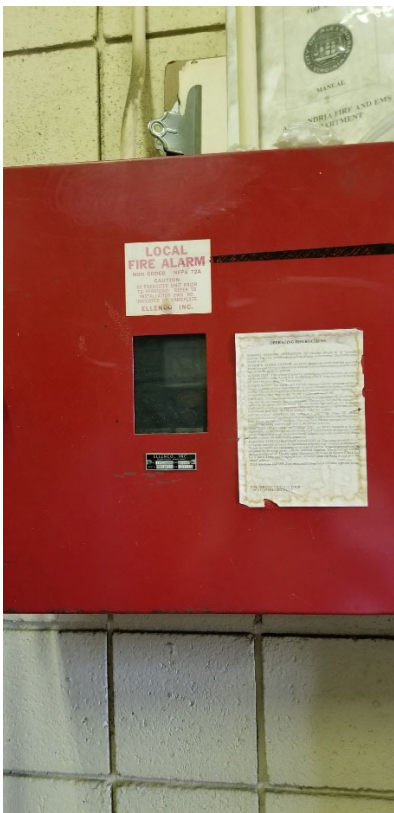
Figure 10: Fire Alarm Control Panel – Local Alarm Only

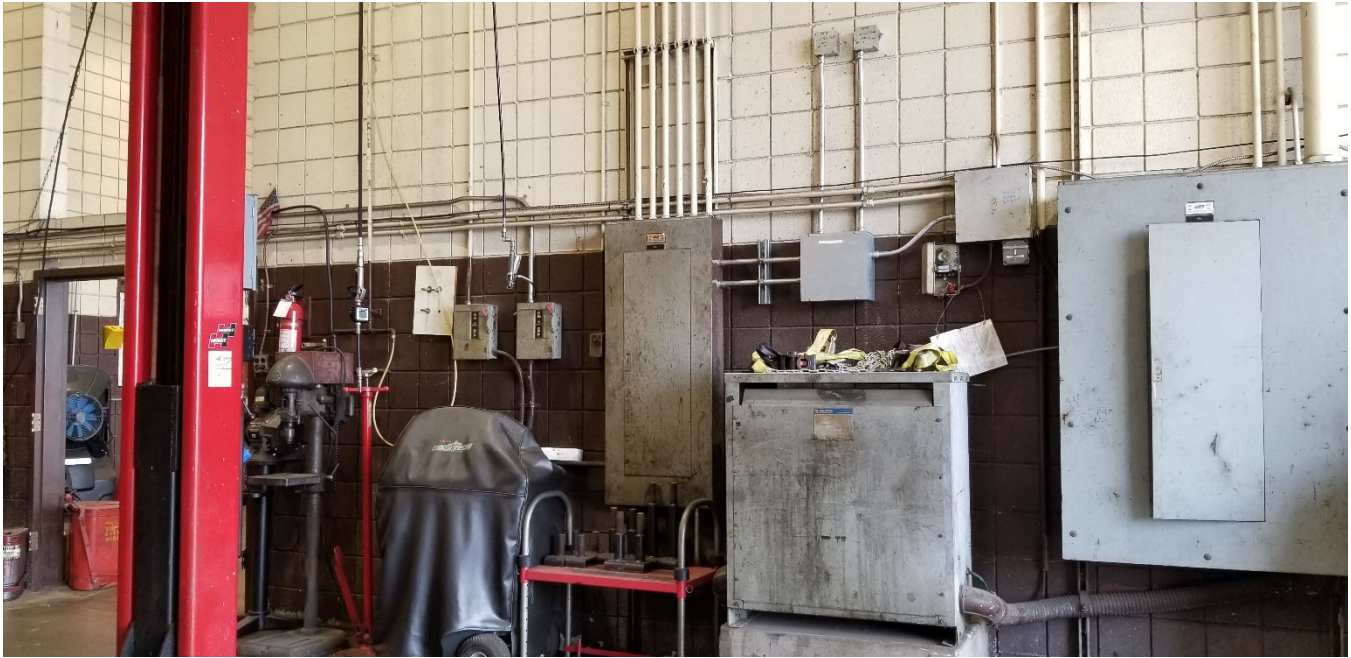
Figure 12: Panelboards and Transformer Exposed to Deteriorating Elements and Being Obstructed by Storage

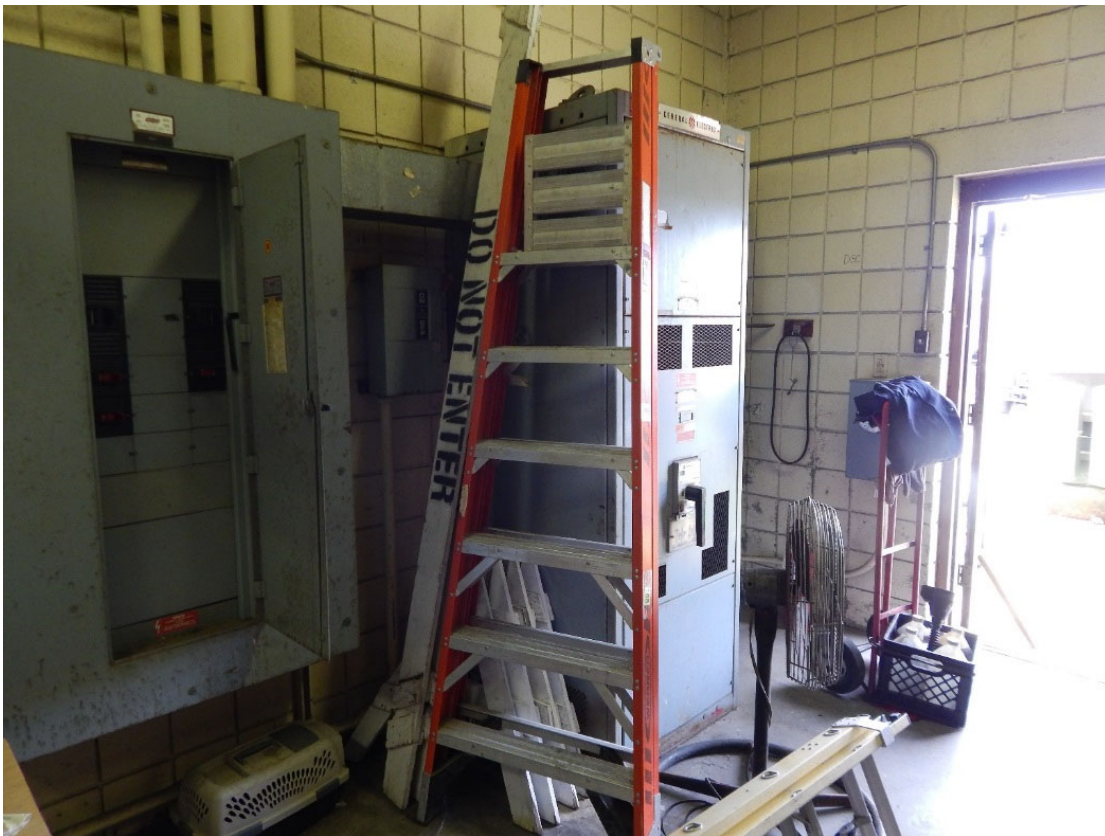
Figure 13: Panelboards and Switchboard Being Obstructed by Storage
