SUBJECT: Final Report

Playground Condition Assessment - Alexandria City Public Schools

Purchase Order No. 240256 FEA Project No. R01.2023.009971

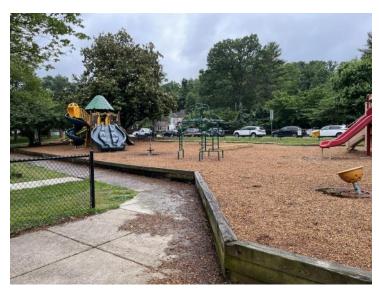
- 14. In the existing condition, due to the engineered wood fiber throughout the playground, all equipment is inaccessible from an Americans with Disabilities Act (ADA) standpoint. Additionally, there are not accessible transfer points onto the two structured play elements. The first step in remediating this deficiency will be to replace engineered wood fiber with poured-in-place protective surfacing in select areas. The second step will be to retrofit transfer stations onto the two structured play elements.

The accessible route needs to be constructed of poured-in-place protective surfacing, at least 60" wide, and at slopes under 1.75%. The accessible route will connect the gate/entry to the playground to transfer stations at the two play structures. The poured-in-place surfacing will overlay a medium-to-fine aggregate (or concrete) subbase. For equipment to be accessible, there must be an accessible route to the equipment.

Play structures require transfer points

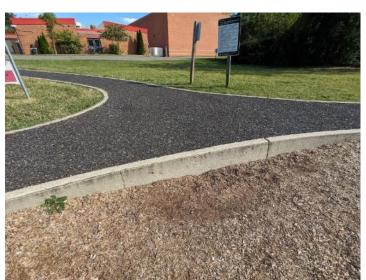
14. In the existing condition, due to the engineered wood fiber throughout the playground, all equipment is inaccessible from an Americans with Disabilities Act (ADA) standpoint. Additionally, there are not accessible transfer points onto the composite play structure. The first step in remediating this deficiency will be to replace engineered wood fiber with poured-inplace protective surfacing in select areas, approximately 3,200 square feet, connecting the accessible walk to the transfer points on the play structure,

and any other accessible features. The second step will be to retrofit transfer stations onto the composite play structure and any additional accessible features.

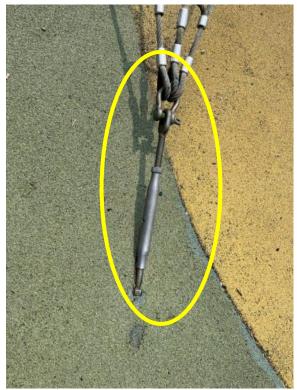
All playground equipment was functioning, but several minor deficiencies were noted through the safety checklist inspections. There was a protrusion hazard in the wooden barriers around older play equipment. There are exposed eye bolt anchors that are tripping hazards. These items can be addressed through minor work order repairs.

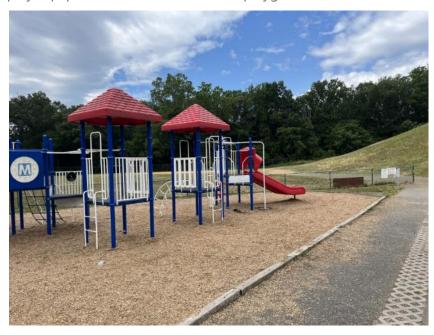
14. In the existing condition, due to the engineered wood fiber throughout the playground, the composite play structures are inaccessible from an Americans with Disabilities Act (ADA) standpoint. Additionally, there are not accessible transfer points onto the composite play structures. The first step in remediating this deficiency will be to replace engineered wood fiber with poured-inplace protective surfacing in select areas, approximately

1,500 square feet connecting the accessible blacktop area to transfer points on the 5-12 structure, and the existing poured-in-place rubber surface under the two smaller play structures. The second step will be to retrofit transfer stations onto all three of the composite play structures.
