ALEXANDRIA CITY PUBLIC SCHOOLS  
COMPREHENSIVE CONDITION AUDITS

- CORA KELLY ELEMENTARY SCHOOL
- FRANCIS C. HAMMOND MIDDLE SCHOOL
- GEORGE MASON ELEMENTARY SCHOOL
- GEORGE WASHINGTON MIDDLE SCHOOL
- MATTHEW MAURY ELEMENTARY SCHOOL
- TRANSPORTATION FACILITY

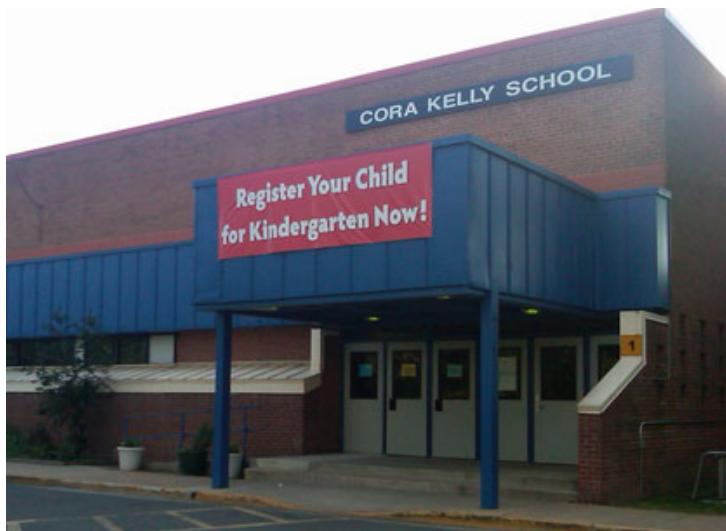
III A. CORA KELLY ELEMENTARY SCHOOL

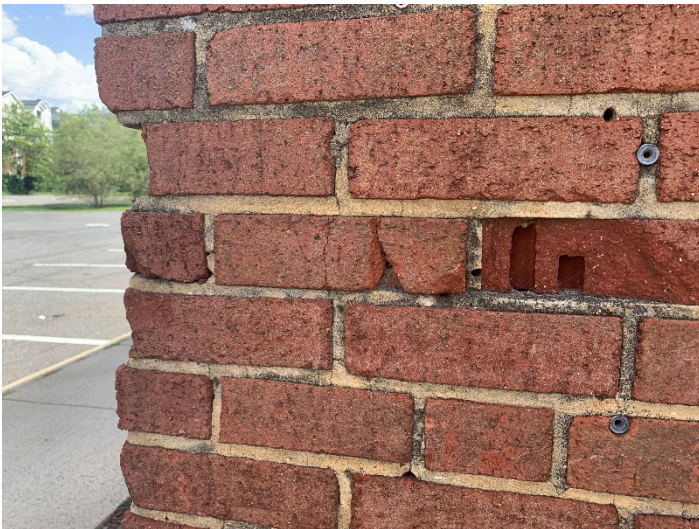
*Figure 3: Joint repair needed*

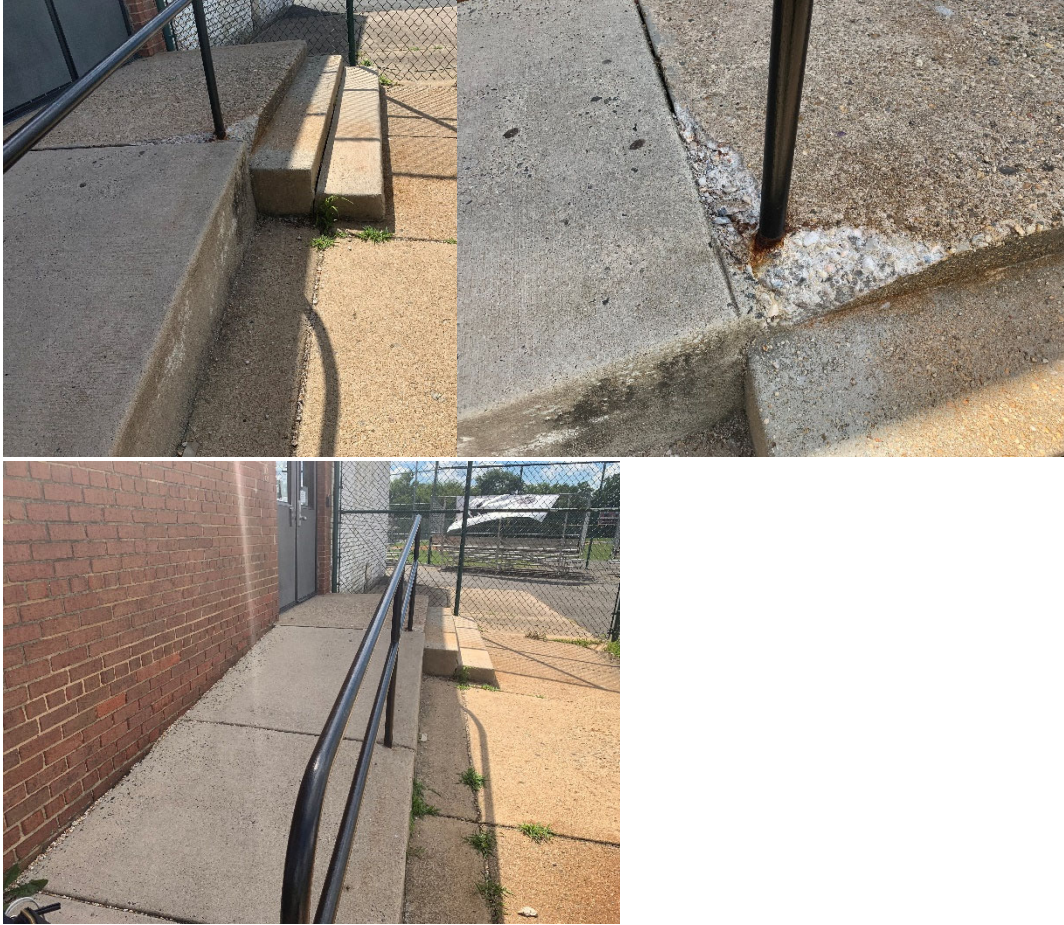
*Figure 4: Exterior ramp*

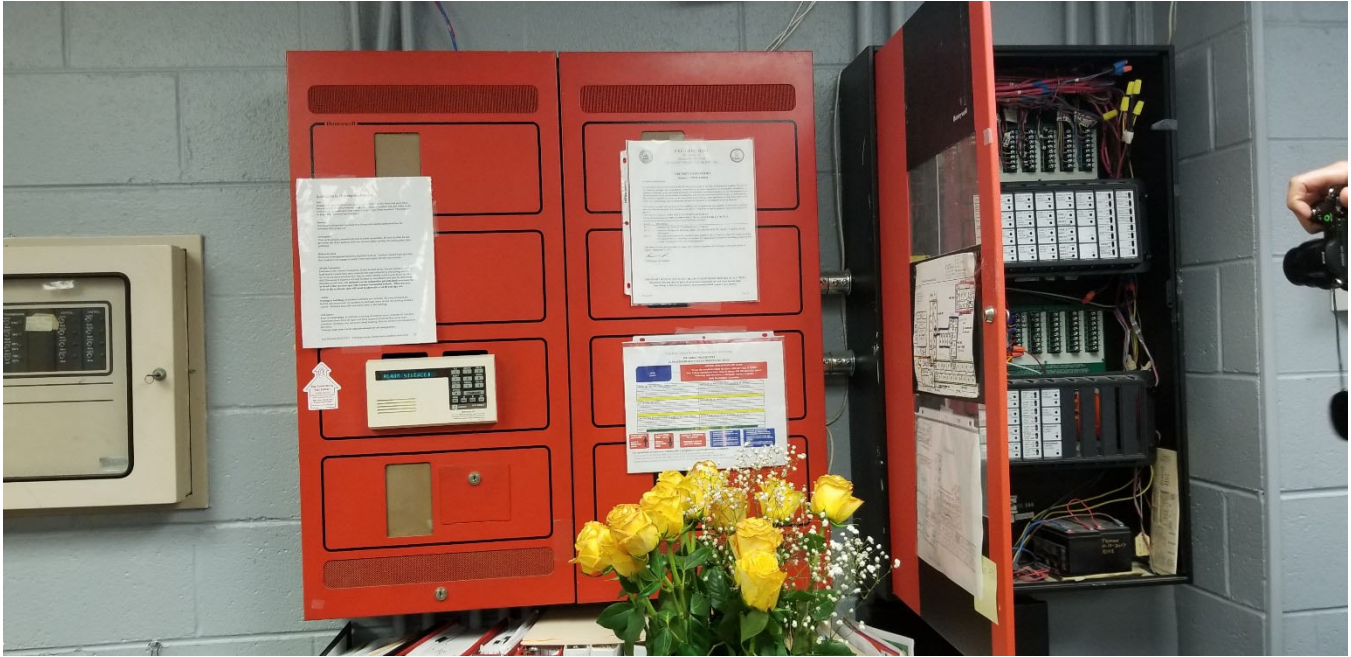
*Figure 10: Fire Alarm Control Panels*

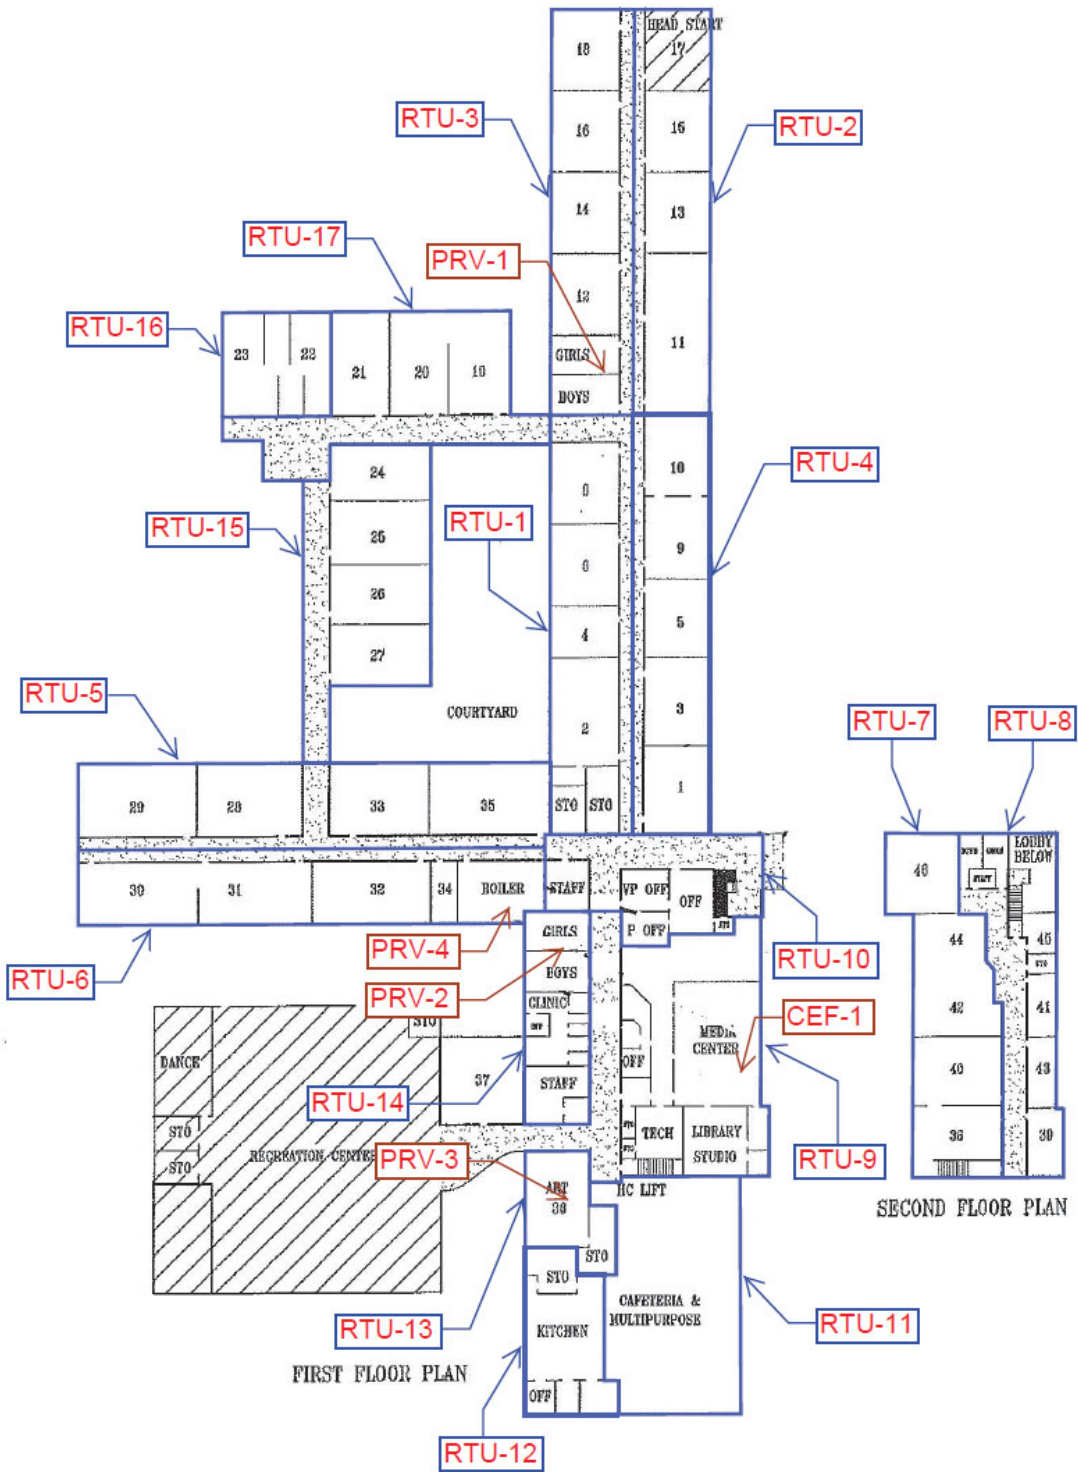
**ALEXANDRIA CITY  
PUBLIC SCHOOLS**

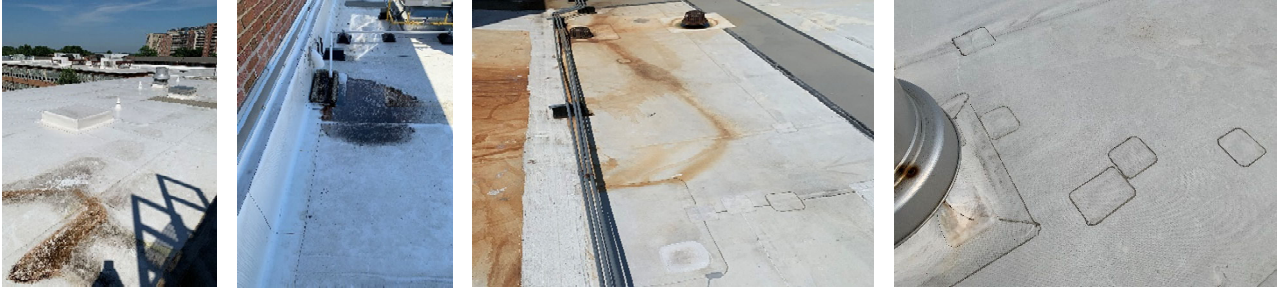
Figure 1. Roof – shown: D wing roof failures and patchwork

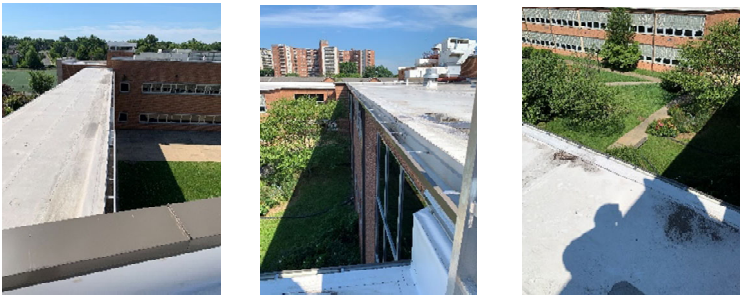
Figure 4. Mono-directional roof to gutter

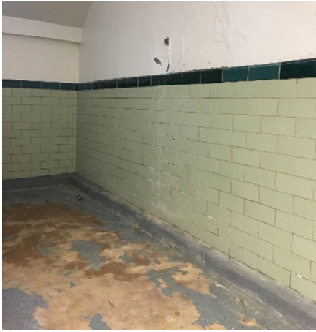
Figure 5. Cafeteria stairwell 9

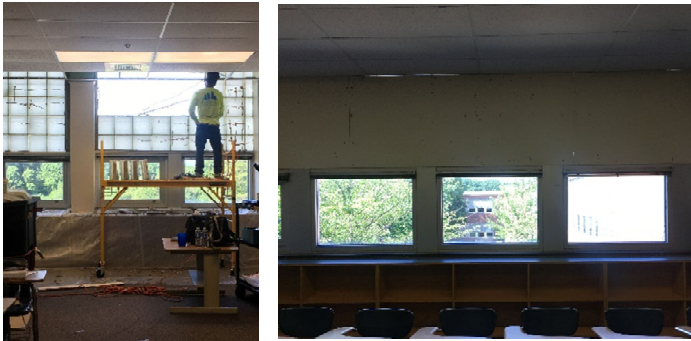
Figure 8. Window replacement (Left to right) E wing in progress and B wing soon to commence.  
**Classroom Samples**

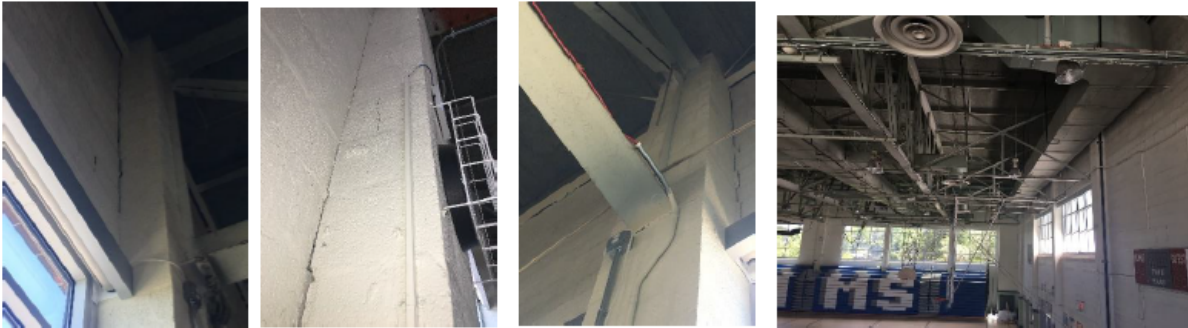
In the gymnasium, columns appear to be separating from the walls.

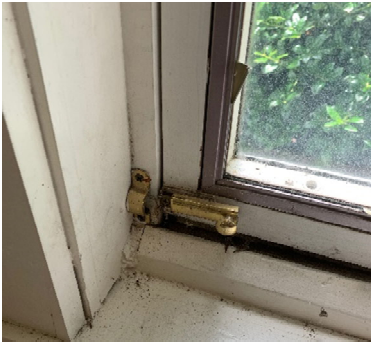
Figure 16 Inoperable Window Hardware

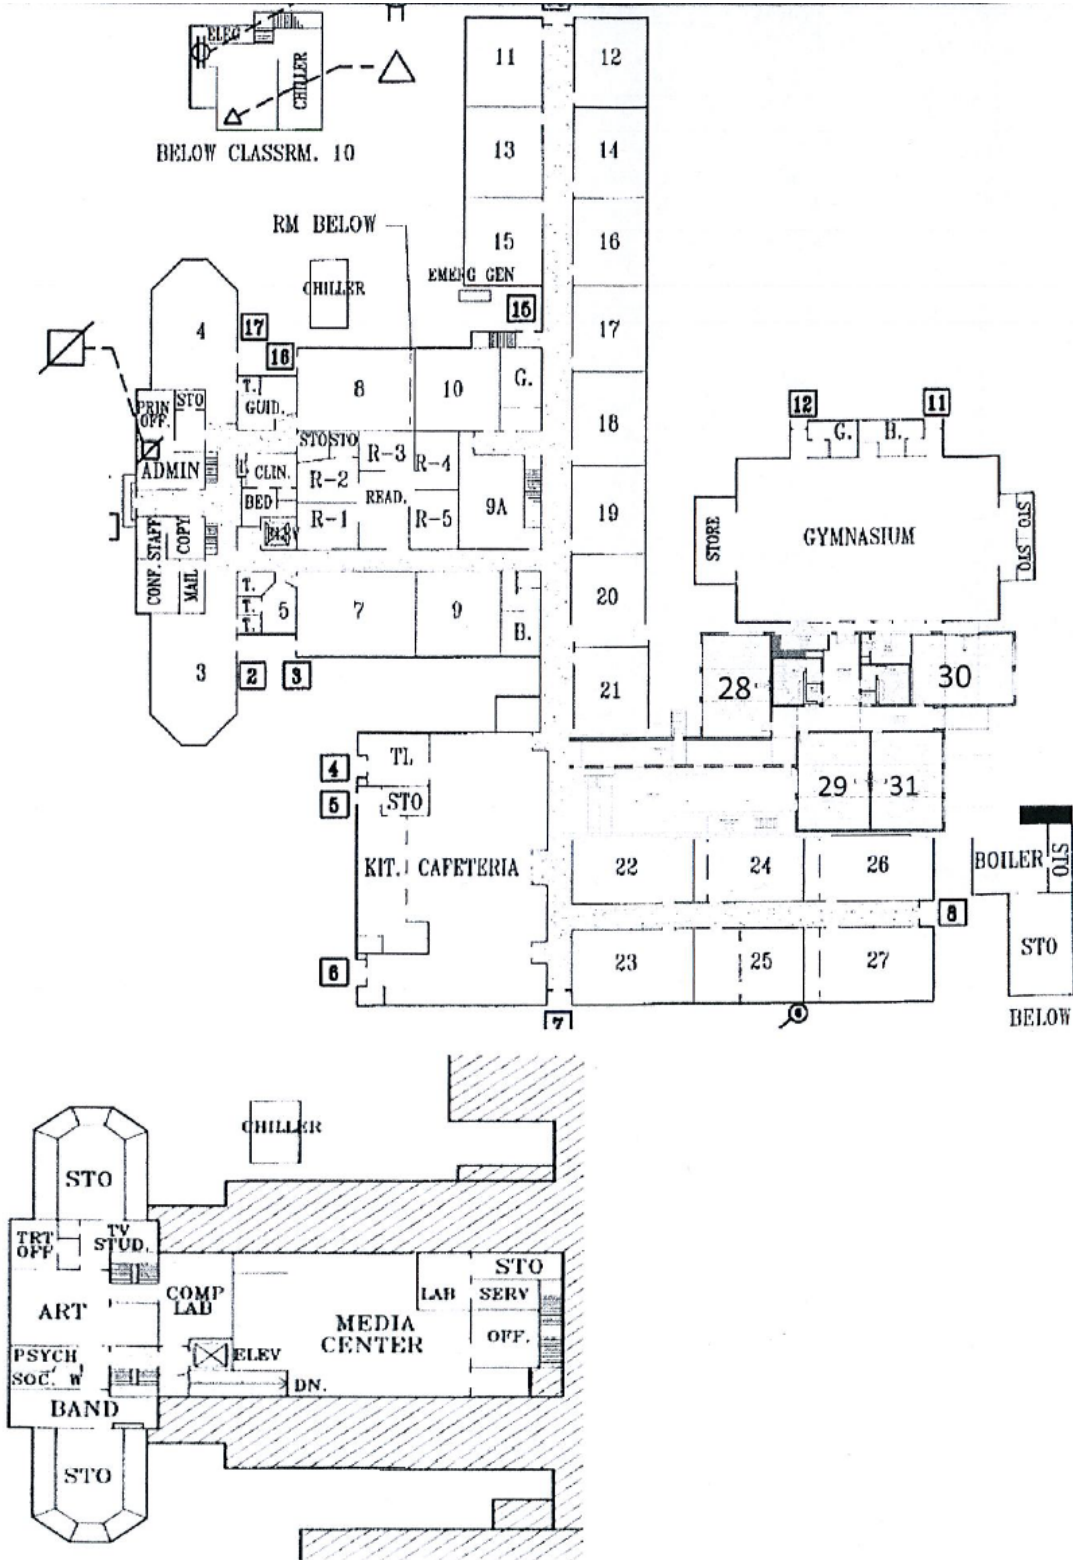
**ALEXANDRIA CITY  
PUBLIC SCHOOLS**

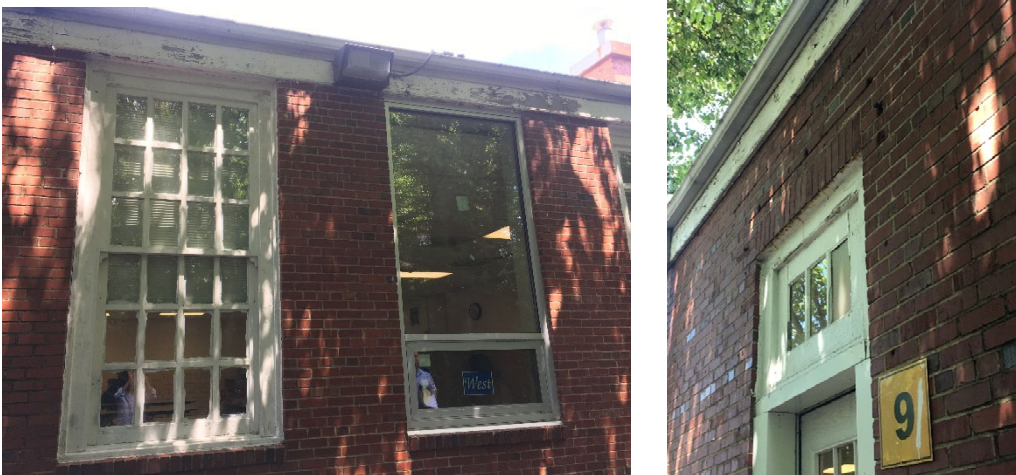
Figure 22 Wood Rot on Windows Due to Moisture

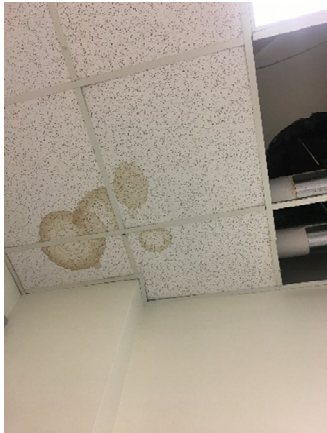
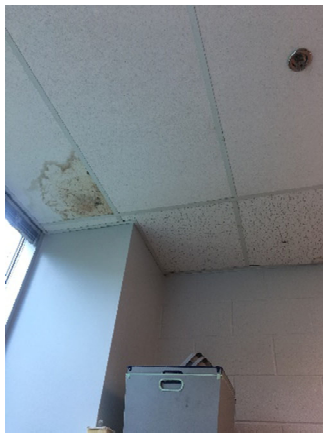
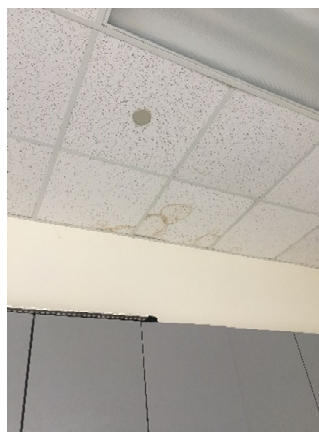
Figure 6 Ceiling Stains

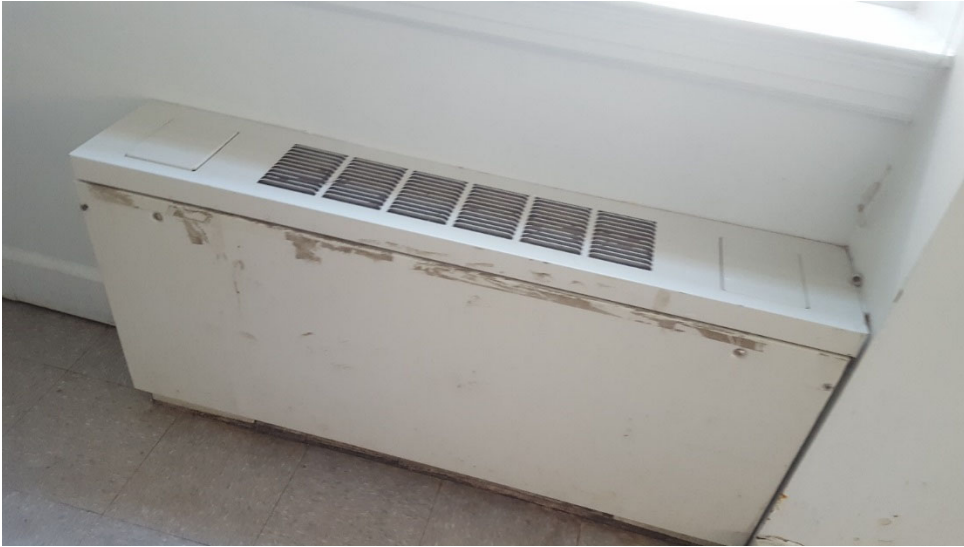
Fan coil unit found in room A113.

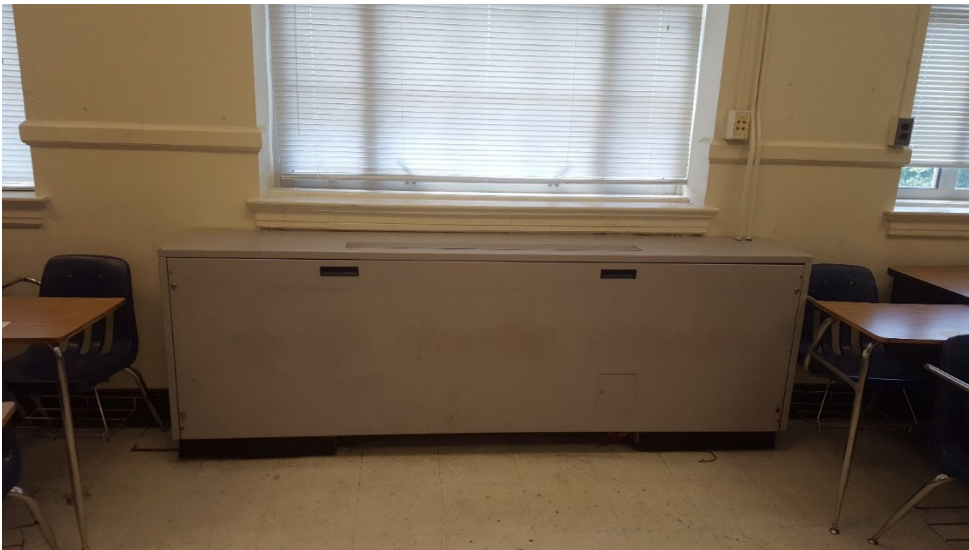
Unit ventilator found in room A310.

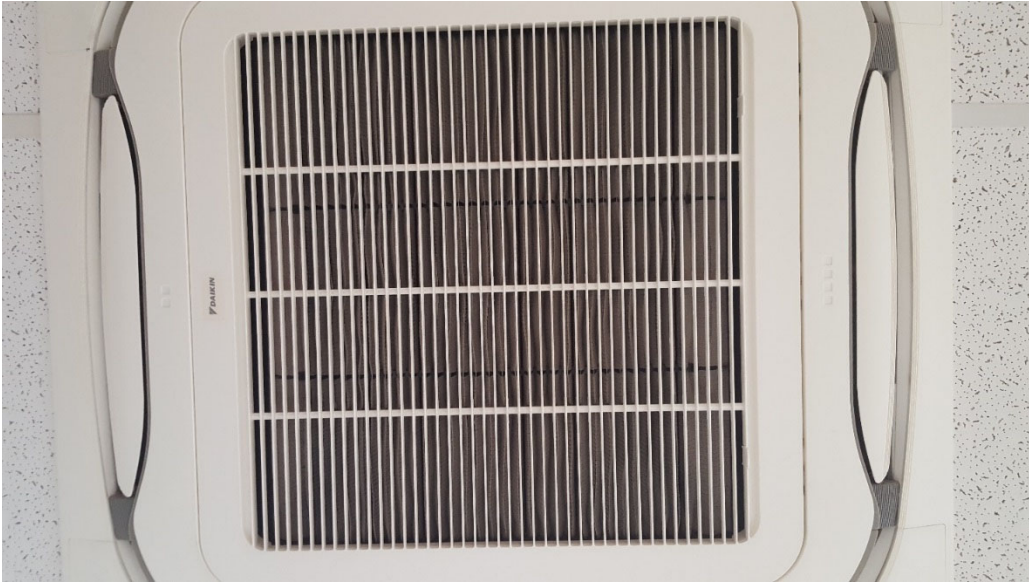
Daikin cassette in cafeteria.

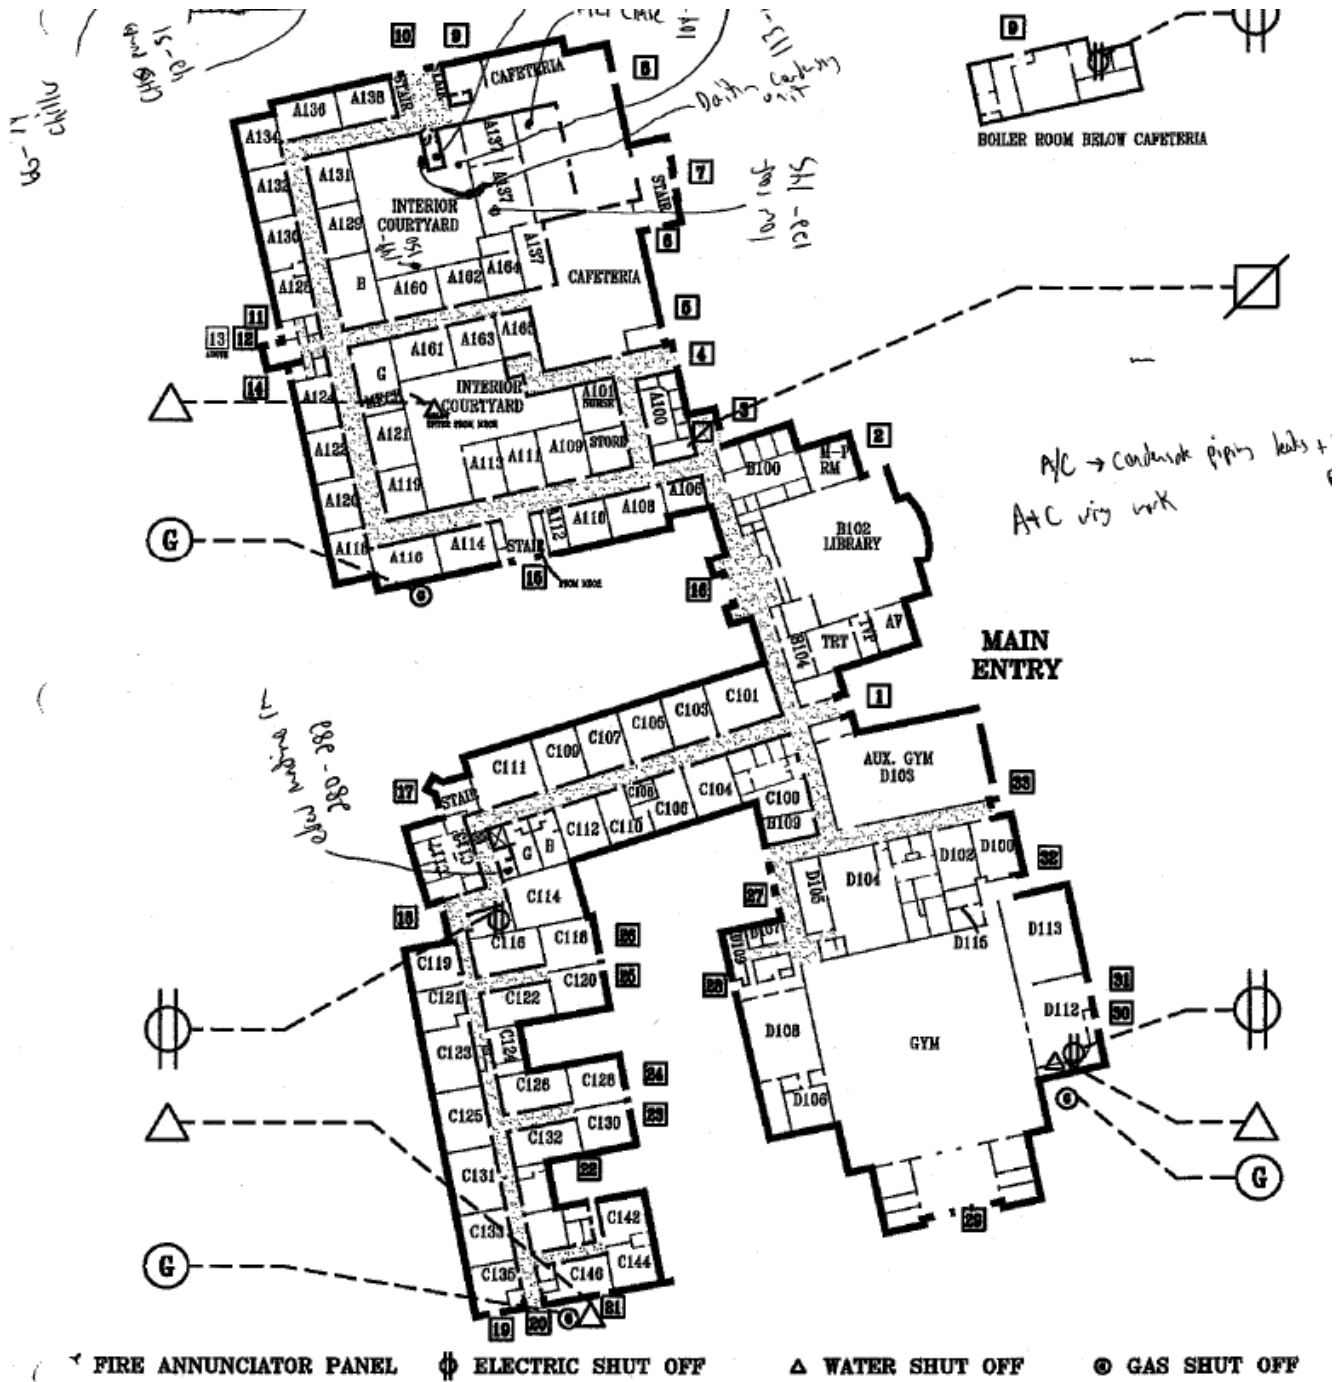
## FLOOR PLAN DIAGRAMS

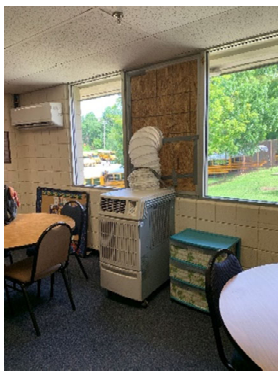
*Figure 4: Patchwork measures to correct HVAC inadequacies*

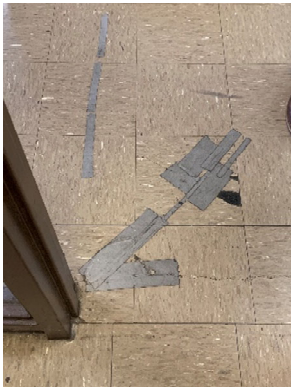
Figure 7: Entry area - Damaged floor tiles

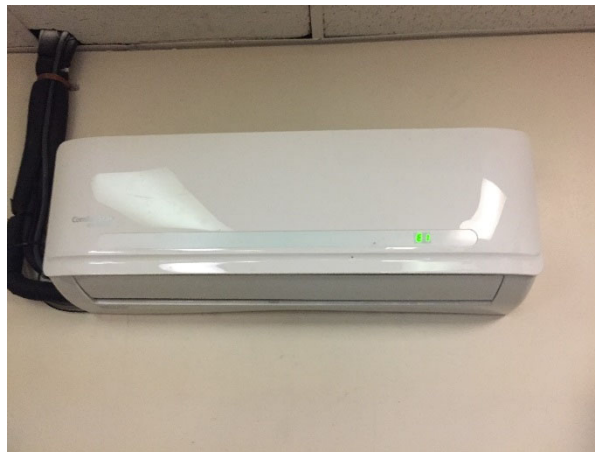
SPLIT SYSTEM AIR CONDITIONER
