ALEXANDRIA CITY PUBLIC SCHOOLS
COMPREHENSIVE CONDITION AUDITS

- CORA KELLY ELEMENTARY SCHOOL
- FRANCIS C. HAMMOND MIDDLE SCHOOL
- GEORGE MASON ELEMENTARY SCHOOL
- GEORGE WASHINGTON MIDDLE SCHOOL
- MATTHEW MAURY ELEMENTARY SCHOOL
- TRANSPORTATION FACILITY

Final Report - DRAFT

August 9, 2019

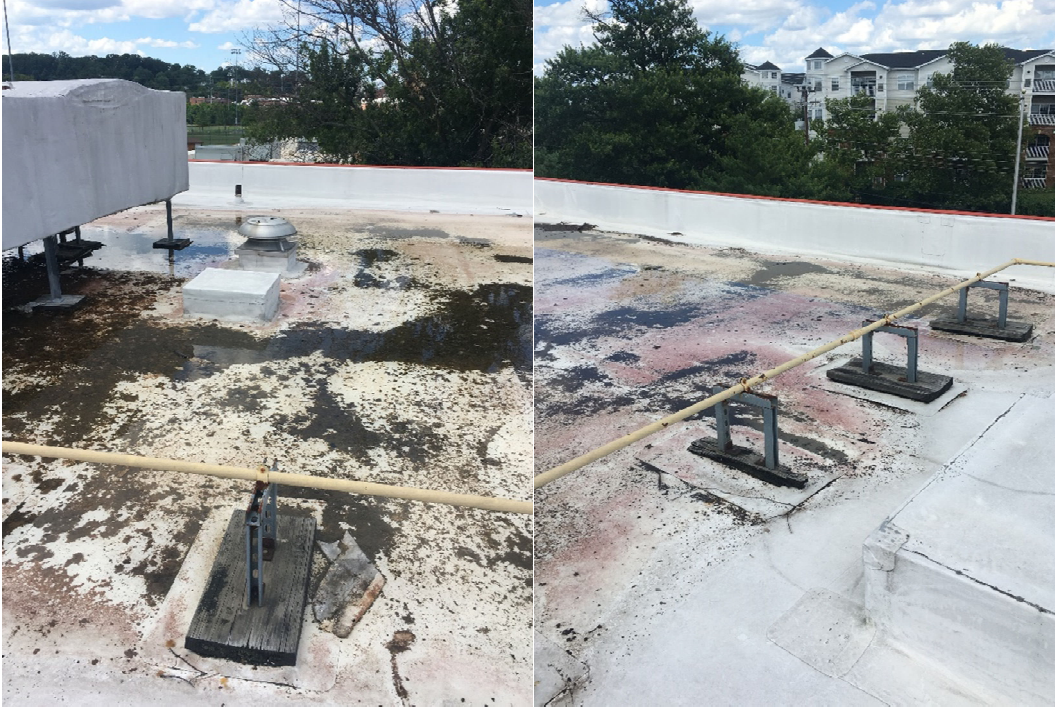
Figure 8 and 2: Water ponding on the roof causing leaks

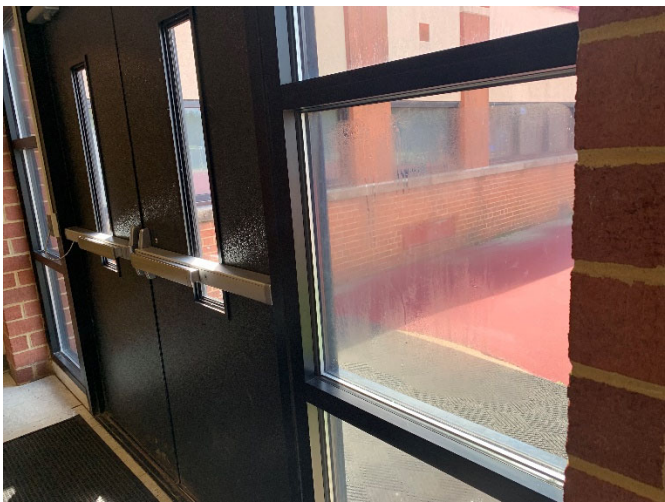
Figure 7: Window Sweating

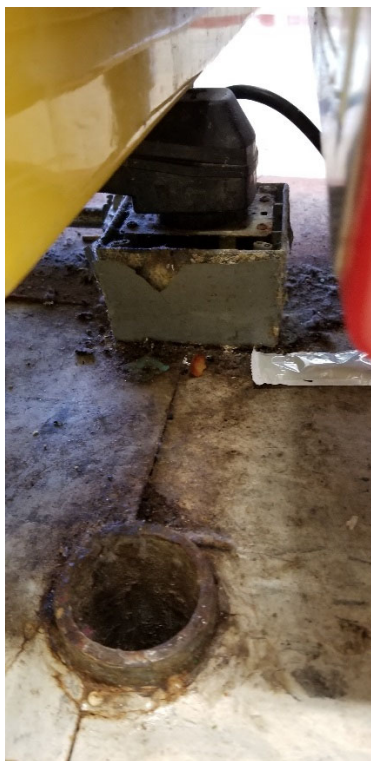
Figure 12: Cafeteria Service Counter – Floor Outlet Missing Cover Plate

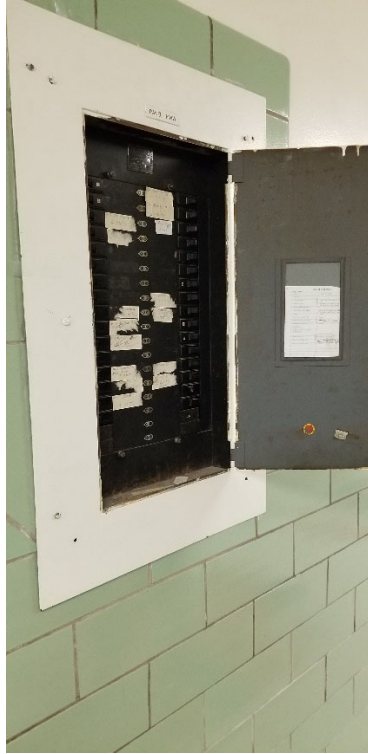
Figure 13: Obsolete Panel 1-WW

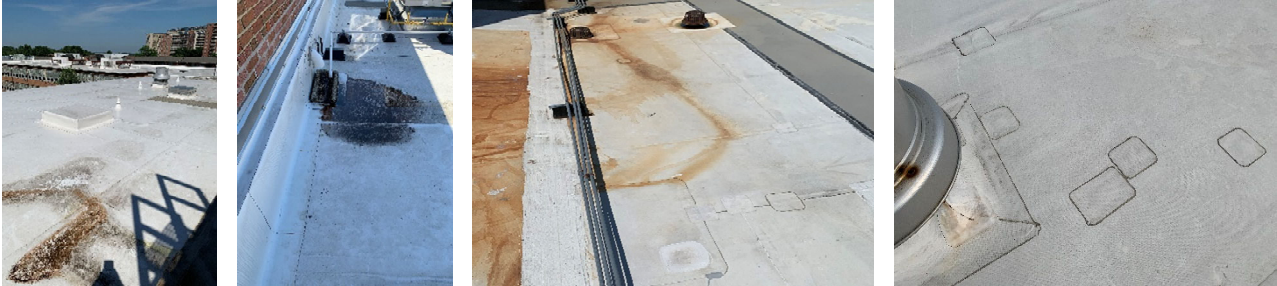
Figure 1. Roof – shown: D wing roof failures and patchwork

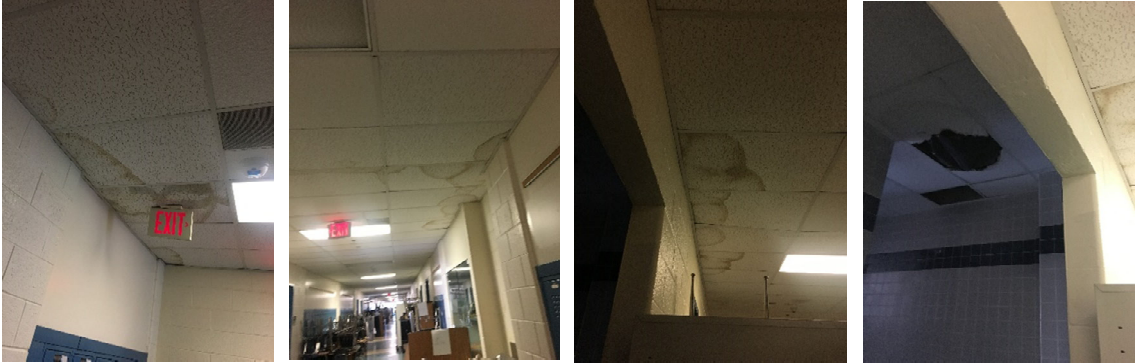
Figure 2. Ceiling stains from roof failure

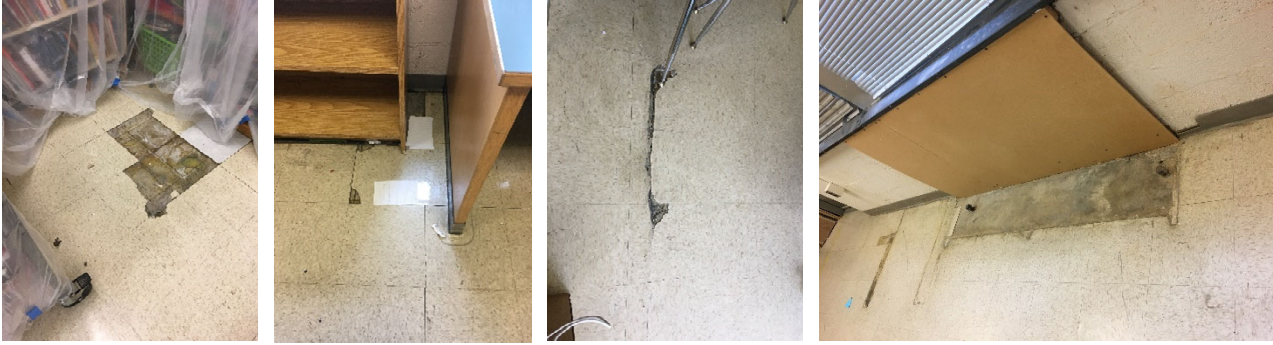
Classroom flooring wear & rear – refer to matrix

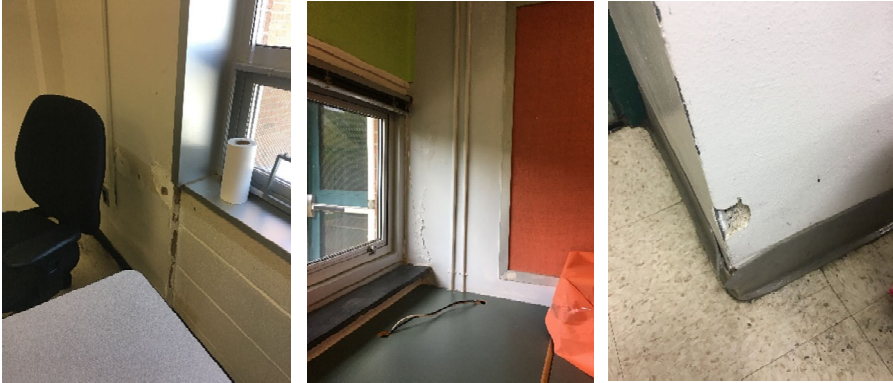
Classroom wall finish issues – refer to matrix

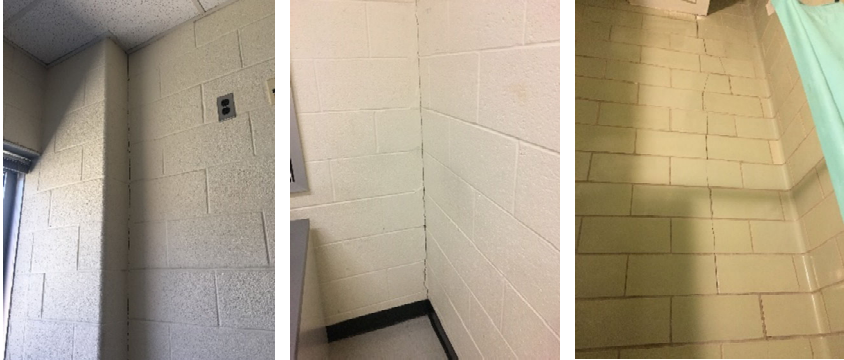
Interior masonry wall cracks – refer to matrix

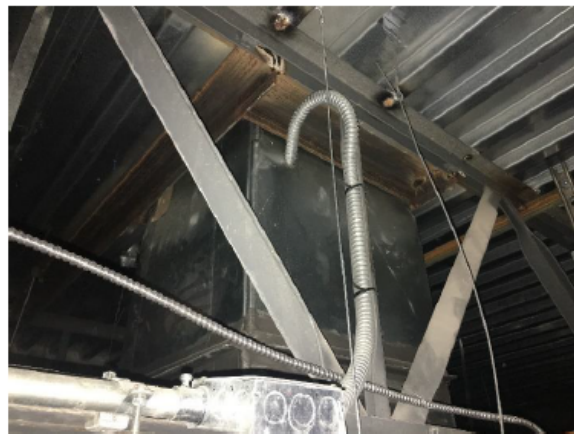
Leaks in the second-floor bathroom of the D-Wing have brought down ceilings and left the bathroom unsafe and unable to be used.

There is minor rusting of some of the steel framing above the bathroom. There are no apparent signs of section loss. Two of the brace angles are very rusted and seem to be failing at the welded joints where there is significant deflection.

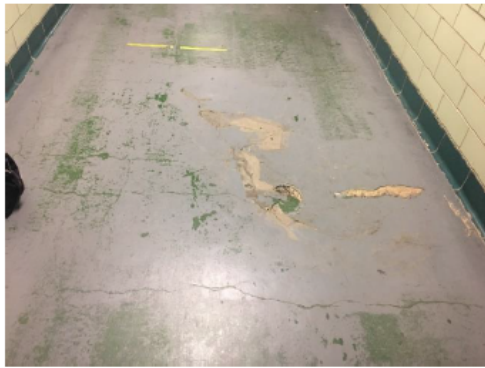
An area of the concrete slab at the lowest level corridor to the locker rooms is damaged.

The concrete slab has some hairline cracking and is spalling in two concentrated areas. The slab appears to have been previously patched. Spalling areas are about 6"x2'-0"x1" deep.

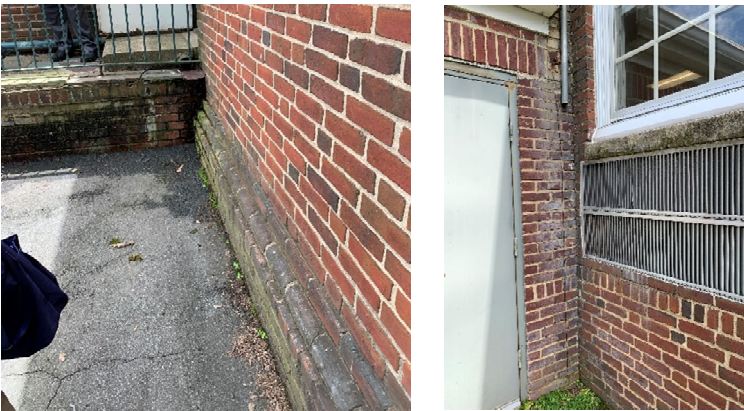
Figure 15 Exterior Wall Moisture and Settlement Cracks

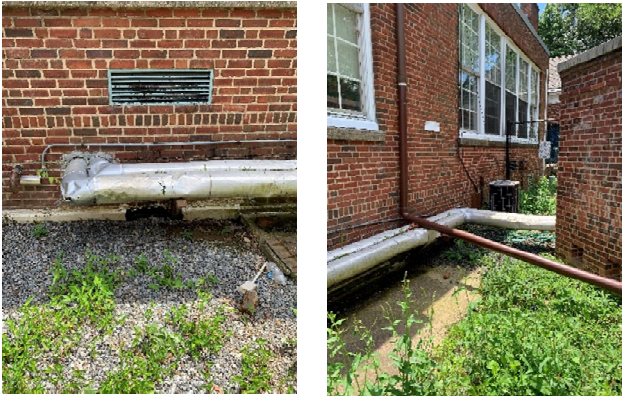
Figure 17 Inadequate Stormwater Drainage

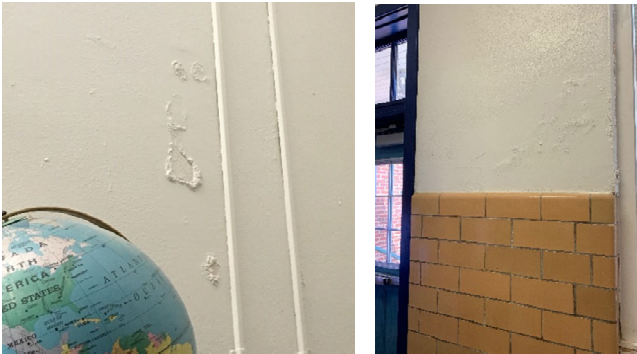
Figure 18 Wall Finishes

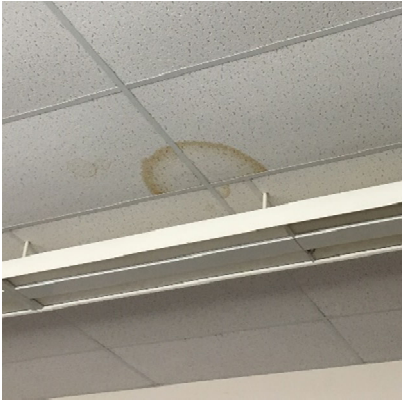
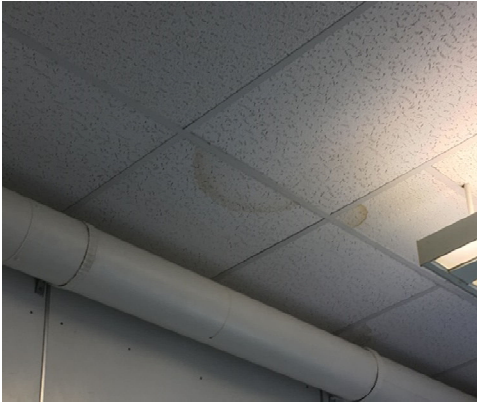
Figure 20 Ceiling Stains

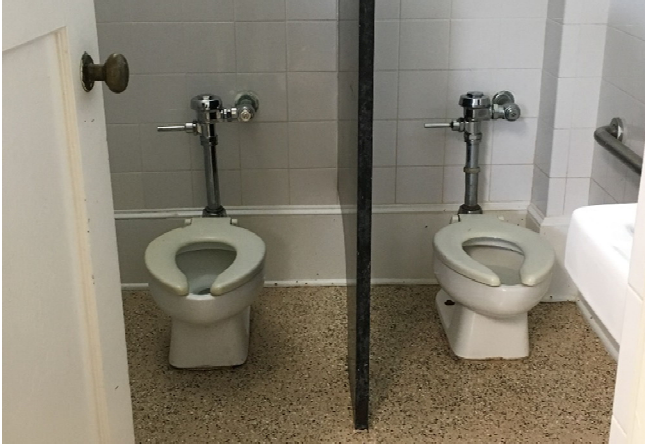
Figure 8 No Stall Doors

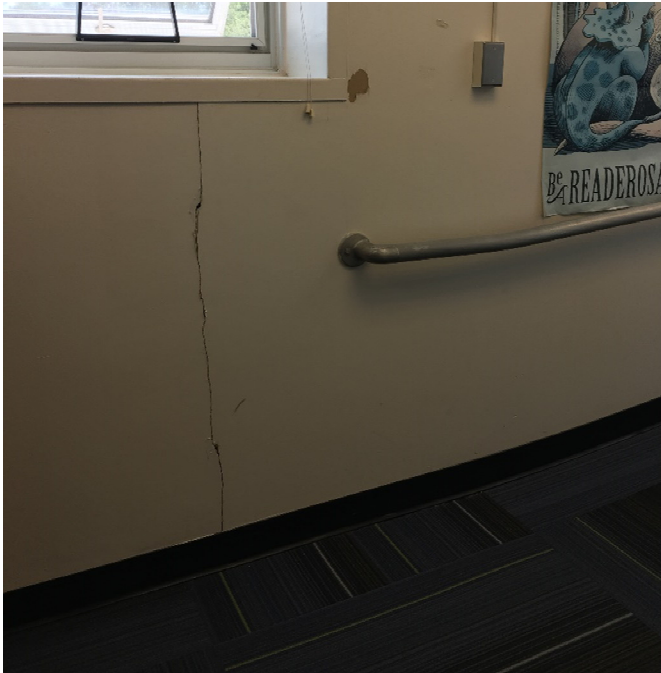
Figure 9 Settlement Crack (seen in Library)

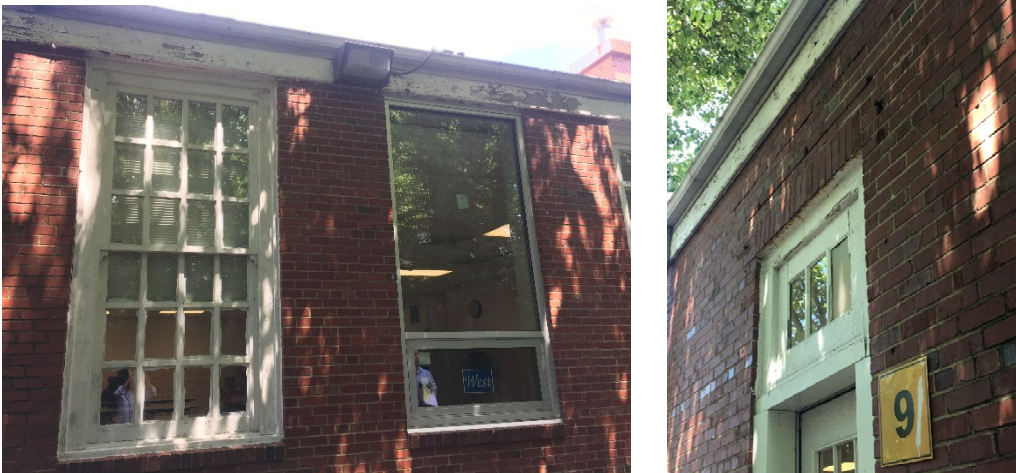
Figure 22 Wood Rot on Windows Due to Moisture

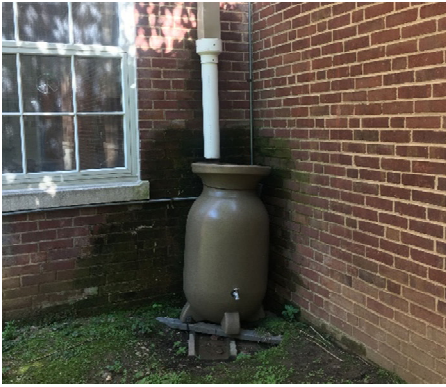
Figure 3 Greywater Collection is Poorly Set

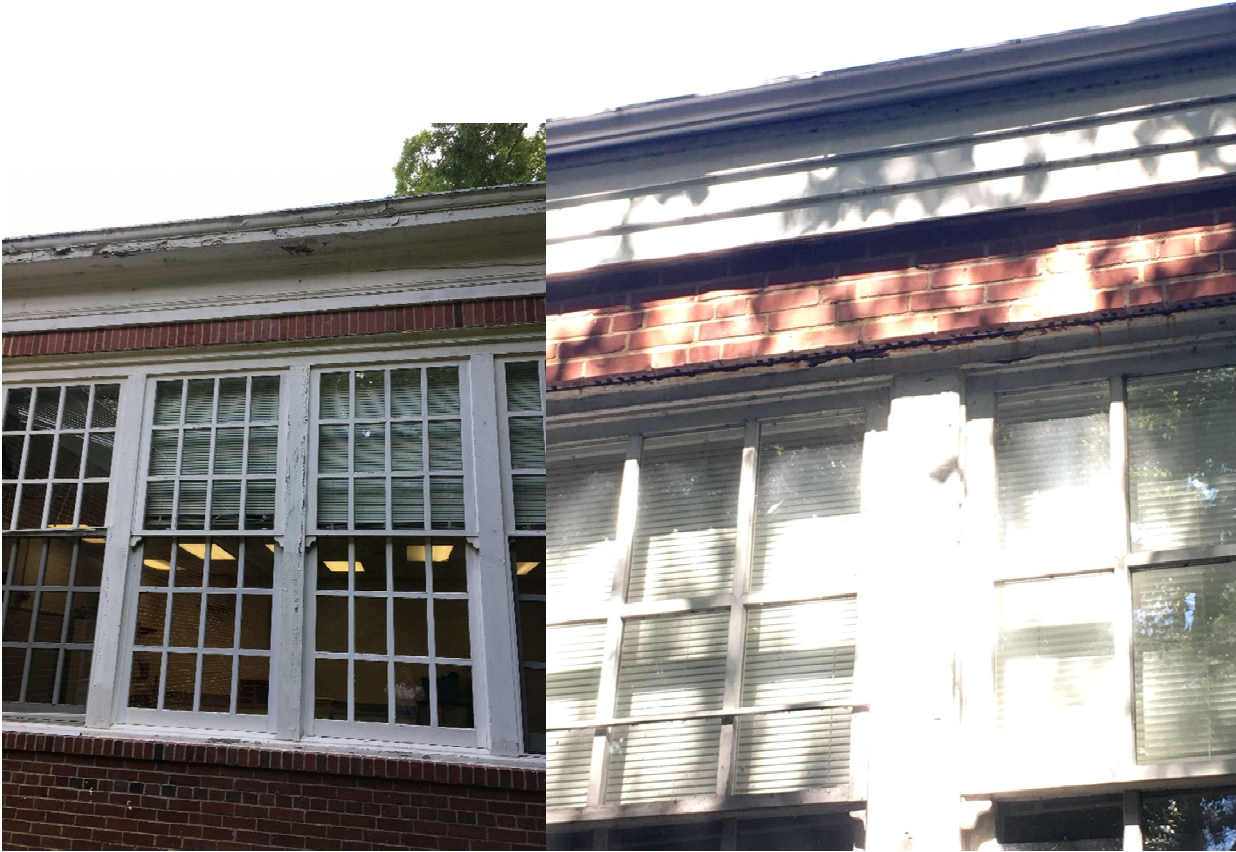
Figure 2: Exterior coping

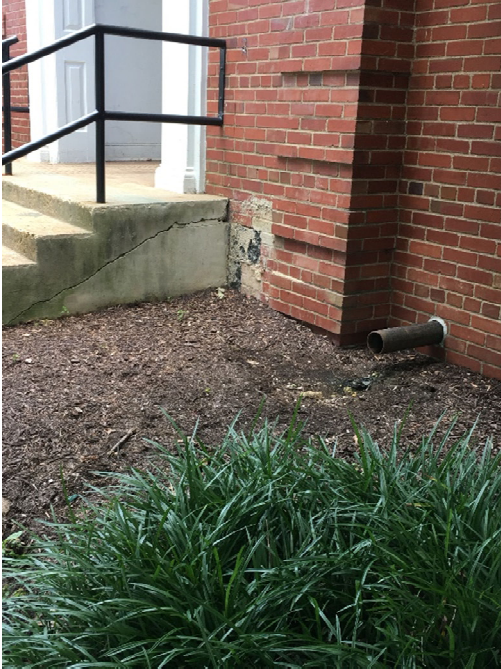
Figure 3: Crack on the entrance steps

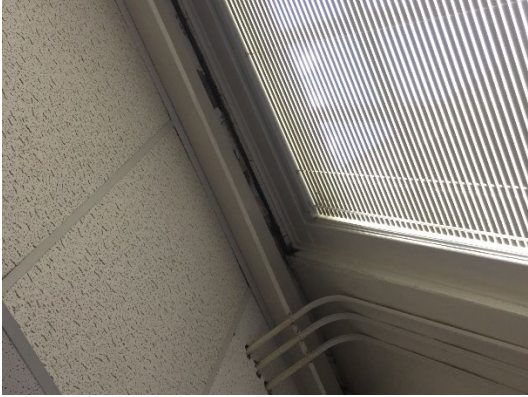
Figure 4: Window frames

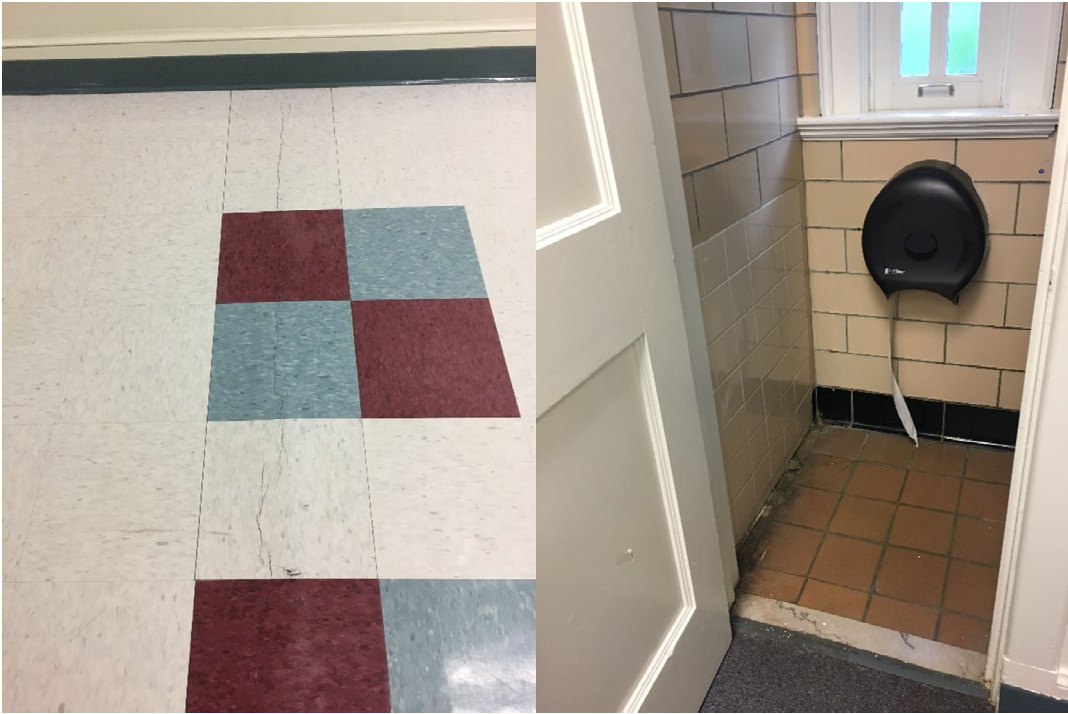
Figure 6: Cracked floor

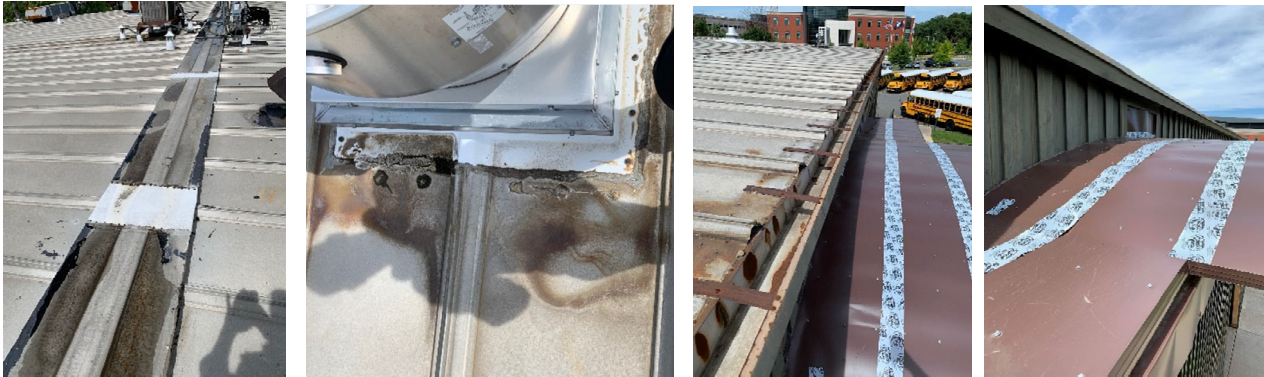
Figure 1. Roof – Leaks, corroded seams and surfaces, gutter detail and incomplete canopy

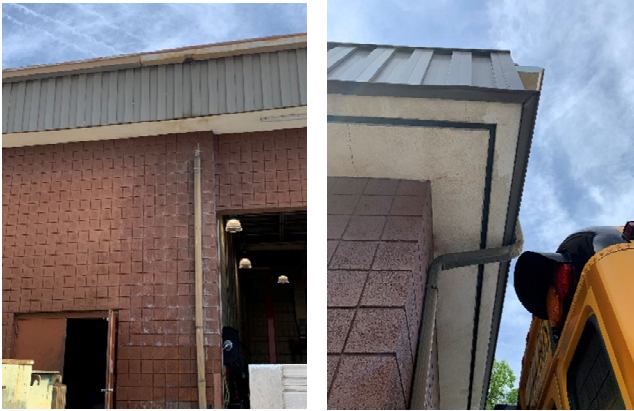
Figure 2. Exterior water damage due to roof drainage failures

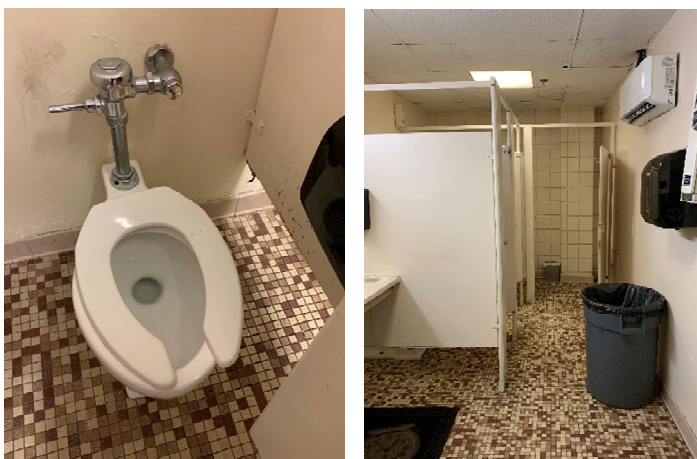
Figure 5: Women's Bathroom – Examples of water damage from leaks

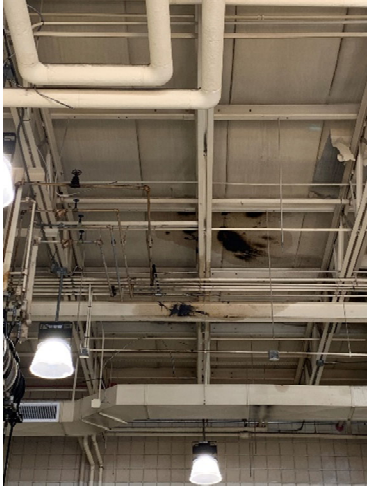
Figure 9: Example of leaks prevalent in high bus bays
