EXHIBITS

EXHIBIT 1:

JOINT TASK FORCE & SUBCOMMITTEE MEETINGS

A2 Services, Inc. Facility Survey of City of Alexandria - City Hall

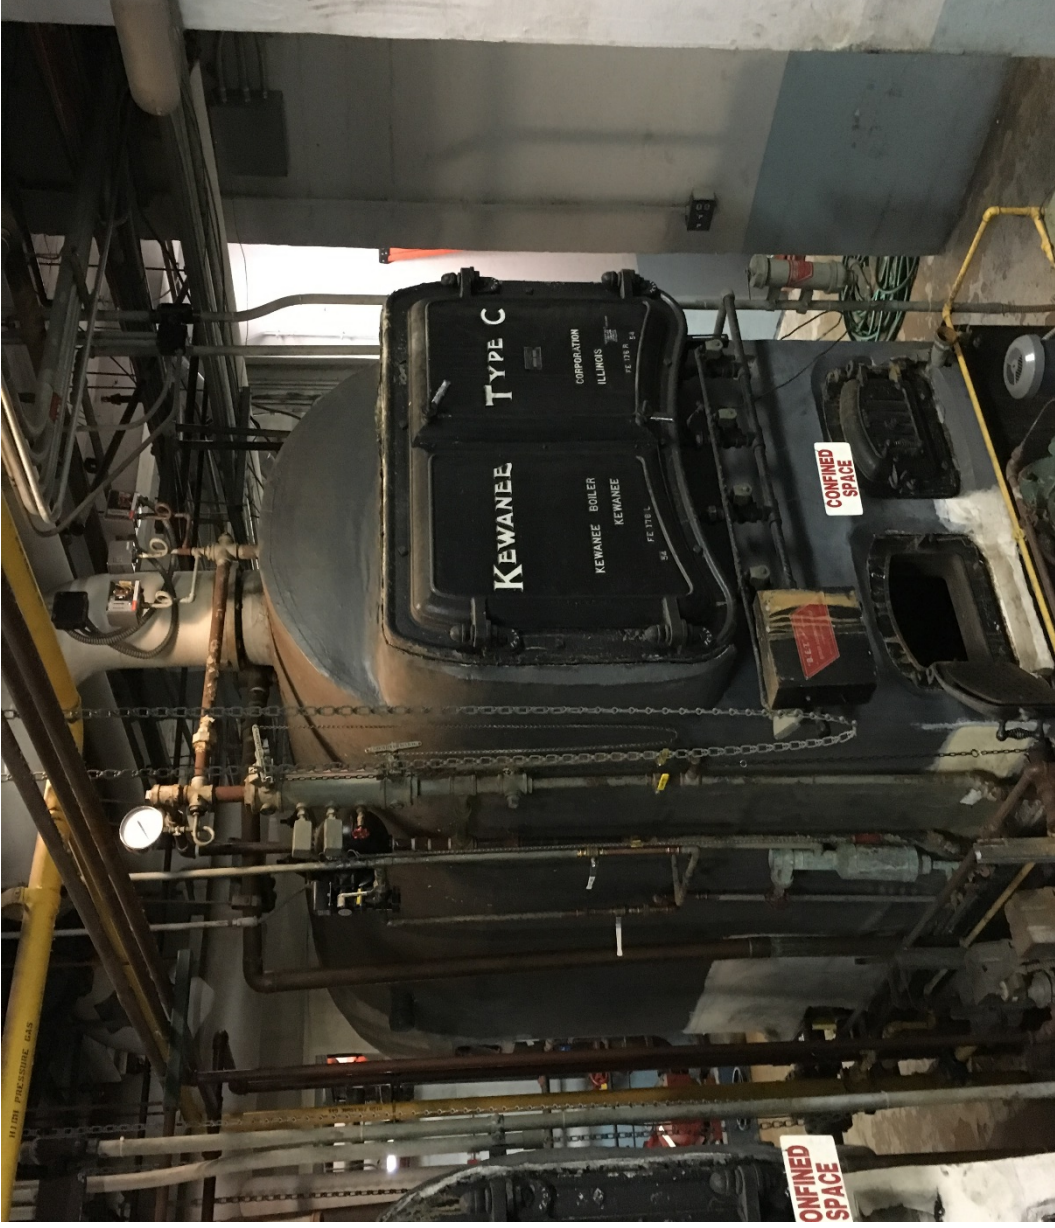
- Finding # - 1. As discussed above the two low pressure steam boilers are in poor condition. These should be considered for replacement soon. Actually the entire heating and cooling system is reaching the end of its useful life. The City of Alexandria should consider a complete heating and cooling system replacement. The City Hall facility would be a good candidate for new variable refrigerant flow heating and cooling system. Roof top dedicated outside air units with heat recovery could provide ventilation. These units would allow the site to meet the ASHRAE 62.1 and 62.2 standards for indoor air quality. This type of system would be the most efficient system available and would be the least expensive and disruptive to fit into this historic building.

Finding # 1 Photo. This picture is of one of the old brick set fire tube boilers. These units are in poor condition.

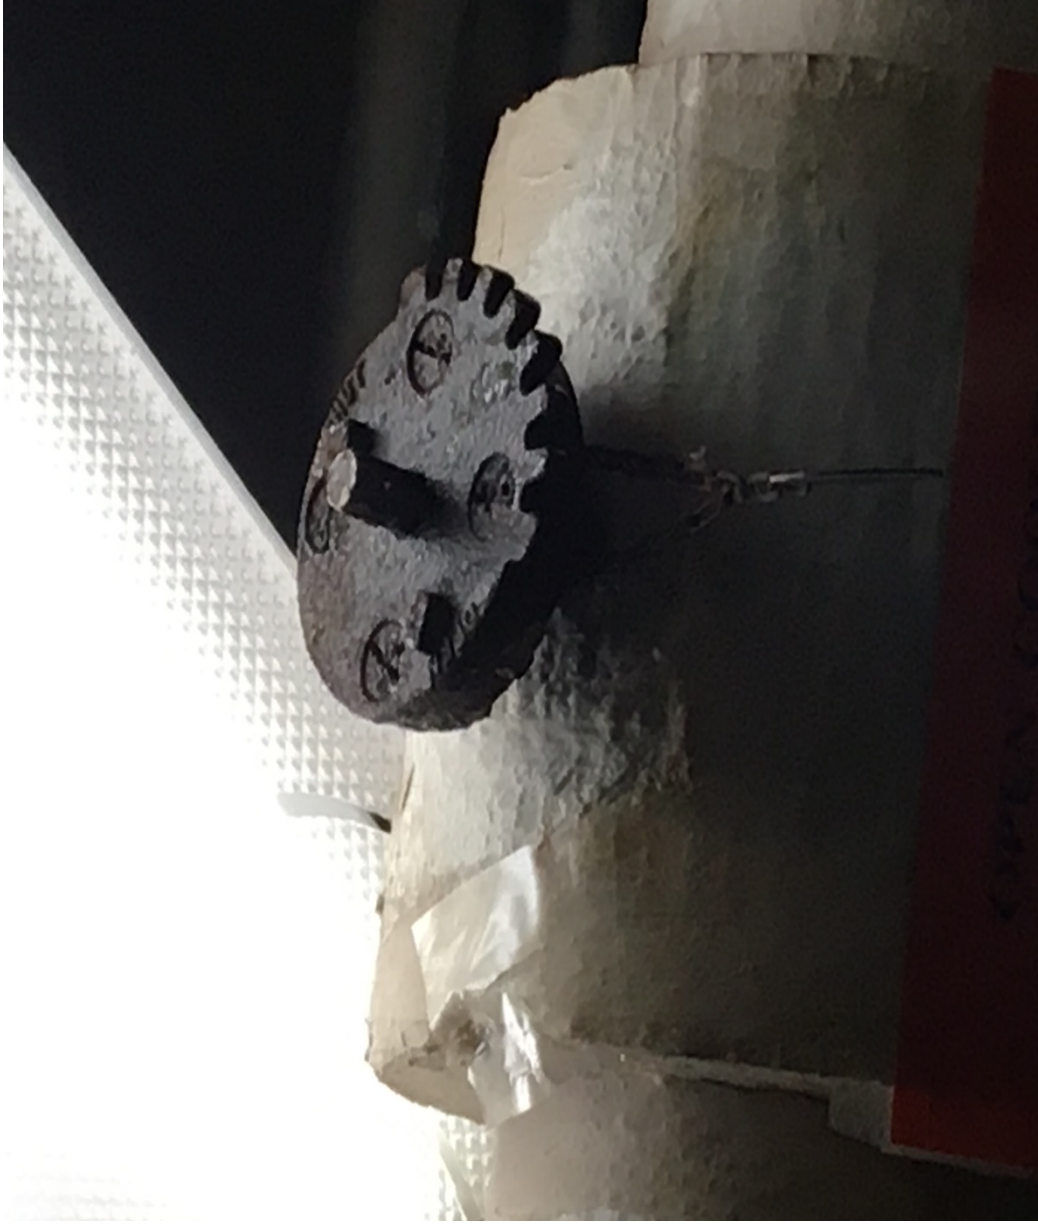
- Finding # - 3. A2 noted that at least two hydronic system manual valves which were have broken handles. **REVISION - While the valves are operable through the use of wrench rather than the designed turning knob, it is recommended that the valves be replaced.**

Finding # 3 Photo. This picture is an example of one valve which needs to be replaced.

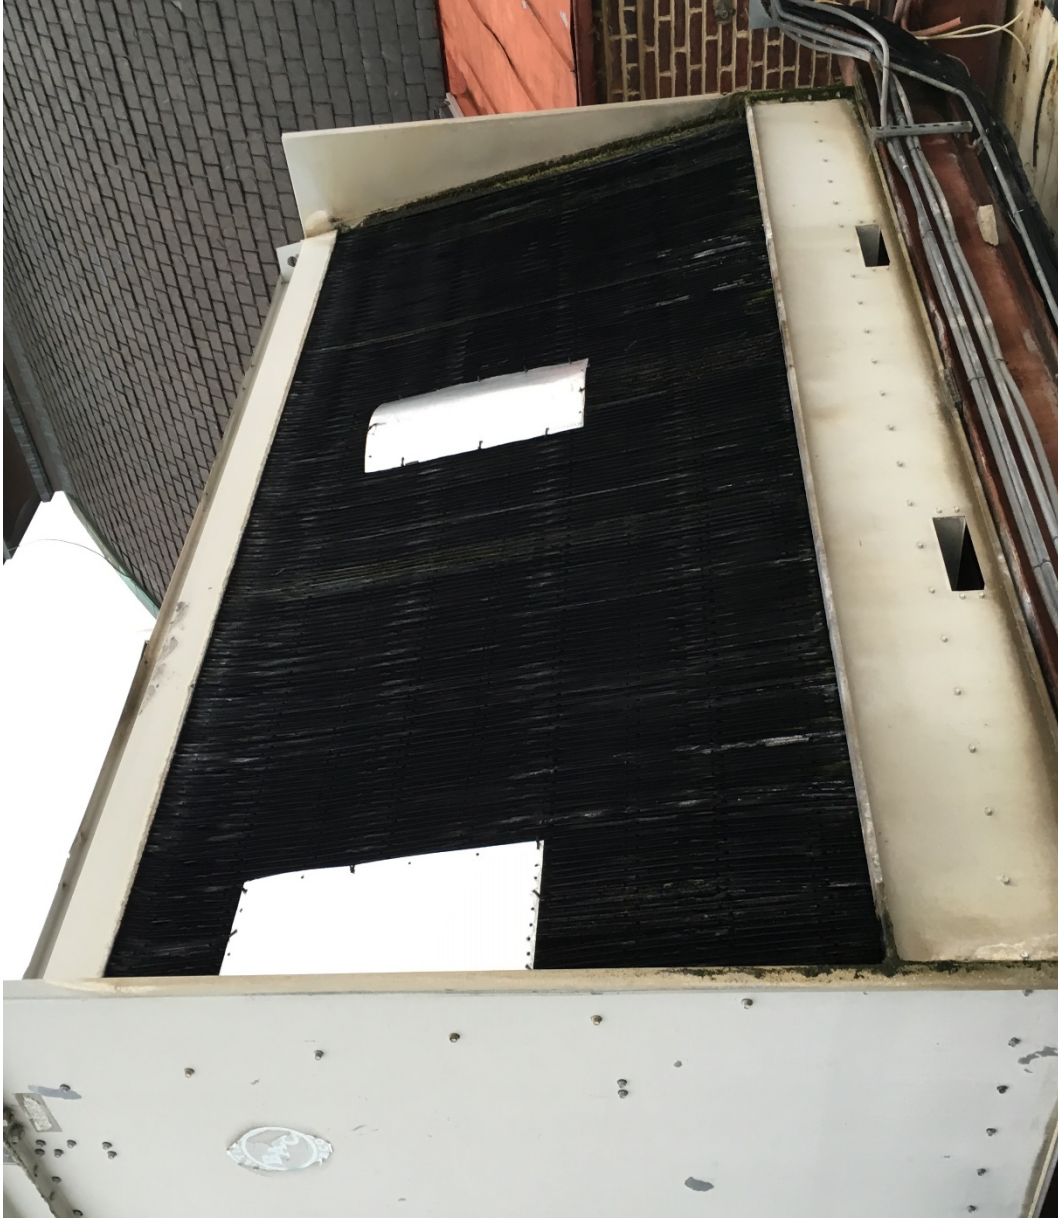
- Finding # - 4. The cooling tower fill is damaged and has been temporarily repaired with some sheet metal to stop the tower water from blowing onto the roof. The fill should be replaced.

Finding # 4 Photo. This picture notes the temporary sheet metal repair to the cooling tower fill.

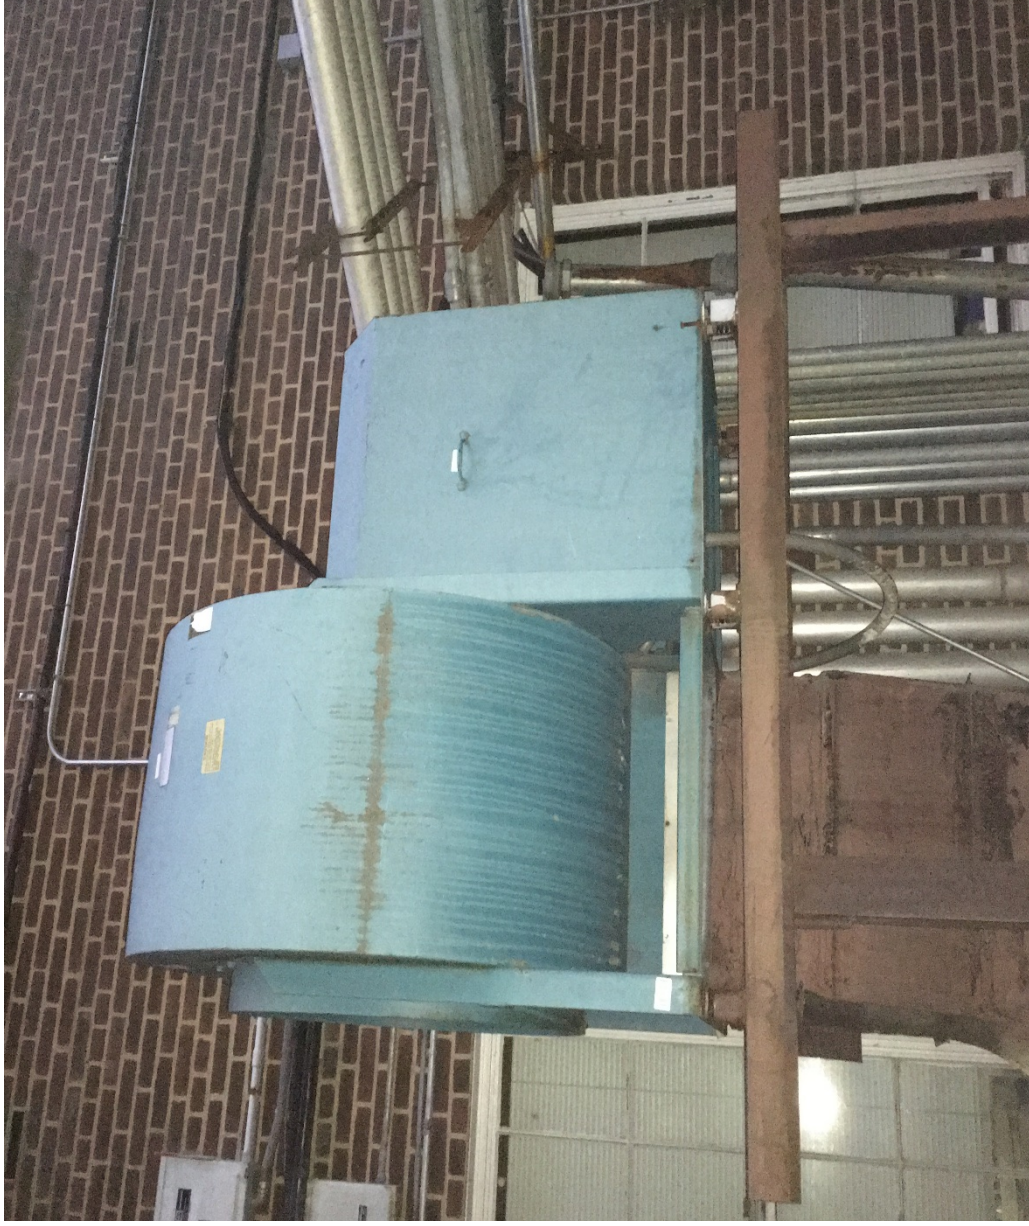
Finding # 9 Photo. This picture is of the second OA fan which most likely causes more issues. It simply dumps unfiltered cold air into the building.

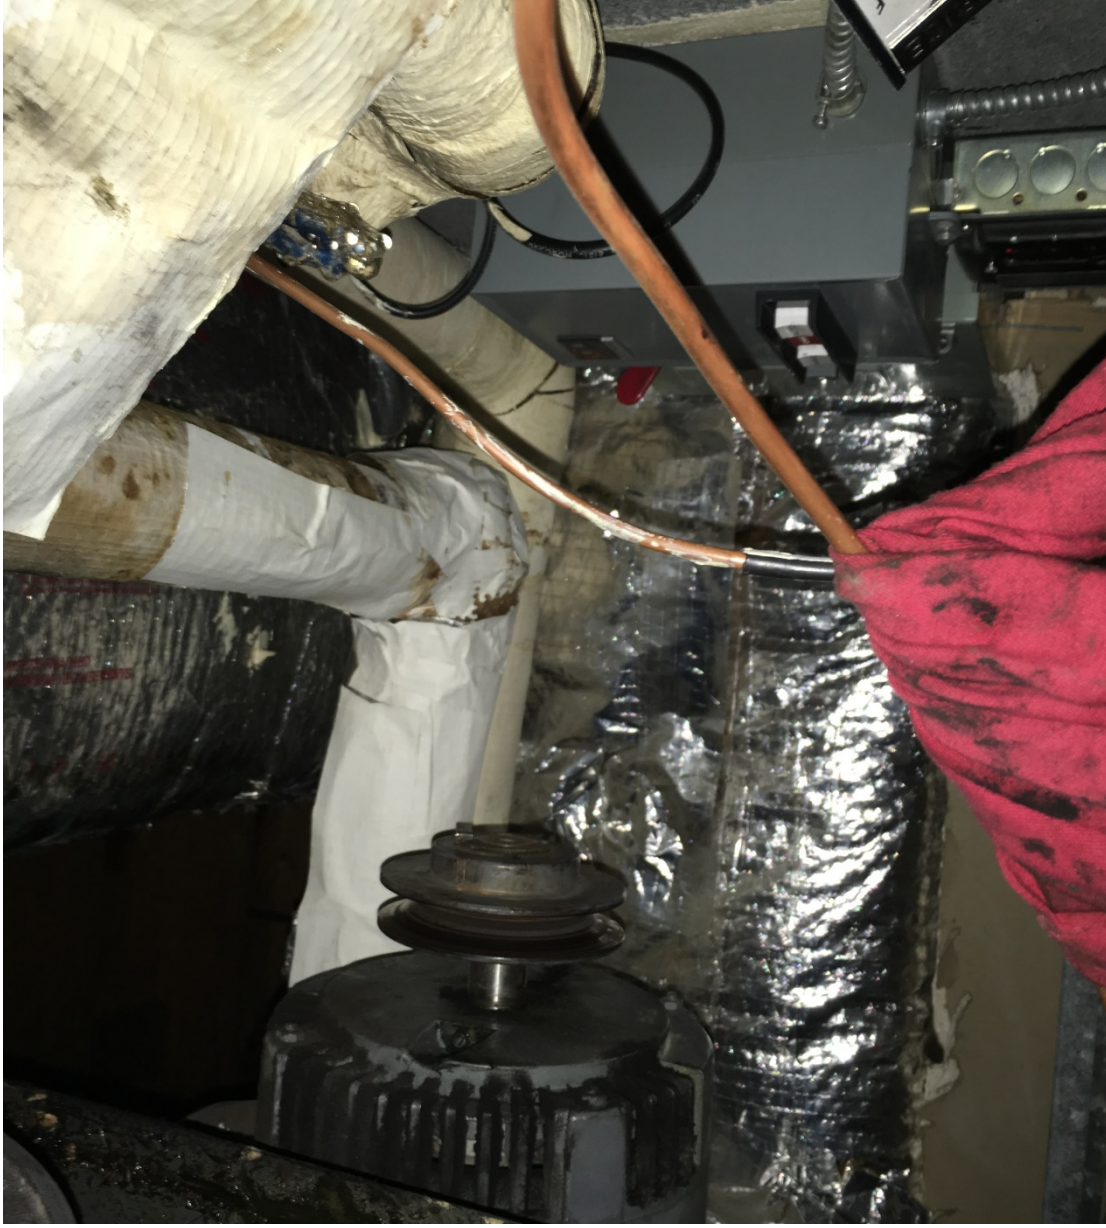
Finding # - 10. There are 20 ceiling hung air handlers which heat and cool the office spaces on the floors. These units are very hard to access for maintenance. There is one unit in the print shop which failed a few years ago and hasn't been repaired because of the problem accessing it. **REVISION – Per DGS the unit has been serviced. Please provide a copy of the work order. That said, as documented by the picture (no belts) the unit remains inoperable.**

Finding # 10 Photo. This picture is of the air handler in the print shop which the fan bearings have failed. It is very hard to access.

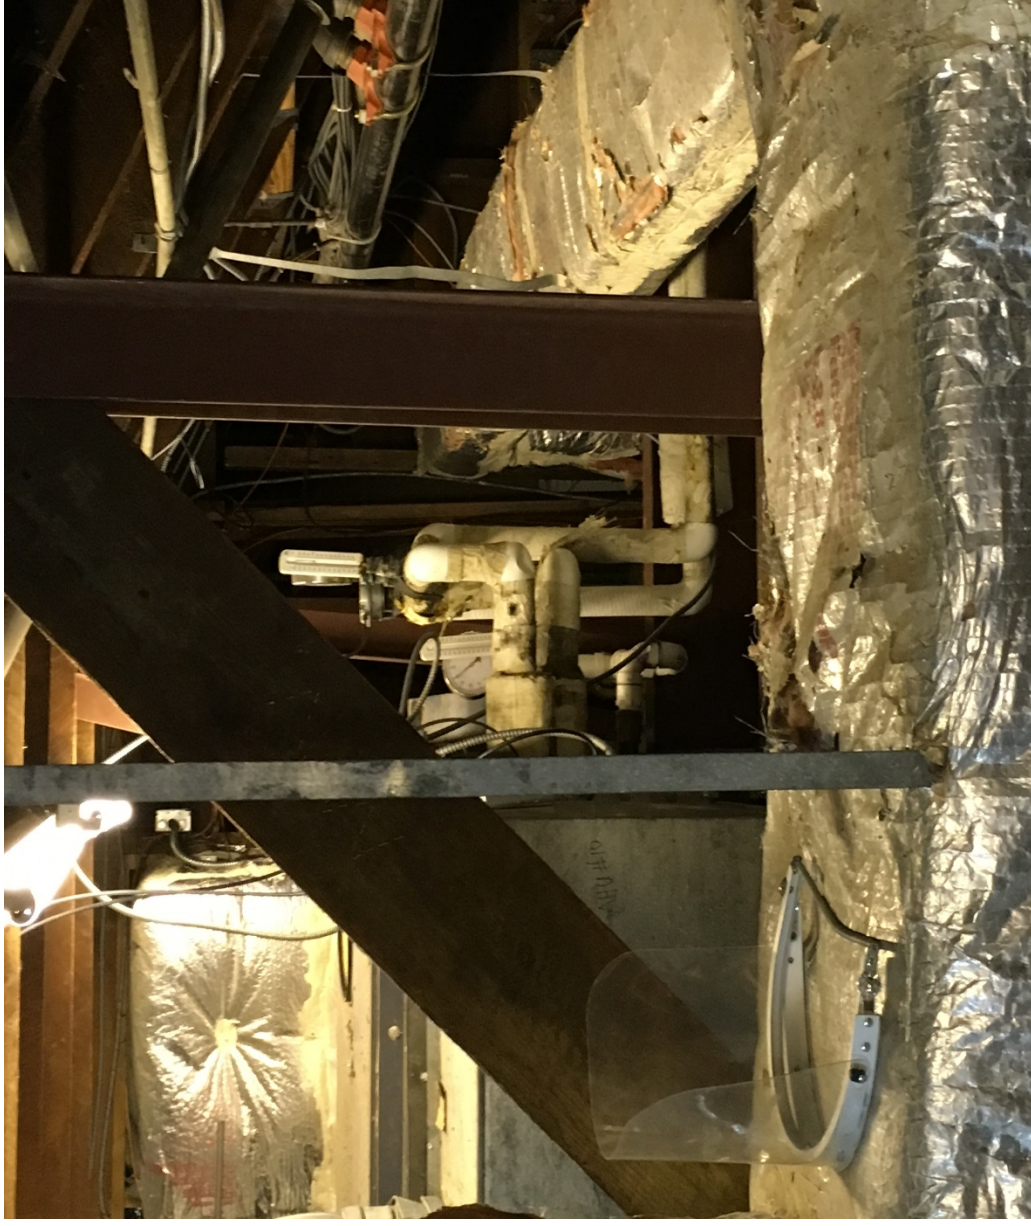
Finding # - 11. There are also 5 air handlers in the building attic. These units do pull outside air through the perimeter wall near the fans. One problem with these units is the condition of the duct work insulation which has failed. This condition will cause condensate leaks into the areas below in summer.

Finding # 11 Photo. This picture is of one of the attic air handlers with damaged duct work insulation. This will cause condensate leaks in summer.

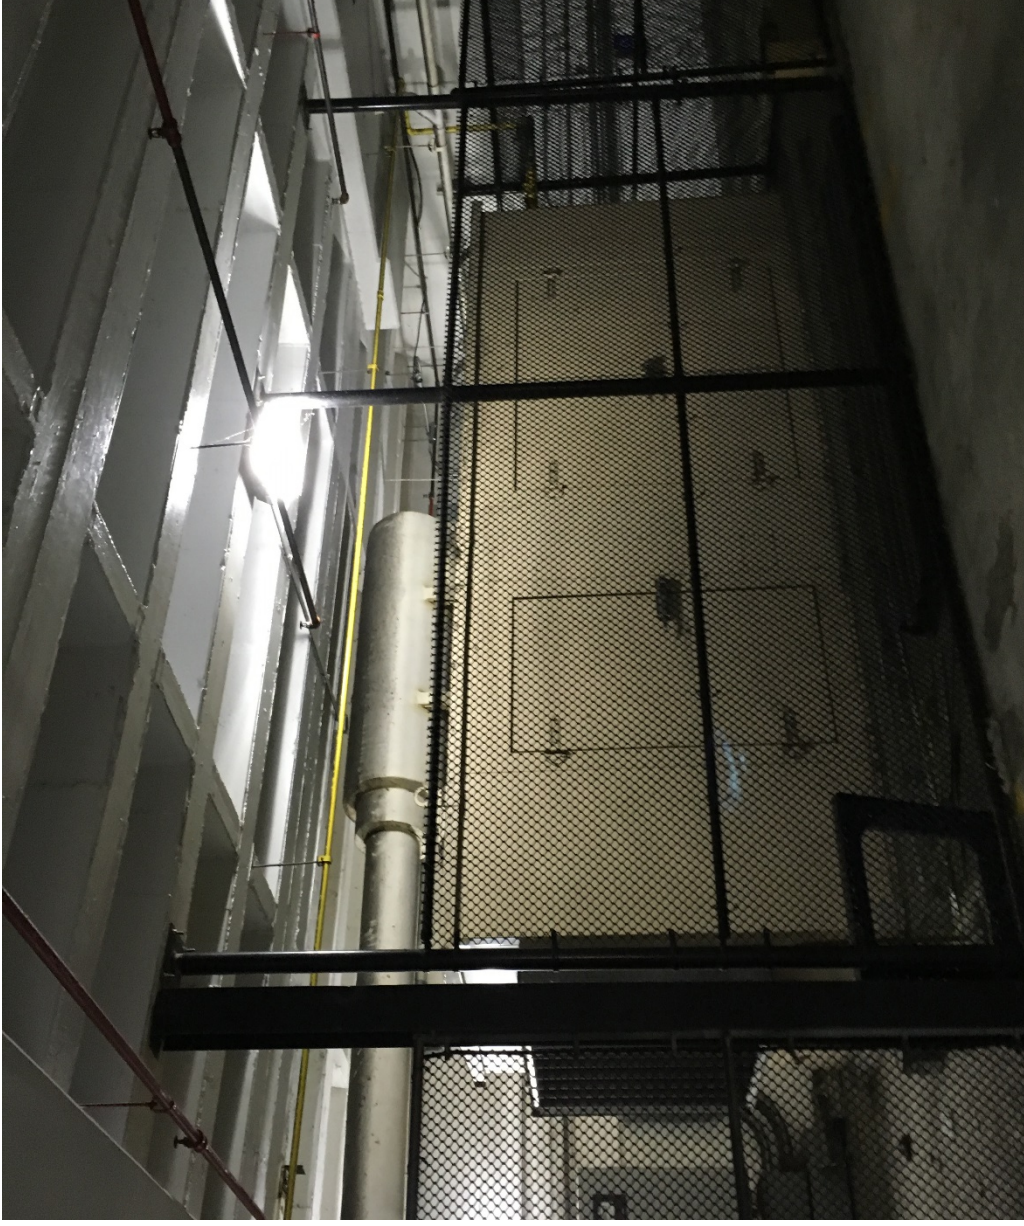
Finding # 16 Photo. A2 recommends that the emergency generator transfer switches be transferred and tested under load at least every 2 months. This picture is of the emergency generator.

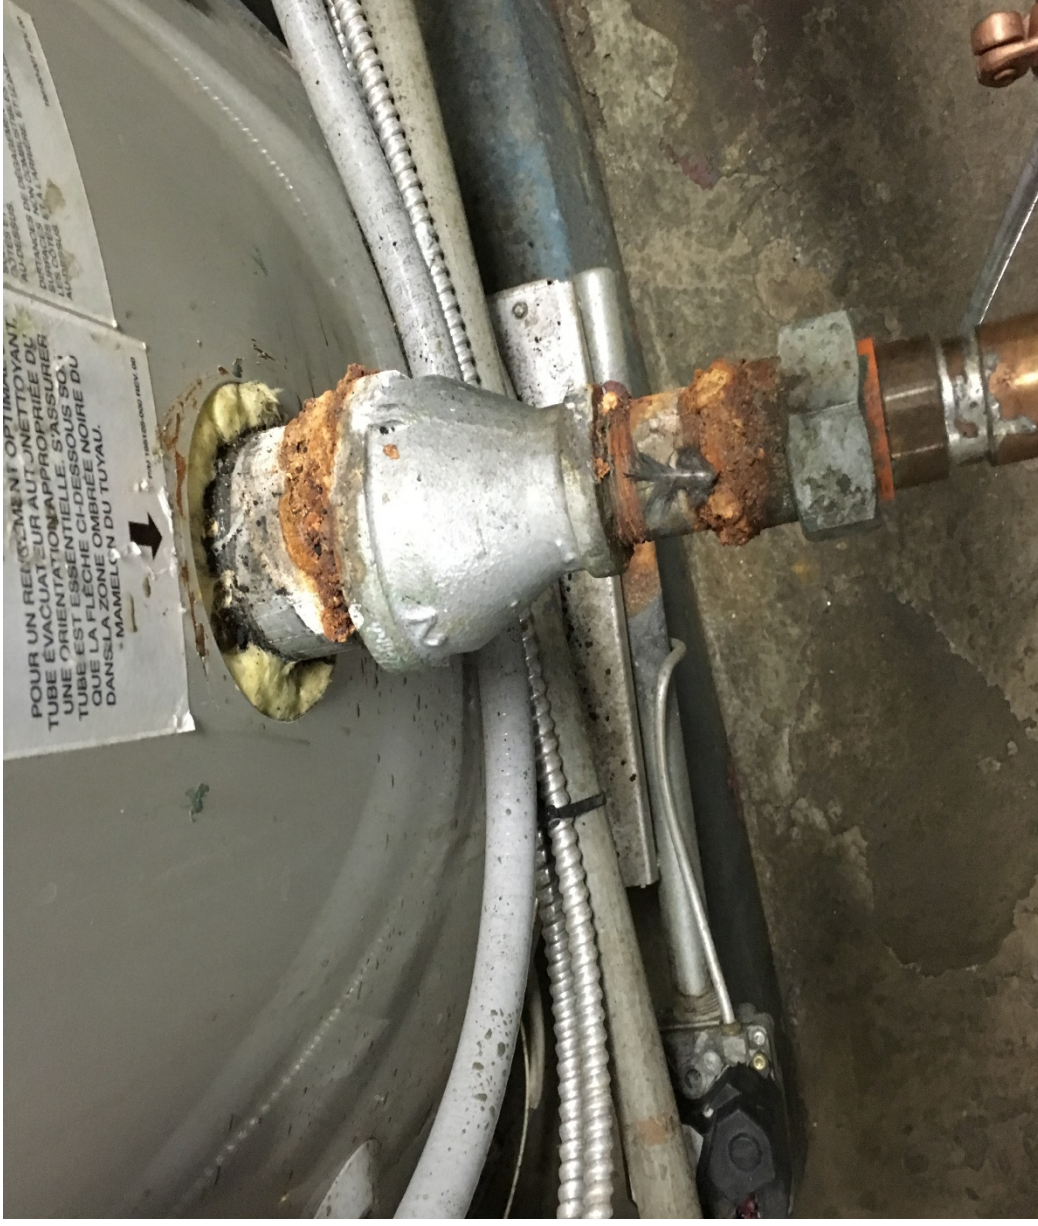
Finding # - 18. The cold water makeup line feeding the domestic hot water heater in the boiler room should be repaired before it fails. This line was installed using dissimilar metals allowing electrolysis to occur. The fittings will need to be replaced with die-electric components to eliminate this dissimilar metal corrosion.

Finding # 18 Photo. This picture notes the corroded inlet water fittings to the domestic water heater in the boiler room.

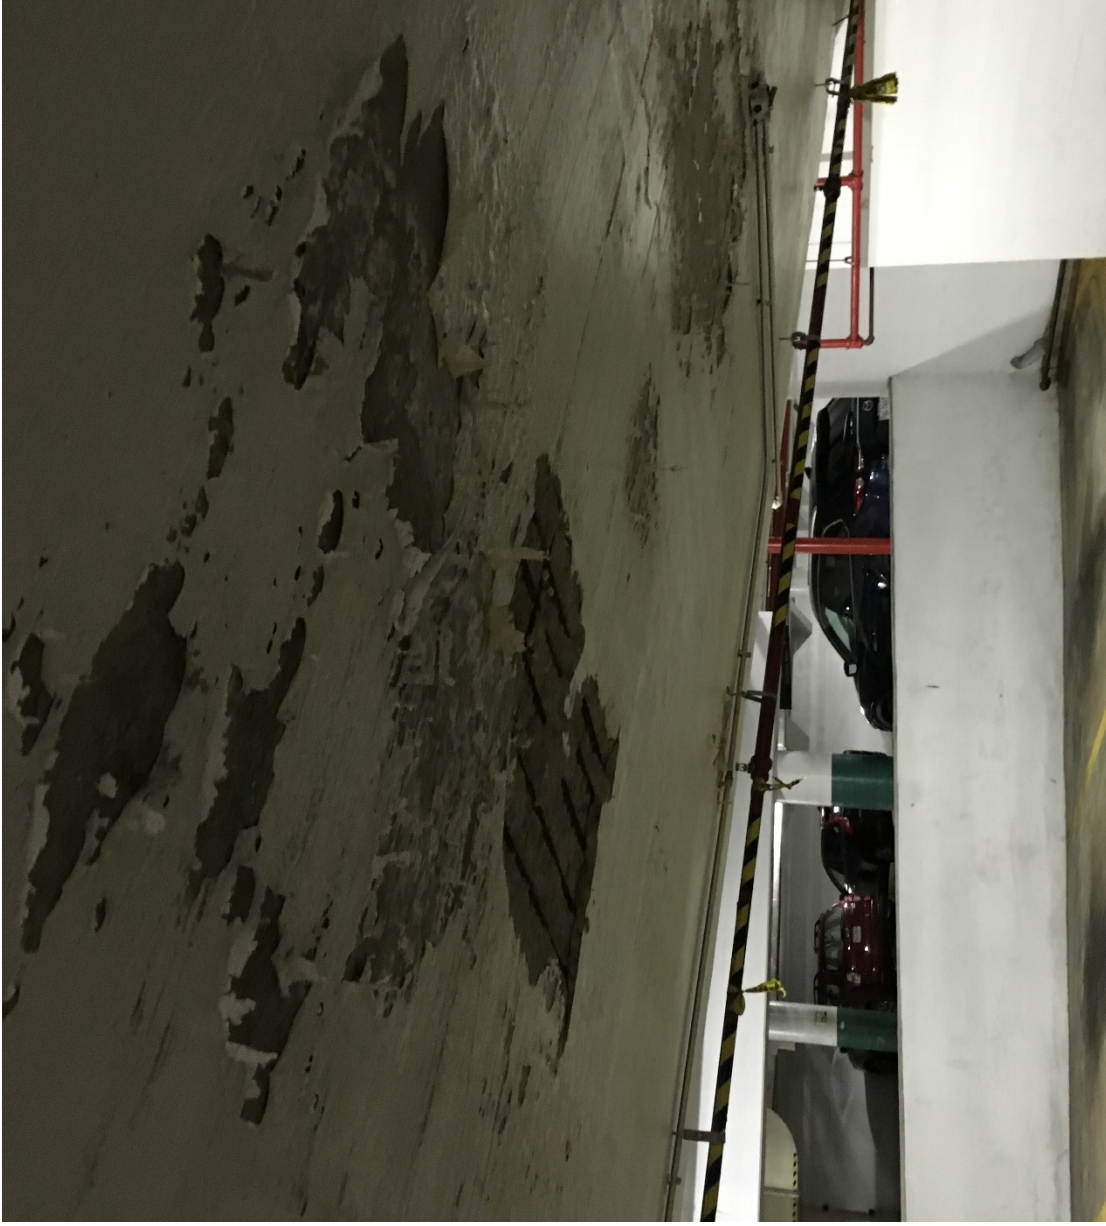
Finding # 24 Photo. This picture is one example of structural damage in the garage from water infiltration.

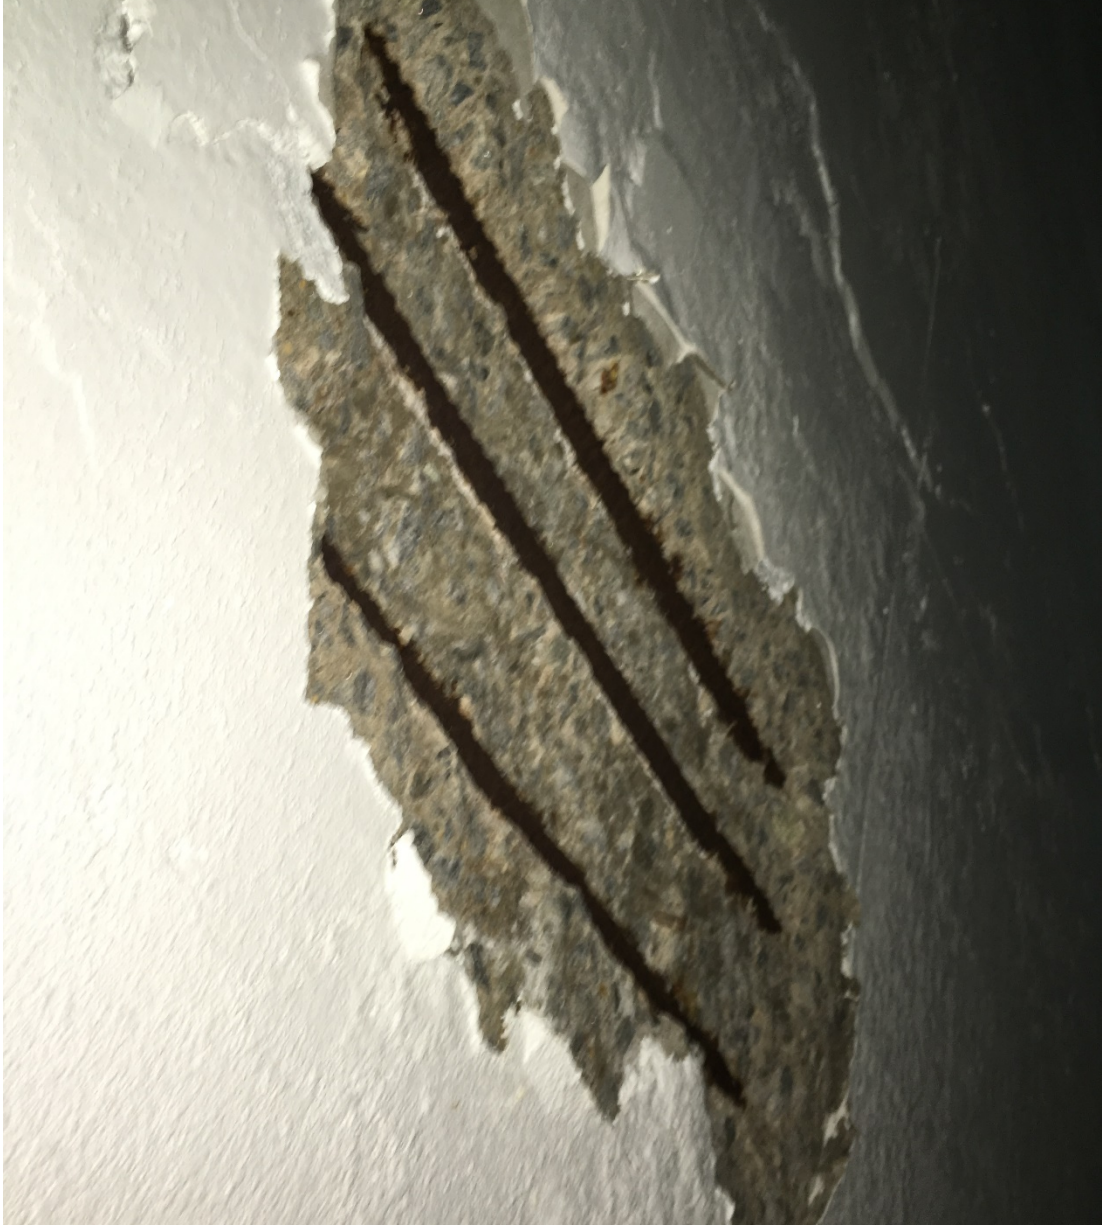
Finding # 24 Photos Continued. This picture is another example of structural damage in the garage.

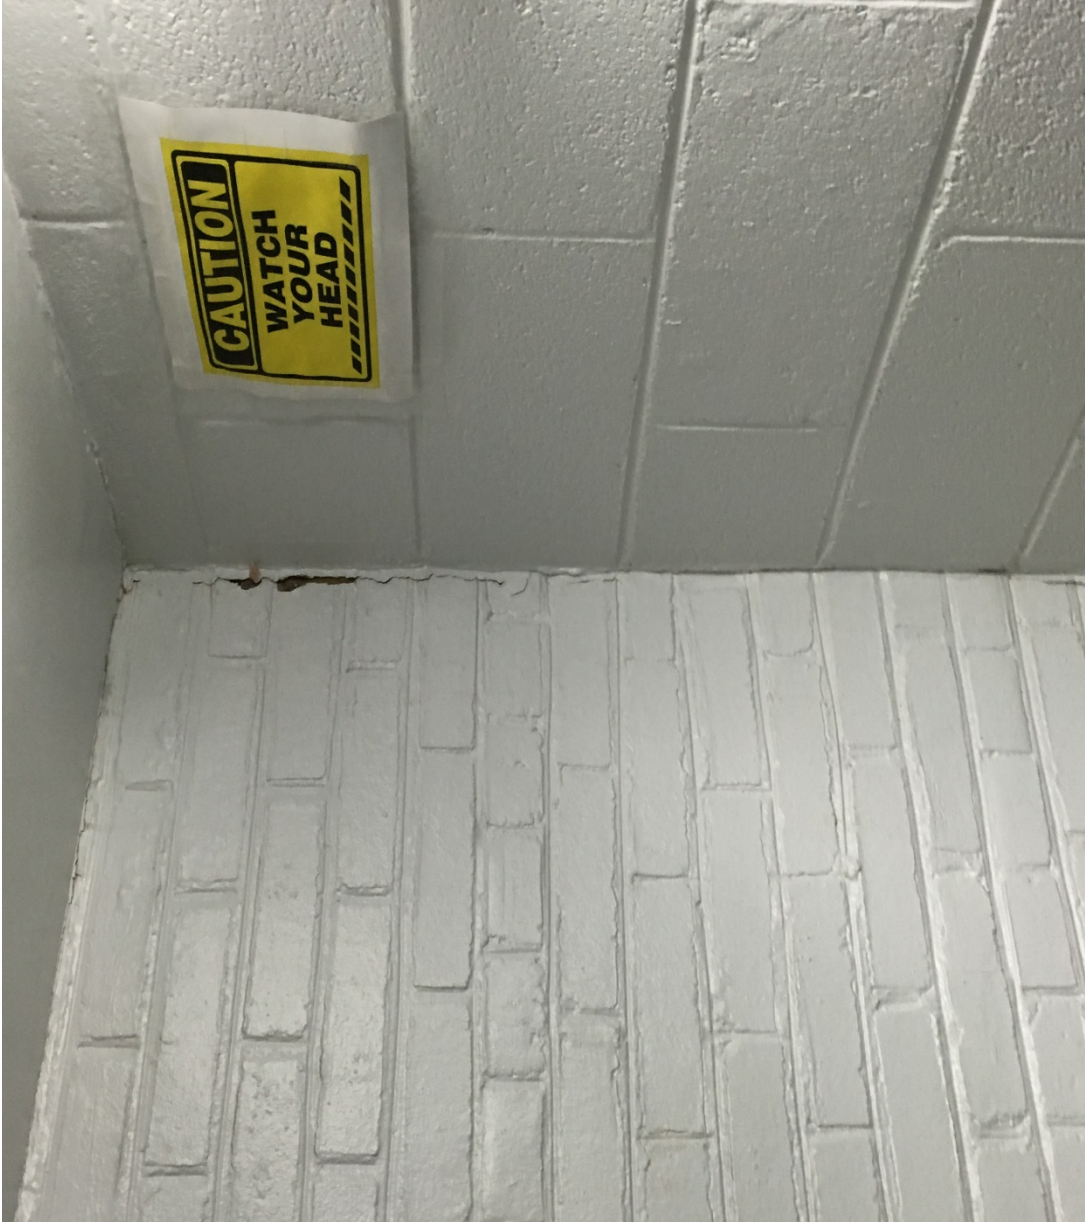
Finding # 27 Photo. This picture notes the crack between the block and the brick walls where water is entering stairway #1.

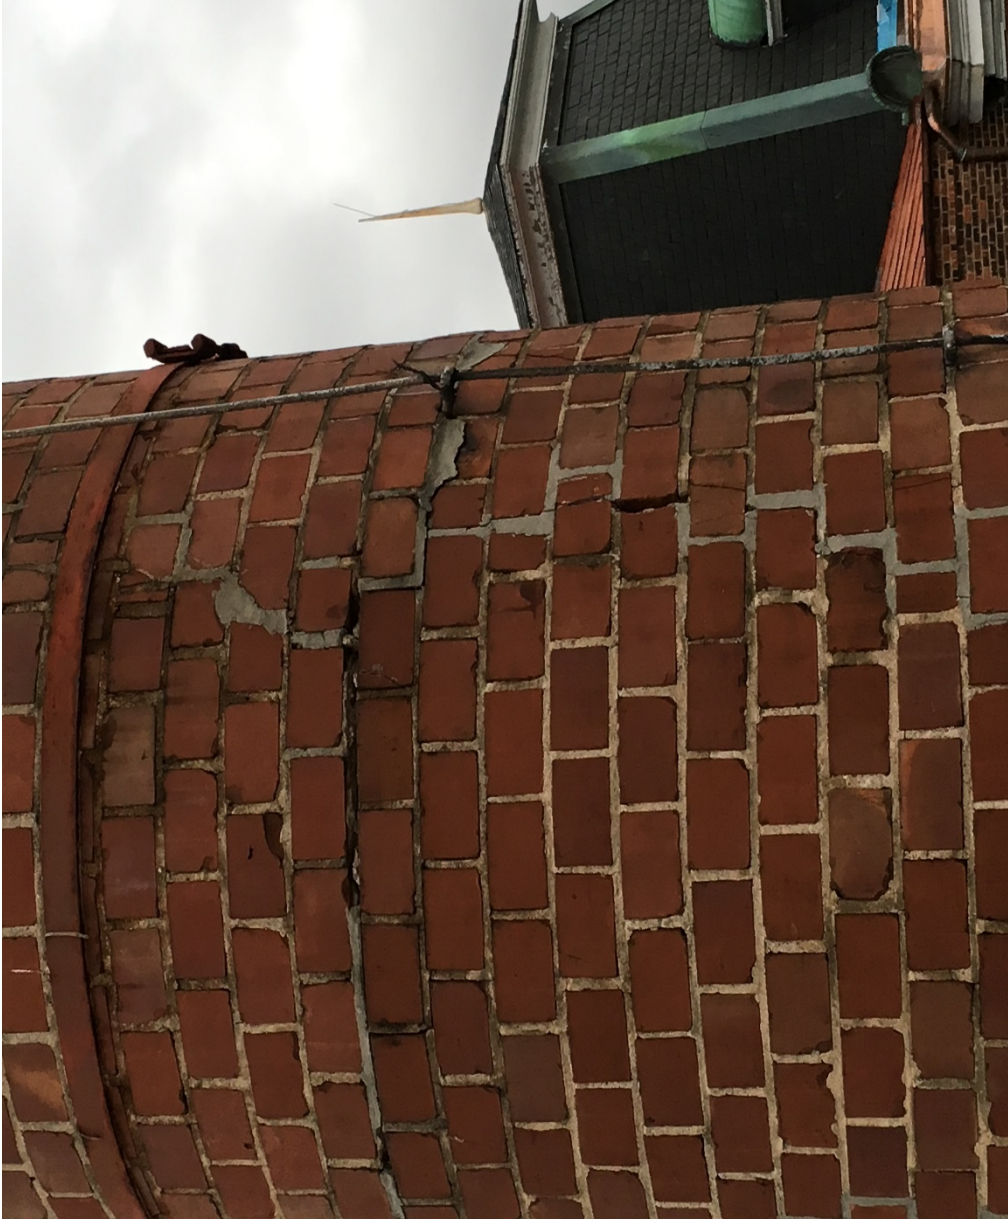
Finding # 28 Photo. This picture notes the structural damage to the brick chimney.

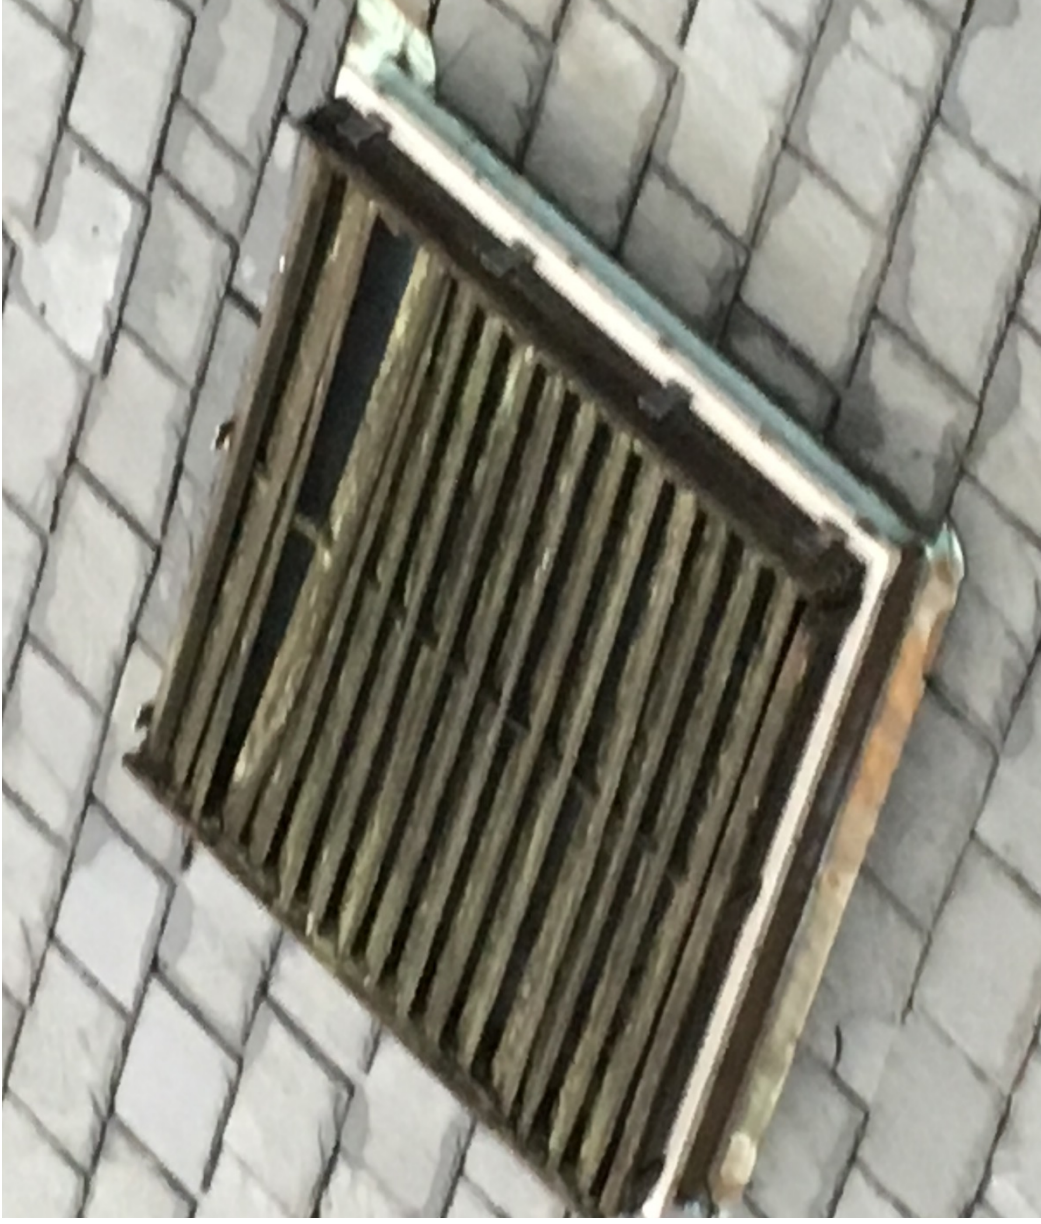
Finding # 29 Photo. The picture notes the rotten wooden louver which will need to be replaced.

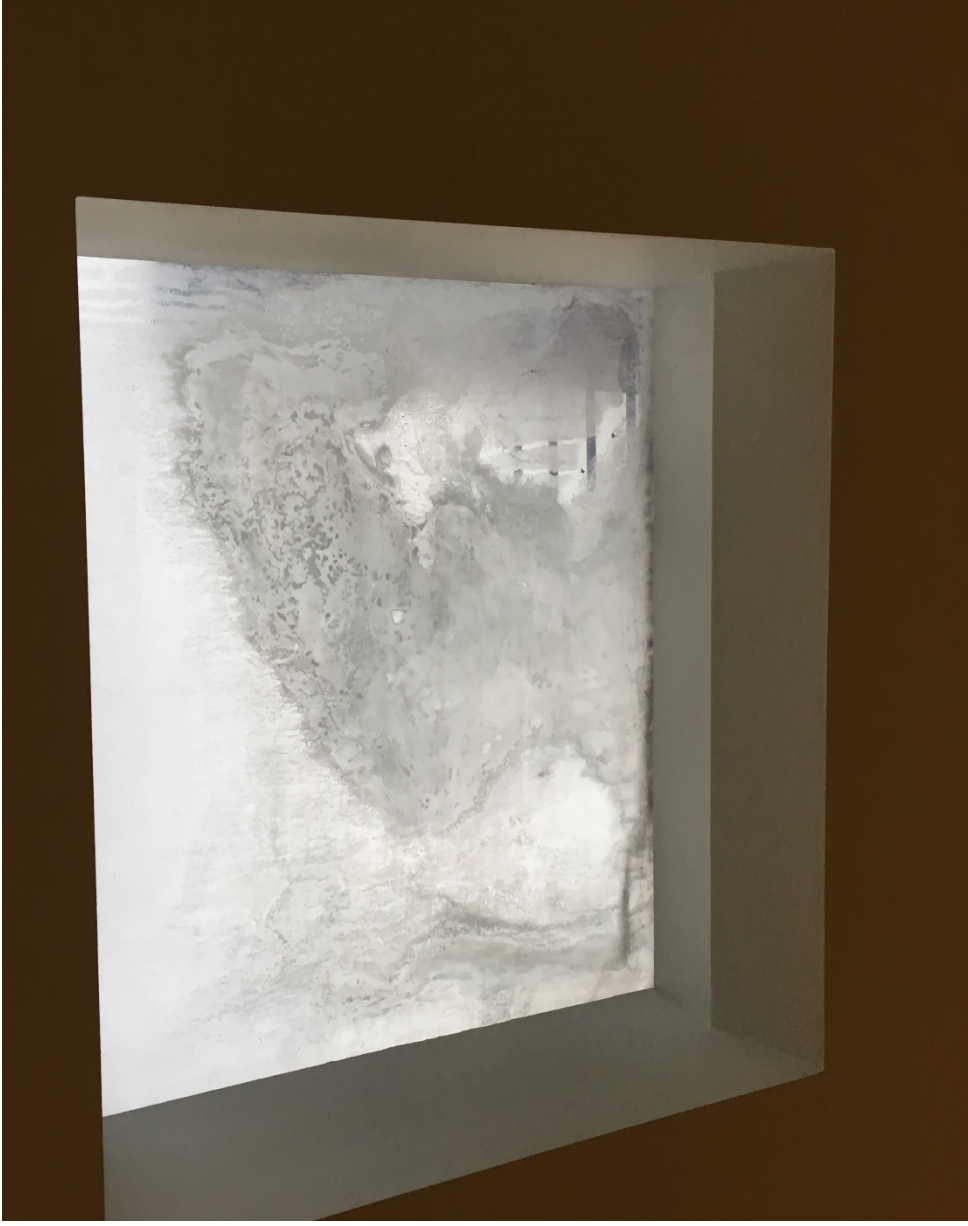
Finding # 31 Photo. This picture is one of the leaking skylights on the 5th floor.

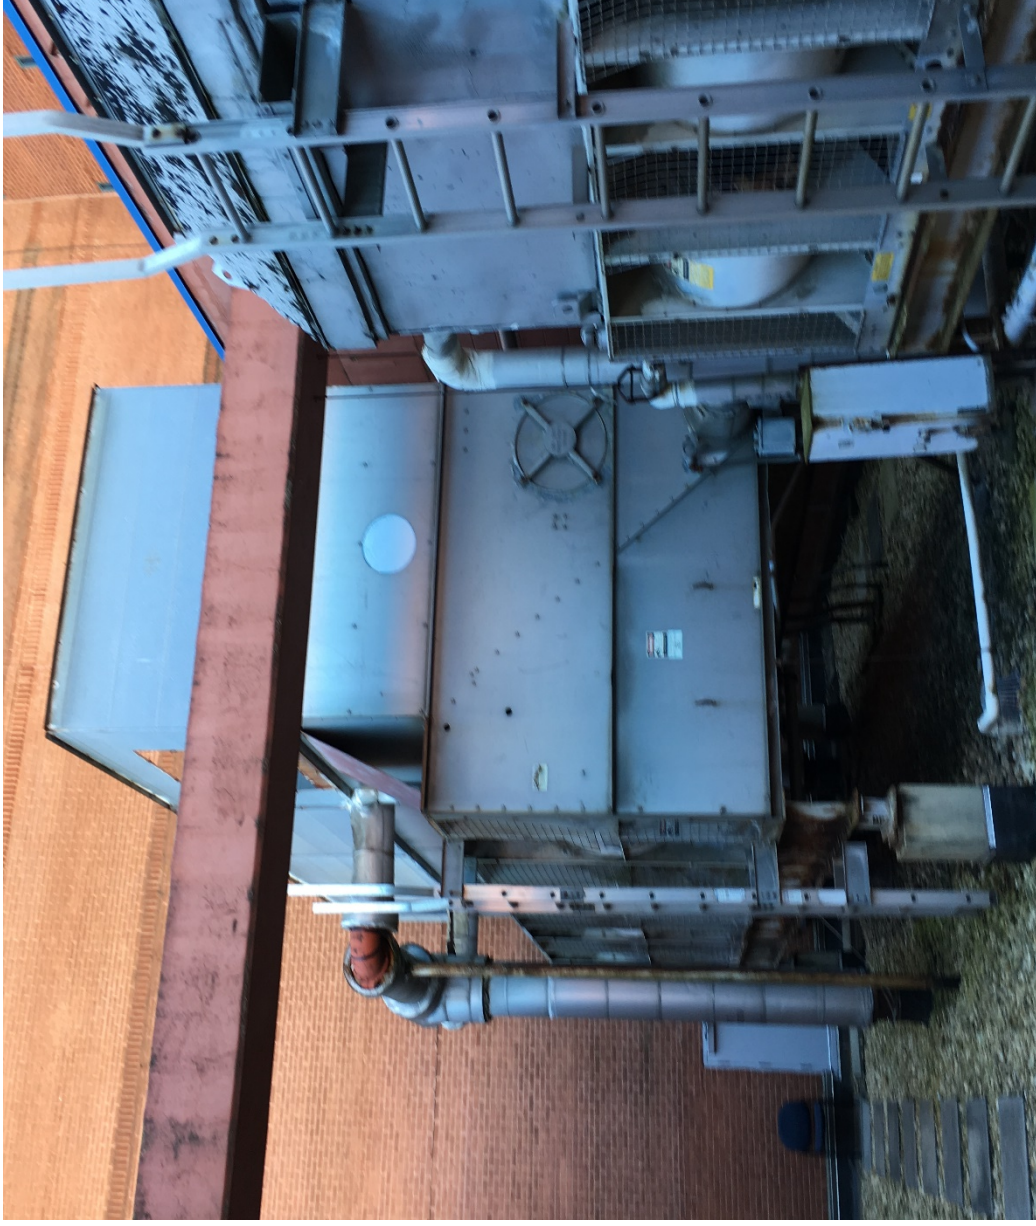
Finding # - 3 Equipment abandoned in place. This picture is of an abandoned in place cooling tower on the roof.

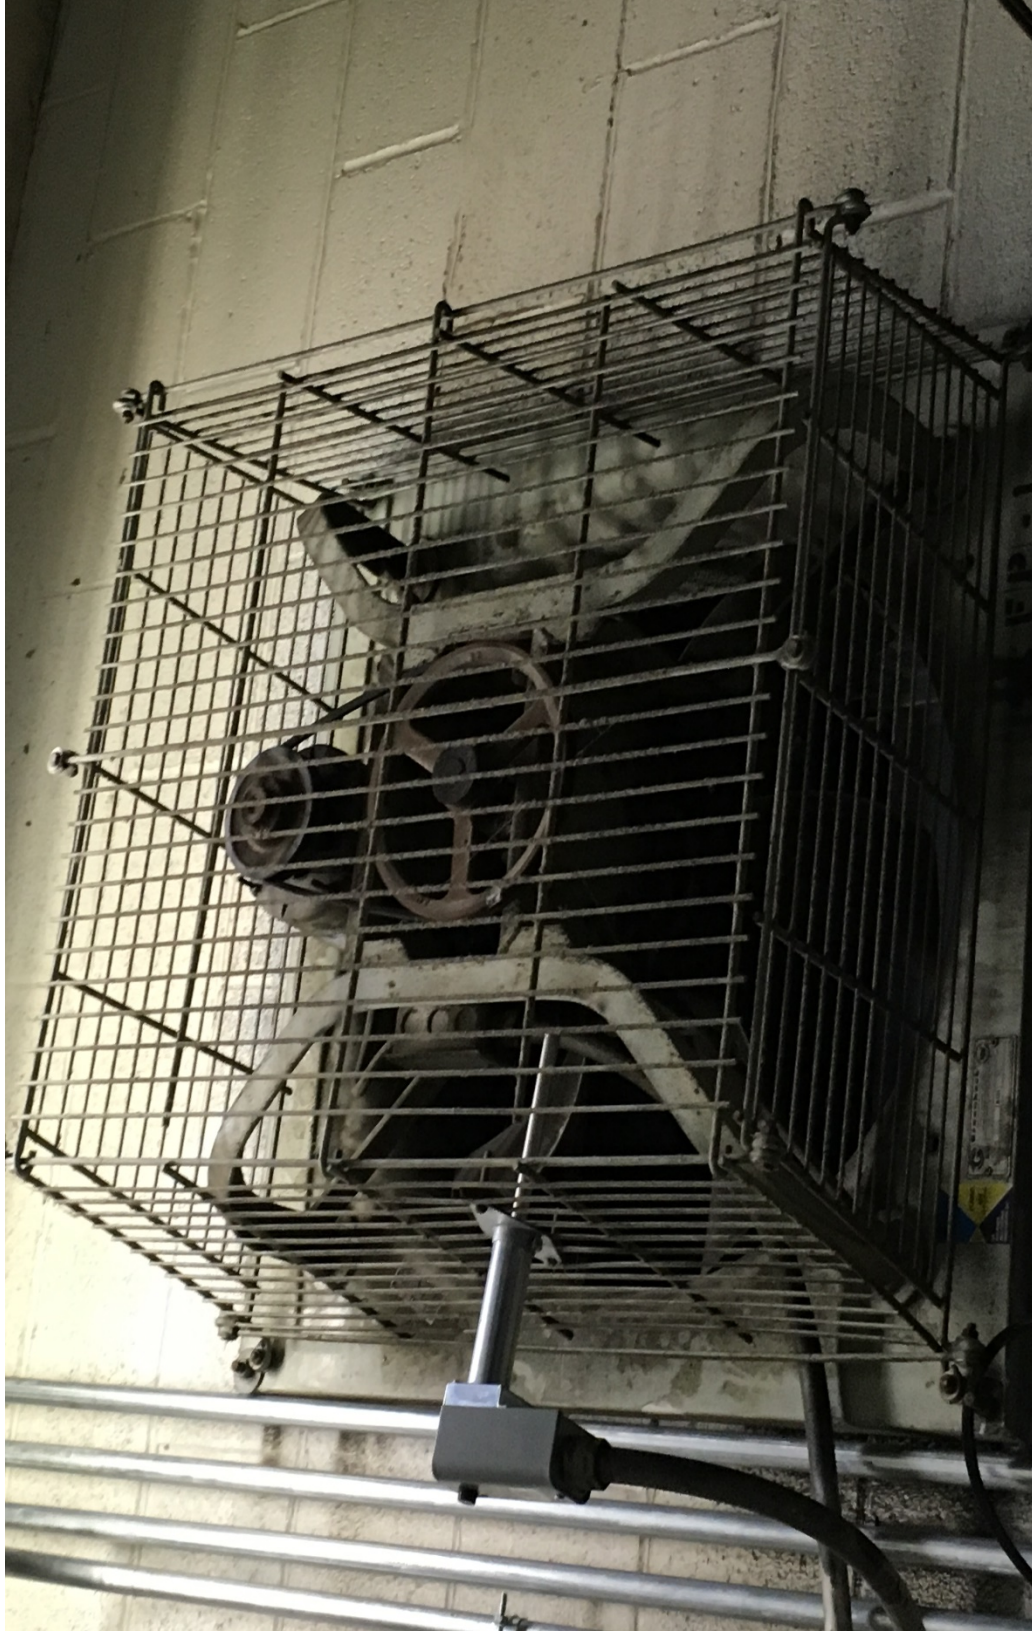
Finding # - 3 Equipment abandoned in place continued. This picture is a wall mounted exhaust fans left in place. There is also a damper assembly related to this fan.
