EXHIBITS

EXHIBIT 1:

JOINT TASK FORCE & SUBCOMMITTEE MEETINGS

A2 Services, Inc. Facility Survey of City of Alexandria - City Hall

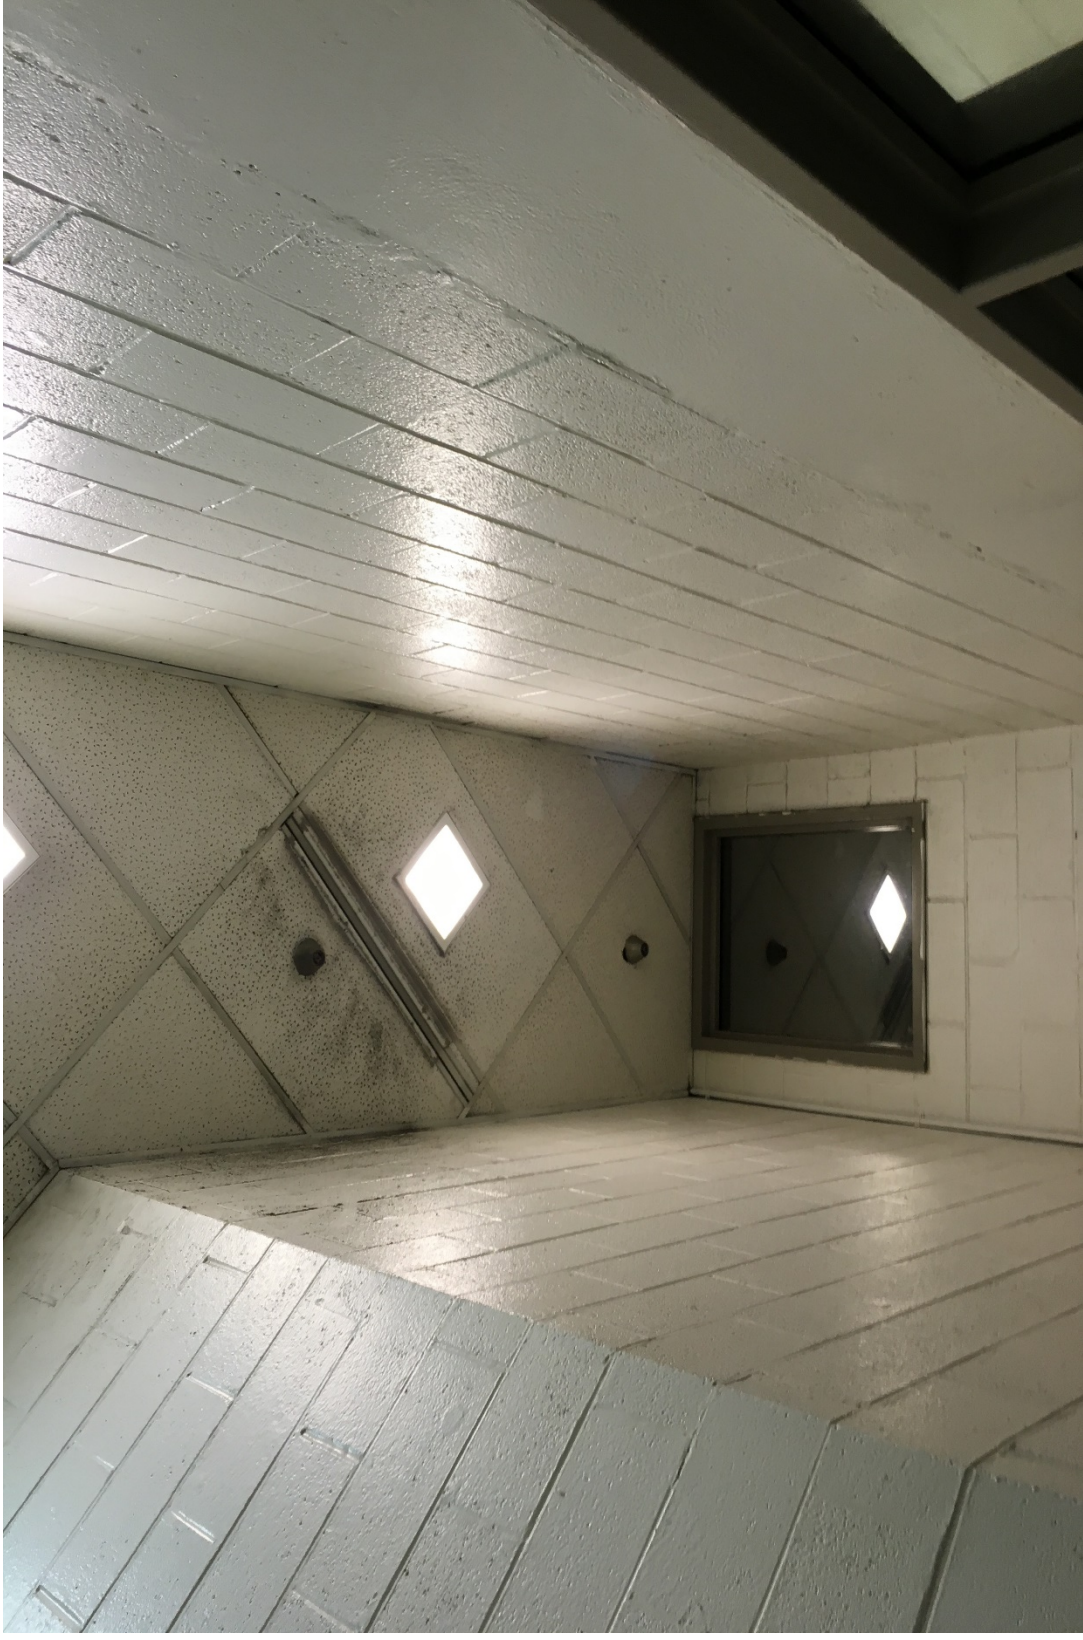
Finding # - 4 This picture is an example of how hard the ceiling diffusers, ceiling tile and light fixtures are to reach.

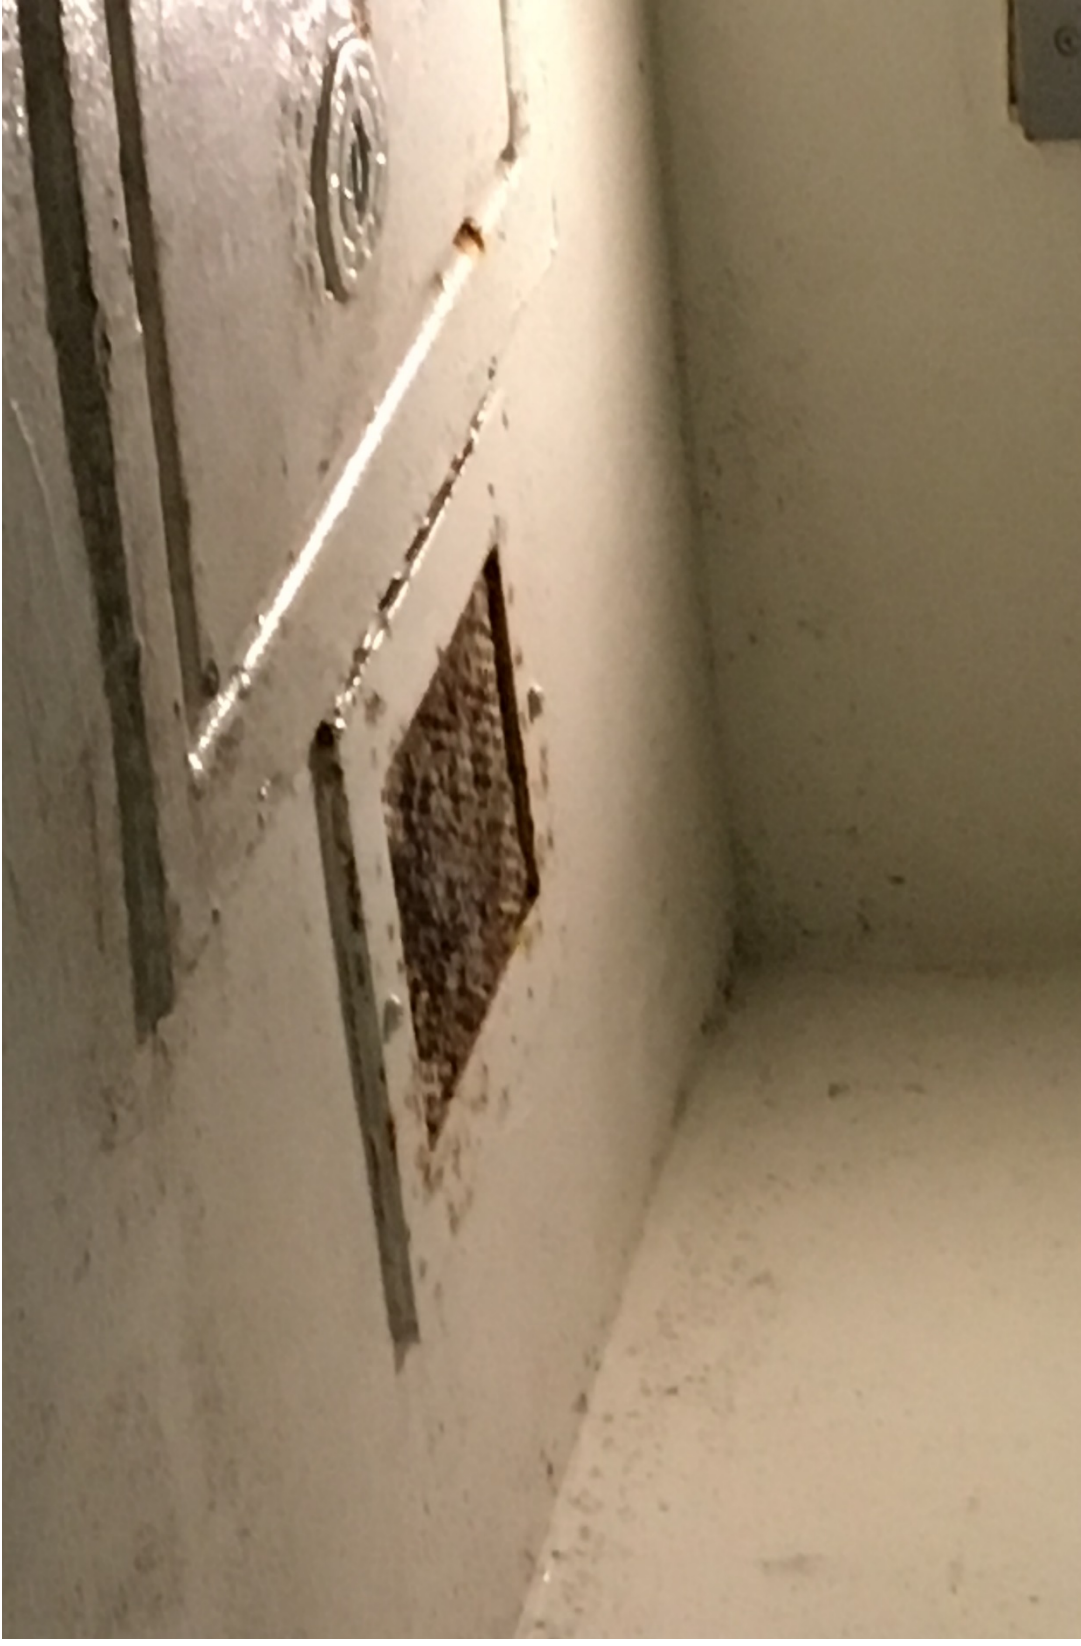
Finding # - 11 Numerous exhaust grills in the jails housing area shower stalls should be replaced.

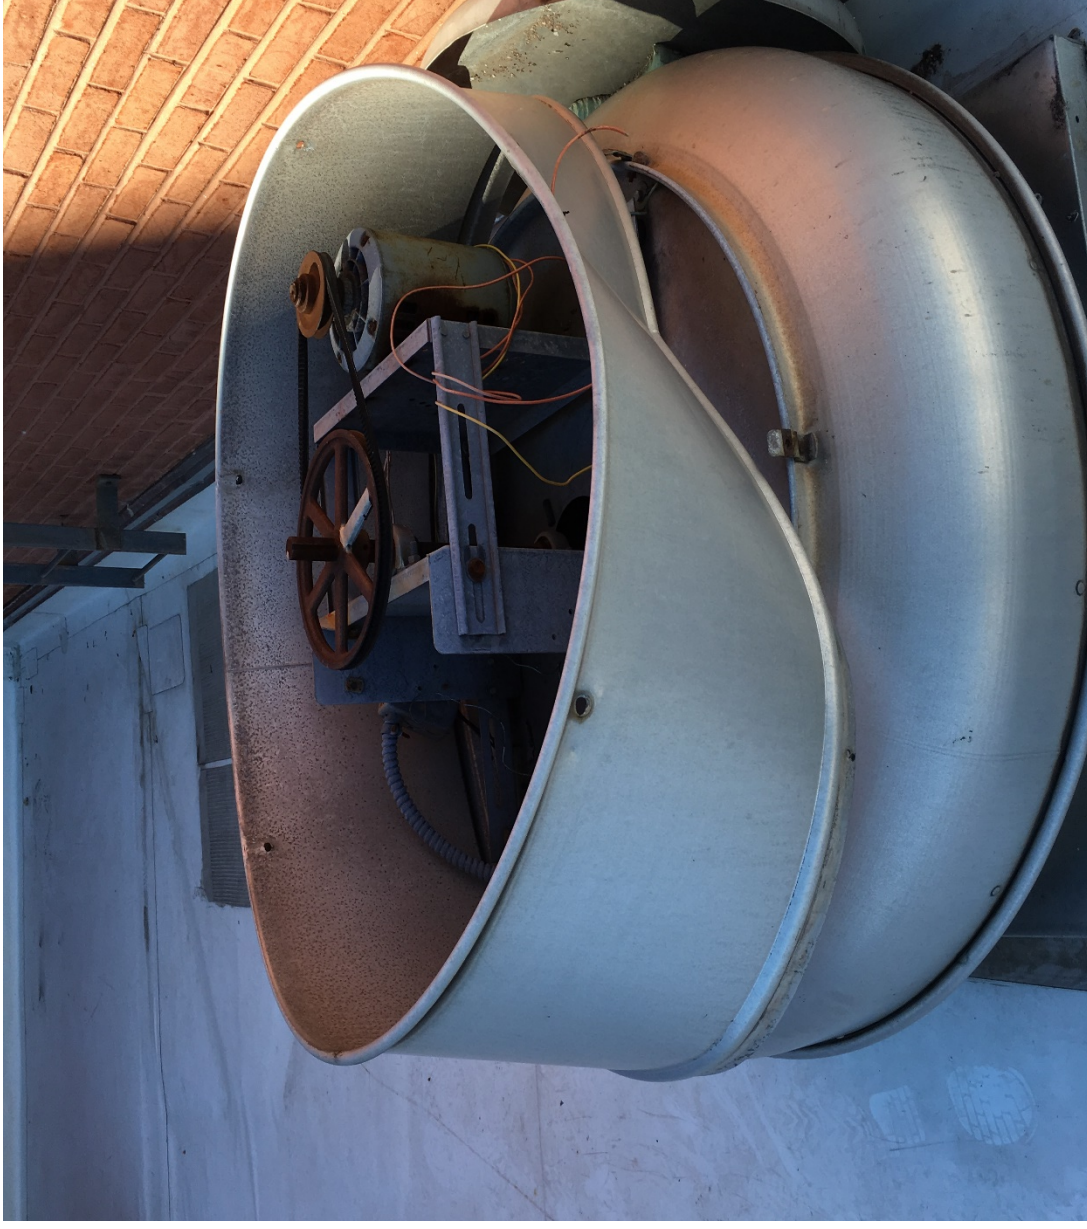
Finding # - 13 One roof top exhaust fan has failed. It should be repaired then put back into service.

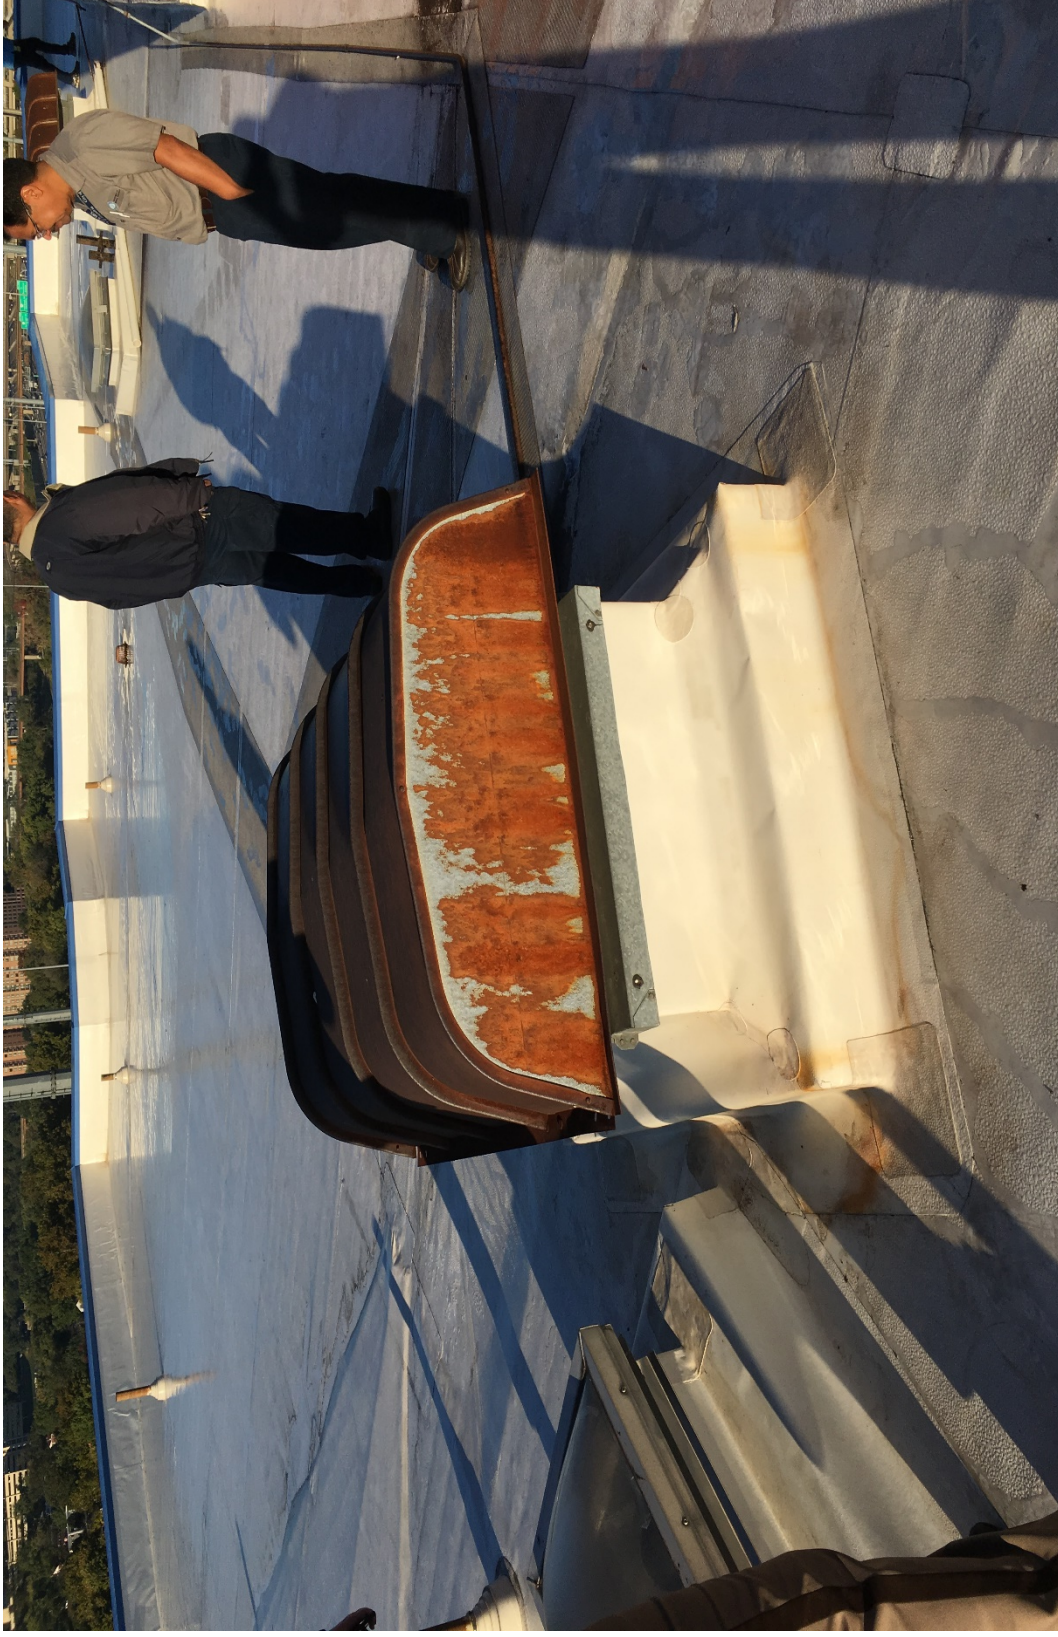
Finding # - 18 This picture is of the building vent dampers where the power wiring and conduit should be repaired.

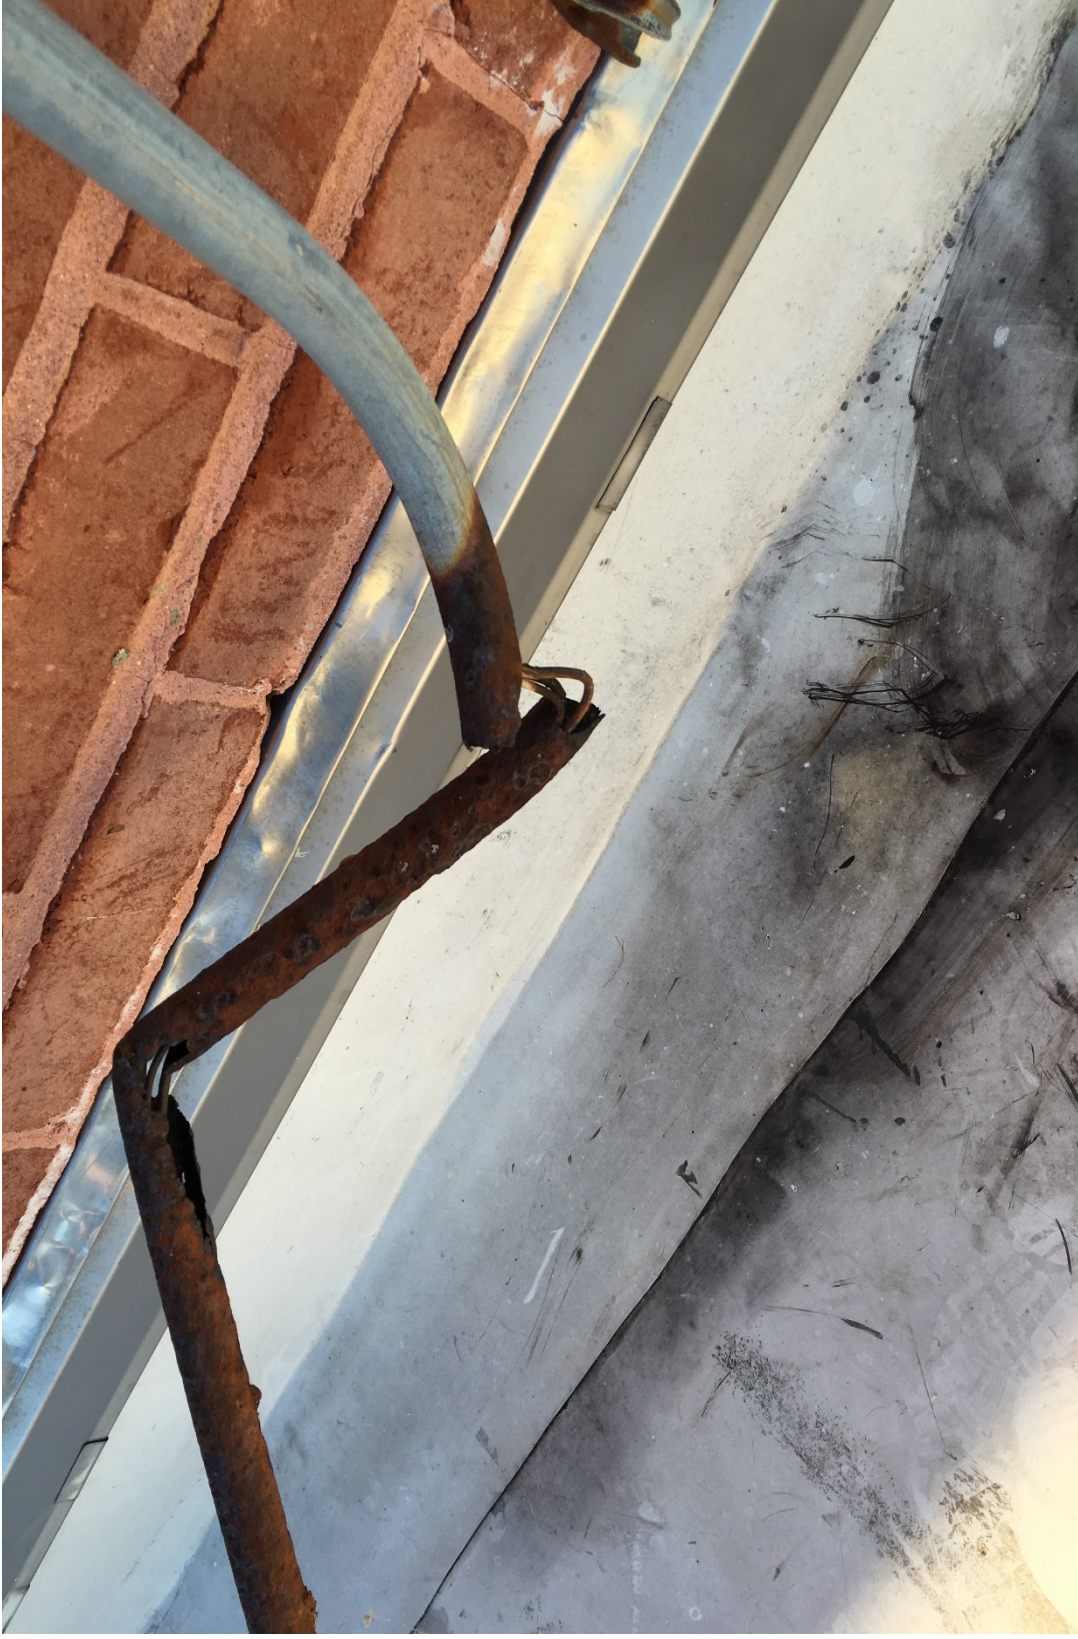
Finding # - 18 continued. This picture is of the damager power wiring and conduit to the damper assembly.

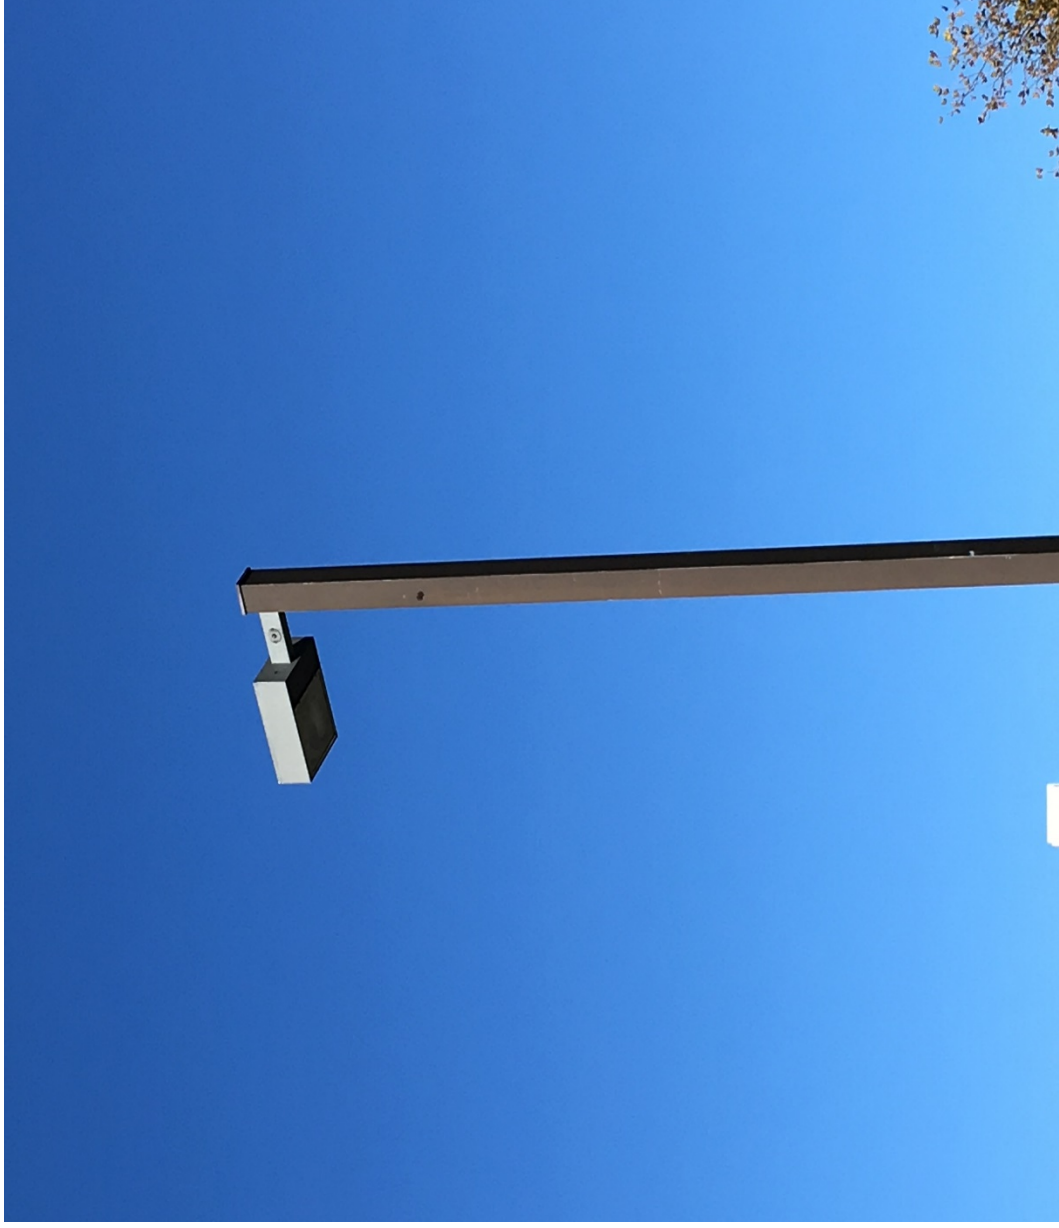
Finding # - 19 This picture is of one the exterior pole light which cannot be accessed for repairs or re-lamping without an outside contractor using a bucket truck.

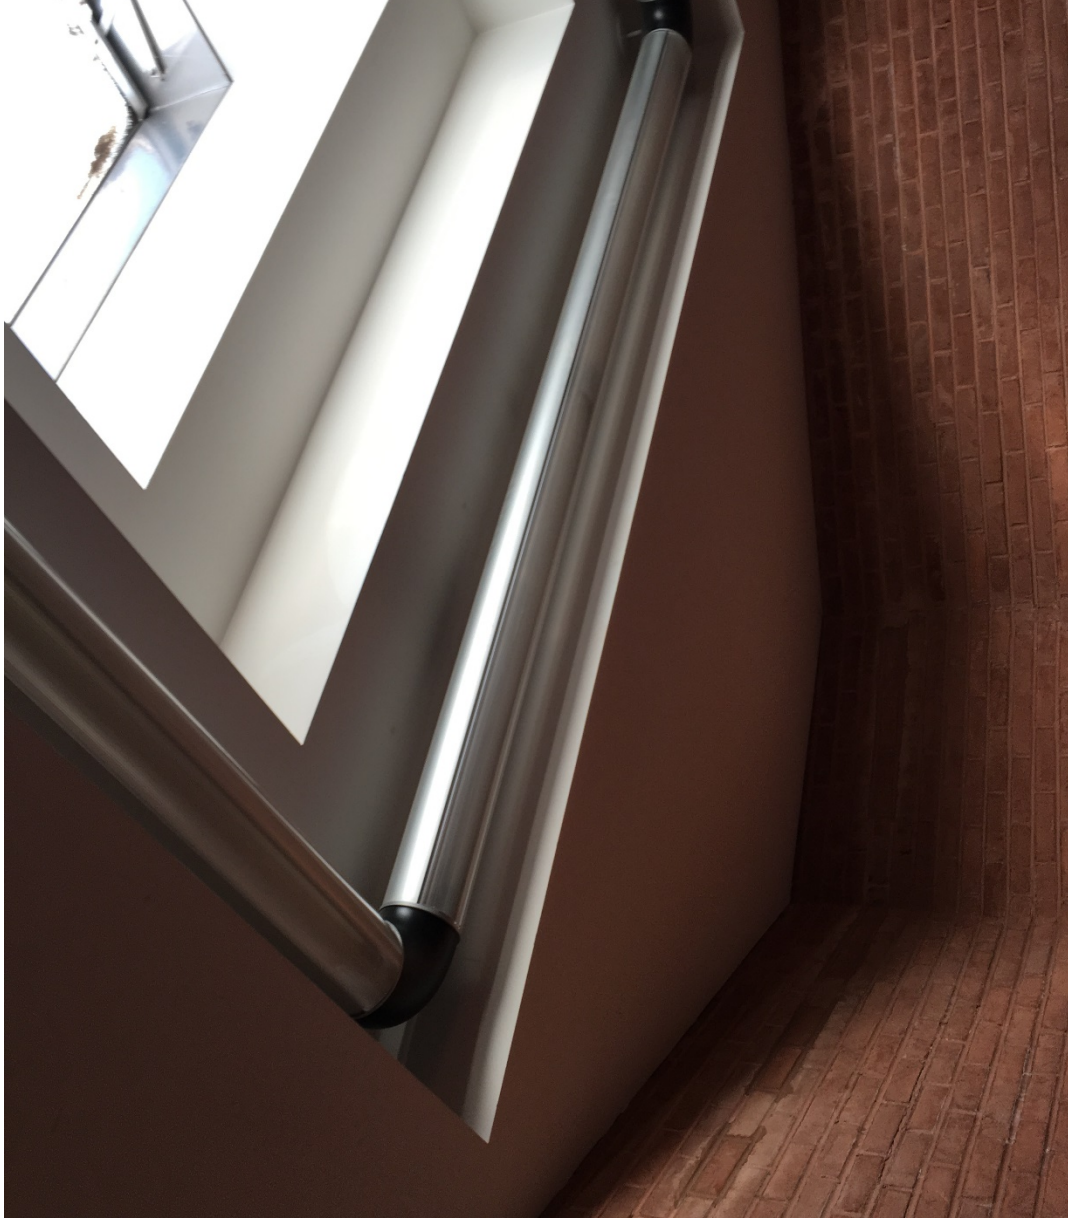
Finding # - 20 This picture is one of the lights in the sheriff's office stairwell which cannot be accessed to change the bulbs or repair the fixtures.

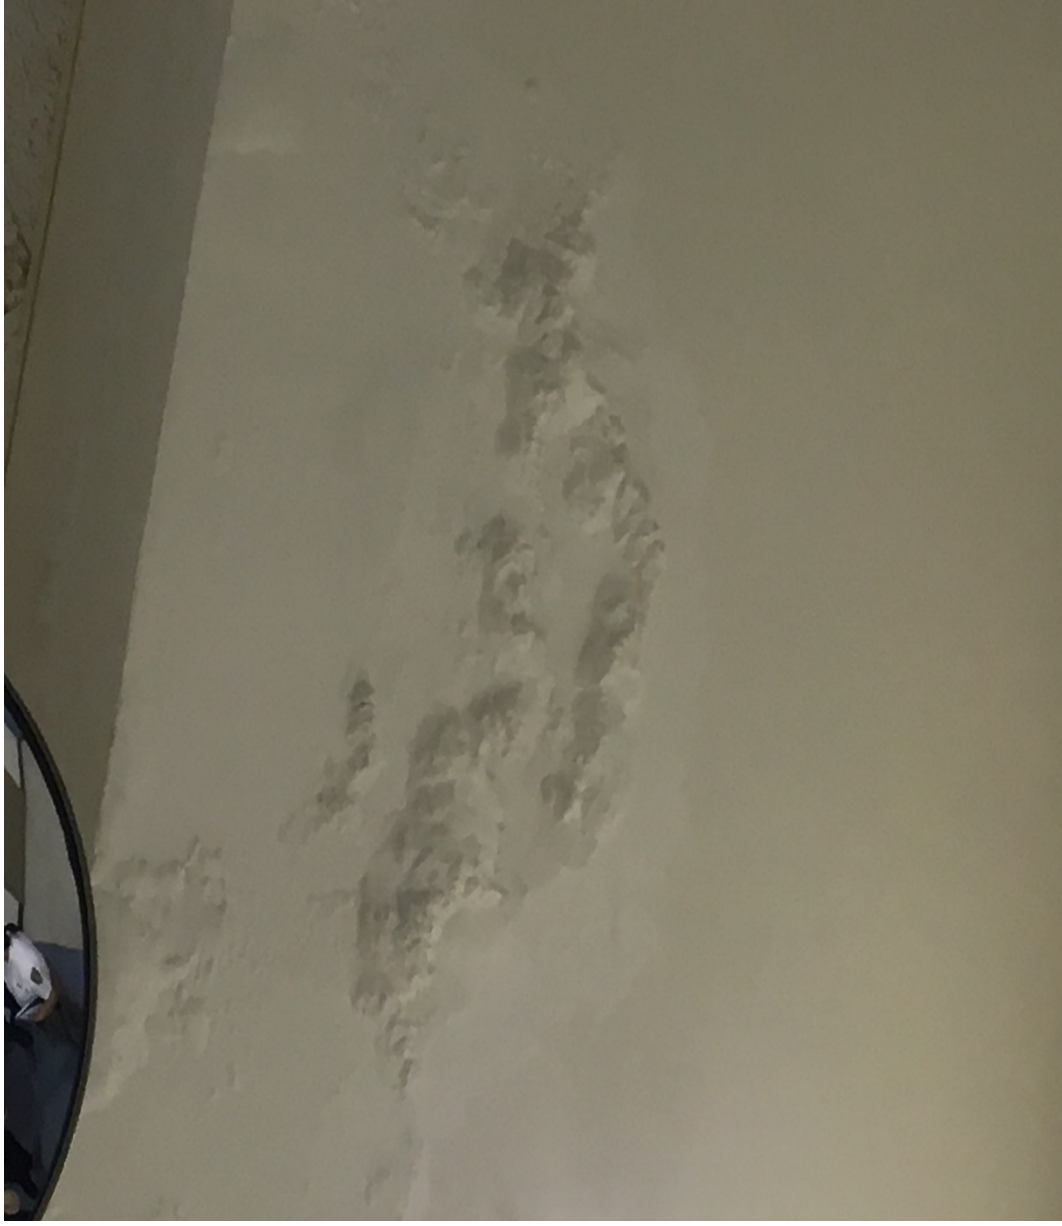
Finding # - 26 This picture denotes water damaged on the concrete slab in 3CF which appears to be caused by a leak from the roof or areas above.

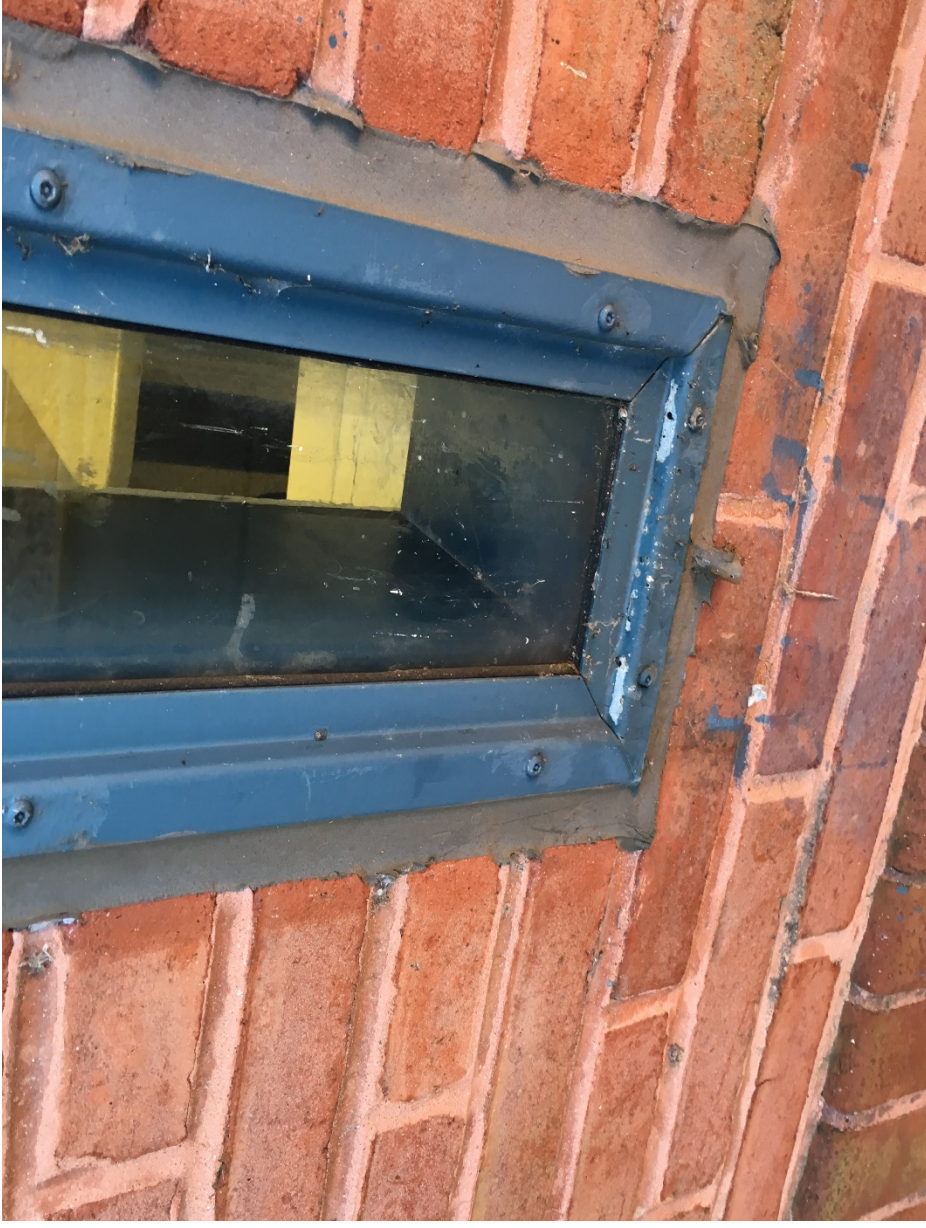
Finding # - 29 The jail and sheriff's office windows are in poor condition in several areas.
