**ALEXANDRIA CITY  
PUBLIC SCHOOLS**

## ALEXANDRIA CITY PUBLIC SCHOOLS COMPREHENSIVE CONDITION AUDITS

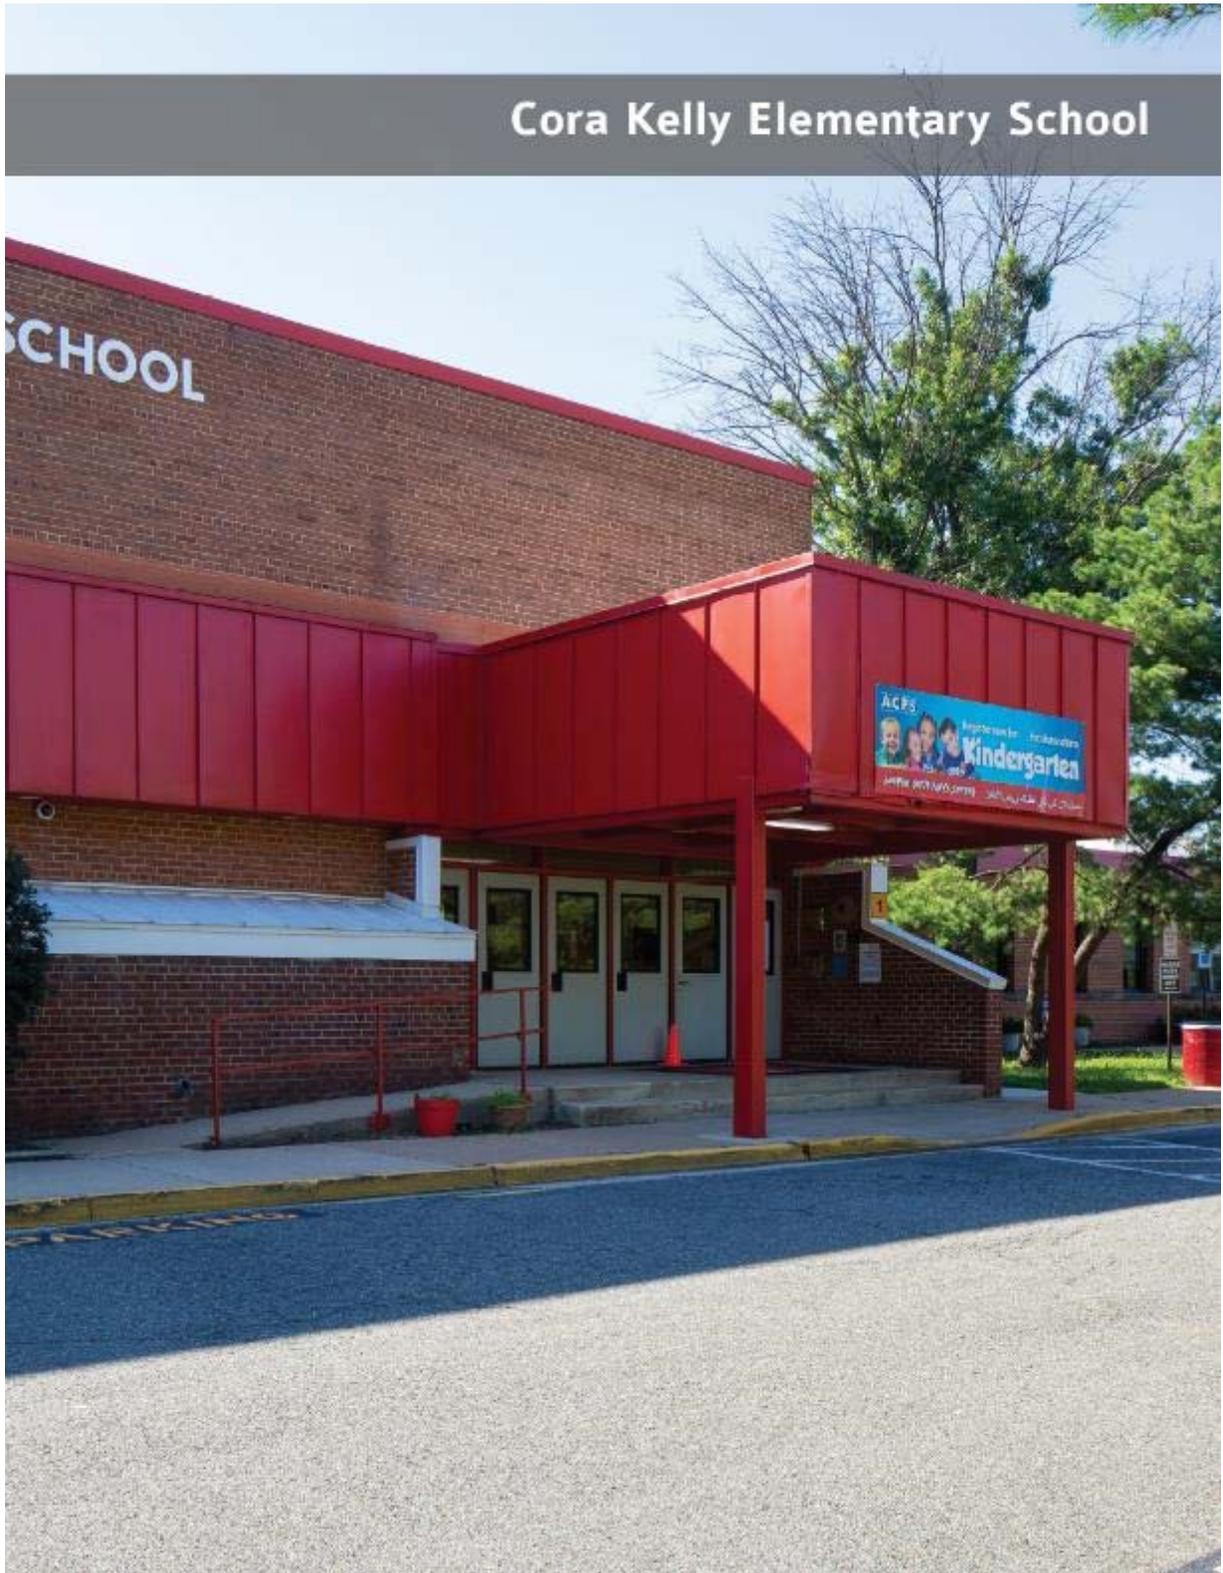
## A. FACILITY DESCRIPTION

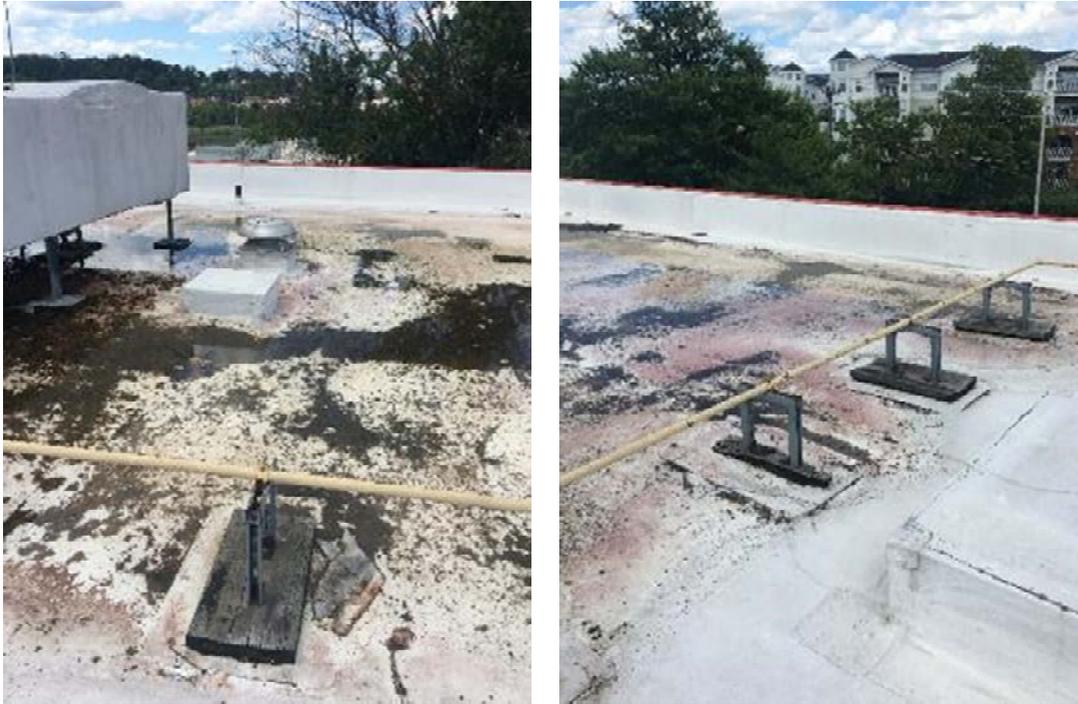
*Figures 1 and 2: Water ponding on the roof causing leaks*

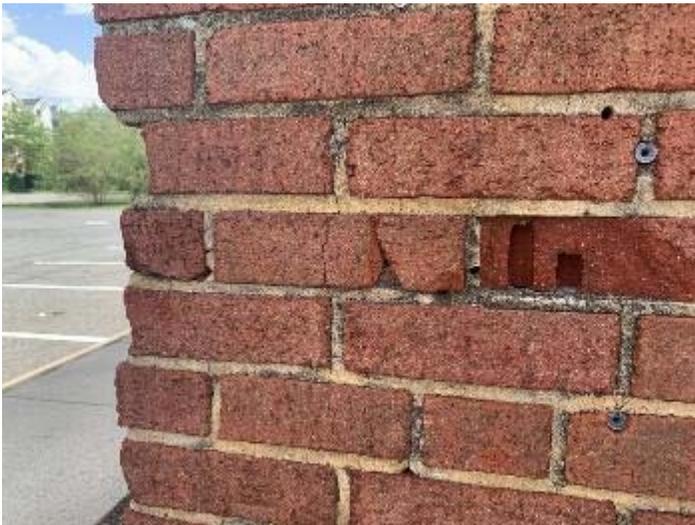
*Figure 3: Joint repair needed*

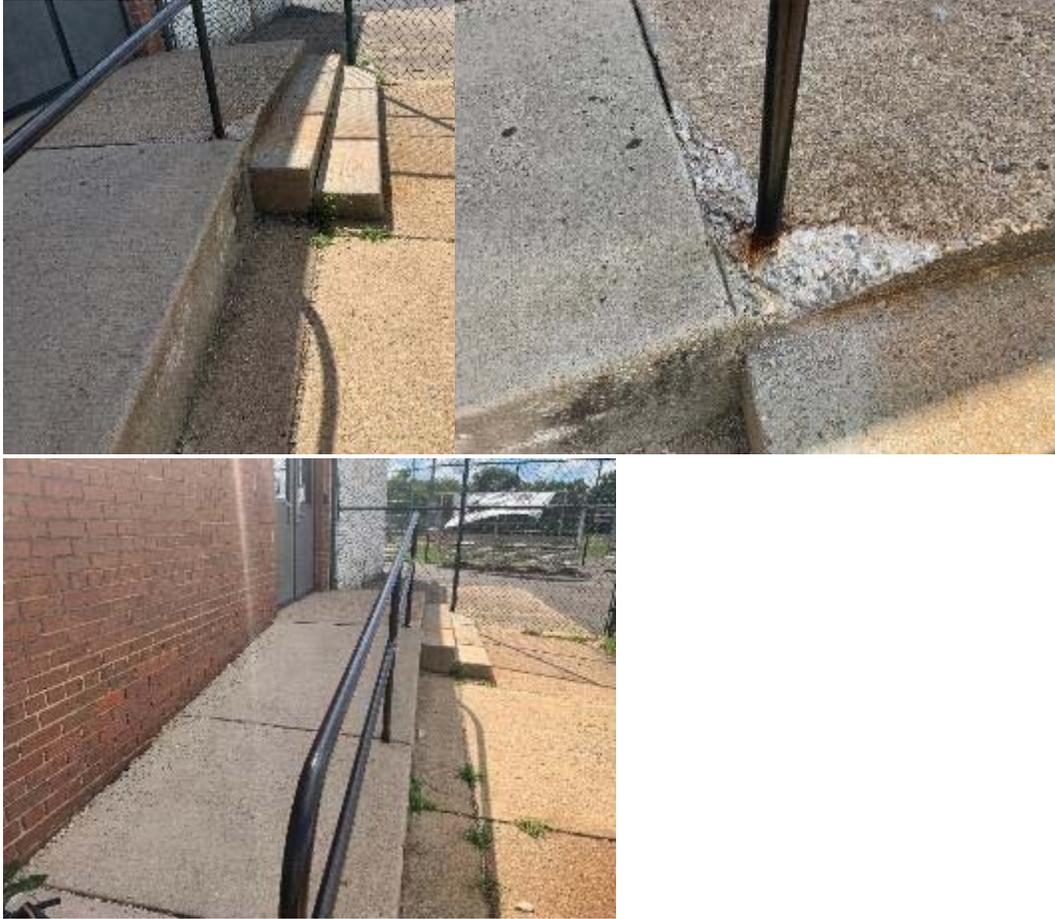
*Figure 4: Exterior ramp*

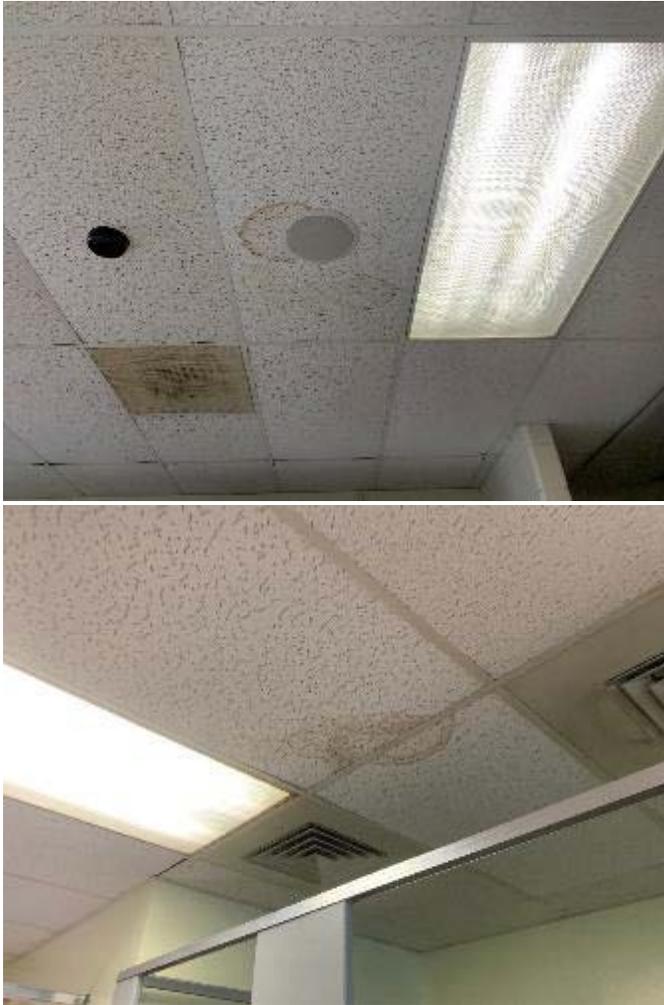
*Figure 5: Leaks and staining on ceiling tiles*

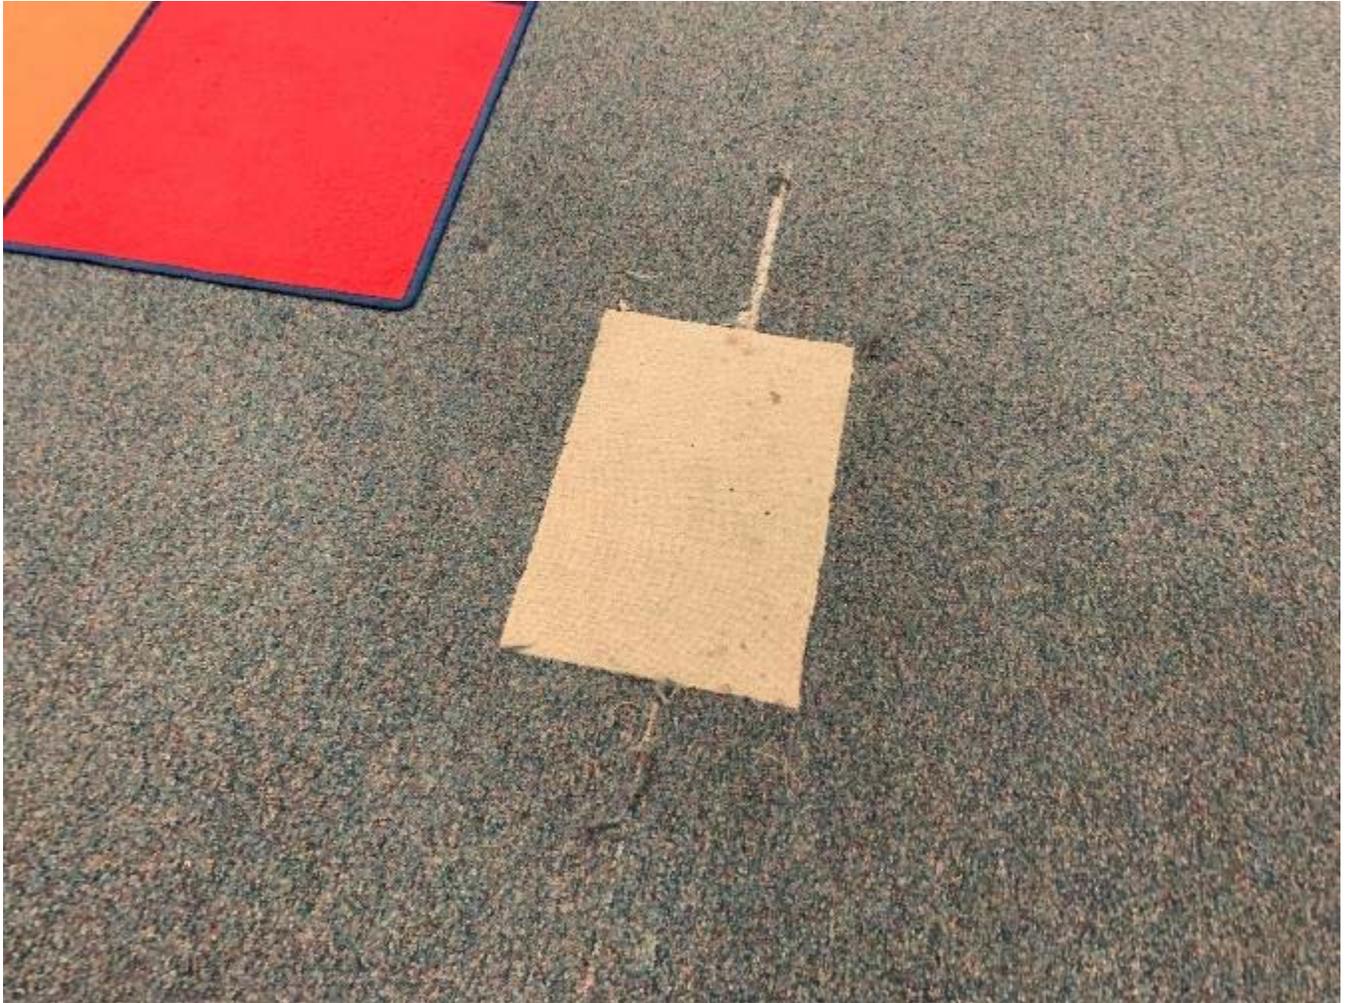
*Figure 6: Carpets need replacement*

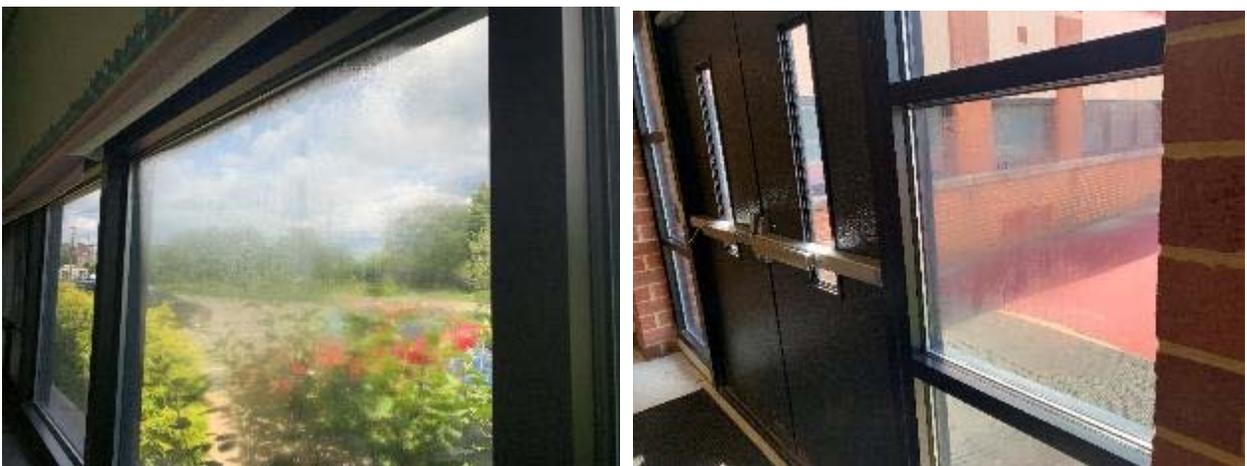
*Figure 7: Window Sweating*

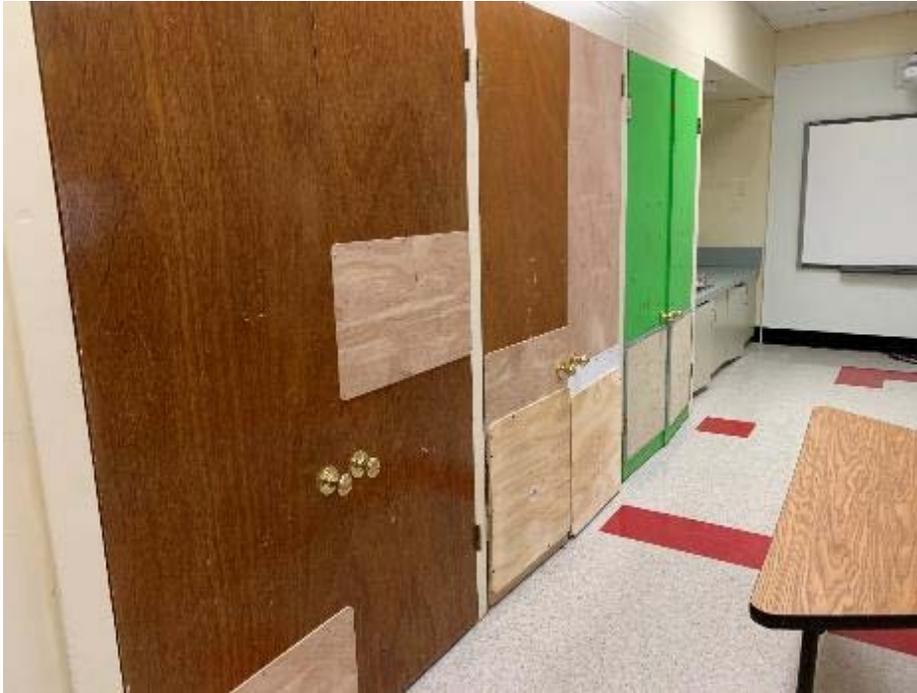
*Figure 11: Furniture laminates damaged*

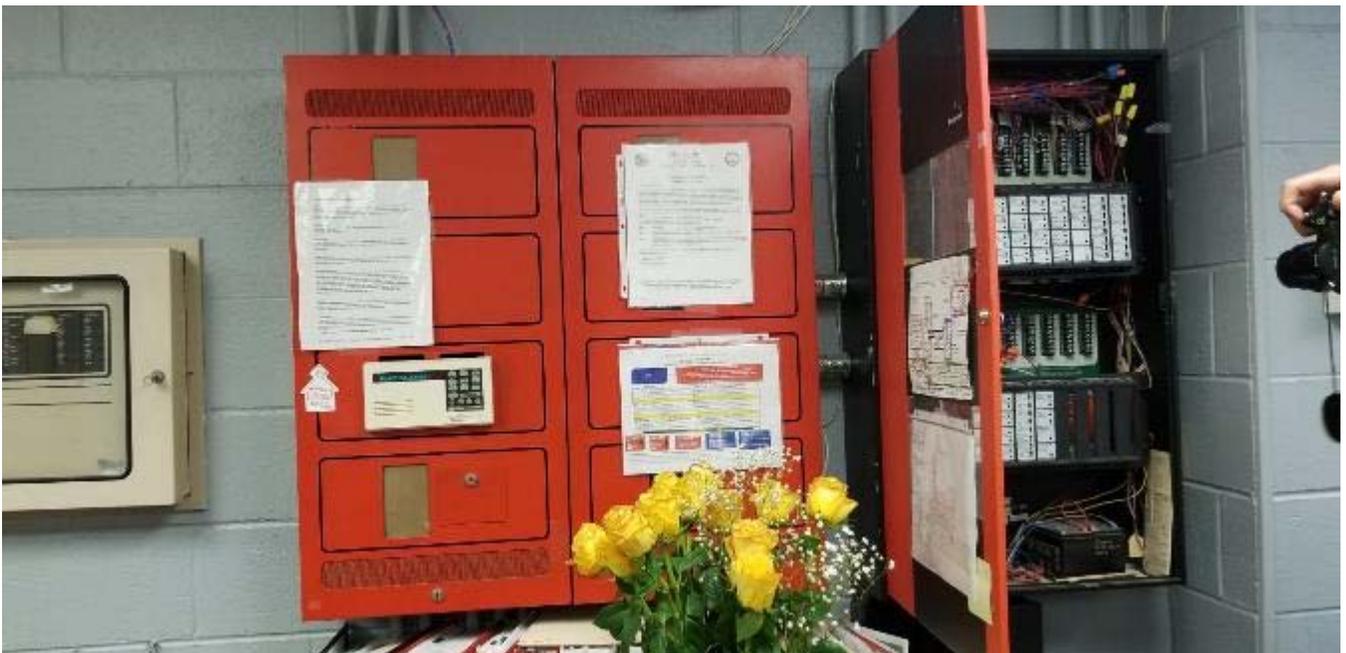
*Figure 8: Fire Alarm Control Panels*

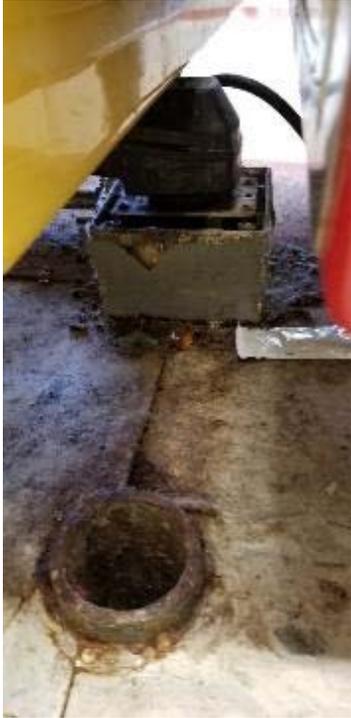
*Figure 10: Cafeteria Service Counter – Floor Outlet Missing Cover Plate*

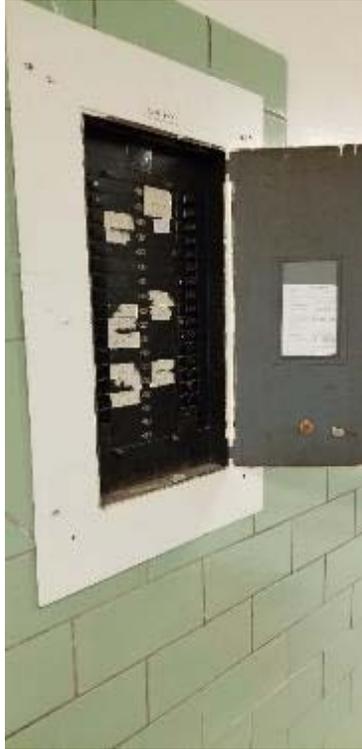
*Figure 11: Obsolete Panel 1-WW*

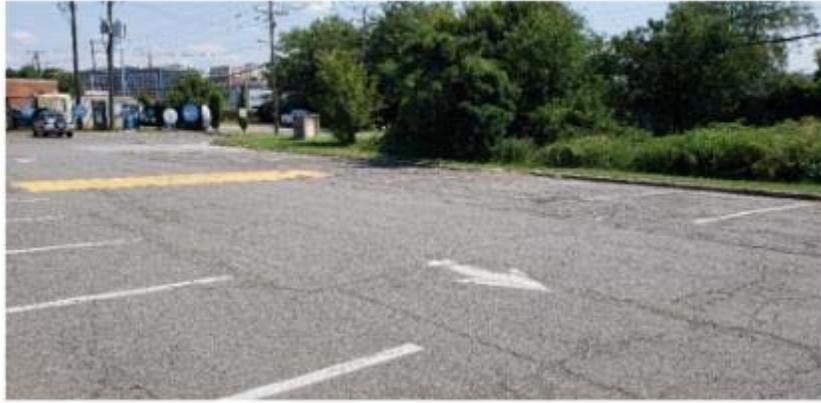
*Figure16: Vehicular pavement surface cracking and speed hump placement*

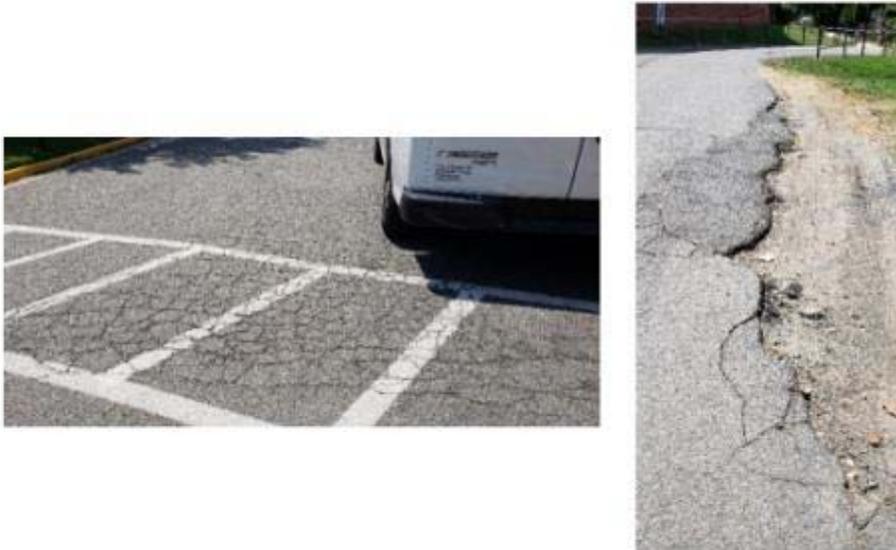
*Figure 17: Vehicular pavement subgrade failure/substantial pavement deterioration*

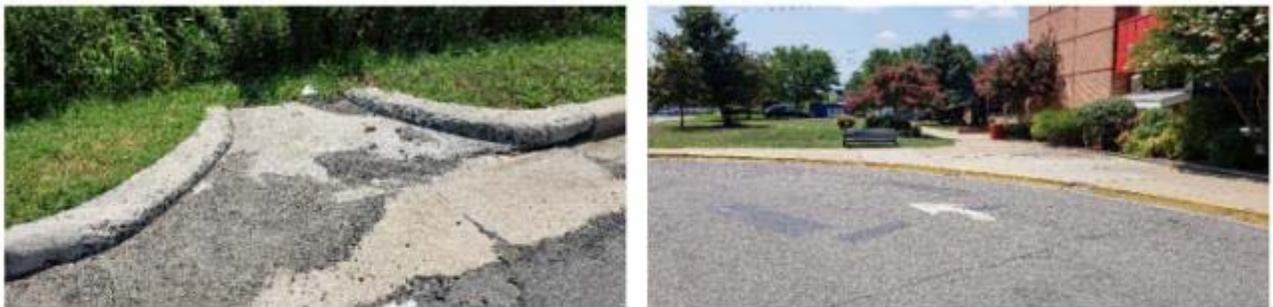
*Figure 18: Vehicular pavement concrete curbing damaged/concrete curb flume damage*

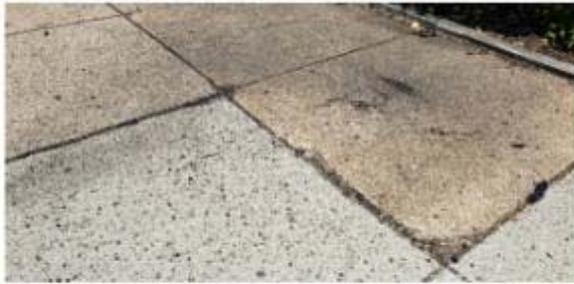
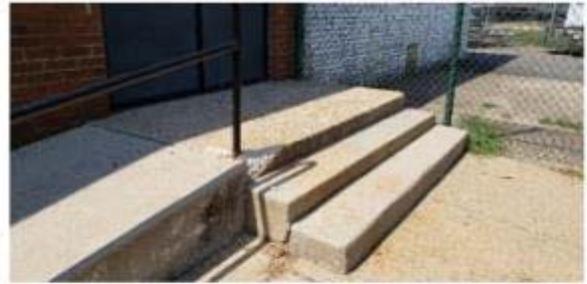
*Figure 19: Cracked/deteriorating concrete sidewalk panels and concrete steps*

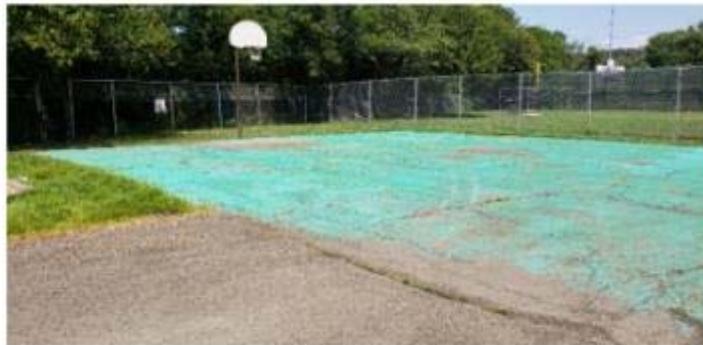
*Figure 20: Basketball court pavement deterioration*

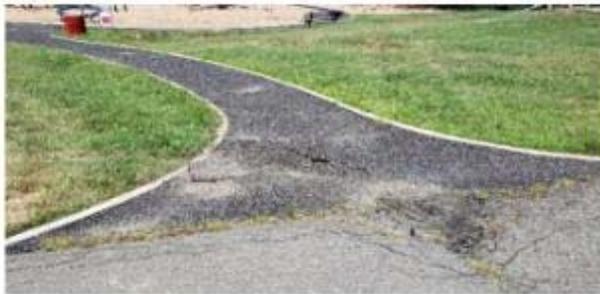
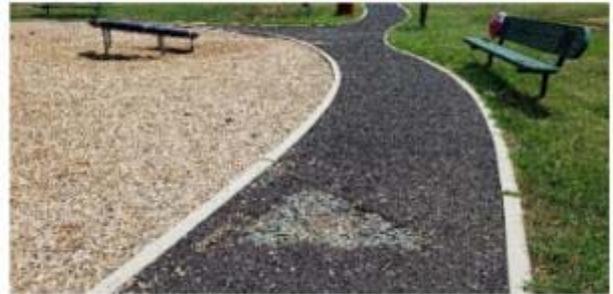
*Figure 21: Pervious pavement failure*

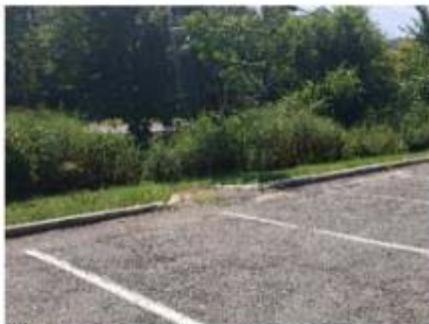
*Figure 22: Curb flume to drainage swale*

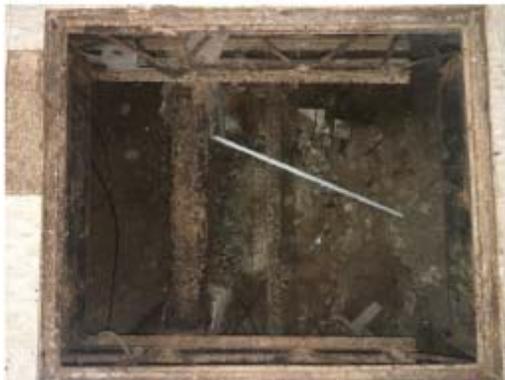
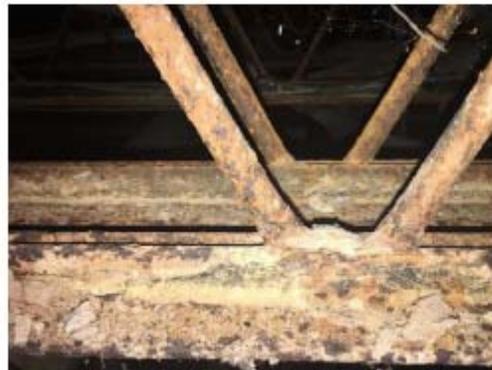
Steel joists in the crawl space beneath Room 2 – STEM Lab, are rusting.

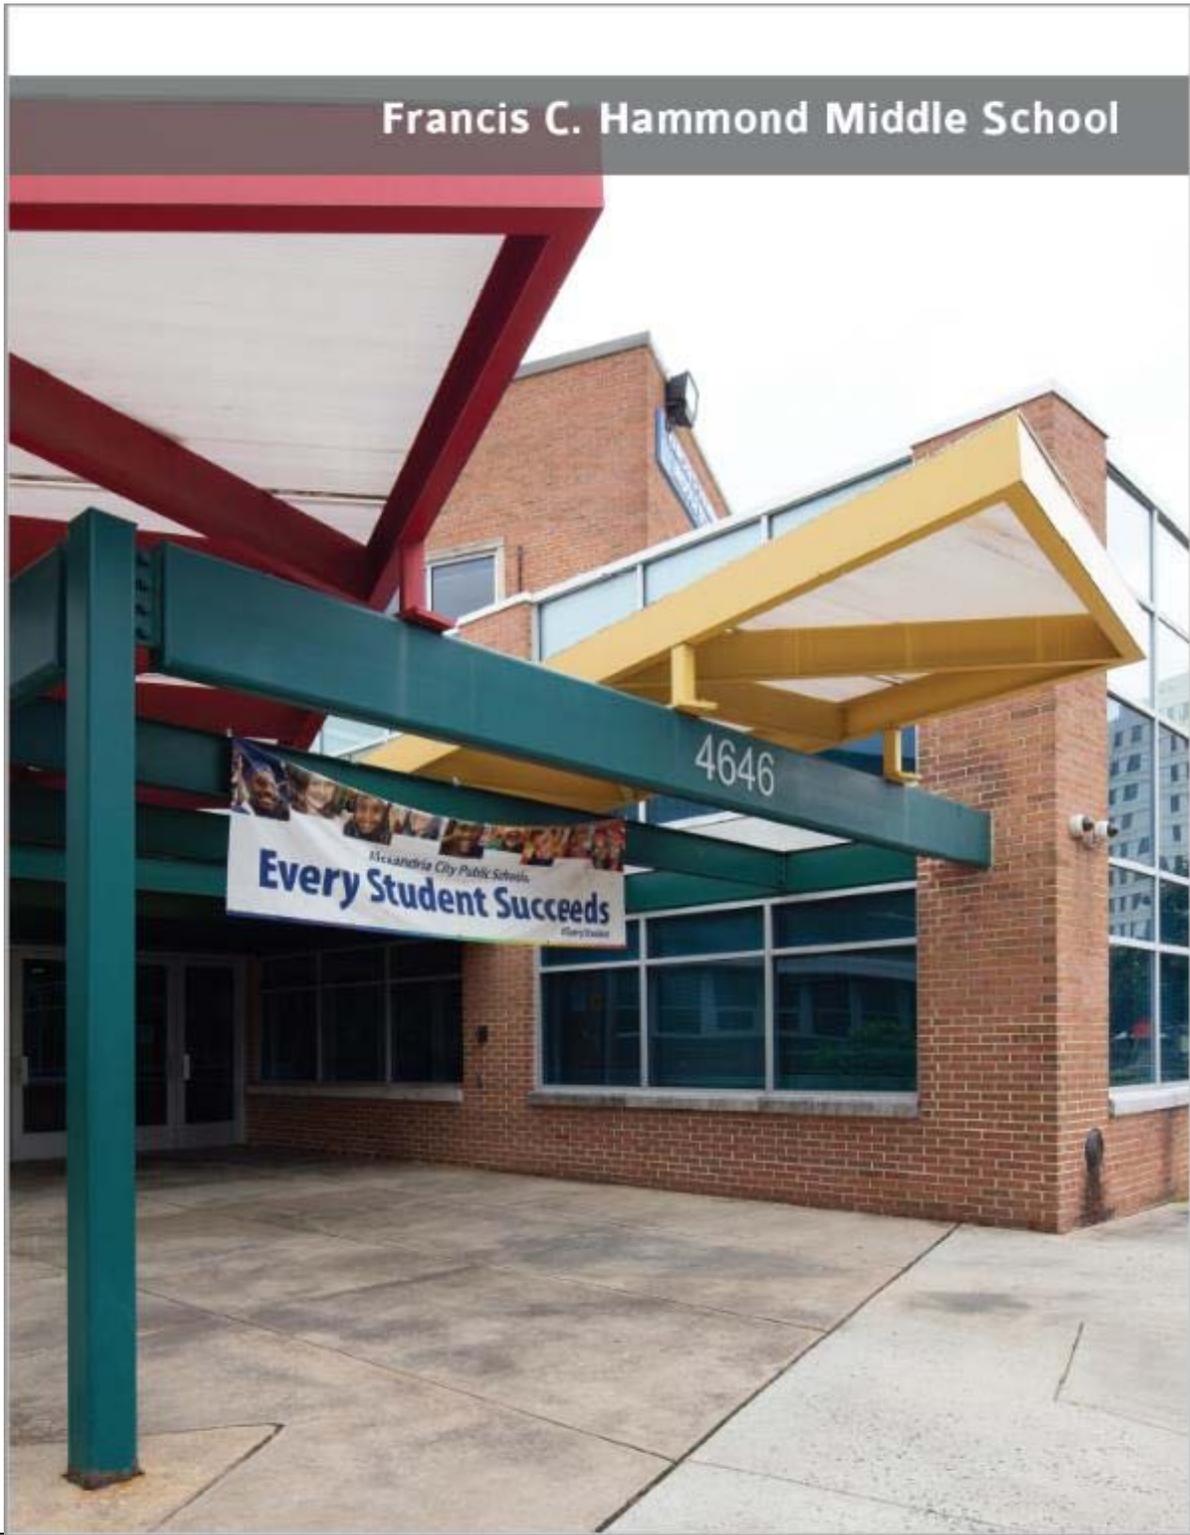
## A. FACILITY DESCRIPTION

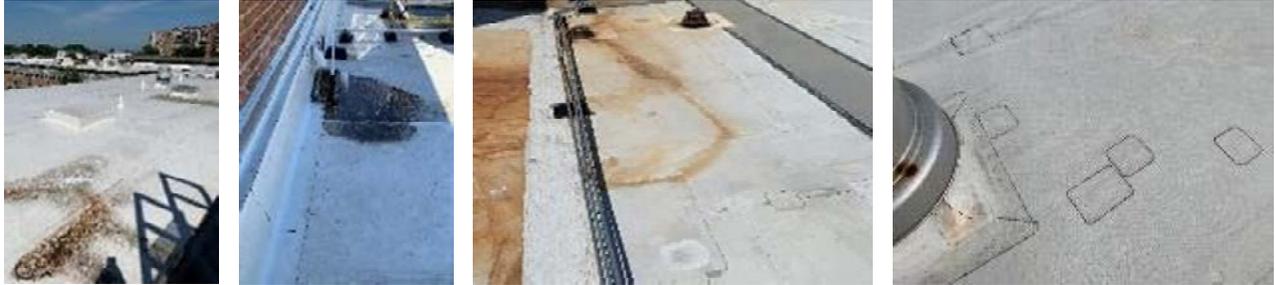
Figure 1. Roof – shown: D wing roof failures and patchwork

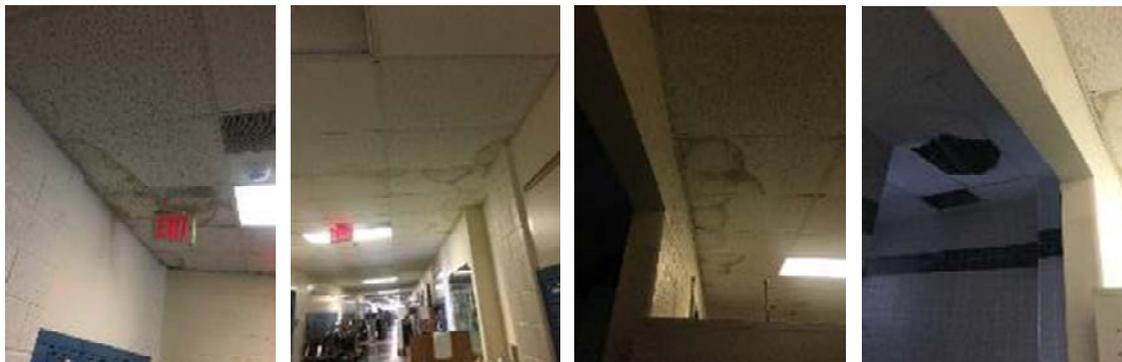
Figure 2. Ceiling stains from roof failure

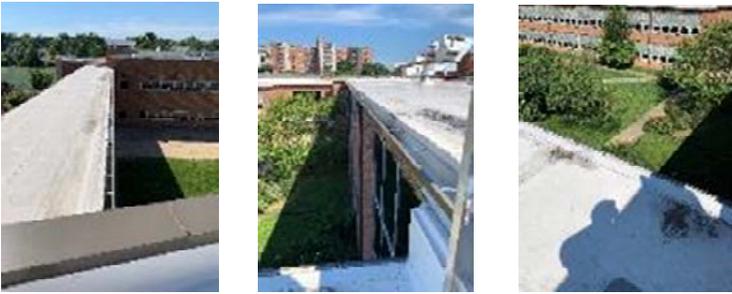
Figure 4. Mono-directional roof to gutter

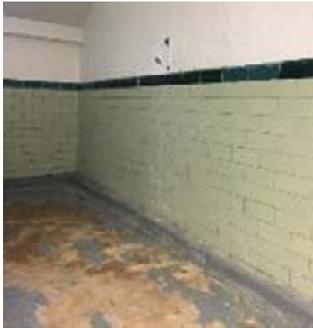
Figure 5. Cafeteria stairwell 9

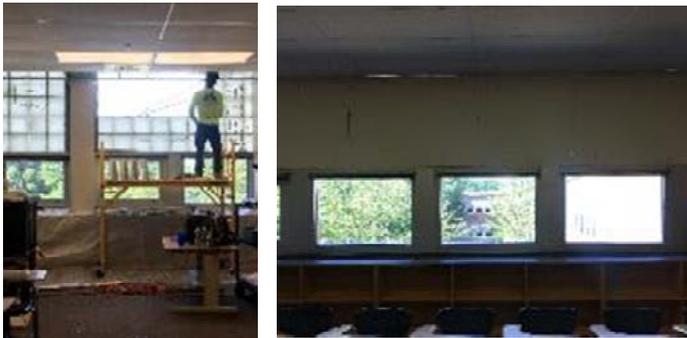
Figure 8. Window replacement (Left to right) E wing in progress and B wing soon to commence.

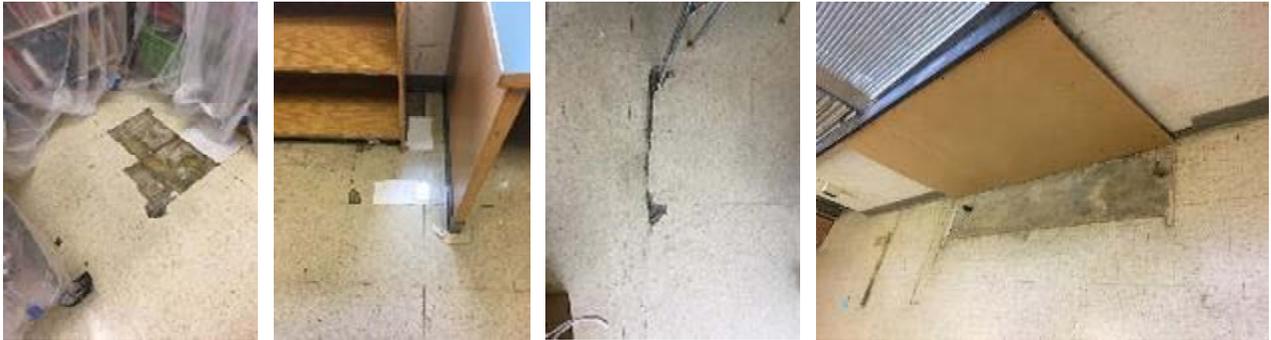
*Classroom flooring wear & tear – refer to matrix*

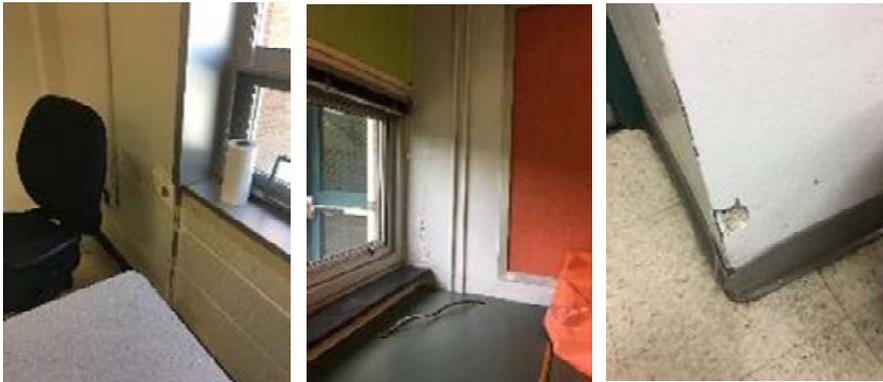
*Classroom wall finish issues – refer to matrix*

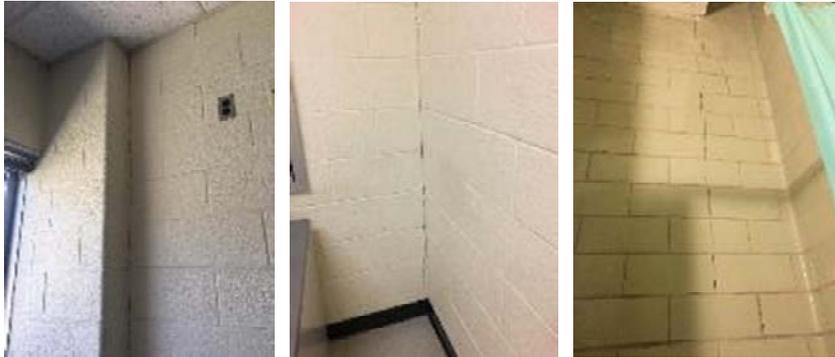
*Interior masonry wall cracks – refer to matrix*

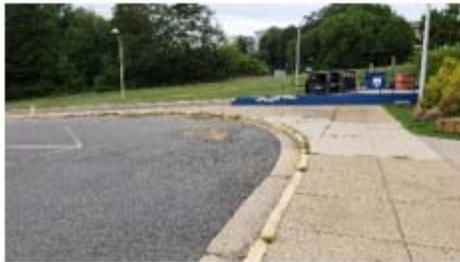
**Pavement Condition at West Lot**

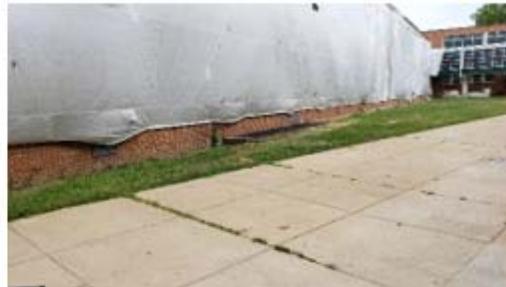
**Grading at courtyard**

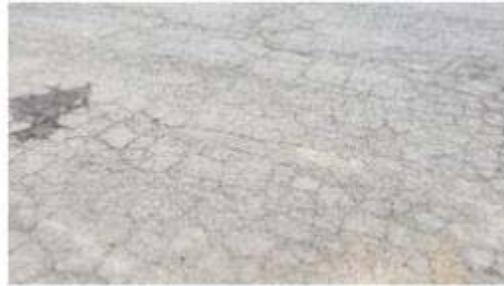
**Pavement condition at roller hockey**

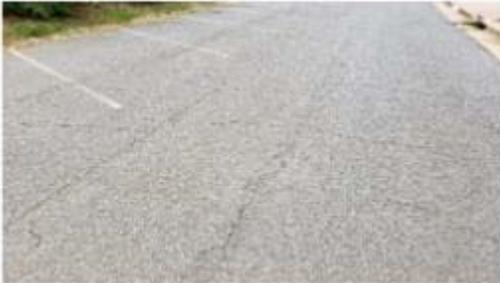
**Pavement condition at northern parking**

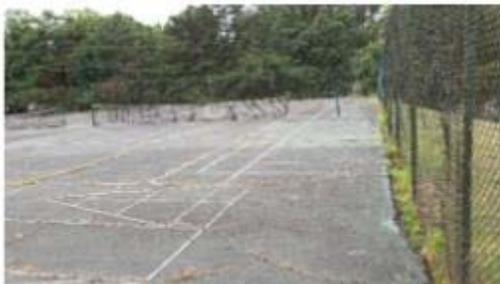
**Pavement condition at tennis**

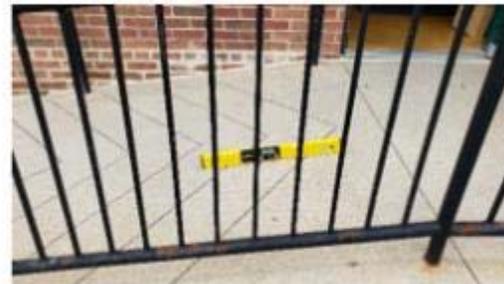
**Northern ADA ramp**

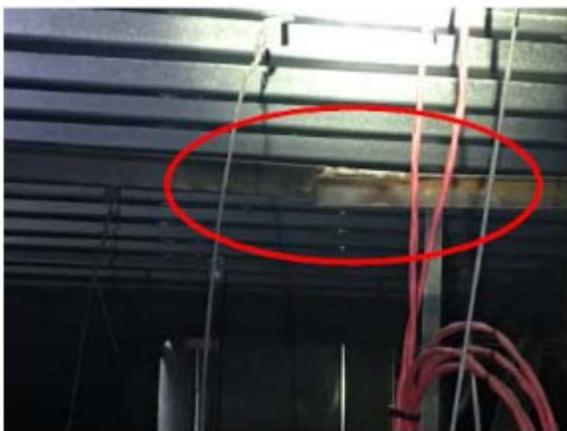
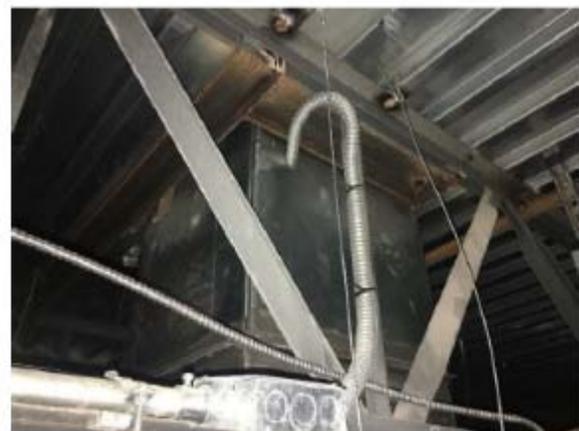
Leaks in the second-floor bathroom of the D-Wing have brought down ceilings and left the bathroom unsafe and unable to be used.

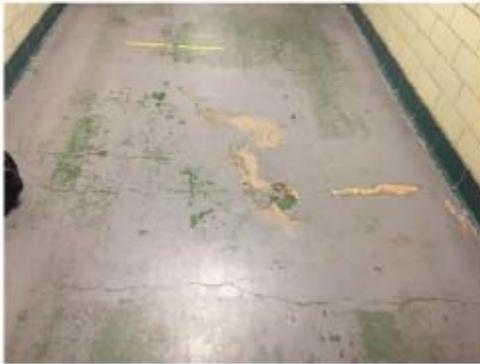
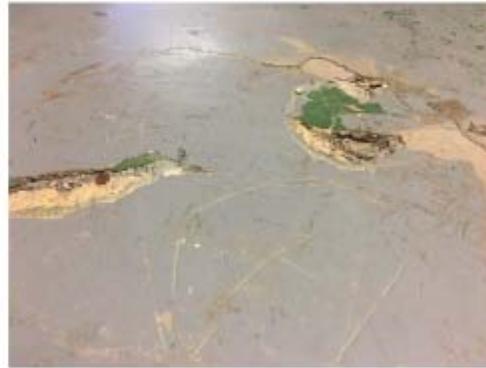
An area of the concrete slab at the lowest level corridor to the locker rooms is damaged.

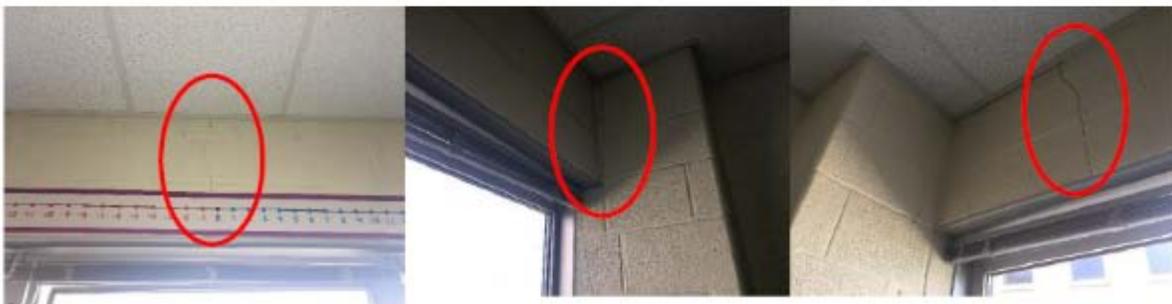
Various spandrels throughout the building have vertical cracks. Shown below are cracks in the spandrel of room D116.

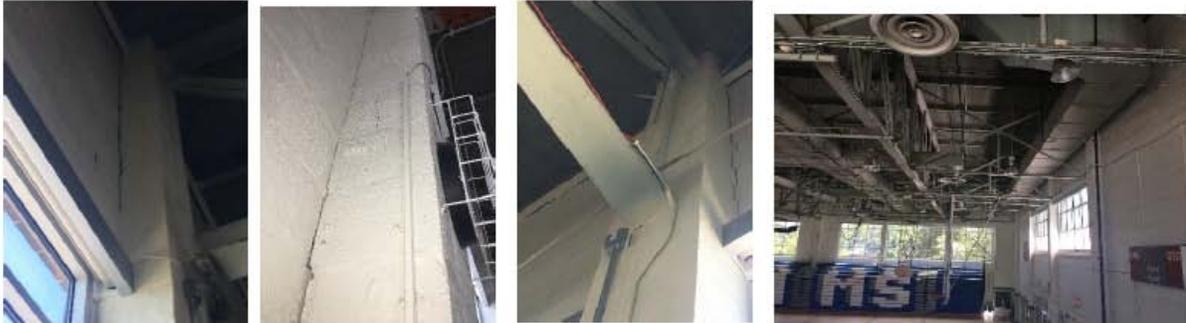
In the gymnasium, columns appear to be separating from the walls.

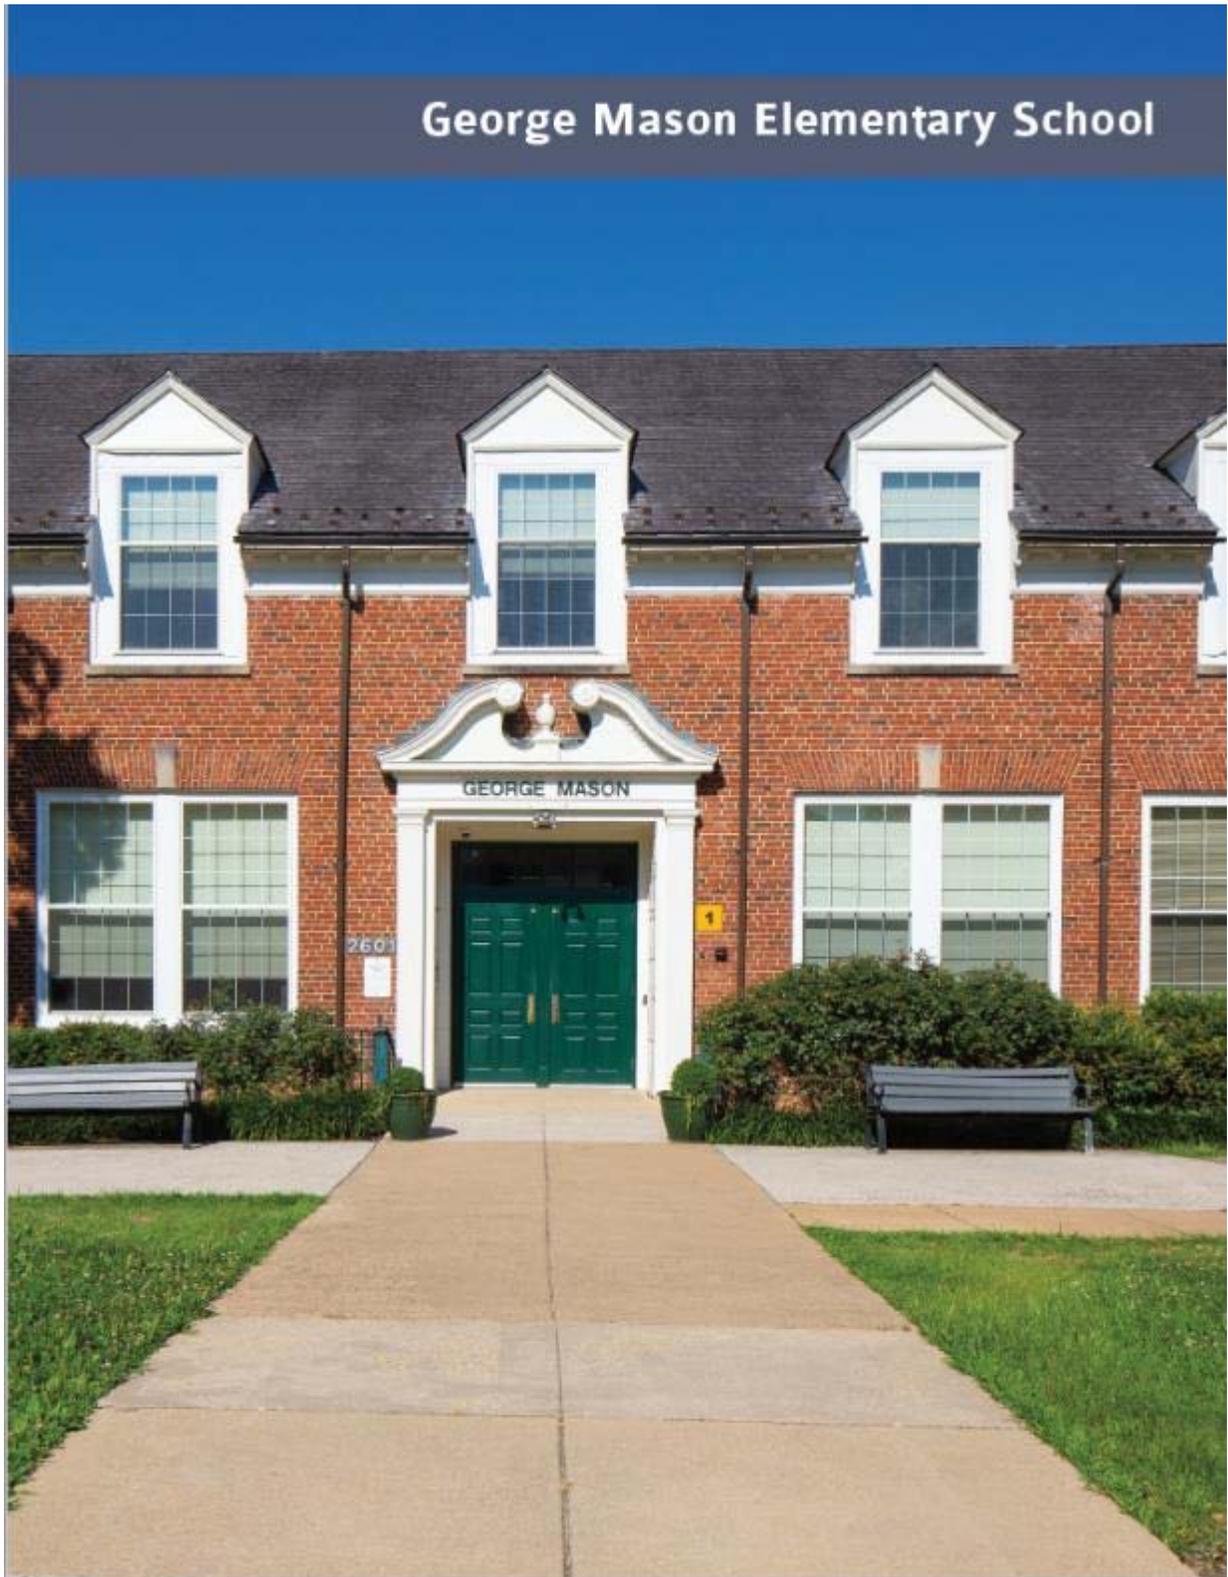
## A. FACILITY DESCRIPTION

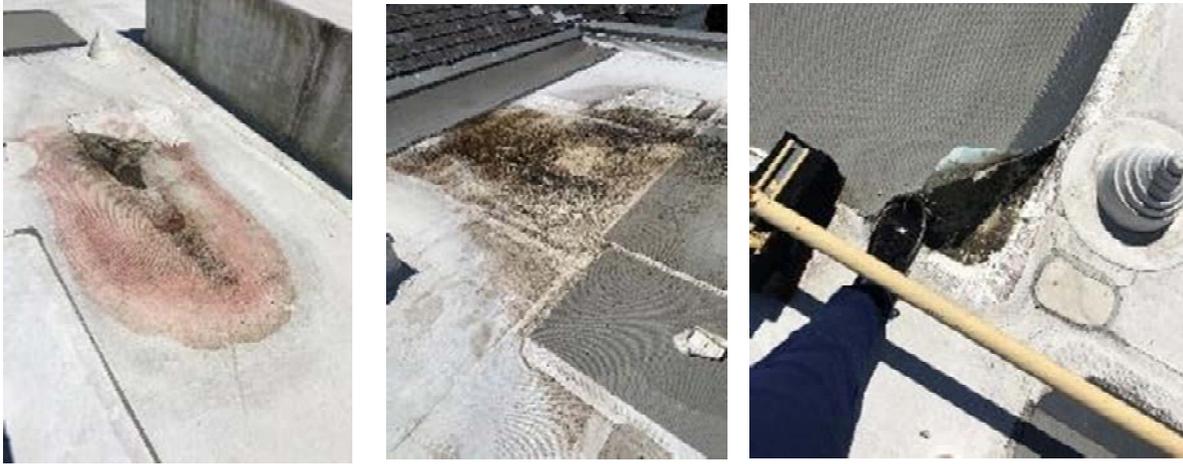
**Figure 12 Roof Failures**

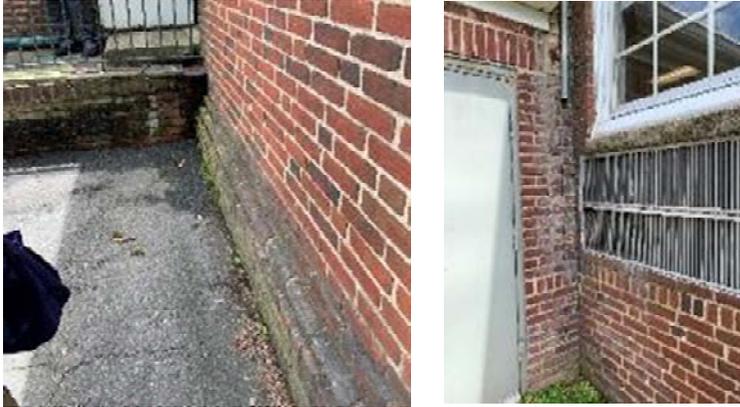
**Figure 13 Exterior Wall Moisture and Settlement Cracks**

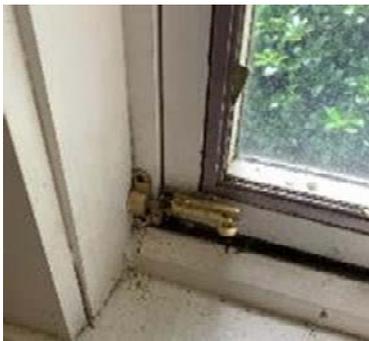
**Figure 14 Inoperable Window Hardware**

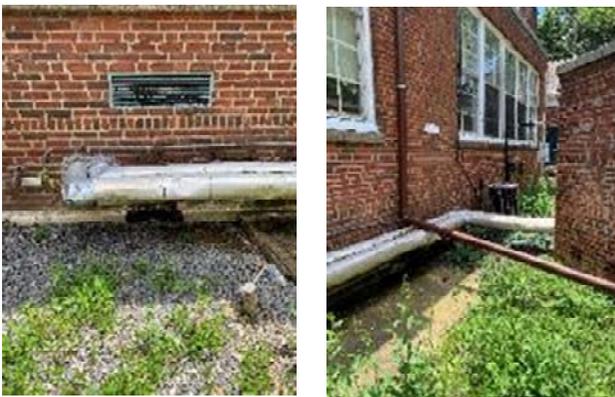
**Figure 15 Inadequate Stormwater Drainage**

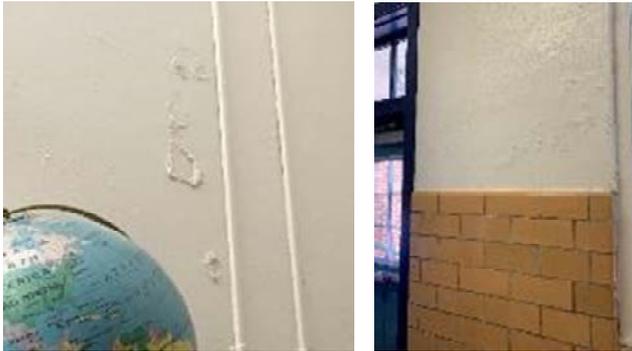
**Figure 16 Wall Finishes**

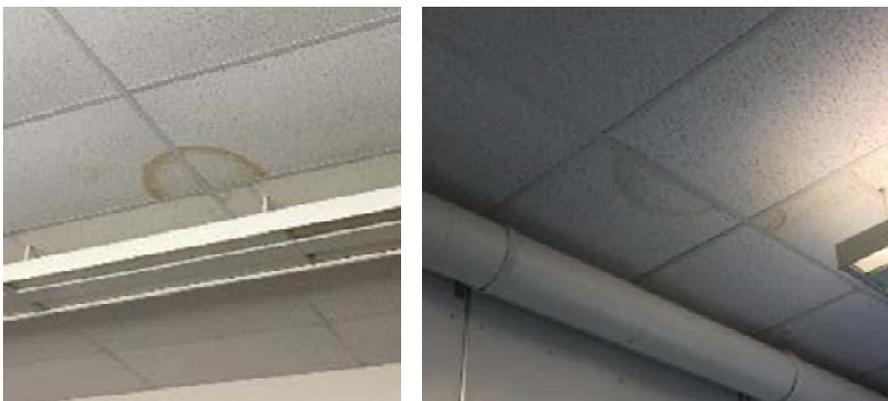
**Figure 18 Ceiling Stains**

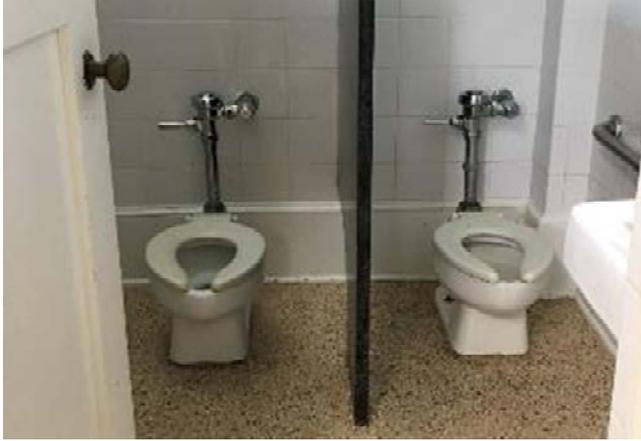
**Figure 8 No Stall Doors**

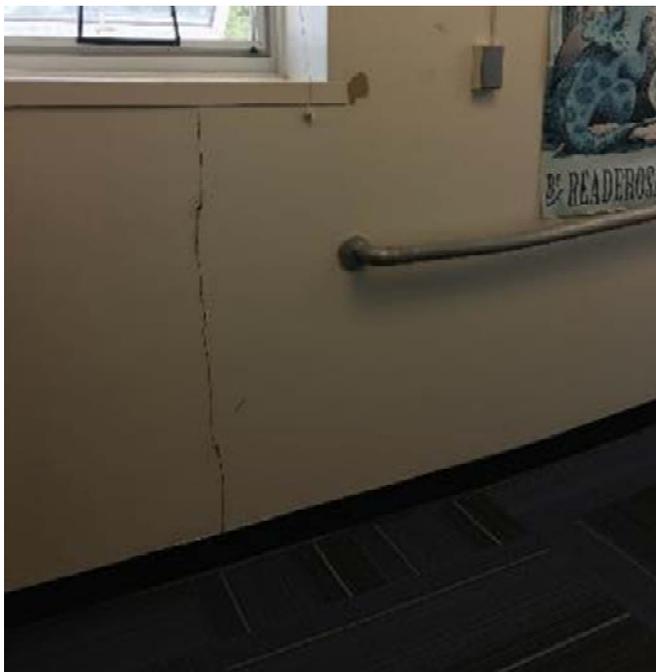
**Figure 9 Settlement Crack (seen in Library)**
