**ALEXANDRIA CITY  
PUBLIC SCHOOLS**

## ALEXANDRIA CITY PUBLIC SCHOOLS COMPREHENSIVE CONDITION AUDITS

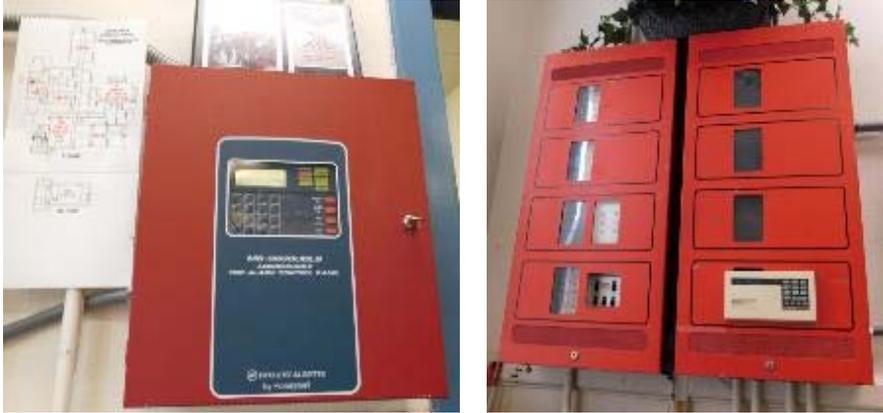
**Figure 10: Fire Alarm Control Panels**

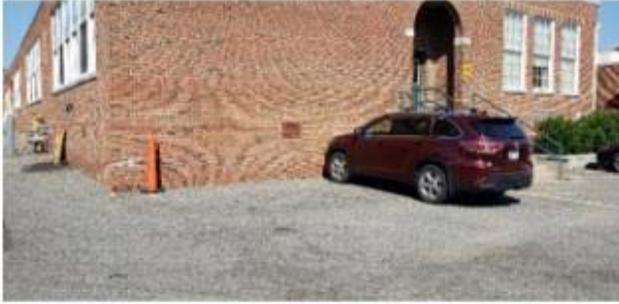
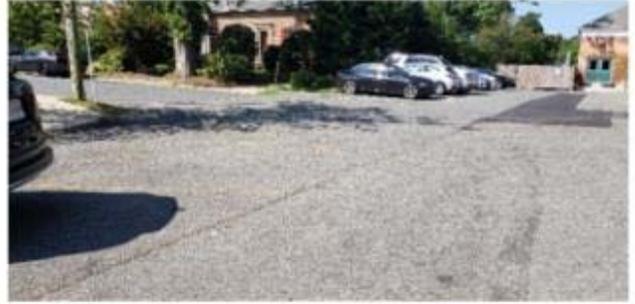
**Figure 19: Vehicular Pavement – Surface Cracking**

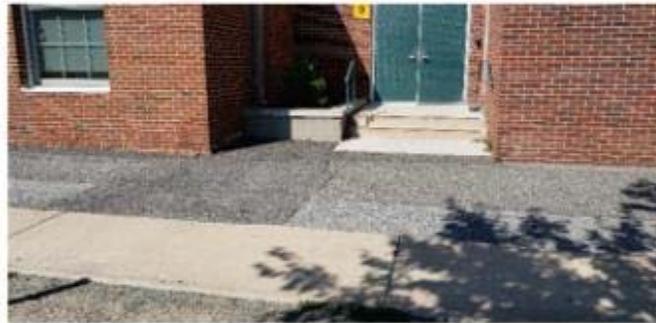
**Figure 20: Vehicular Pavement – Subgrade Failure/Substantial Pavement Deterioration**

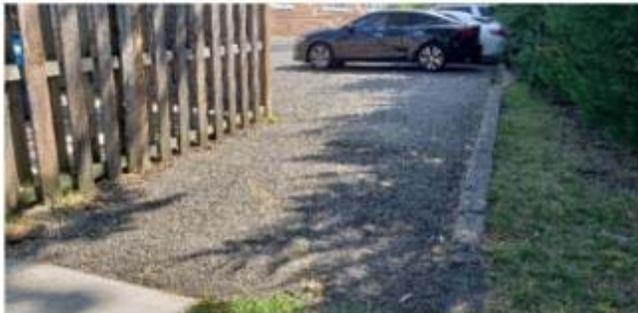
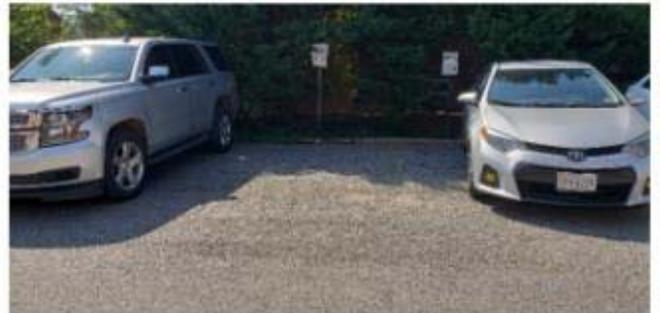
**Figure 21: Vehicular Pavement – Concrete and Asphalt Curbing Damaged/Missing**

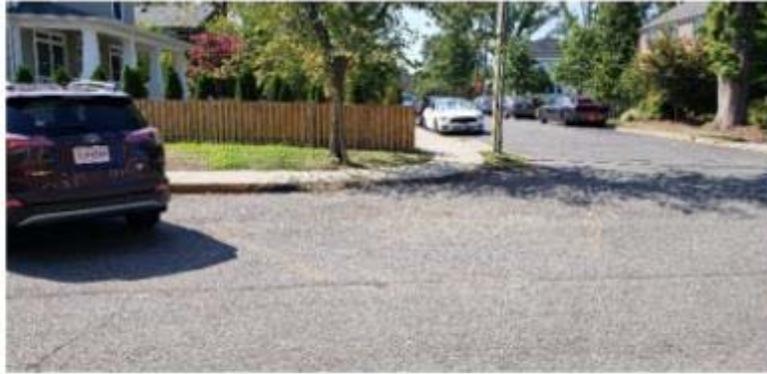
**Figure 22: Vehicular Pavement – Faded/Missing Striping**

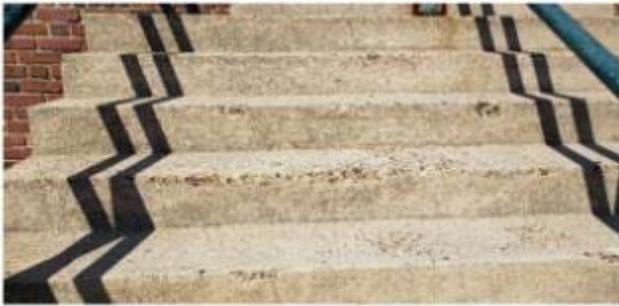
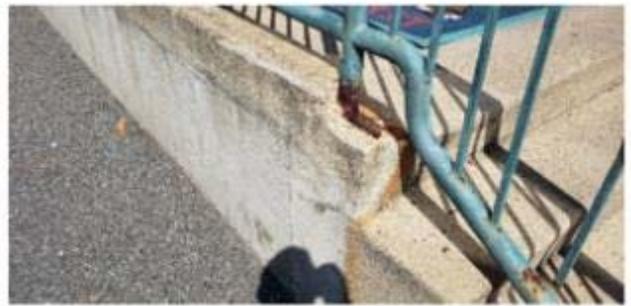
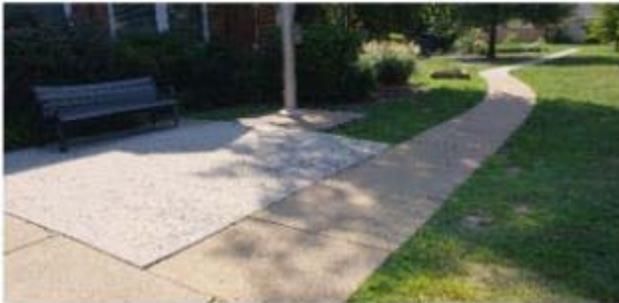
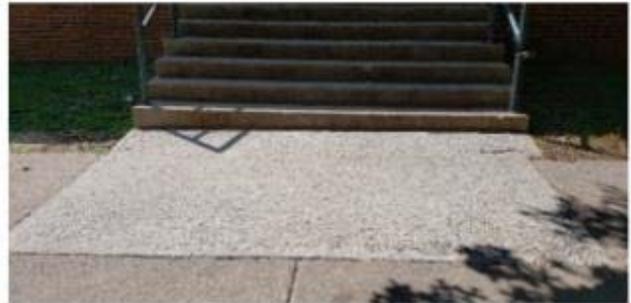
**Figure 23: Pedestrian Pavement – Cracked/Deteriorating Concrete Sidewalk Panels and Concrete Steps**

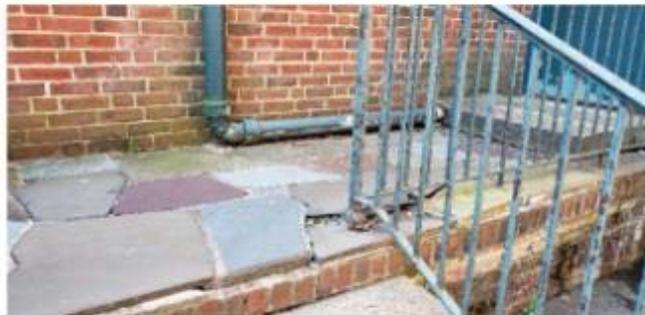
**Figure 24: Pedestrian Pavement – Cracked and Damaged Slate Pavers at Doorways**

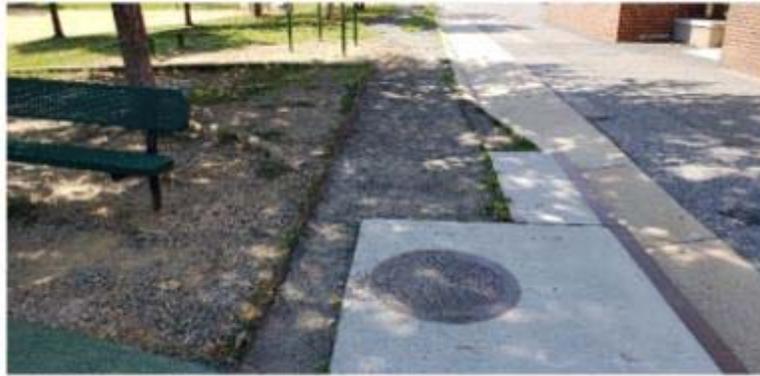
**Figure 25: Pedestrian Pavement – Stone Aggregate Walkway (Additional Stone Required)**

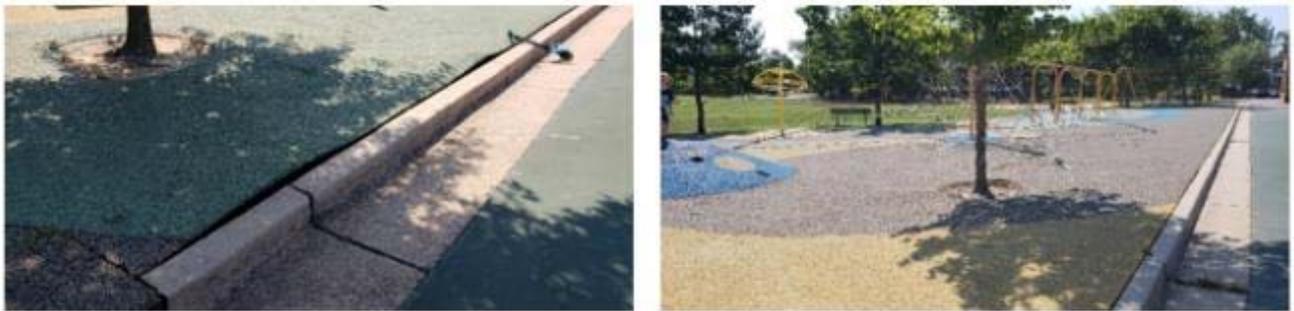
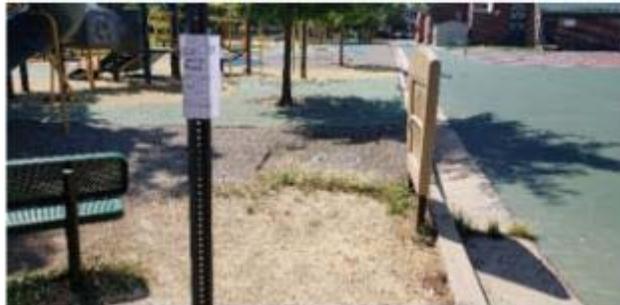
**Figure 26: Pedestrian Pavement – Rubber Play Surfacing Damaged/Heaving**

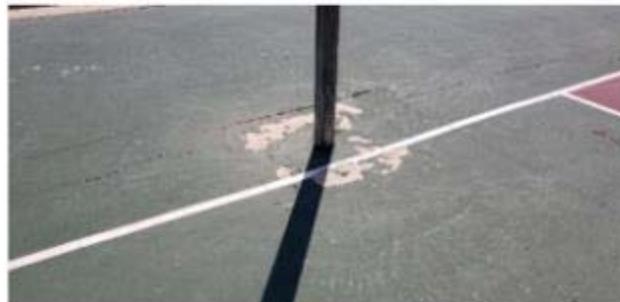
**Figure 27: Pedestrian Pavement – Colored Asphalt Hardscape Play Area – Minor Surface Cracking**

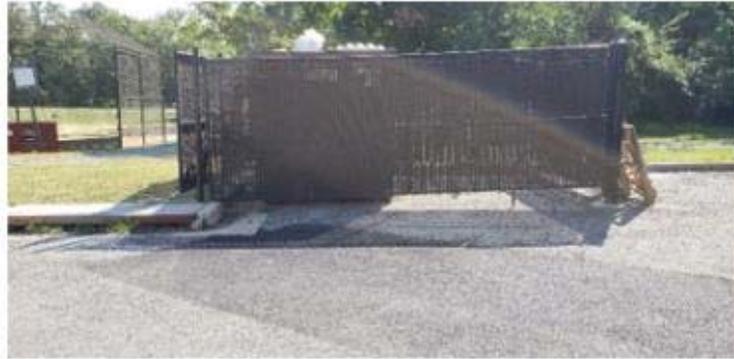
**Figure 28: Vehicular Pavement – No Dedicated Concrete Dumpster Pad**

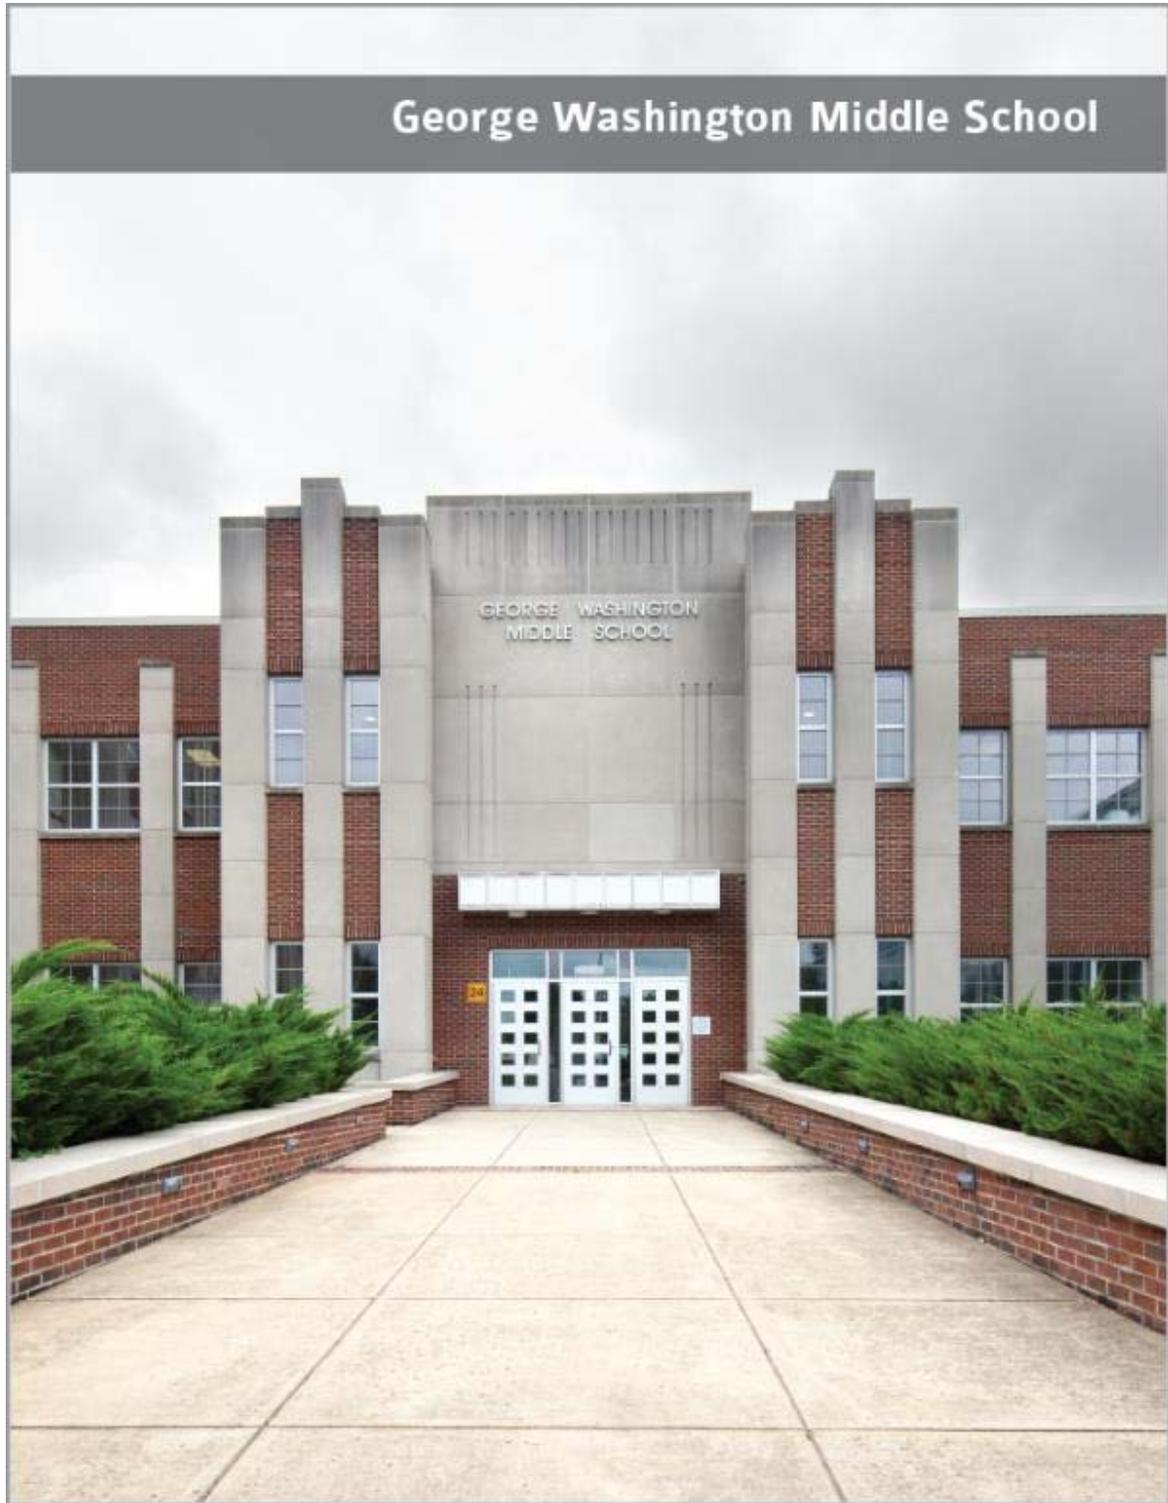
## A. FACILITY DESCRIPTION

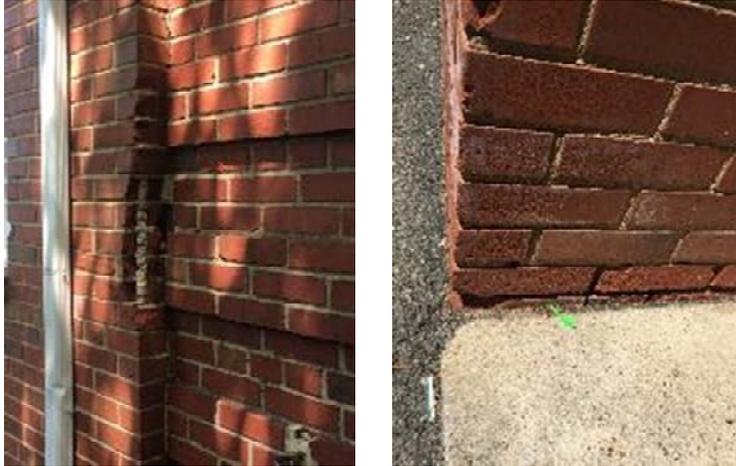
Figure 19: Exterior Walls (weathering and mortar vanishing)

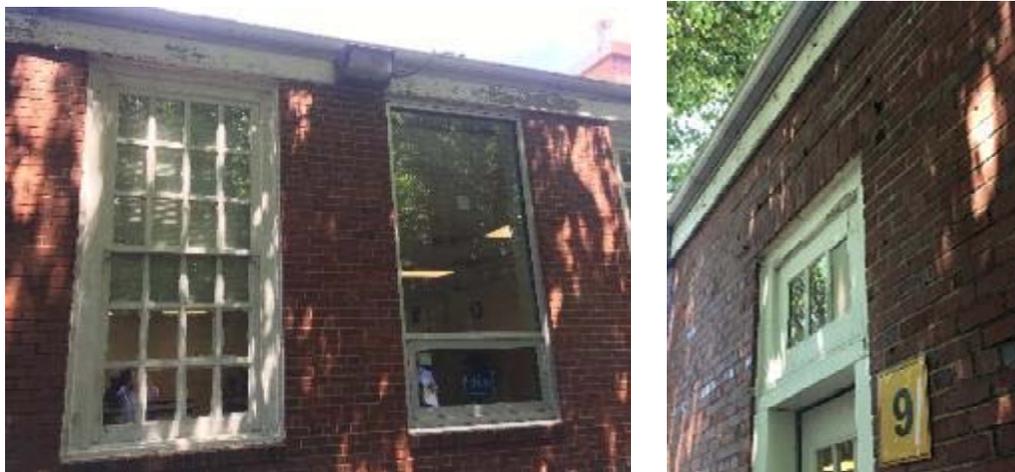
Figure 20: Wood Rot on Windows Due to Moisture

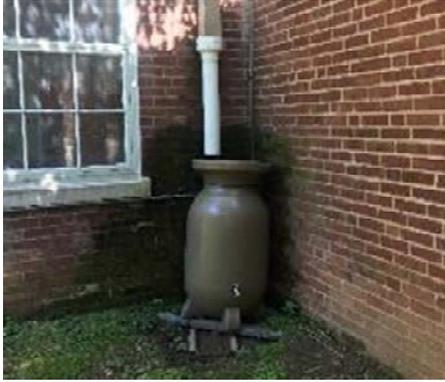
Figure 3: Greywater Collection is Poorly Set

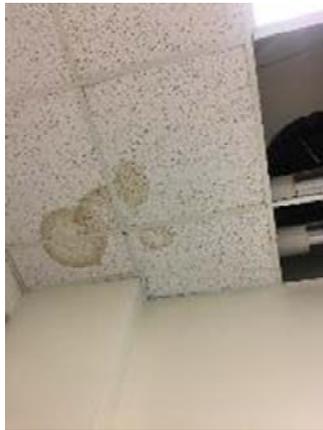
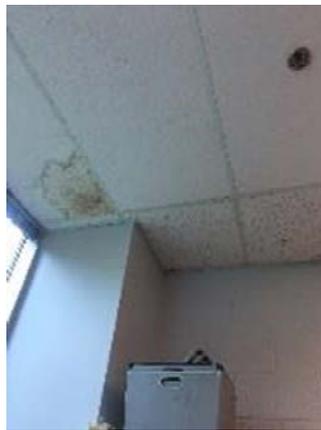
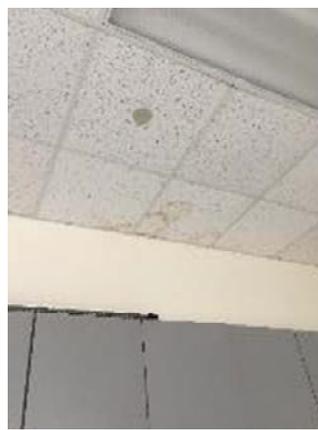
Figure 6: Ceiling Stains

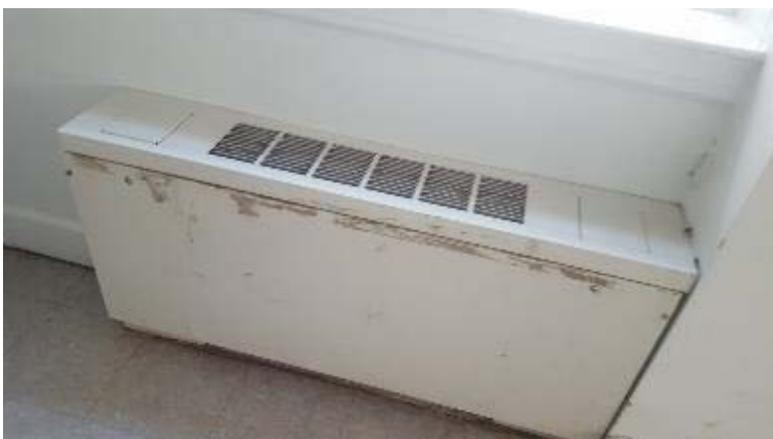
Figure 12: Fan coil unit found in room A113.

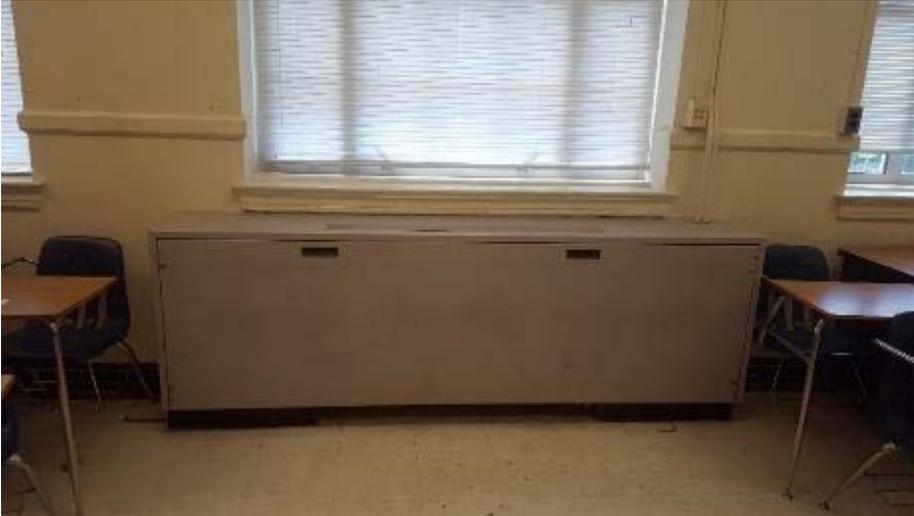
Figure 13: Unit ventilator found in room A310.

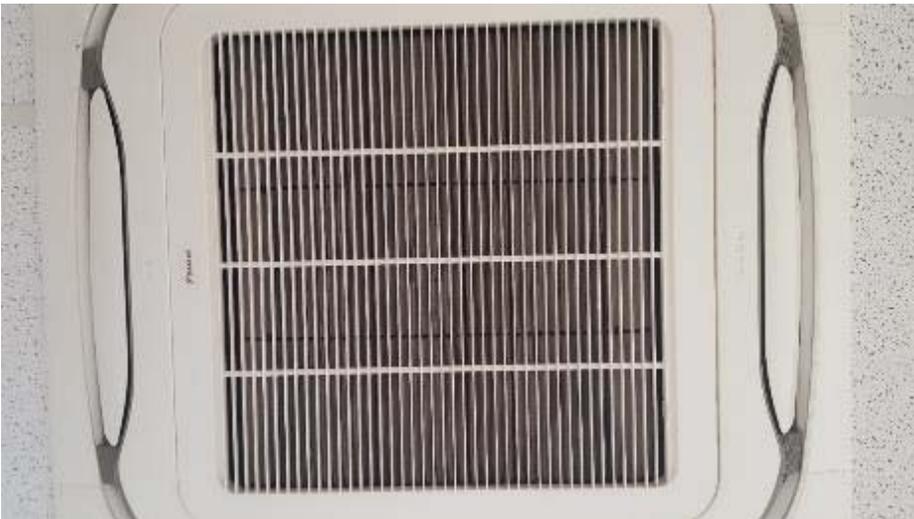
Figure 14: Daikin cassette in cafeteria.

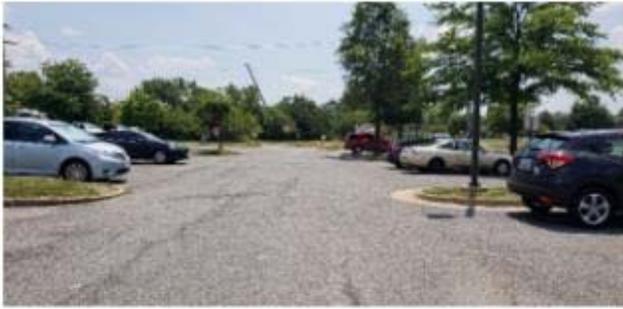
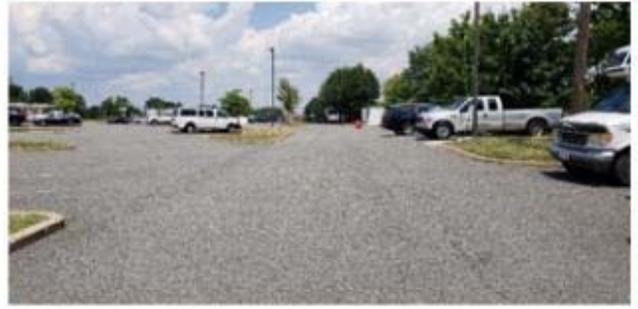
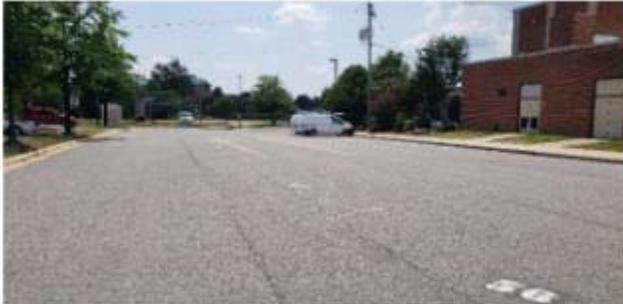
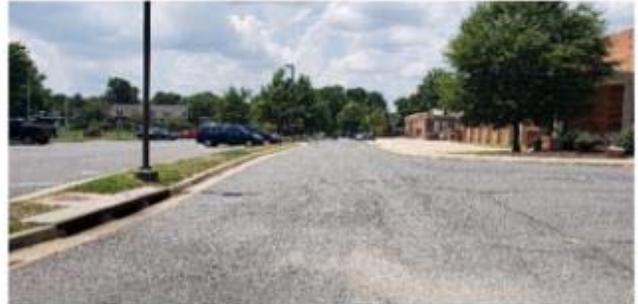
Figure 15: Vehicular Pavement – Surface Cracking

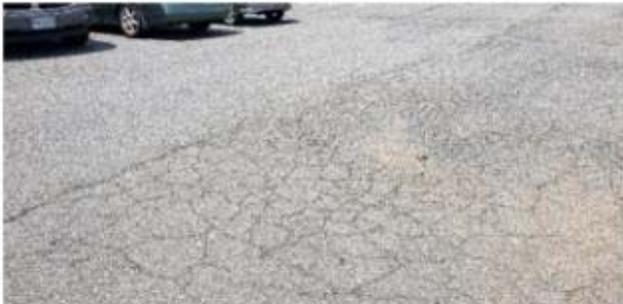
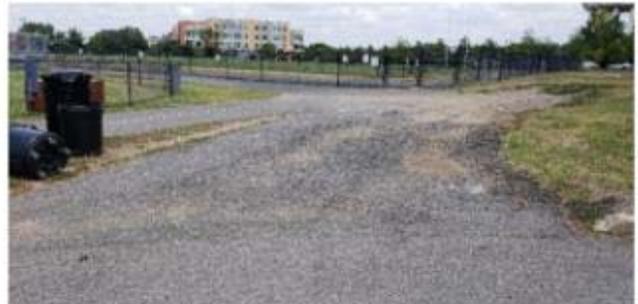
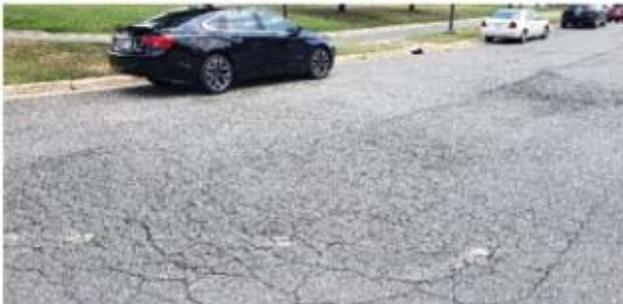
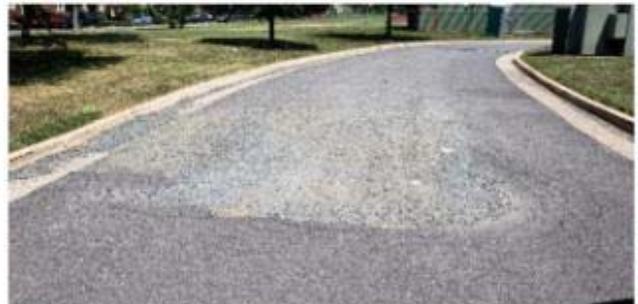
Figure 16: Vehicular Pavement – Subgrade Failure/Substantial Pavement Deterioration

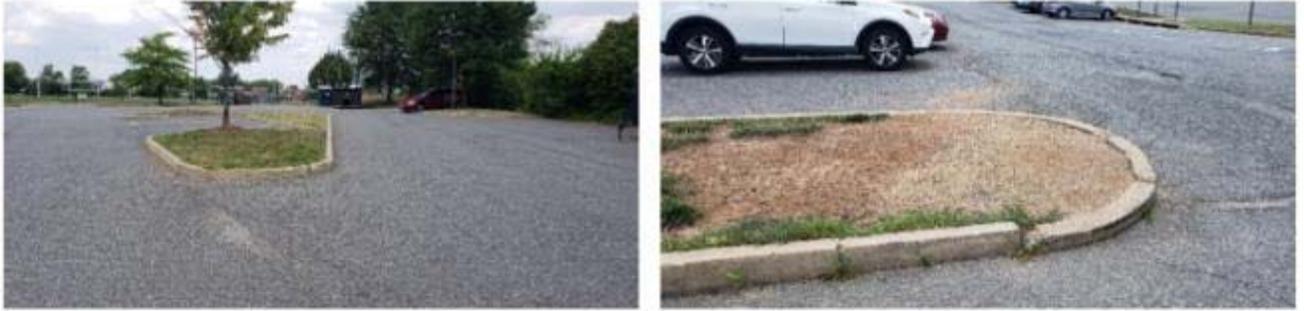
Figure 17: Vehicular Pavement – Concrete Curbing Damaged

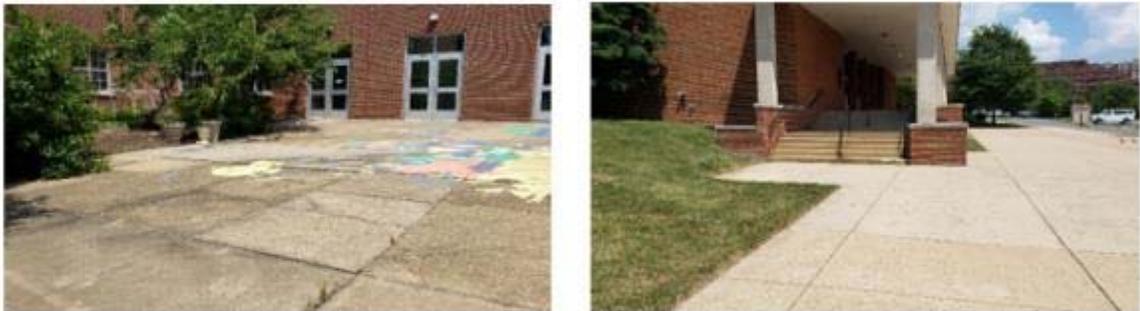
Figure 18: Pedestrian Pavement – Cracked/Deteriorating Concrete Sidewalk Panels and Concrete Steps

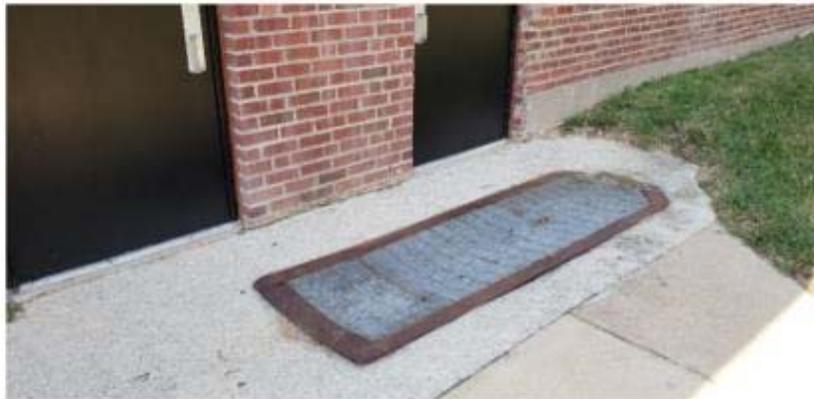
Figure 19: Pedestrian Drain Cover and Surrounding Ingress/Egress Slab Deteriorating

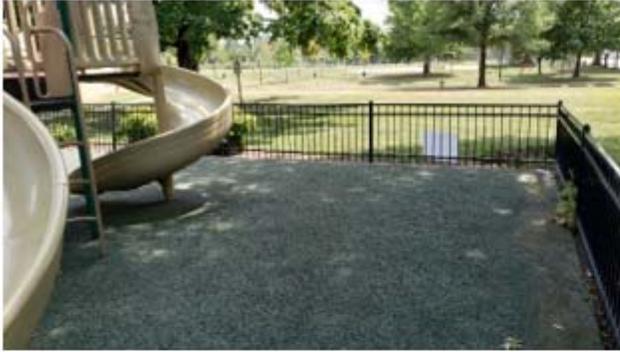
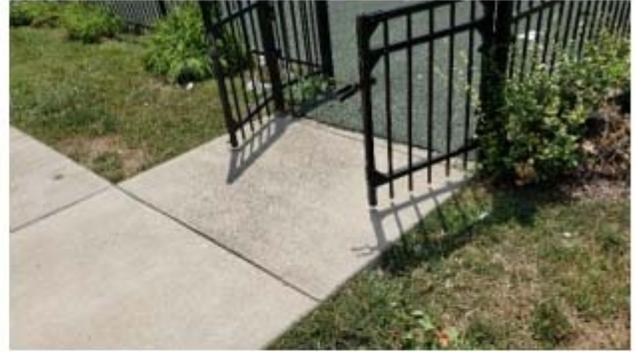
Figure 20: Pedestrian Pavement – Rubber Play Surfacing Requiring Maintenance/Cleaning/Repair

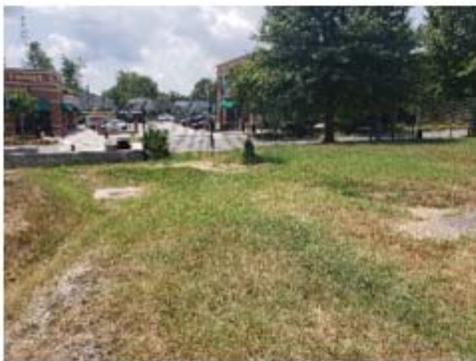
Figure 21: Outfall ditch and inlet at E. Braddock Road

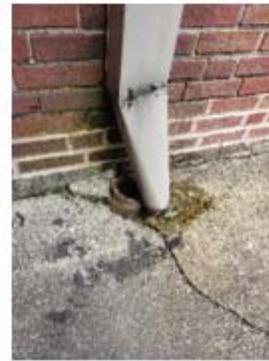
Figure 22: Roof Leader in need of repair

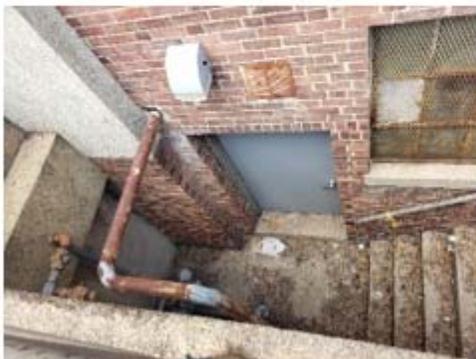
Figure 23: Clogged drain at bottom of stairs

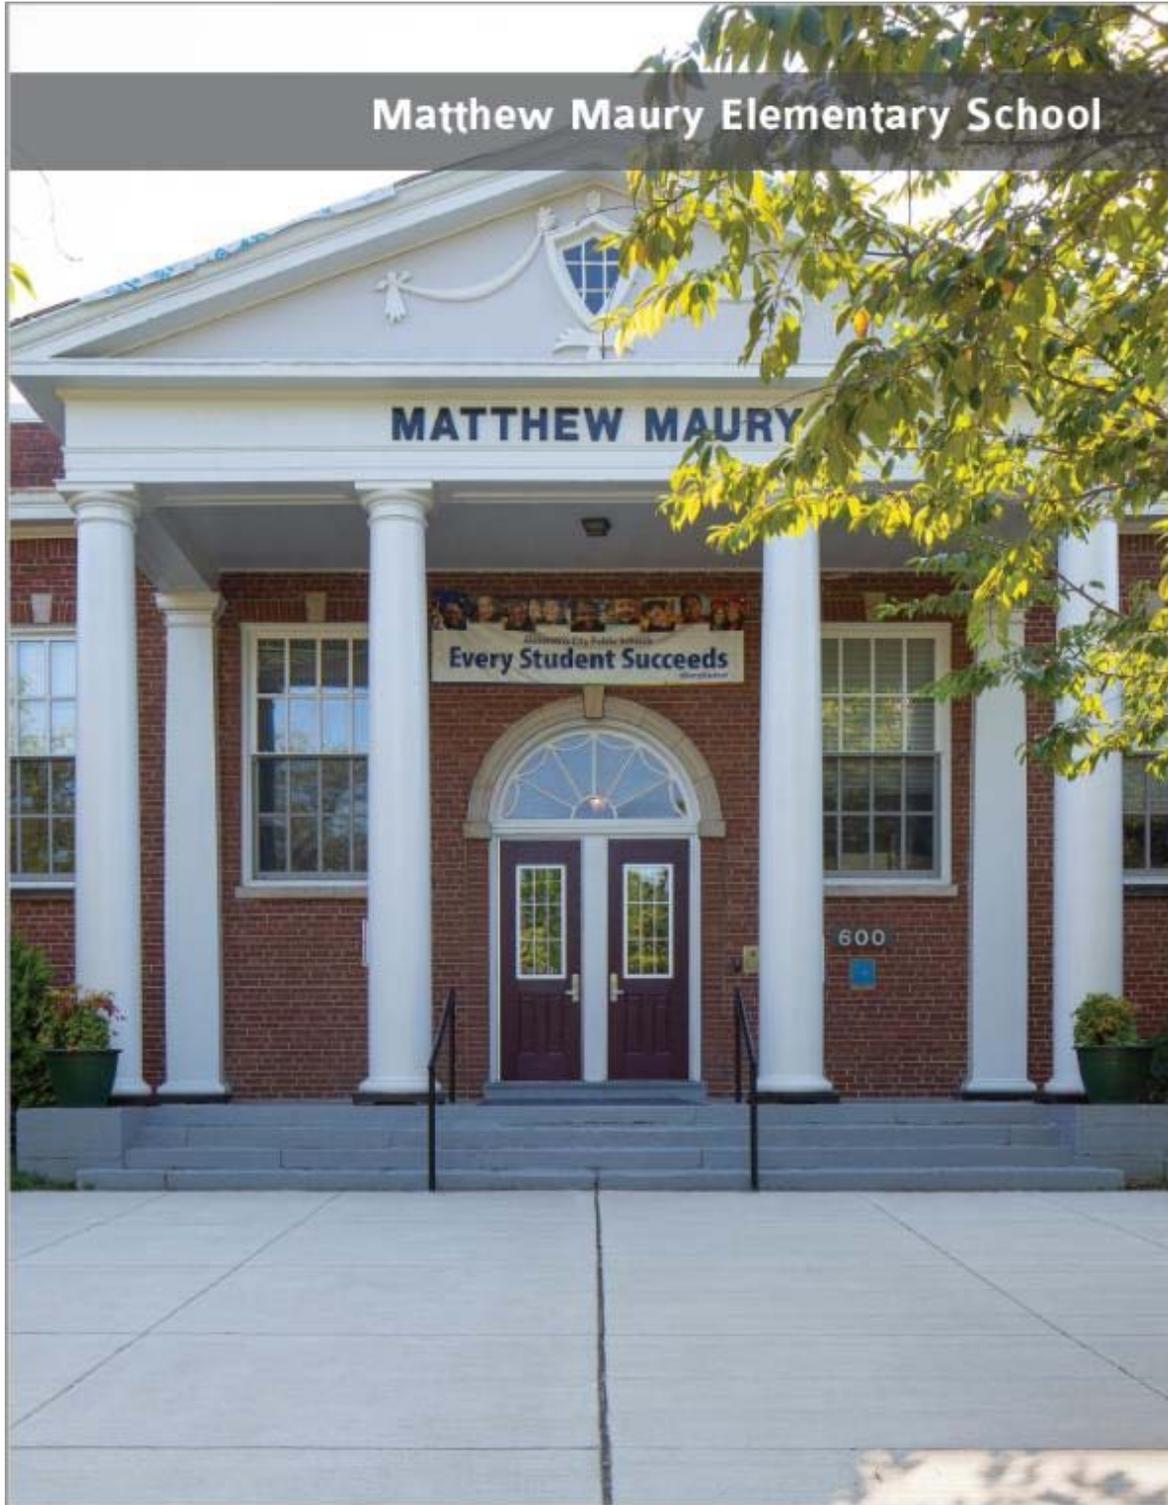
## A. FACILITY DESCRIPTION

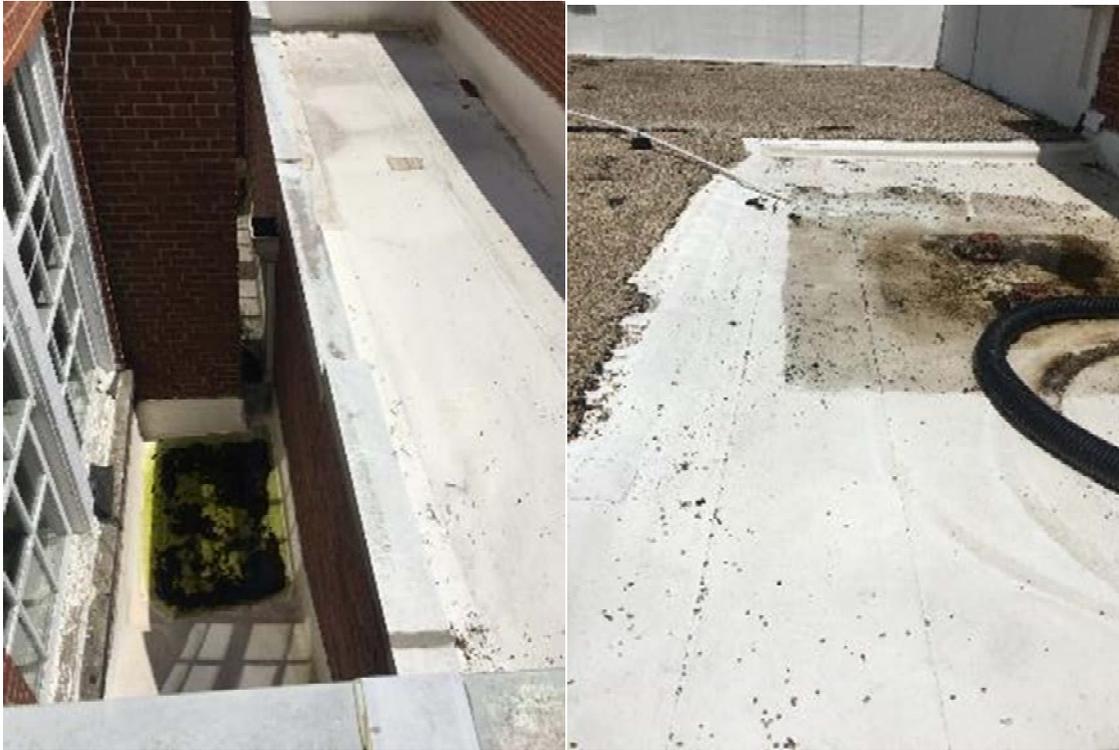
Figure 1: Roof leaks

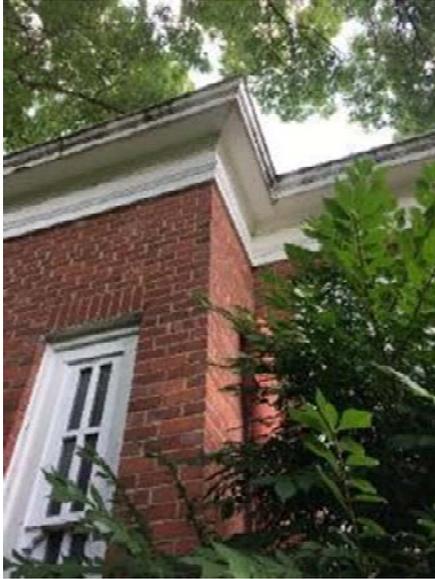
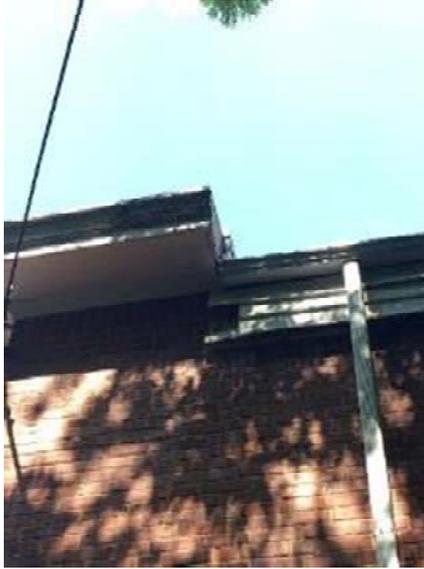
Figure 2: Exterior coping

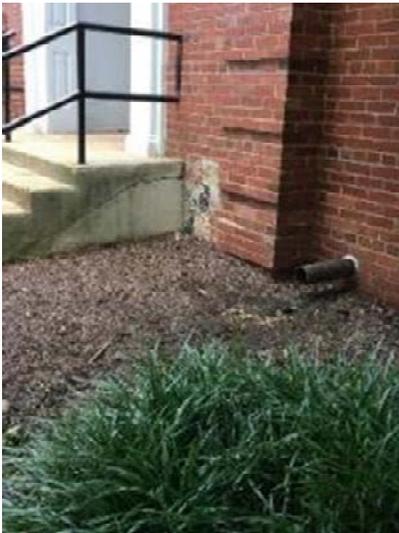
Figure 3: Crack on the entrance steps

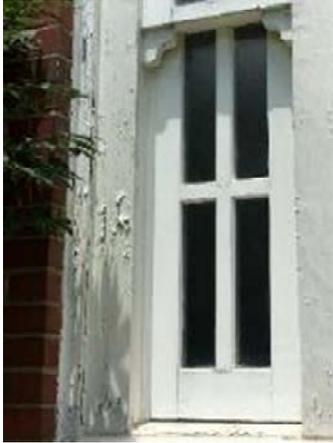
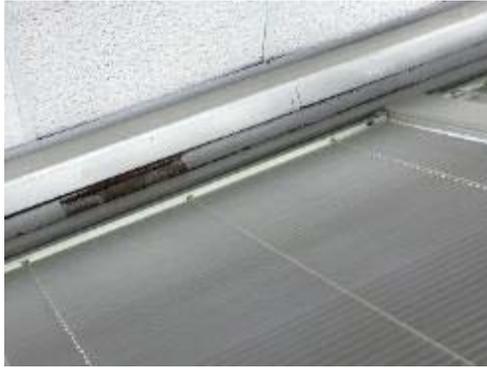
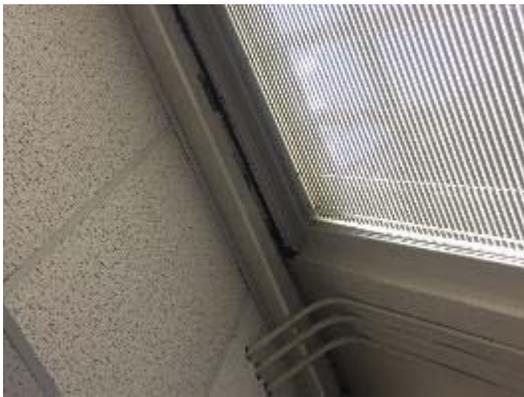
Figure 4: Window frames

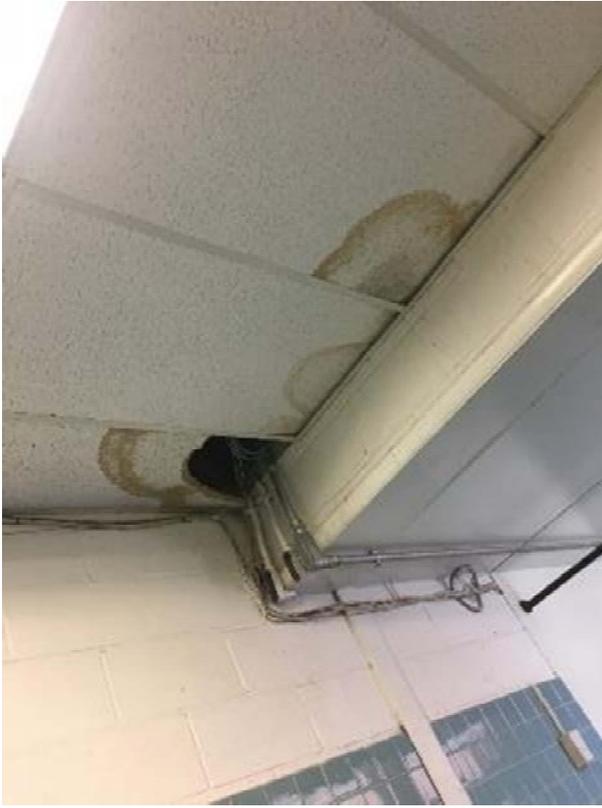
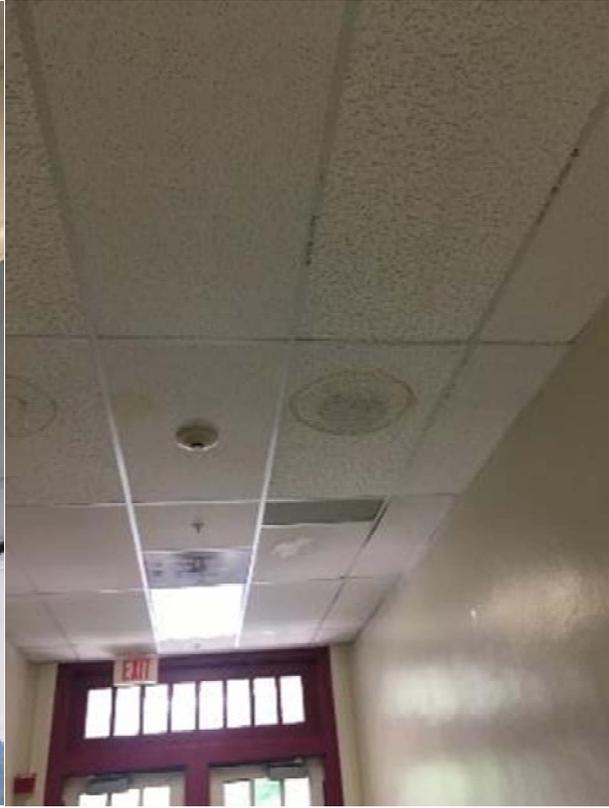
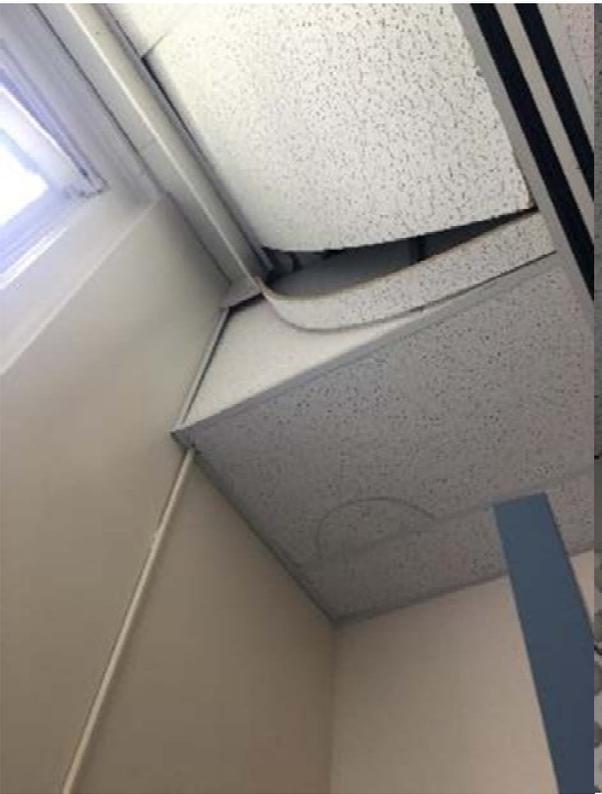
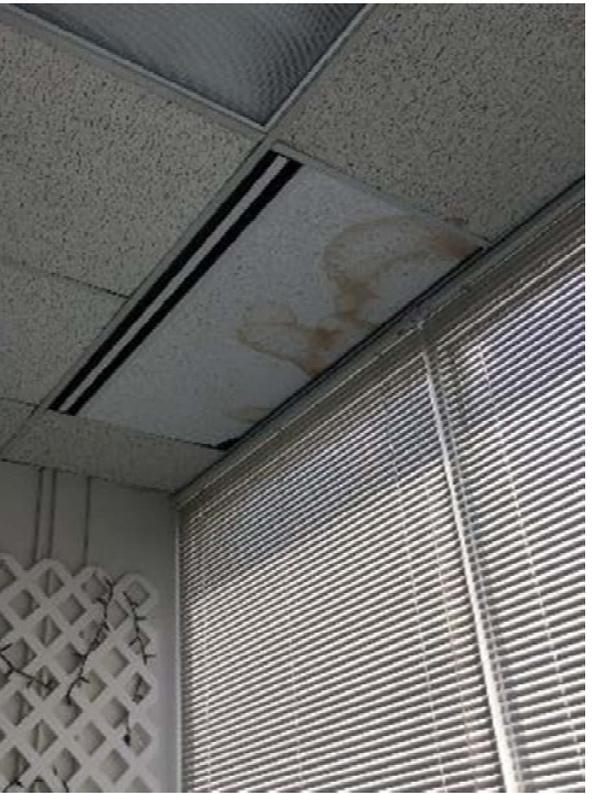
Figure 5: Ceiling stains

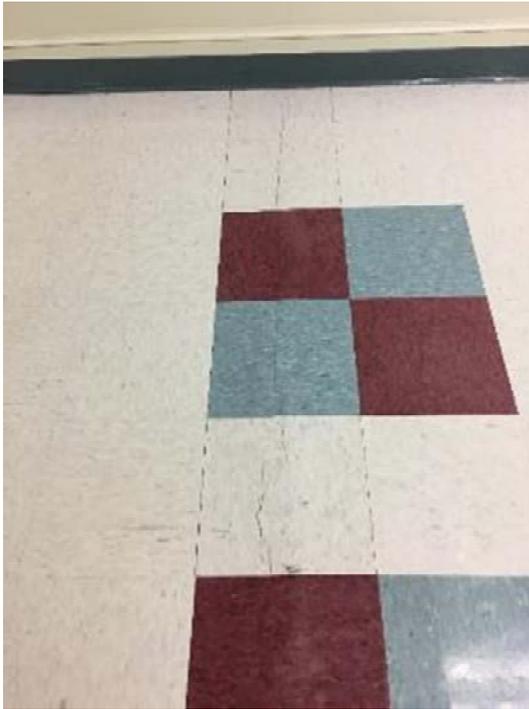
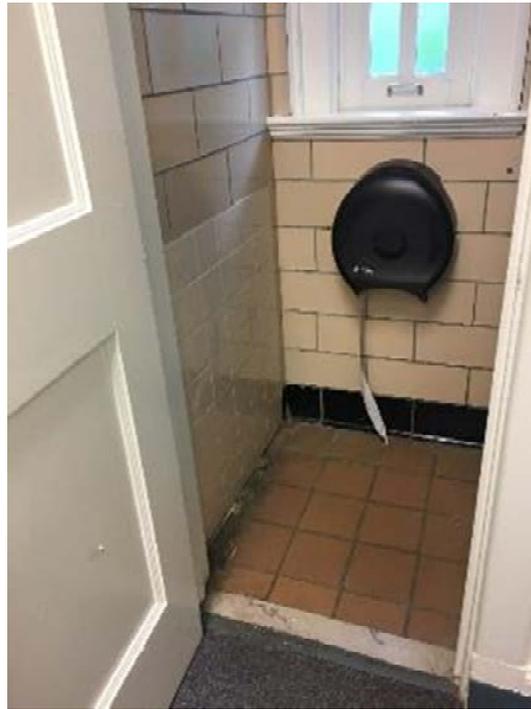
Figure 6: Cracked floor

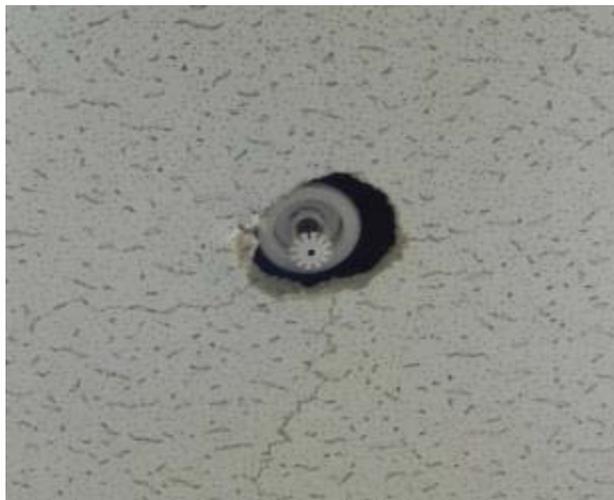
Figure 12: Sprinkler improperly installed above ceiling tile

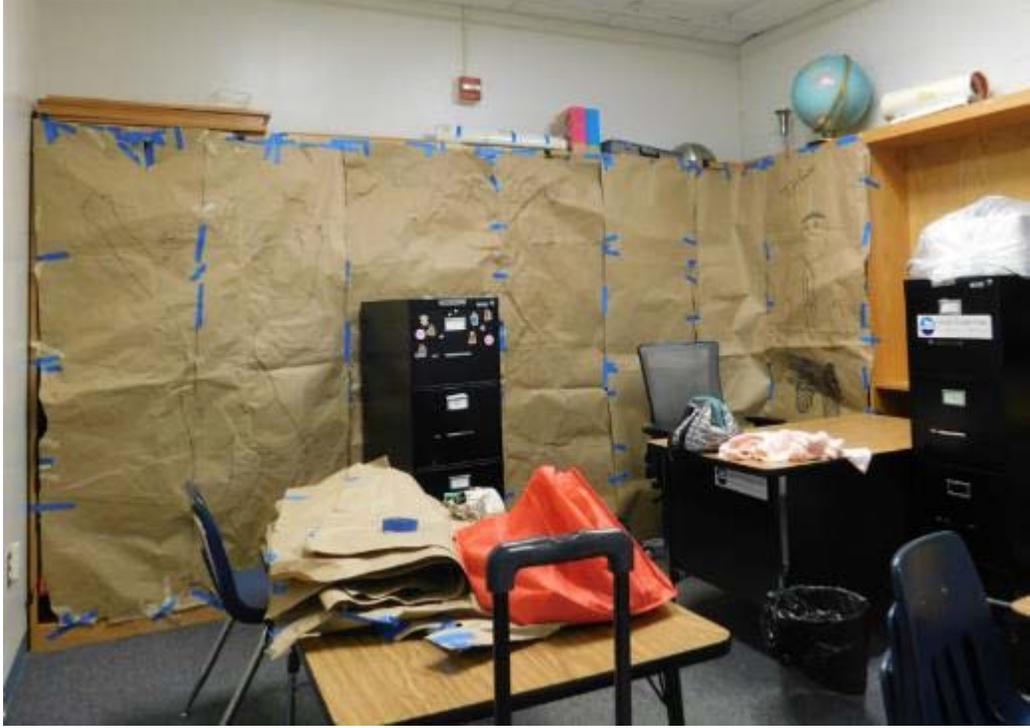
Figure 13: Kraft paper covering shelves

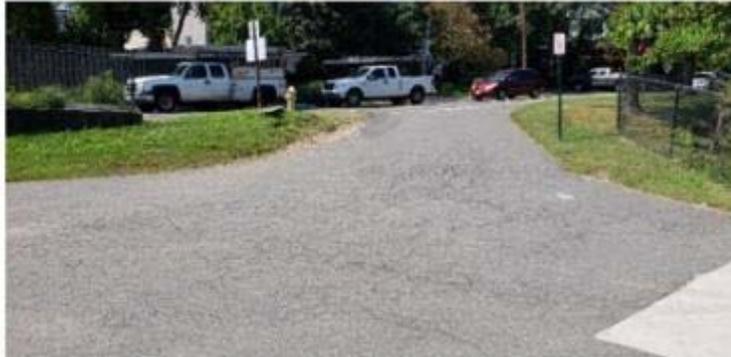
Figure 16: Vehicular pavement surface cracking

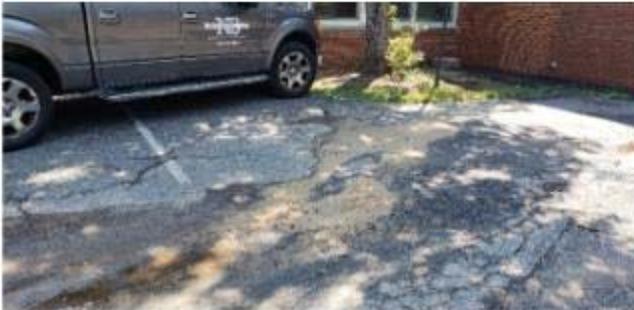
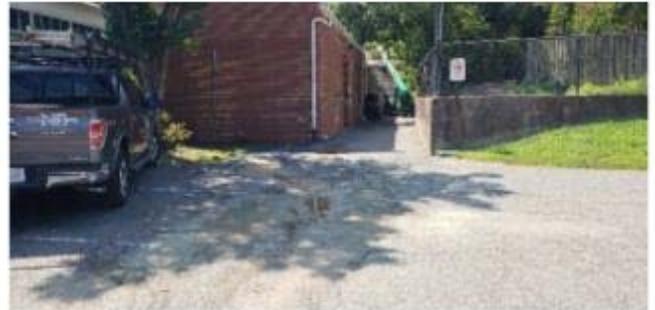
Figure 17: Vehicular pavement subgrade failure/substantial pavement deterioration

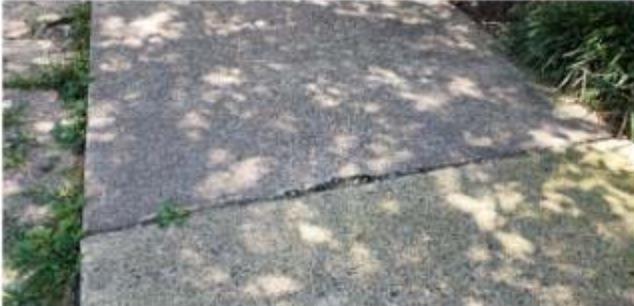
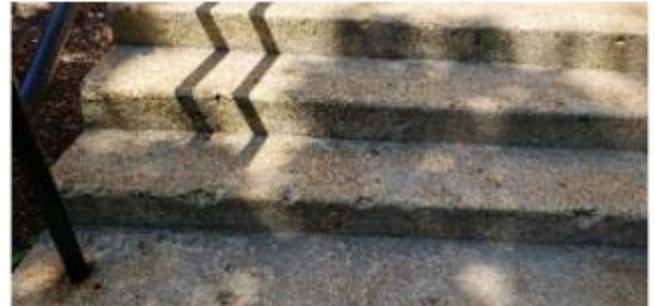
Figure 18: Cracked/deteriorating concrete sidewalk panels and concrete steps

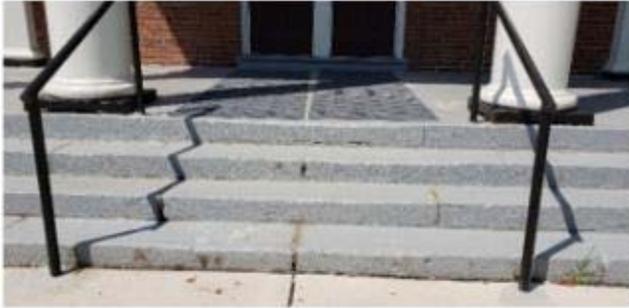
Figure 19: Worn non-slip/sealant coat on masonry steps

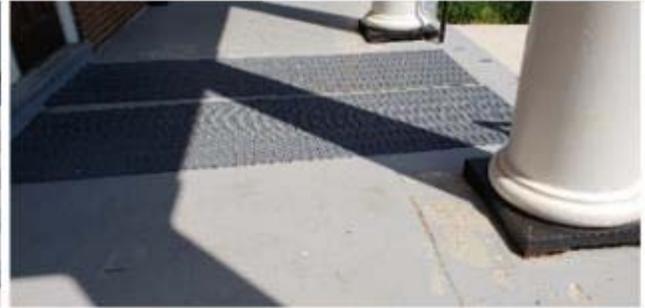
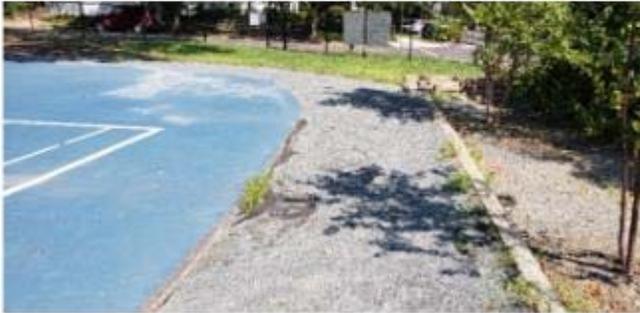
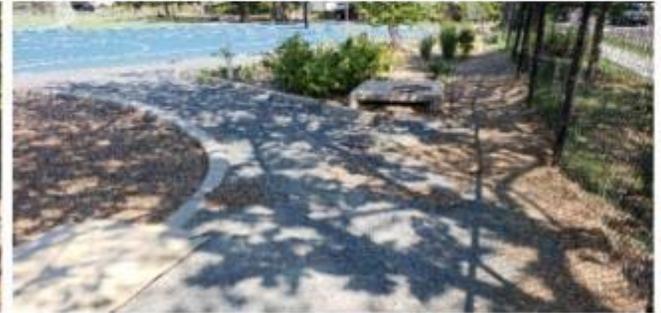
Figure 20: Stone aggregate walkway (additional stone required)
