**ALEXANDRIA CITY  
PUBLIC SCHOOLS**

## ALEXANDRIA CITY PUBLIC SCHOOLS COMPREHENSIVE CONDITION AUDITS

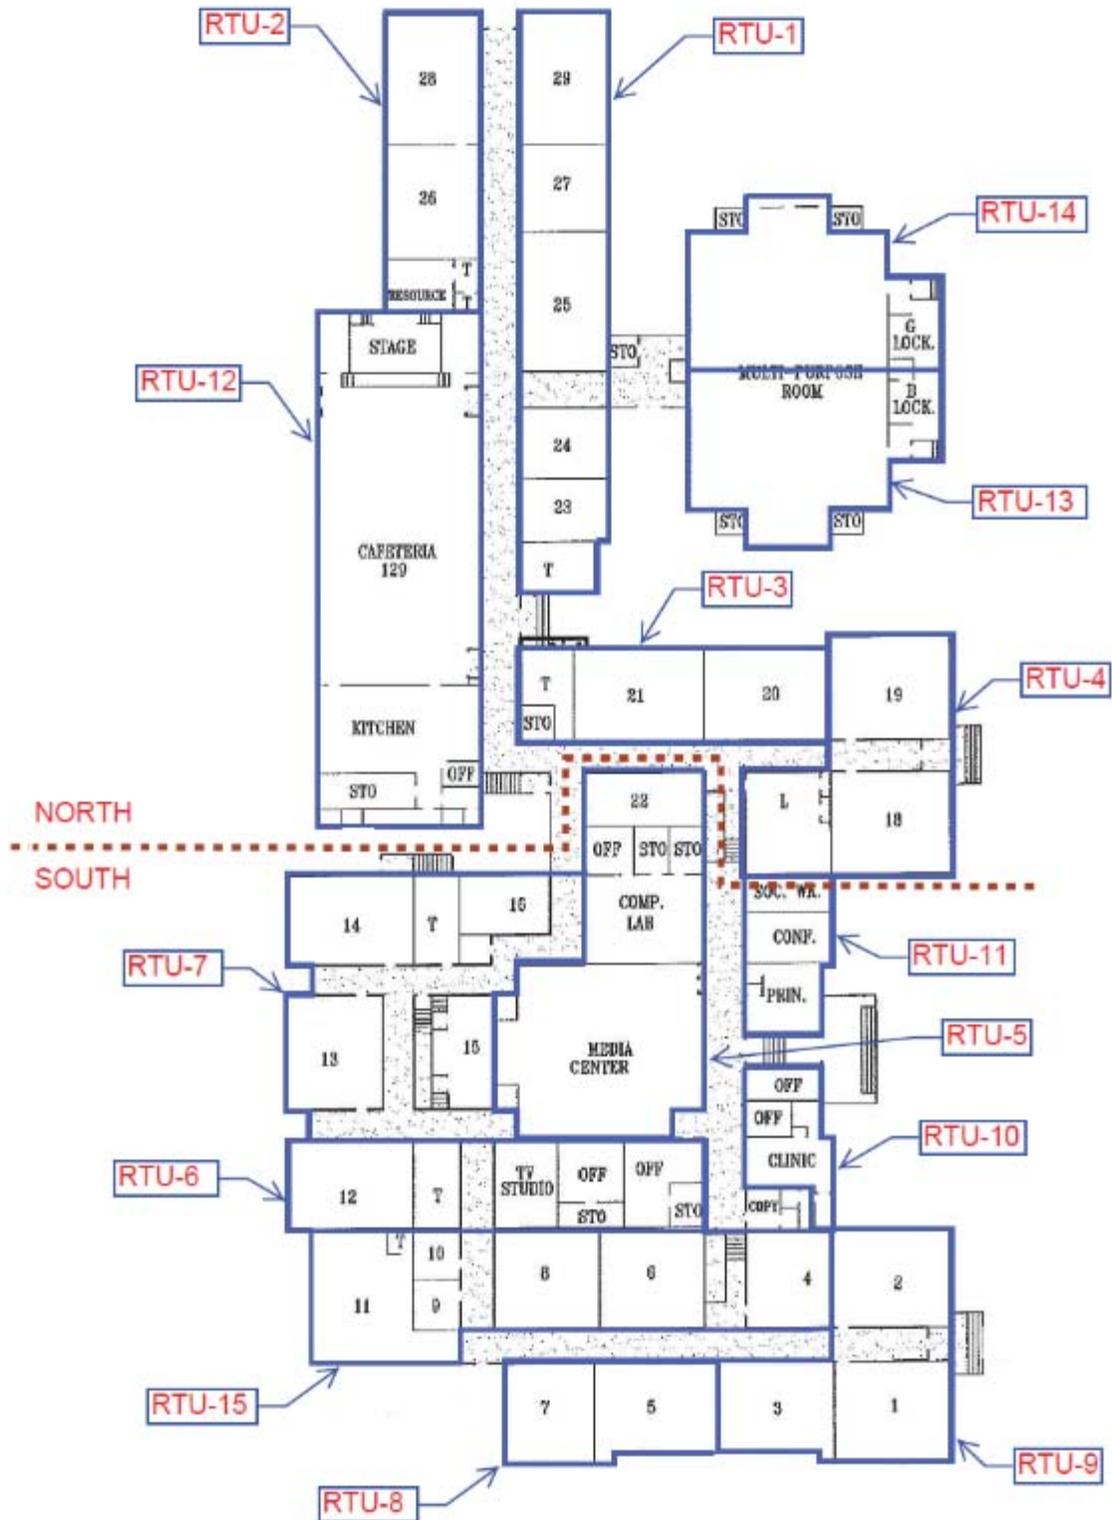
**FLOOR PLAN DIAGRAM**

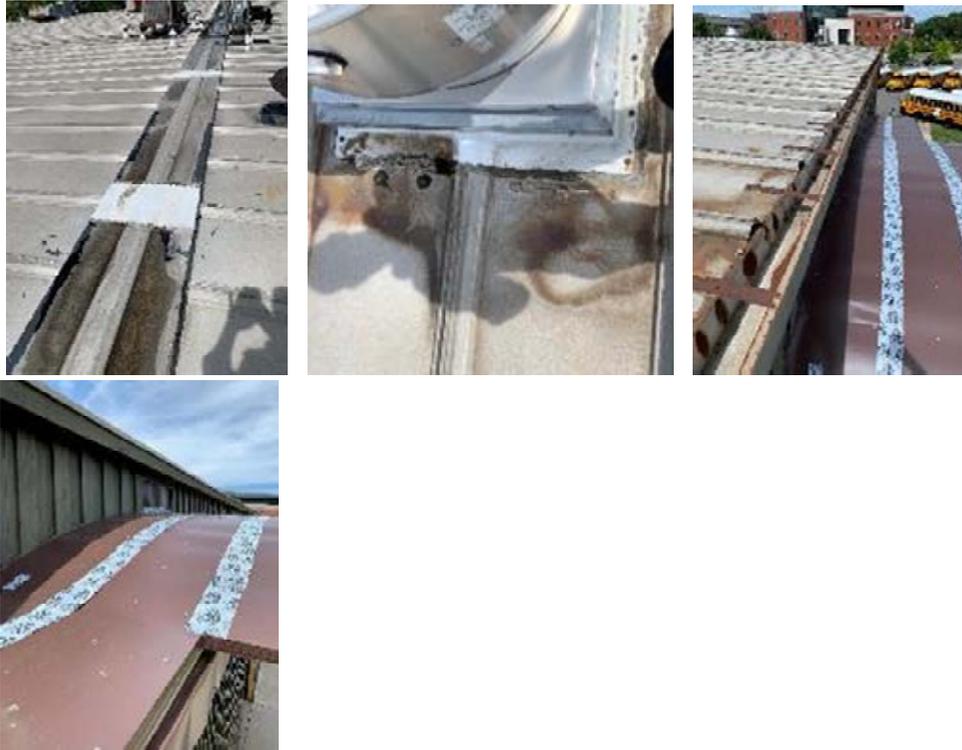
Figure 1. Roof – Leaks, corroded seams and surfaces, gutter detail and incomplete canopy

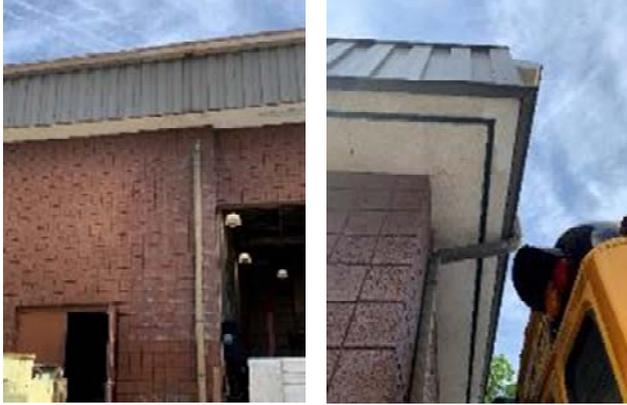
Figure 2. Exterior water damage due to roof drainage failures

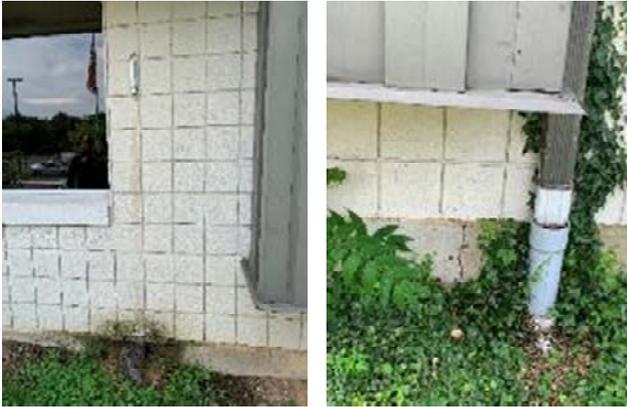
Figure 3: Examples of water infiltration and subsurface breaches in exterior enclosure

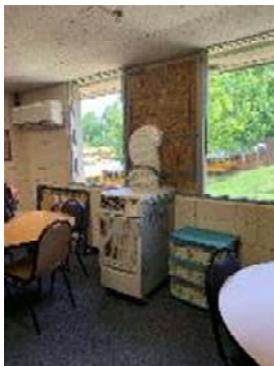
Figure 4: Patchwork measures to correct HVAC inadequacies

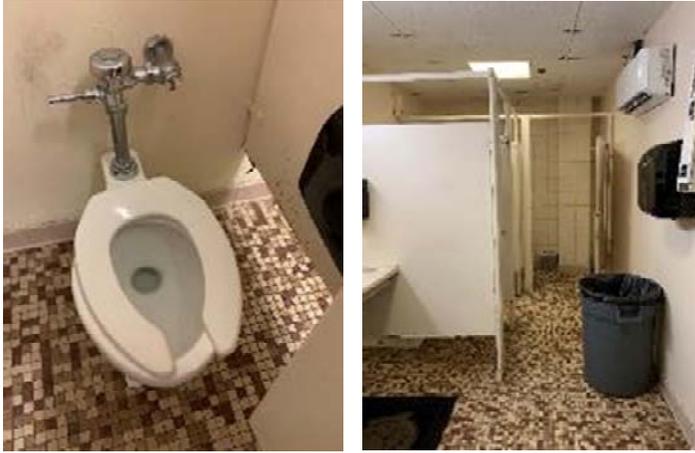
*Figure 5: Women's Bathroom – Examples of water damage from leaks*

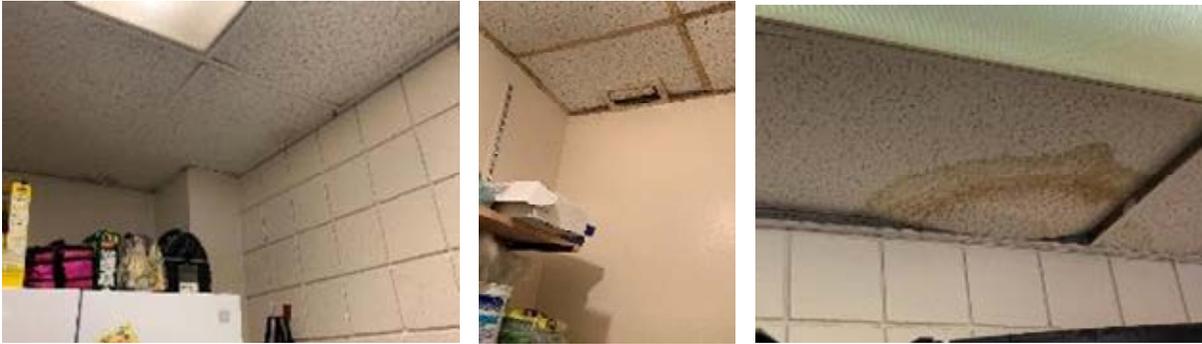
*Figure 6: Examples of roof leaks and damaged ceiling tiles throughout upper level*

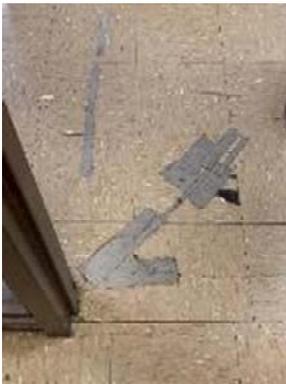
*Figure 7: Entry area - Damaged floor tiles*

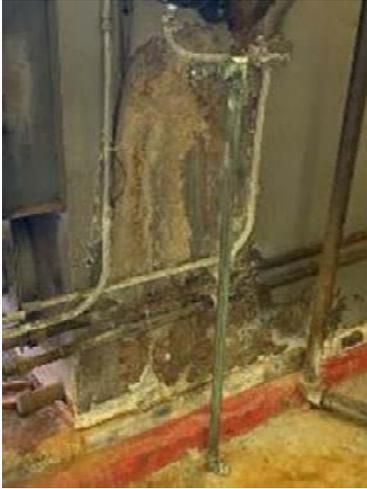
Figure 8: Example of ground water infiltration in utility and bus bays

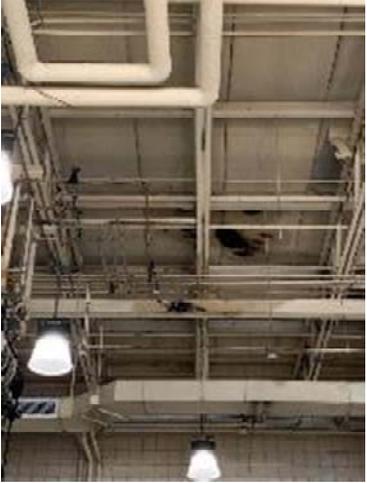
Figure 9: Example of leaks prevalent in high bus bays

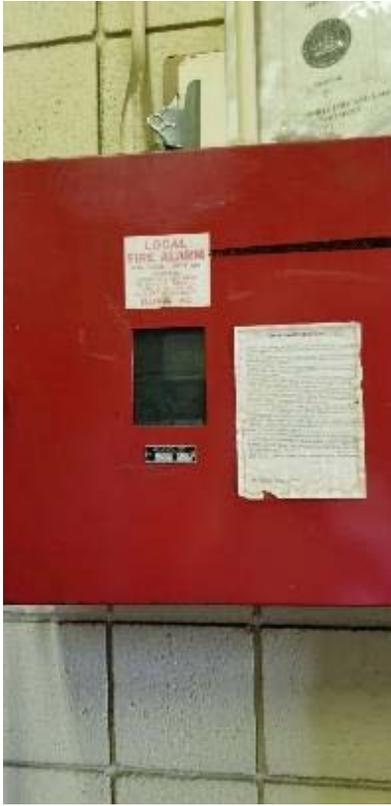
Figure 10: Fire Alarm Control Panel – Local Alarm Only

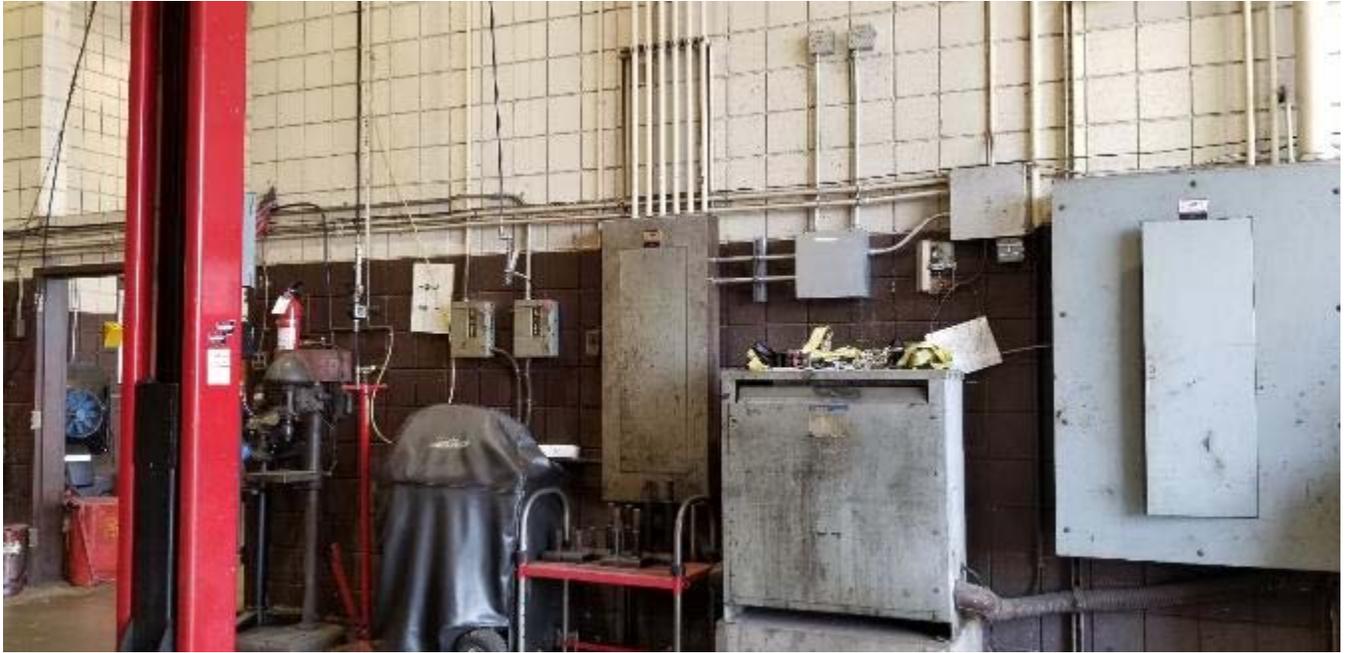
Figure 12: Panelboards and Transformer Exposed to Deteriorating Elements and Being Obstructed by Storage

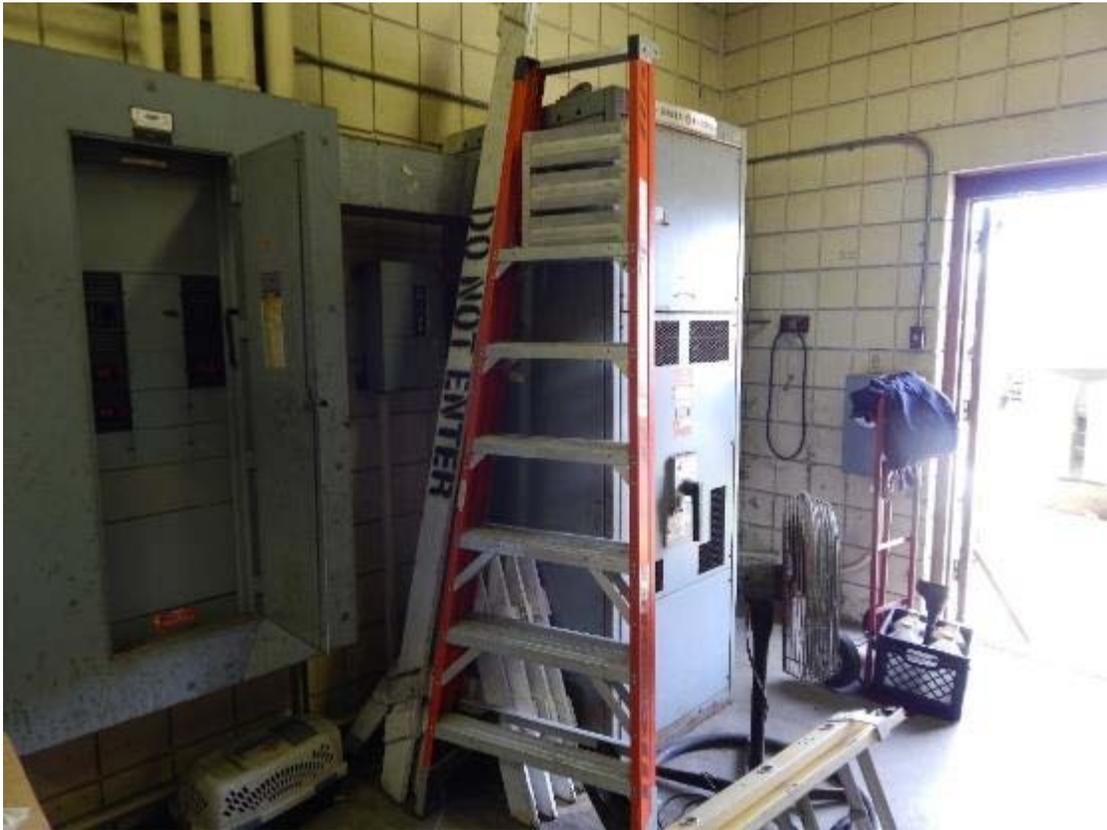
Figure 13: Panelboards and Switchboard Being Obstructed by Storage

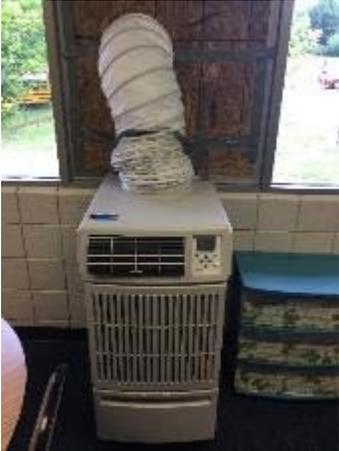
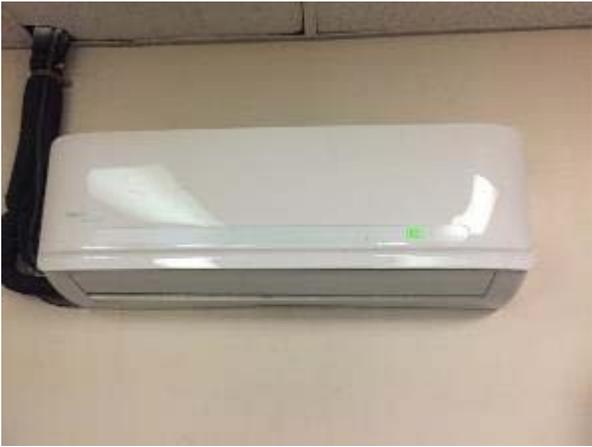
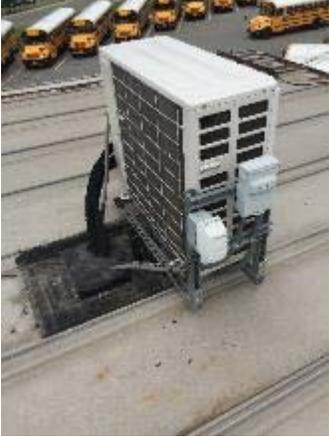
Figure 15: SPOT COOLER

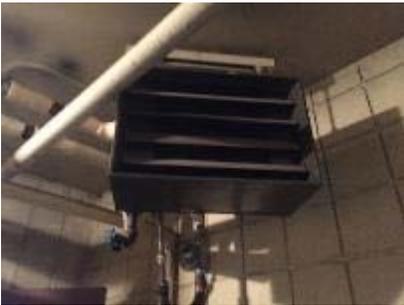
Figure 17: UNIT HEATER

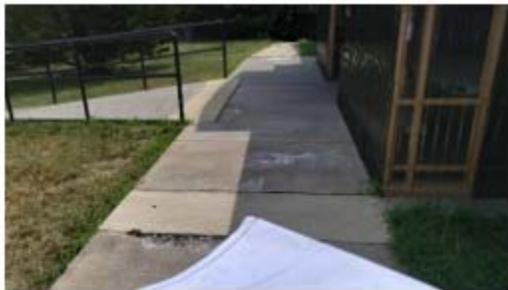
Figure 23: Southwest panel failure

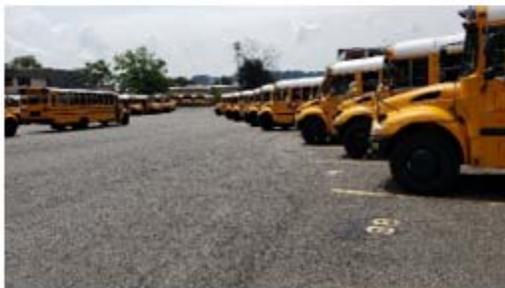
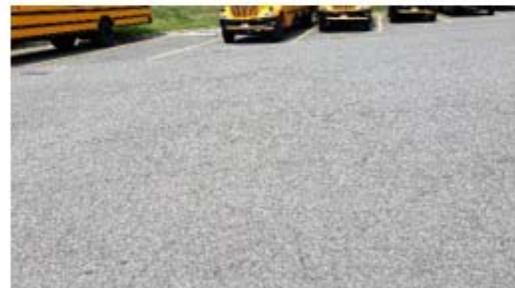
Figure 24: Bus parking areas

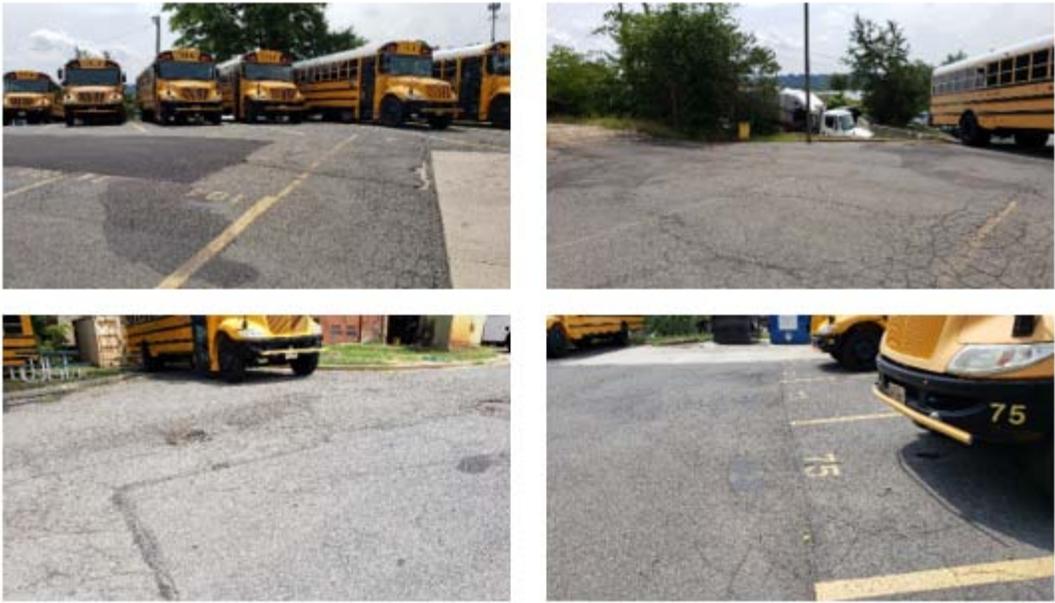
Figure 25: South parking area pavement deterioration

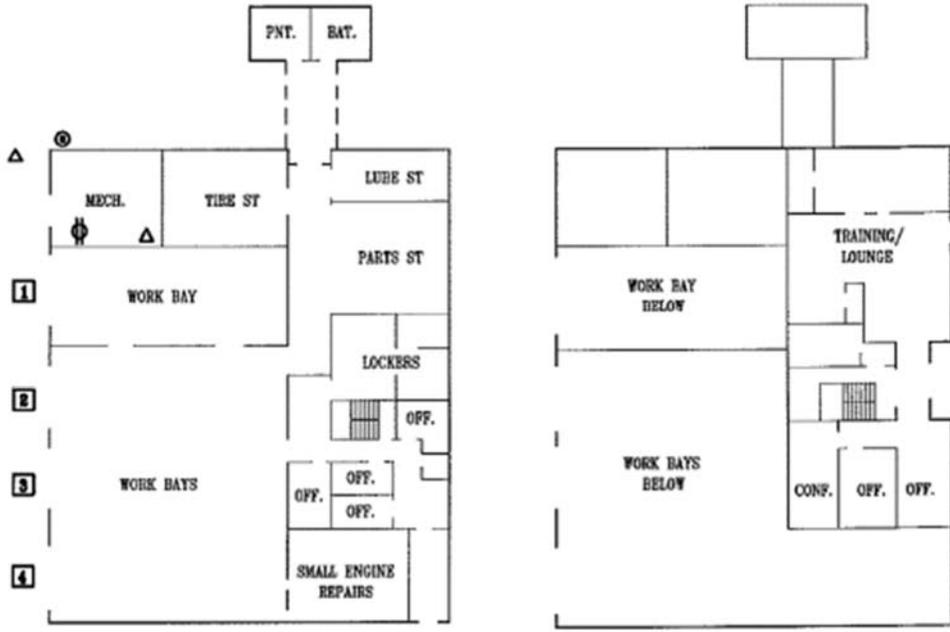
**FLOOR PLAN DIAGRAMS**

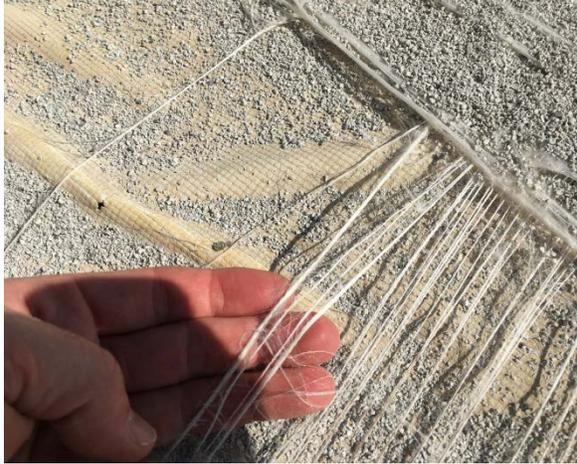
R-1 Deteriorated roof membrane.

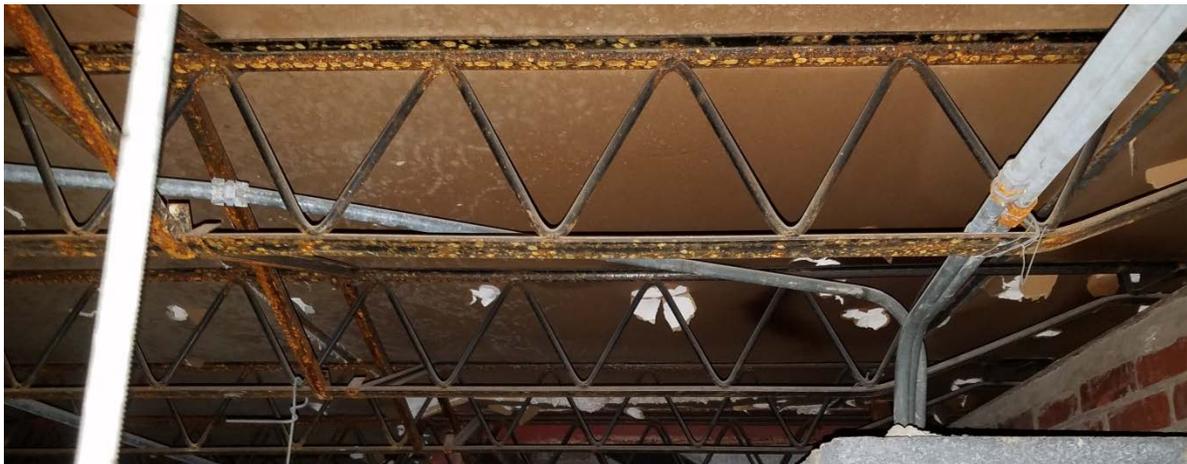
High levels of humidity and condensation.

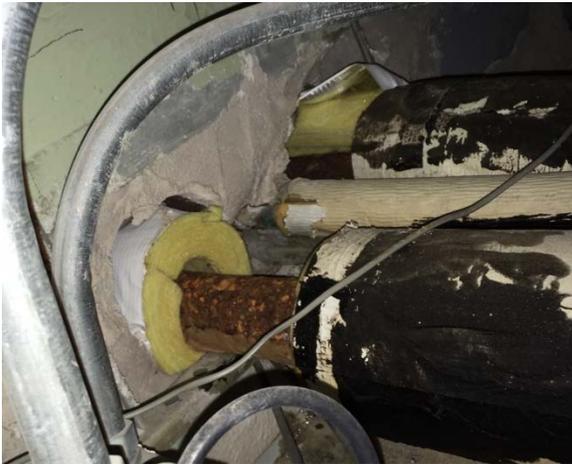
H-1 Deteriorated insulation on HVAC piping.

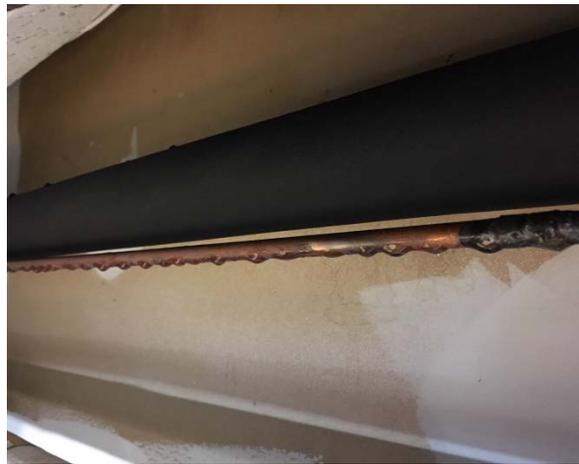
H-2 No insulation on refrigerant piping- condensation.

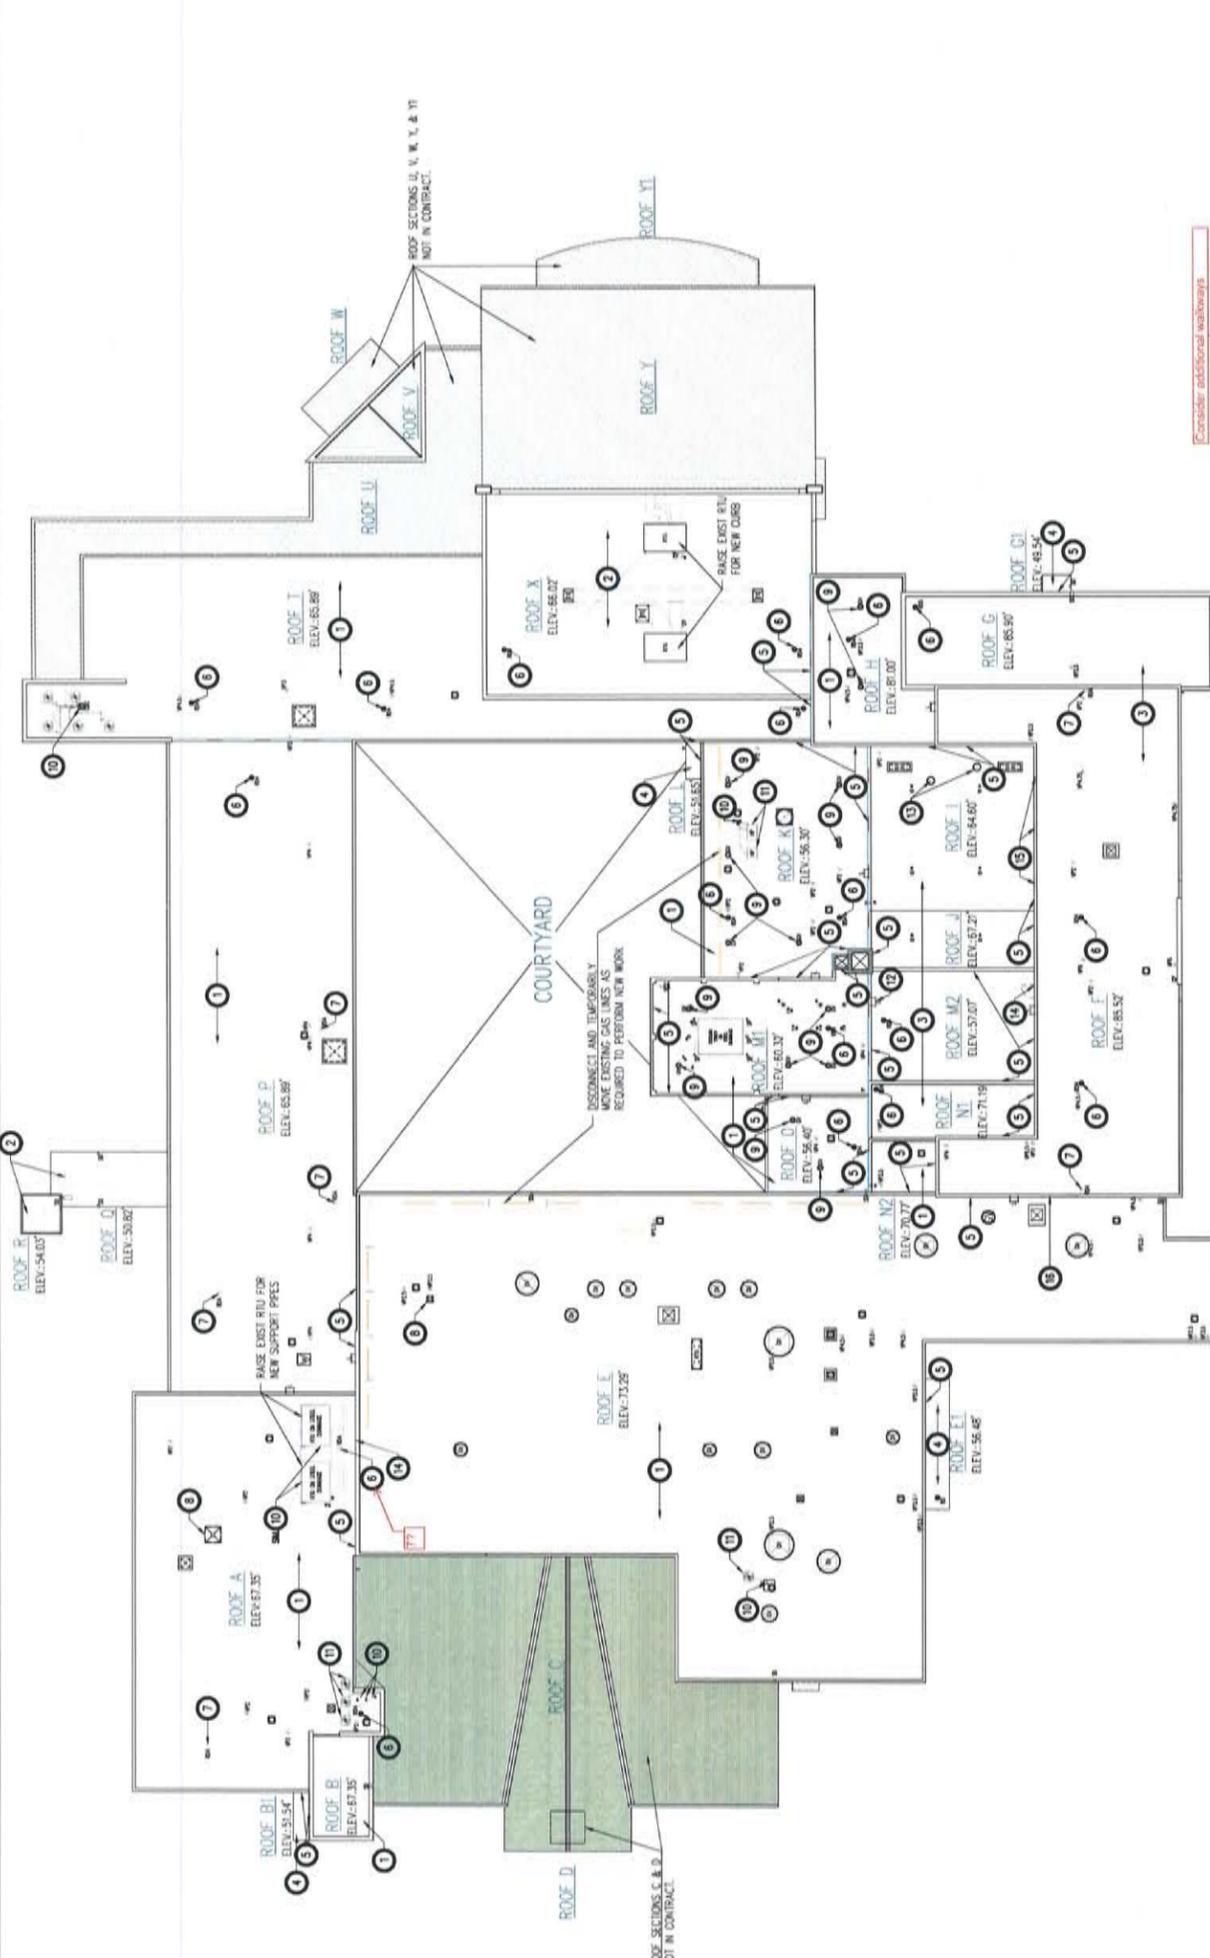
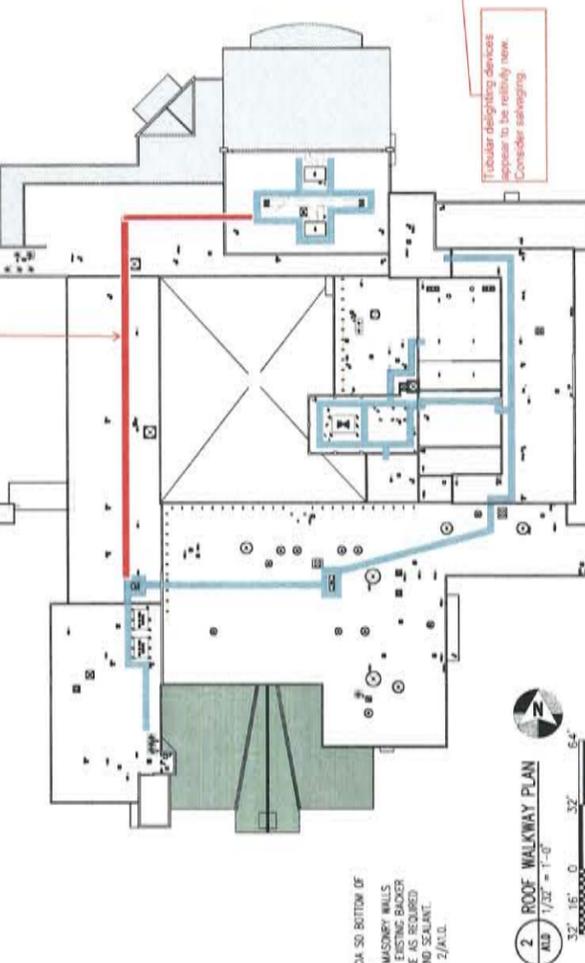
- ### GENERAL CONSTRUCTION NOTES
- CONTRACTOR SHALL FABRICATE METAL COPINGS ON FASCIA SO BOTTOM OF METAL IS 1-INCH BELOW BOTTOM OF COPING BED JOIN.
  - REPLACE ALL EXISTING SEALANT IN CONTROL JOINTS OF MASONRY WALLS WITH POLYURETHANE SEALANT FOR EXTERIOR WALLS AND SILICONE SEALANT FOR INTERIOR WALLS. REMOVE ALL SEALANT TO REMOVE ALL SEALANT. INSTALL NEW BACKER ROD AND SEALANT.
  - INSTALL WALKWAYS AS SHOWN ON ROOF WALKWAY PLAN 2/A1.0.

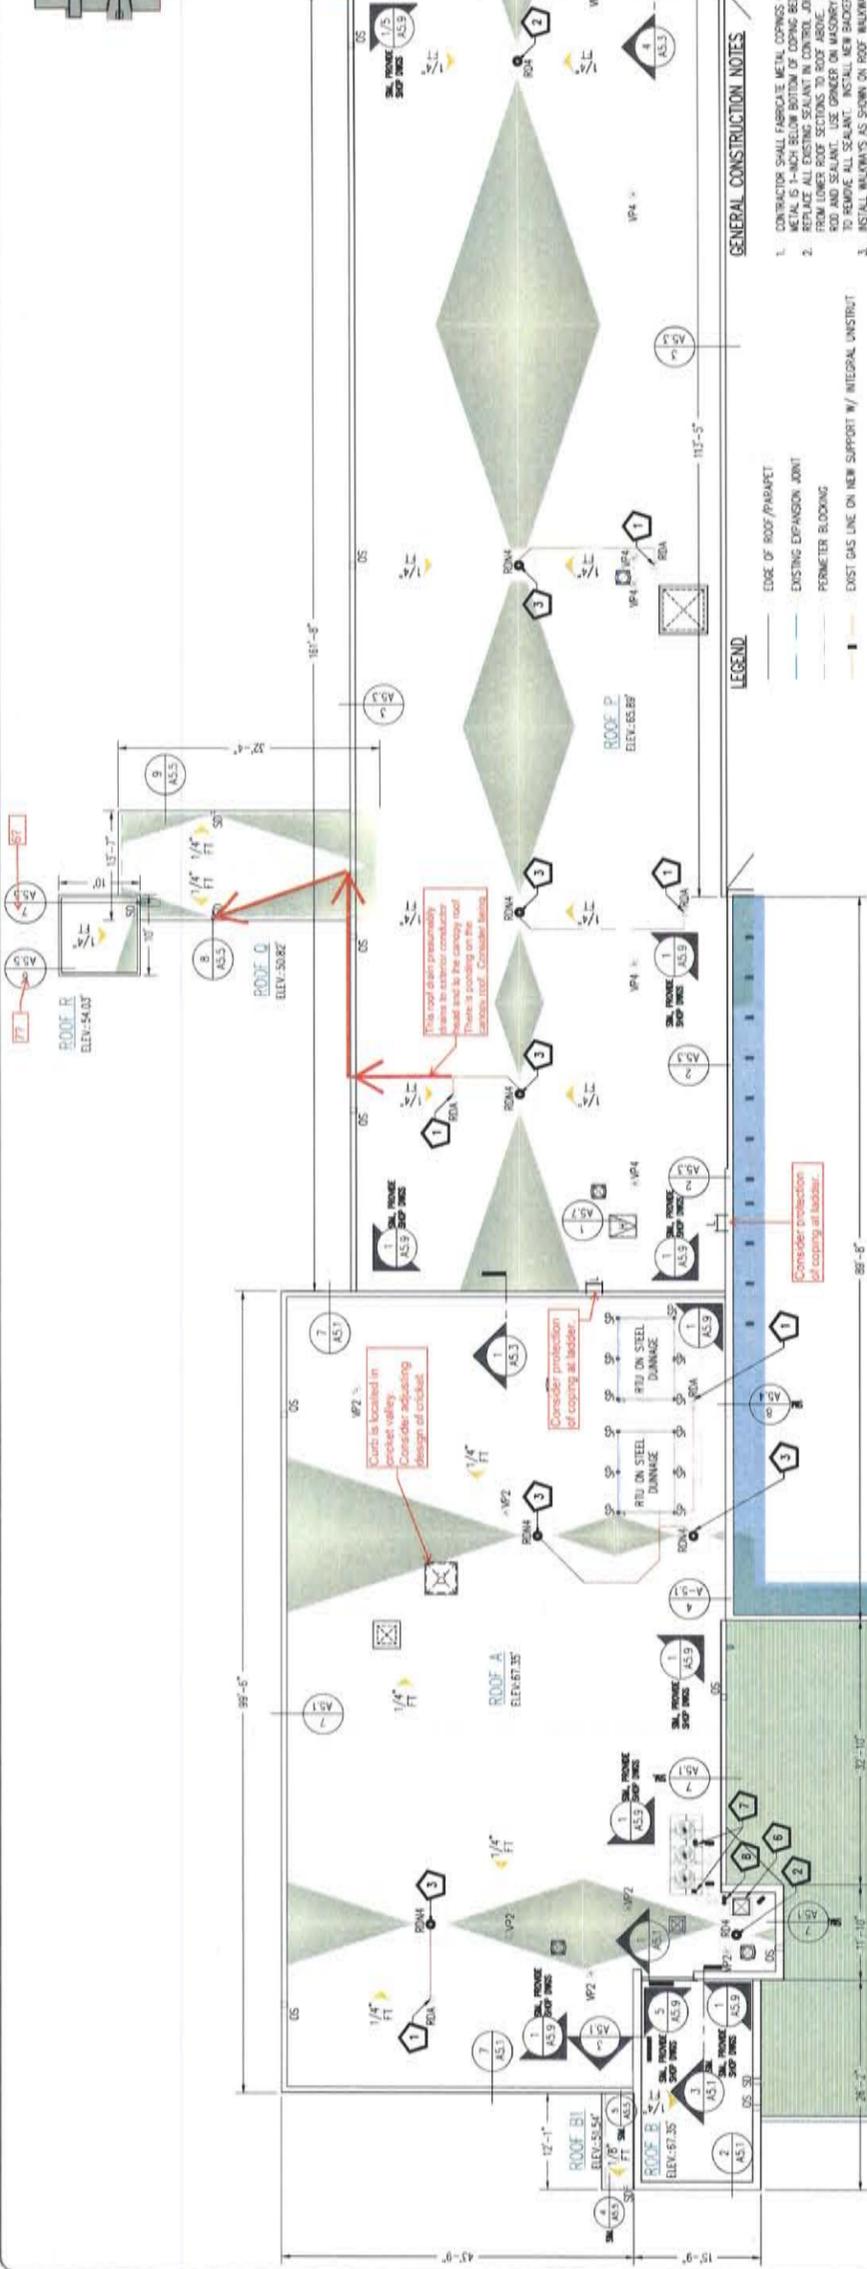
- GENERAL CONSTRUCTION NOTES**
- CONTRACTOR SHALL FABRICATE METAL COSSINS ON FLASHING SO BOTTOM OF METAL IS 1/4" BELOW BOTTOM OF COPING BED JOINT.
  - REPLACE ALL EXISTING SEALANT IN CONTROL JOINTS OF MASONRY WALLS FROM LOWER ROOF SECTIONS TO ROOF ABOVE. REMOVE EXISTING BACKER ROD AND SEALANT. USE GRINDER ON MASONRY SURFACE AS REQUIRED TO REMOVE ALL SEALANT. INSTALL NEW BACKER ROD AND SEALANT.

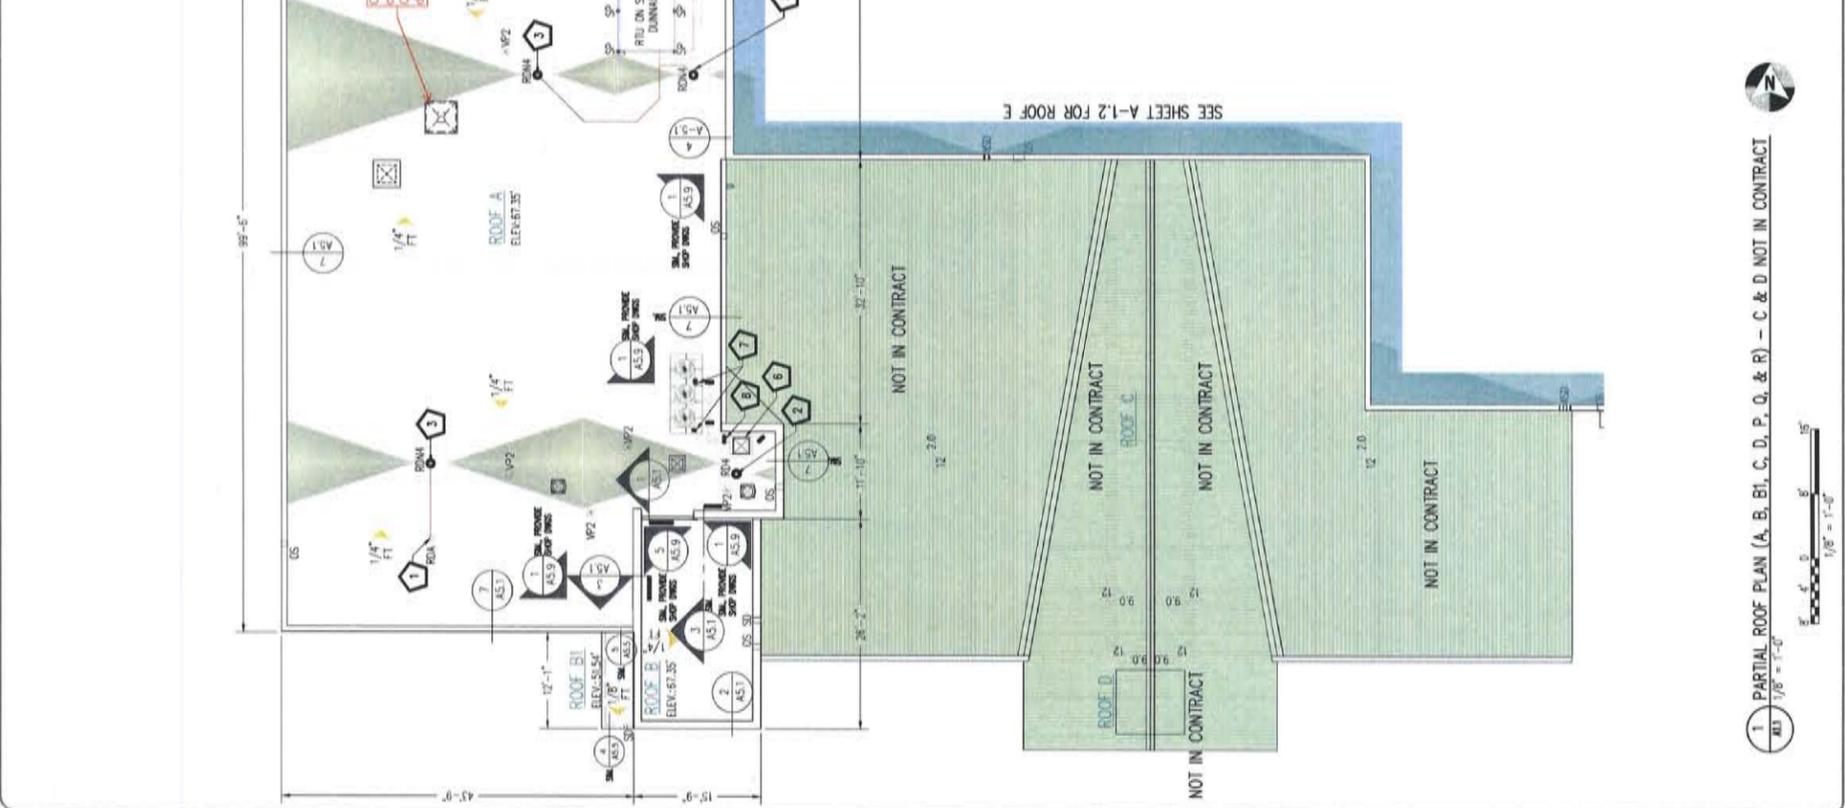
SEE SHEET A-1.1 FOR ROOF A

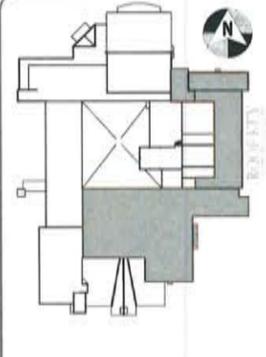
GENERAL CONSTRUCTION NOTES

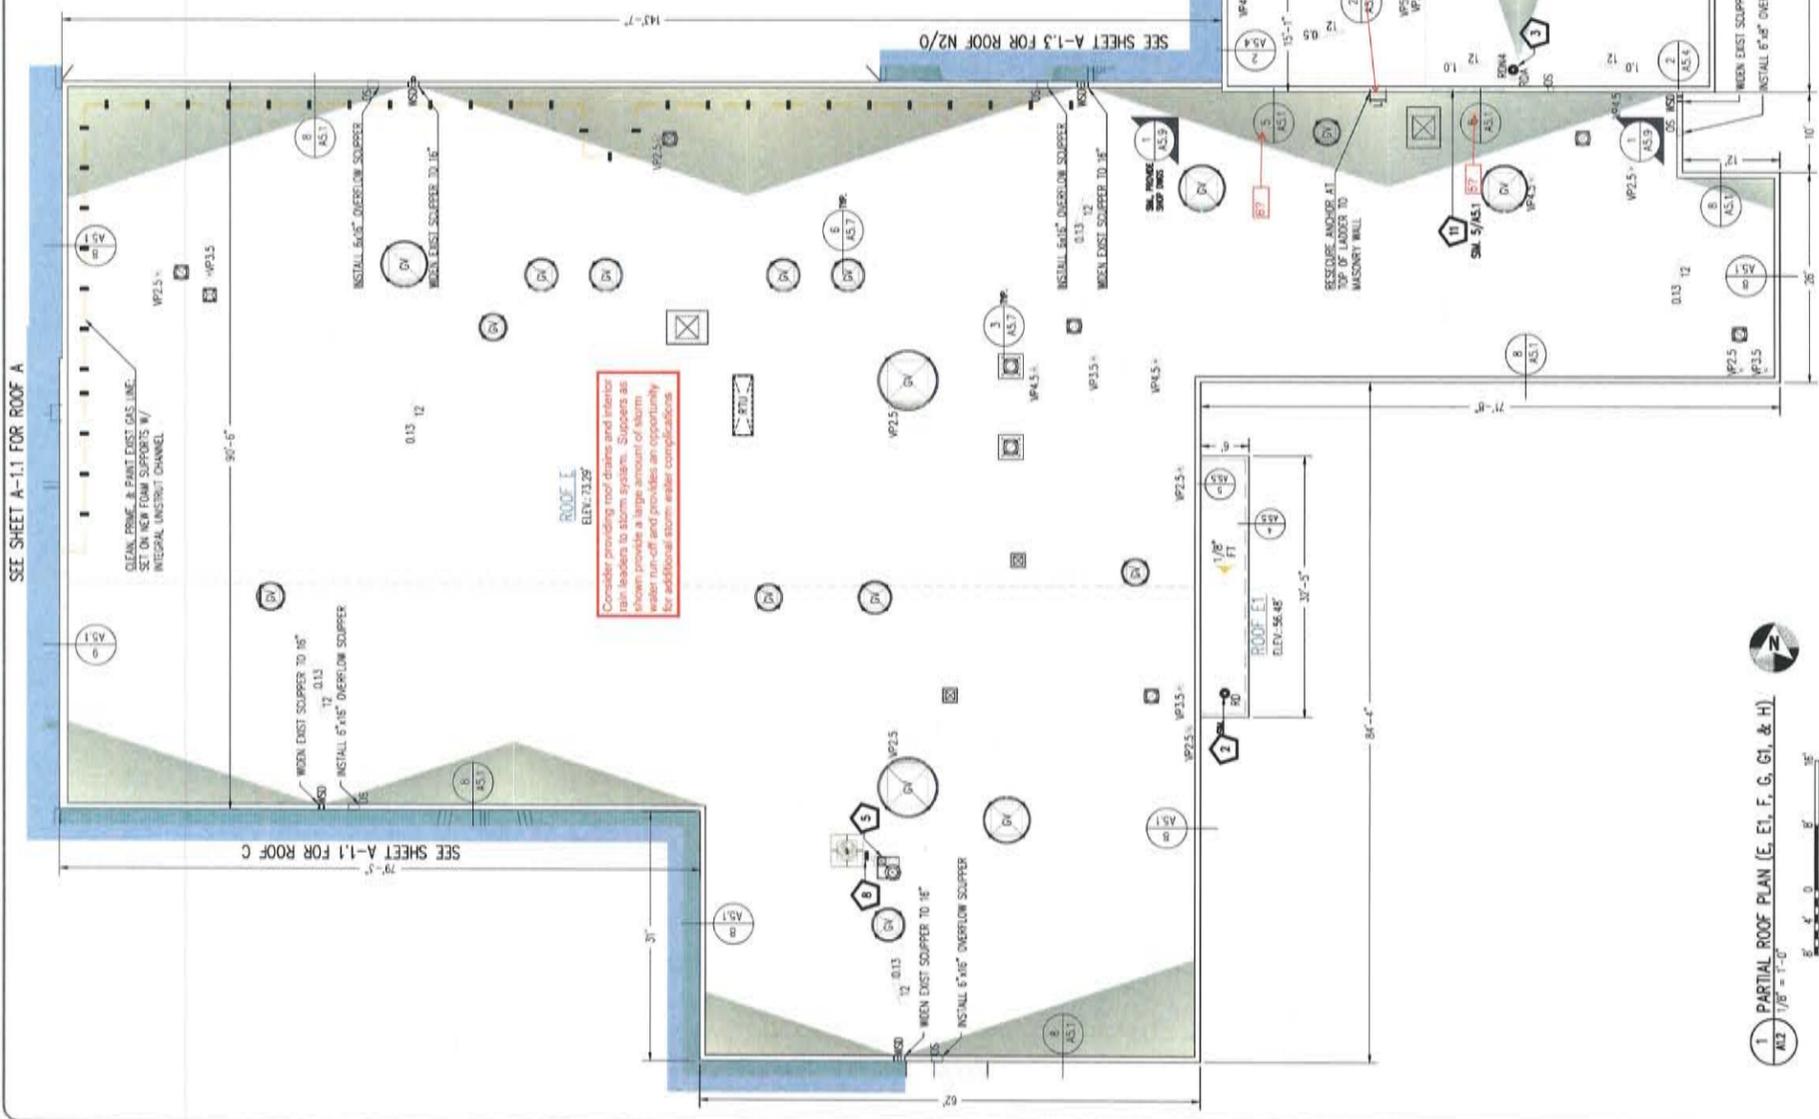
ROOF REPLACEMENT  
 MOUNT VERNON COMMUNITY SCHOOL  
 ALEXANDRIA CITY PUBLIC SCHOOLS  
 2601 COMMONWEALTH AVENUE  
 ALEXANDRIA, VIRGINIA 22305

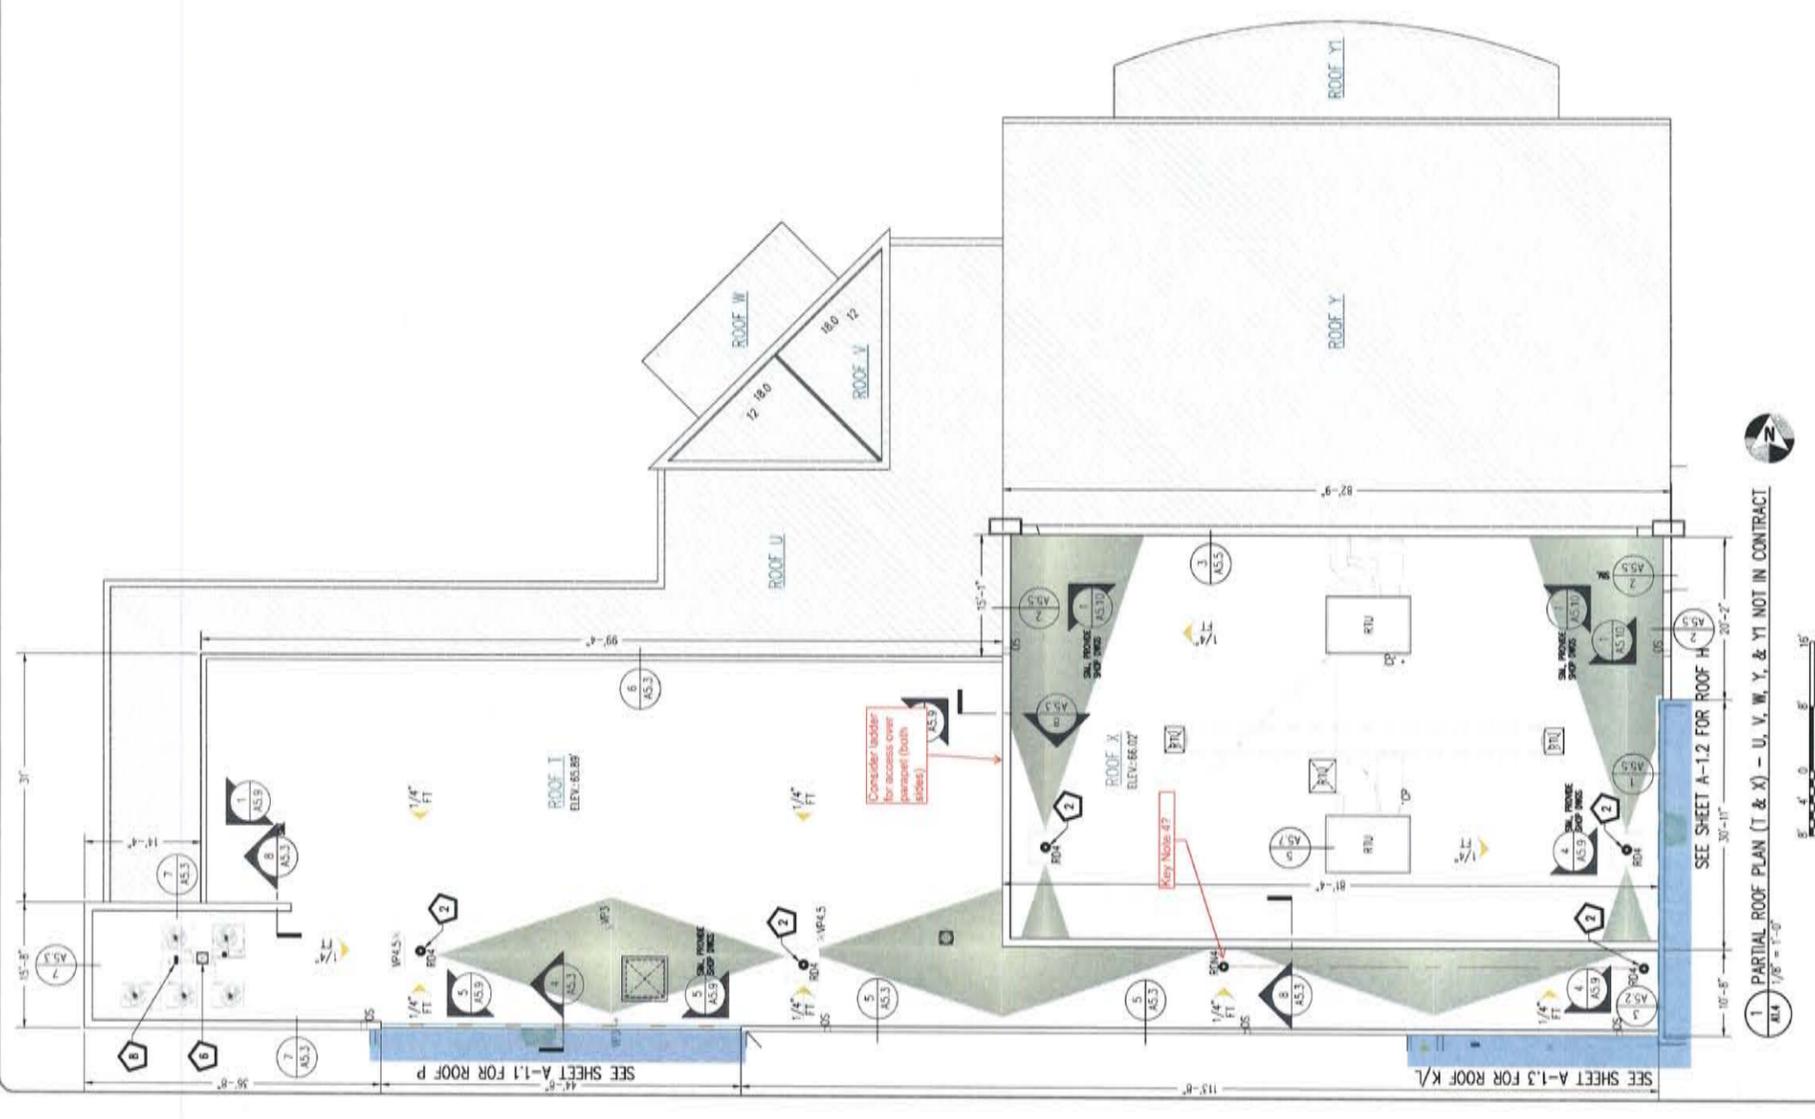
- LEGEND**
- EDGE OF ROOF/PARAPET
  - EXISTING EXPANSION JOINT
  - PERIMETER BLOCKING
  - EXIST GAS LINE ON NEW SUPPORT W/ INTEGRAL UNISTRUT
  - DECK SLOPE BOUNDARY

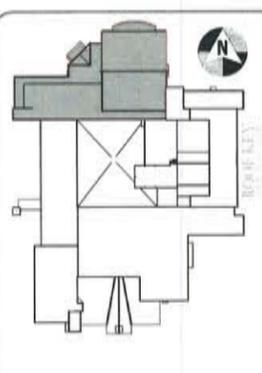
ROOF REPLACEMENT  
 MOUNT VERNON COMMUNITY SCHOOL  
 ALEXANDRIA CITY PUBLIC SCHOOLS  
 2601 COMMONWEALTH AVENUE  
 ALEXANDRIA, VIRGINIA 22305
