**ALEXANDRIA CITY  
PUBLIC SCHOOLS**

## ALEXANDRIA CITY PUBLIC SCHOOLS COMPREHENSIVE CONDITION AUDITS

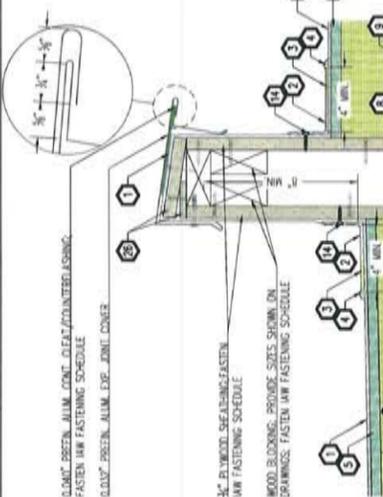
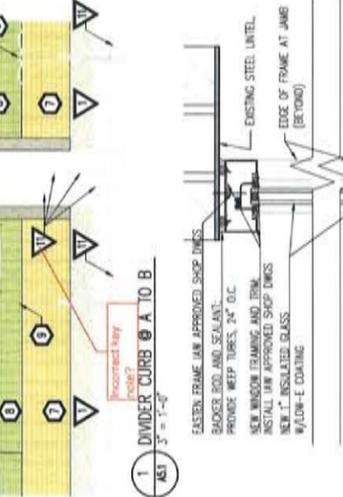
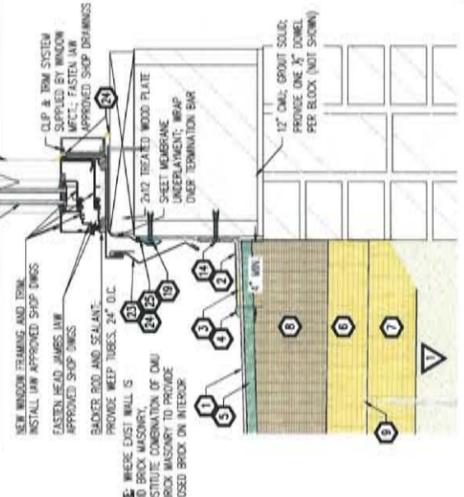
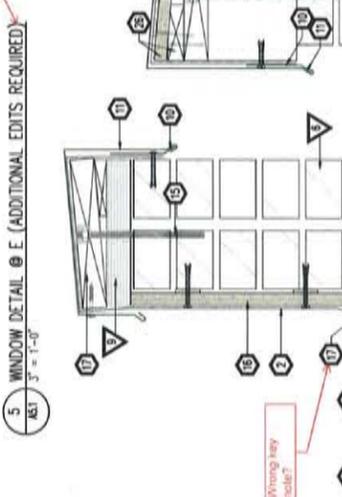
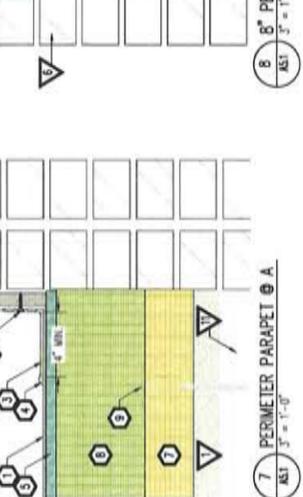
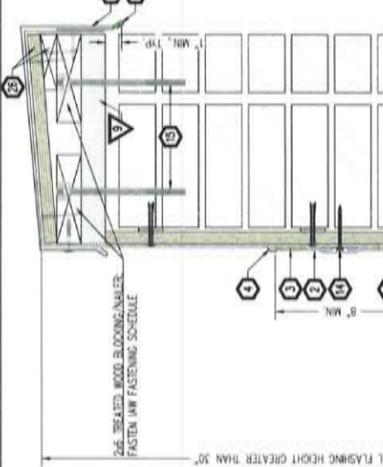
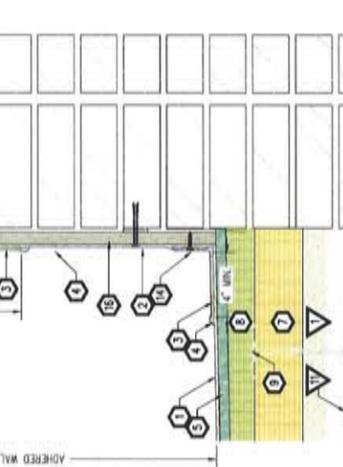
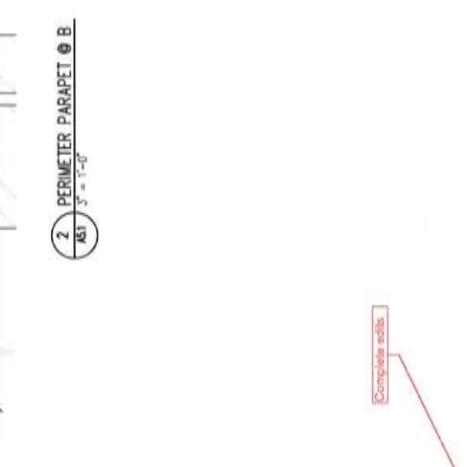
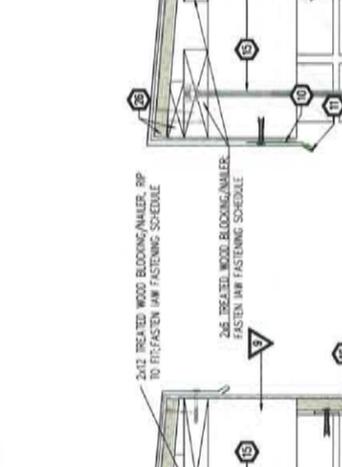
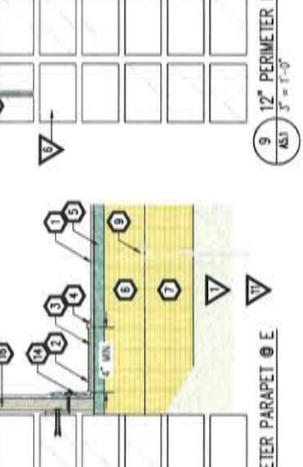
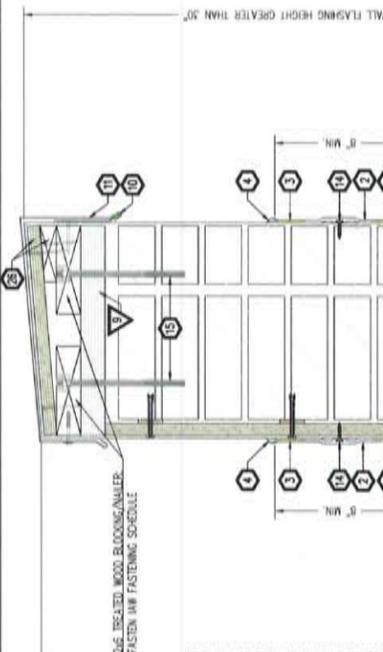
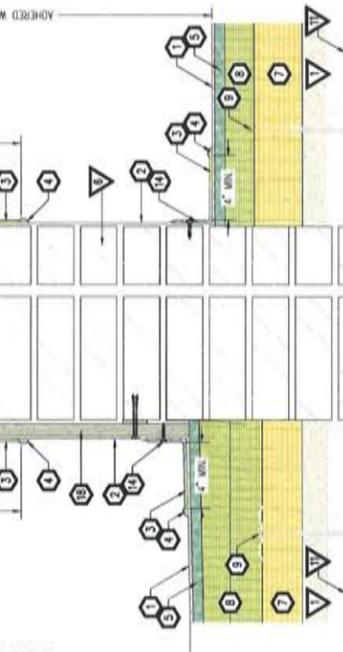
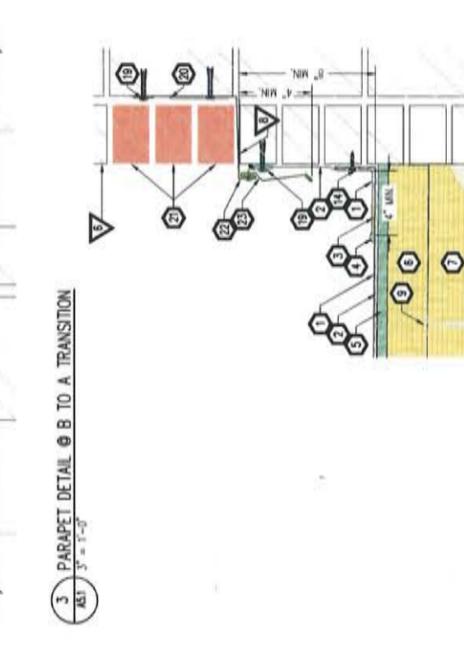
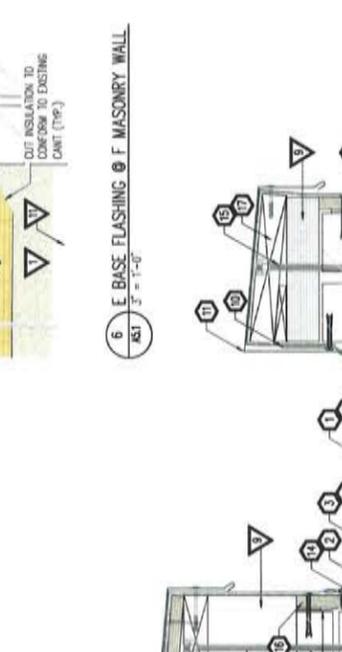
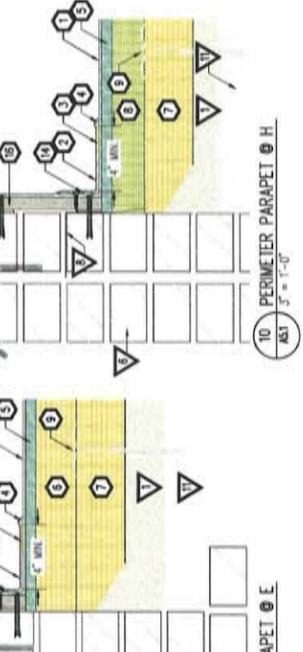
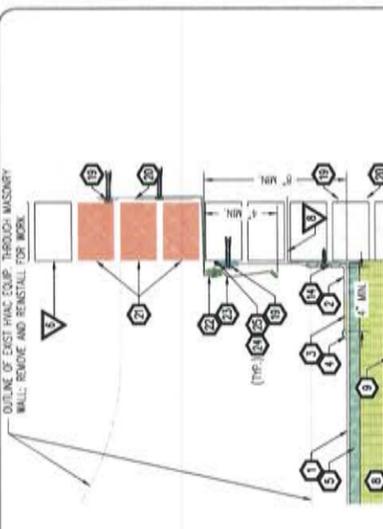
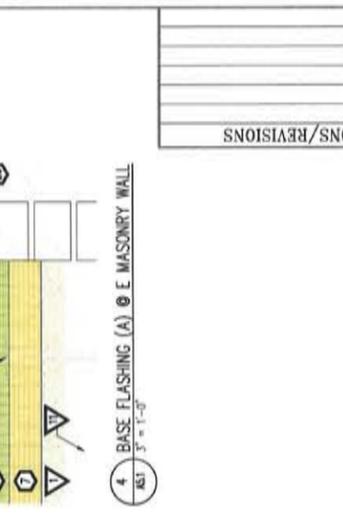
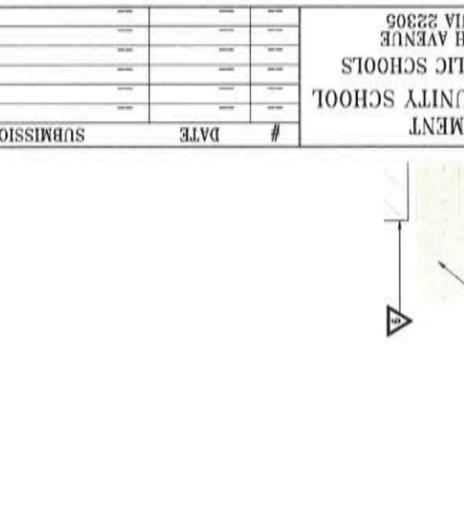
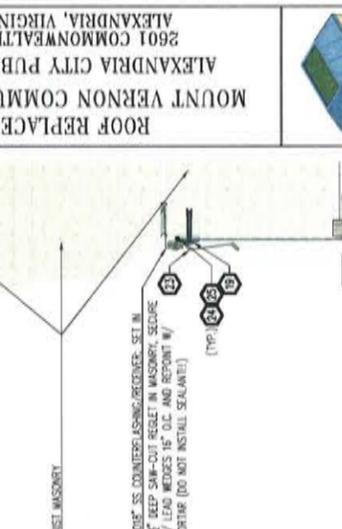
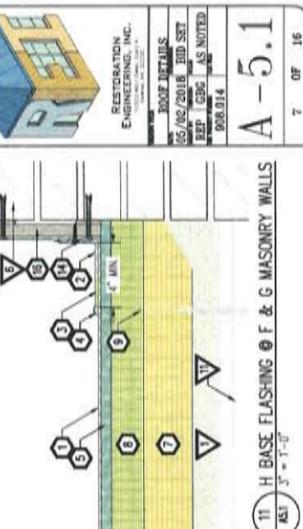
**ROOF DETAILS - KEYED NOTES:**

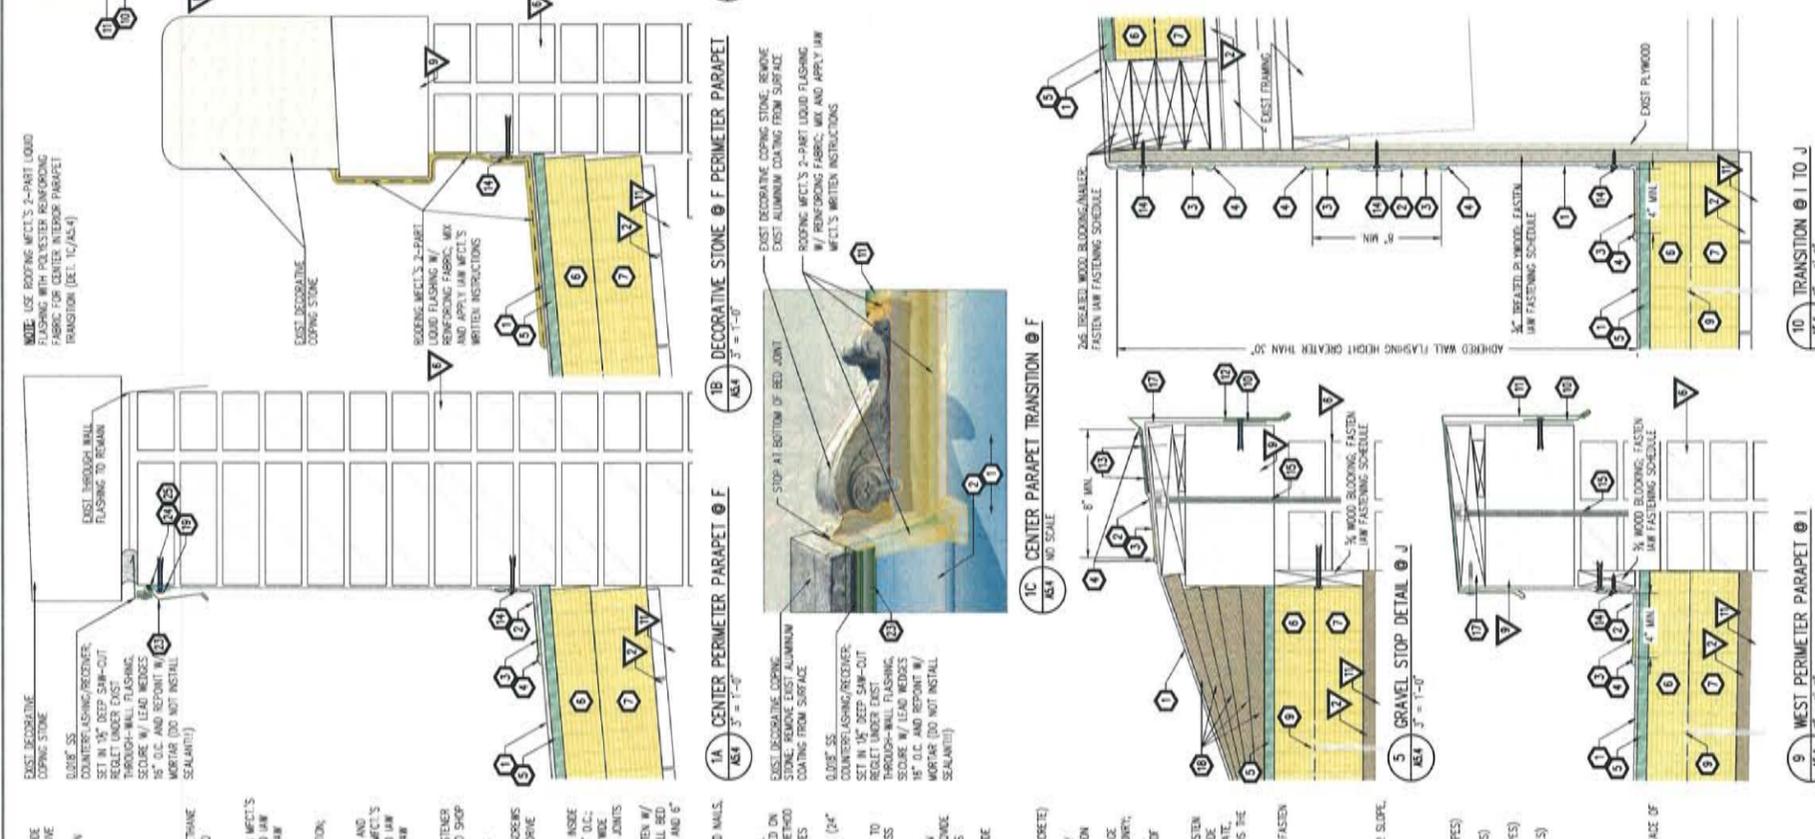
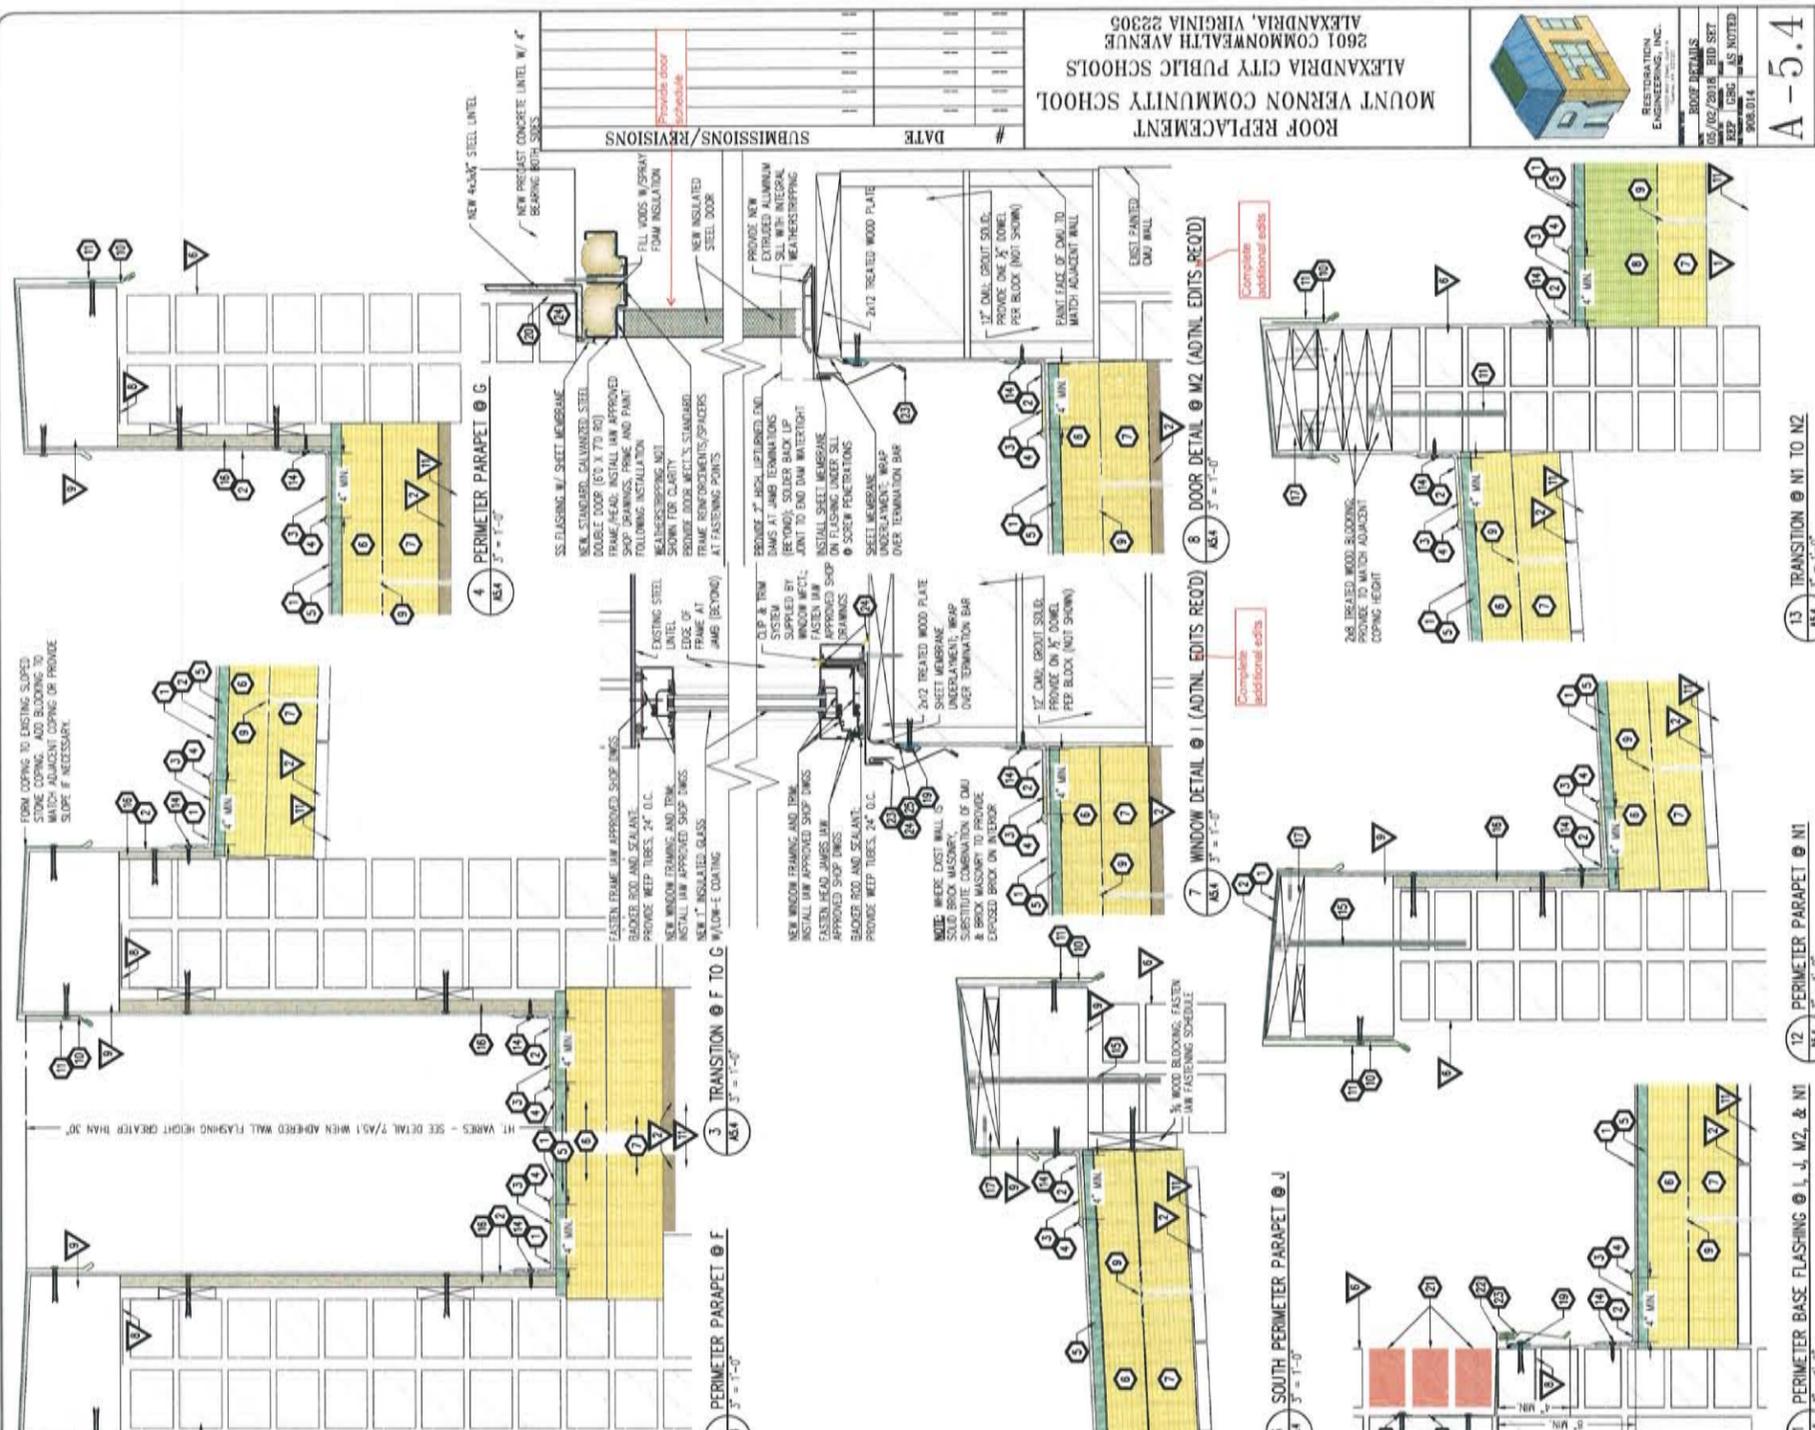
- ROOF DETAILS - KEYED NOTES:**
- 50 MIL FIBERGLASS REINFORCED POLYVINYL CHLORIDE (PVC) ROOFING MEMBRANE SET IN BONDING ADHESIVE
  - METL'S RECOMMENDED FLASHING MEMBRANE SET IN BONDING ADHESIVE

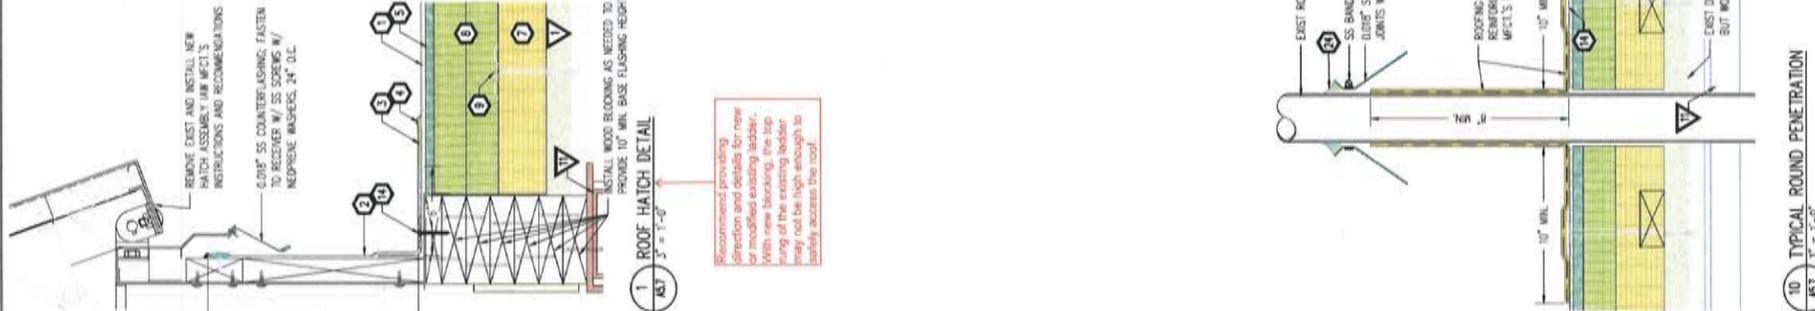
**1 ROOF HATCH DETAIL**  
 AS7 3" = 1'-0"

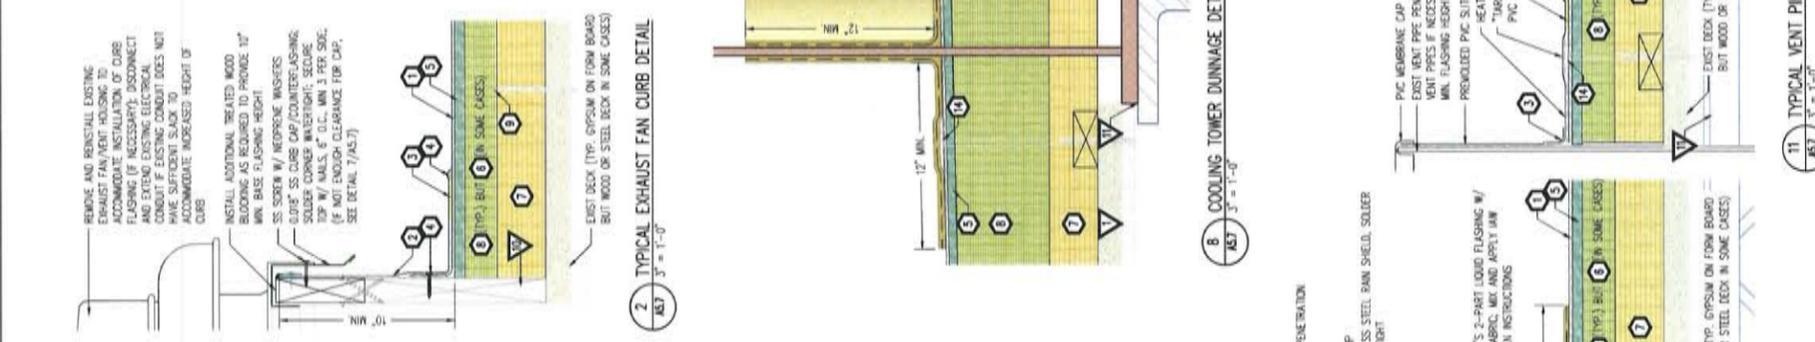
**2 TYPICAL EXHAUST FAN CURB DETAIL**  
 AS7 3" = 1'-0"

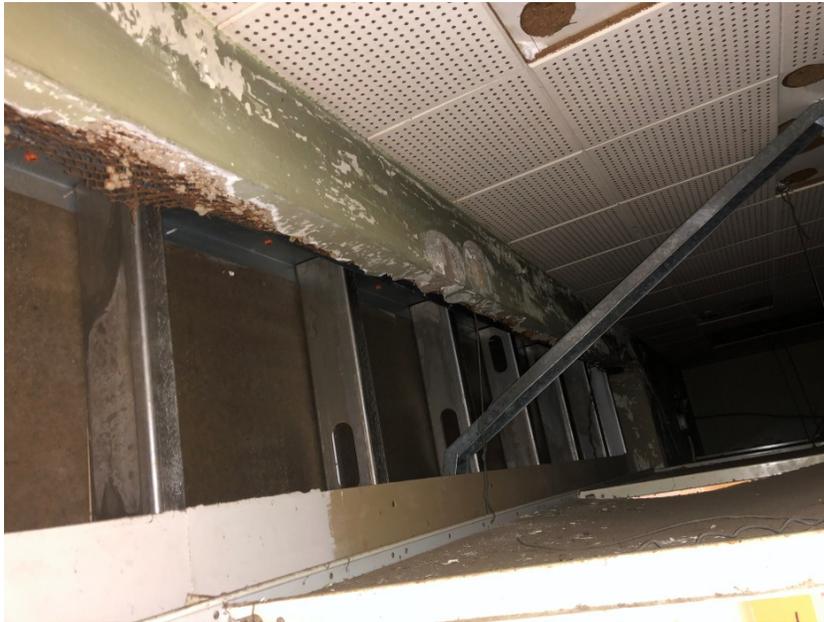
Exterior wall is only covered by gypsum board in ceiling space. No vapor barrier and insulation present.  
(Typical most above most classrooms' ceiling)

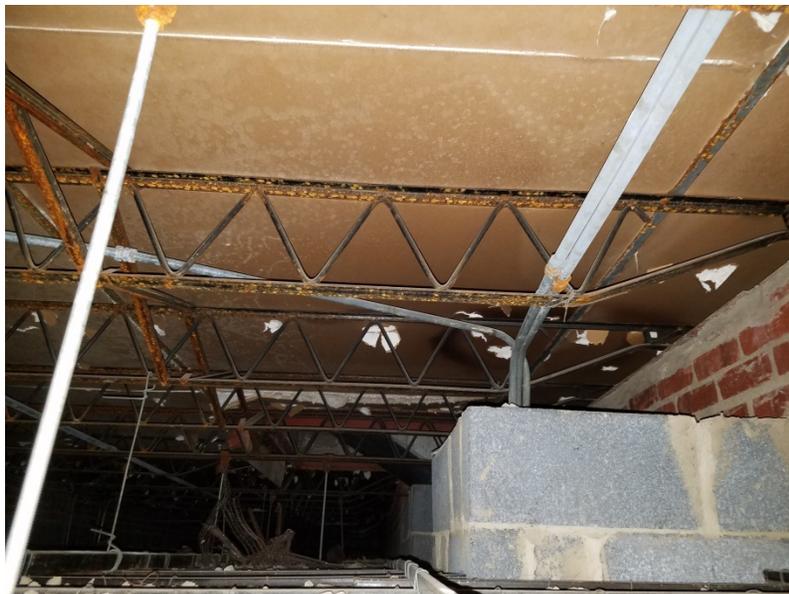
Water marks found along joists and ceiling. (Above the corridor by room 318)

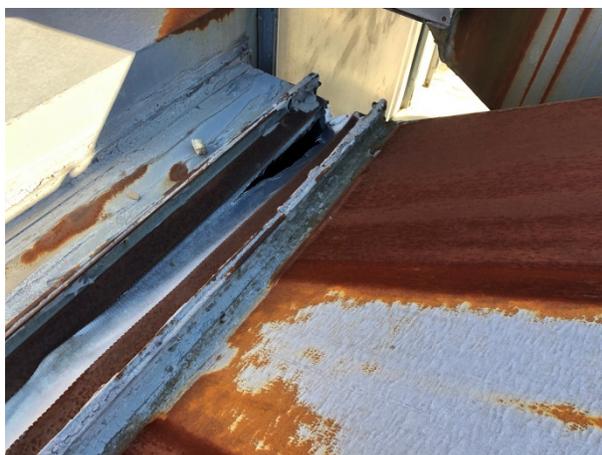
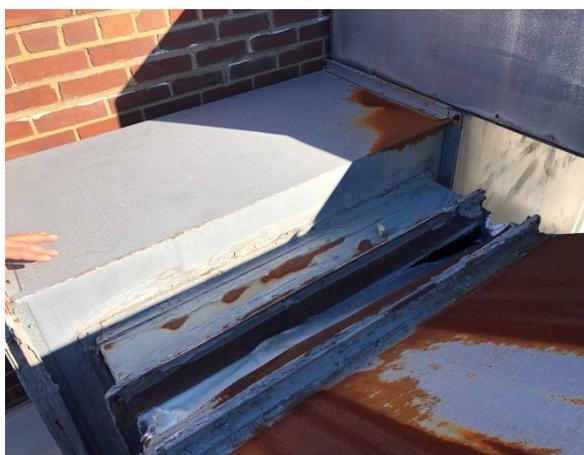
Tear in return air flex duct connection to RTU mixing box. (Auditorium RTU)

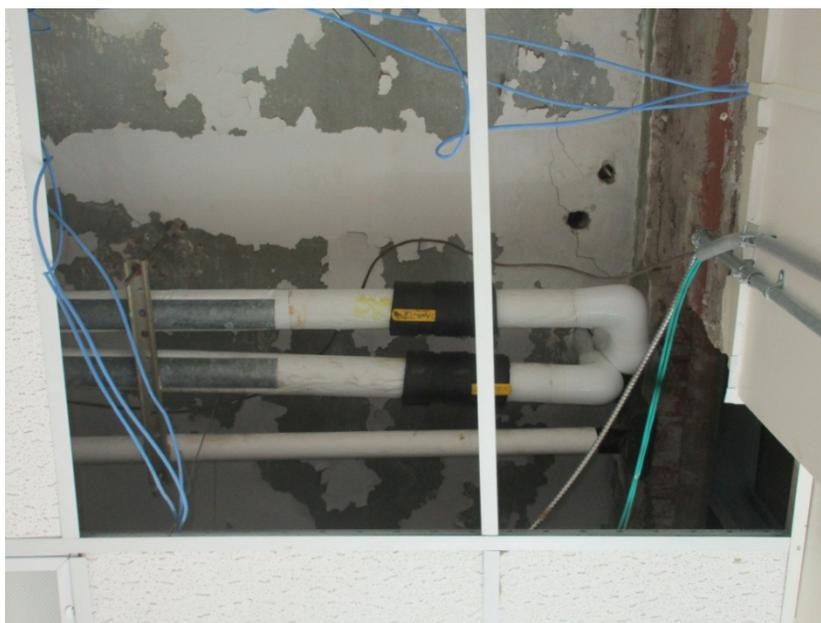
Sign of excessive moisture above the ceiling which cause the paint to peel off and created stain on the pipe insulations.

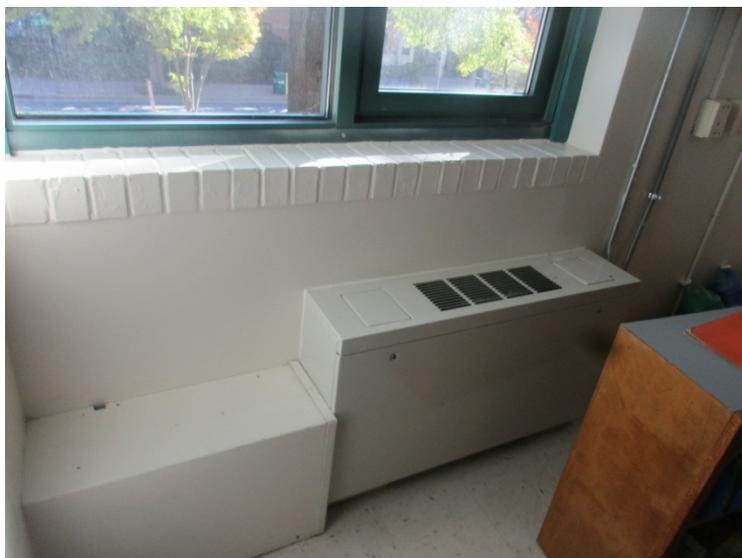
Typical Fan Coil Unit (FCU)

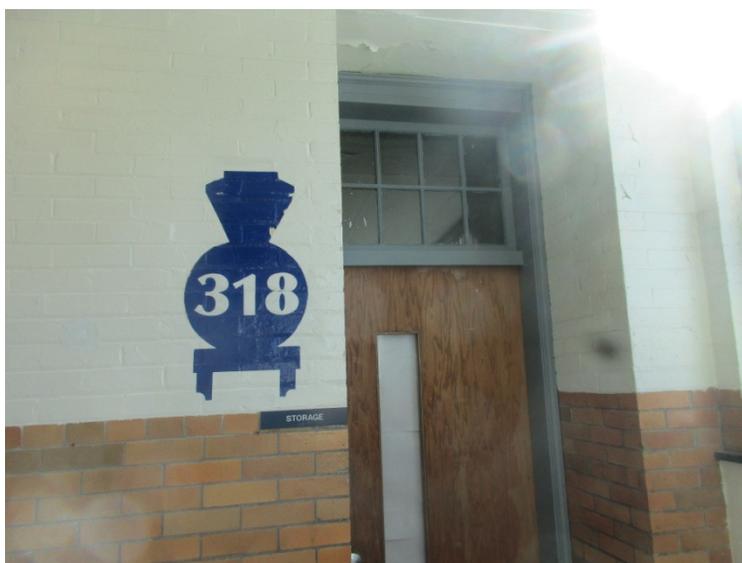
Sign of Excessive moisture and condensation on the door and ceiling.

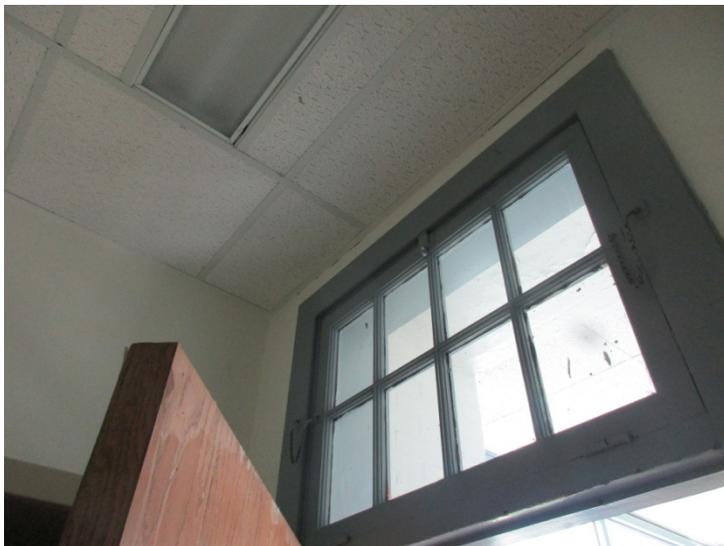
Close-up image indicating top of the door with condensation tracks.

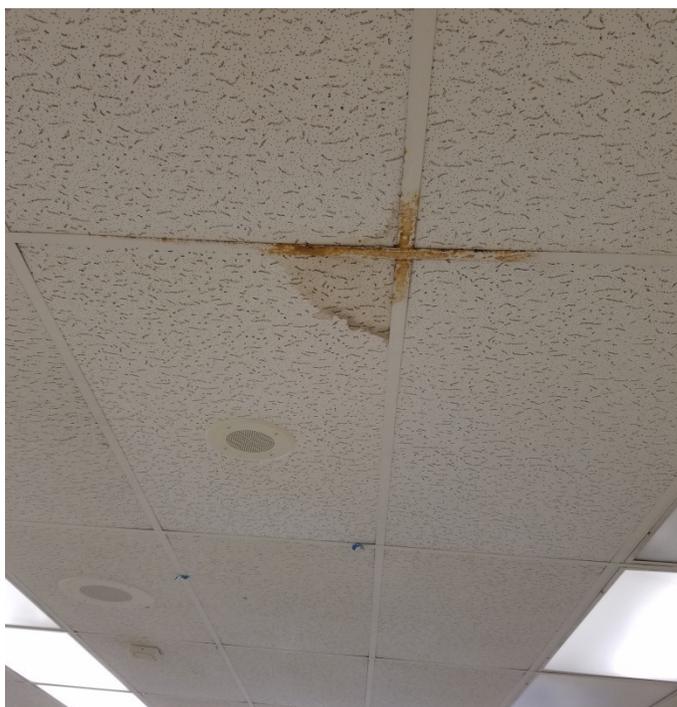
Ceiling damage from Plumbing leak (room 105)

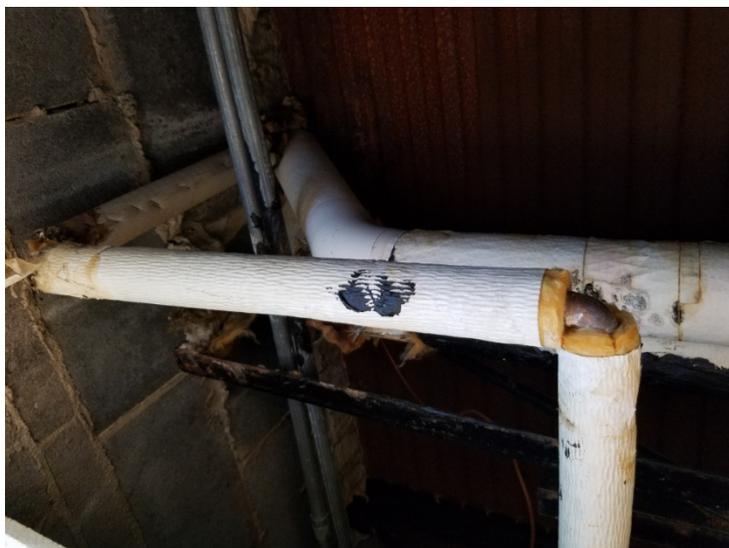
Sign of condensation on pipe insulation and floor deck. (Room 102)

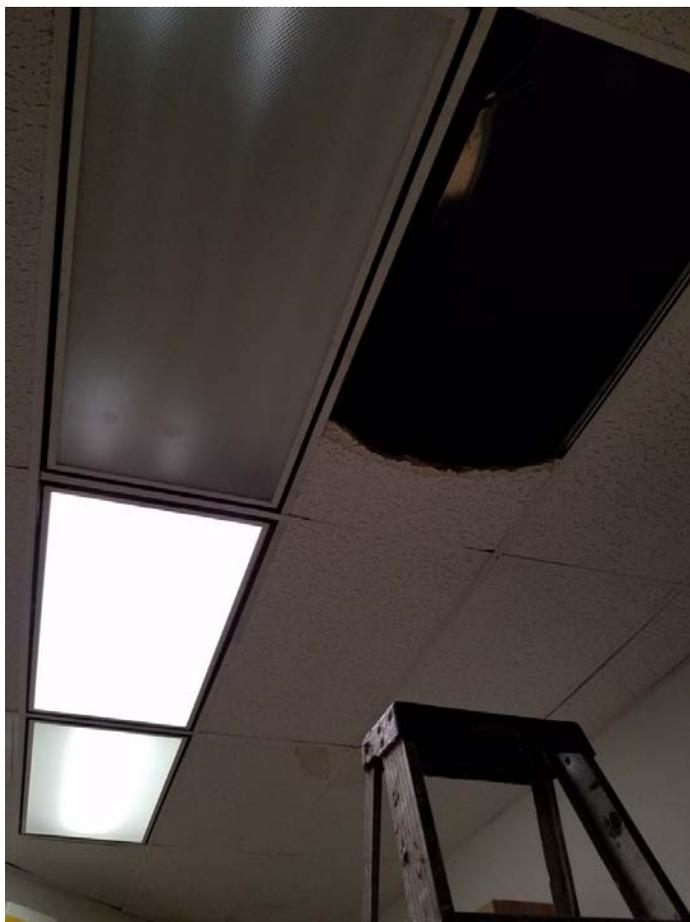
Ceiling damage due to condensation from AC unit above. (Room 106 B)

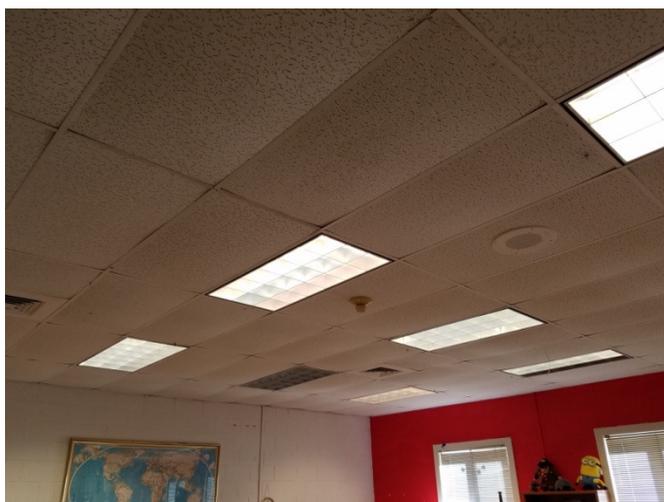
Sagging Ceiling tiles, indicative of excessive RH (library)
