PATRICK HENRY SCHOOL
FEASIBILITY STUDY - APPENDIX
MAY 6, 2015

TABLE OF CONTENTS

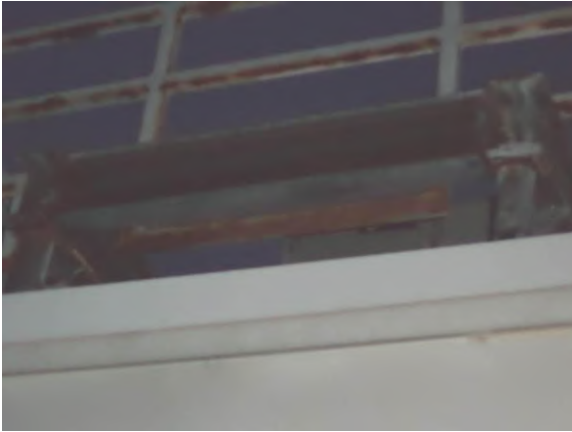
Figure 2: Deterioration of MEP roof top steel.

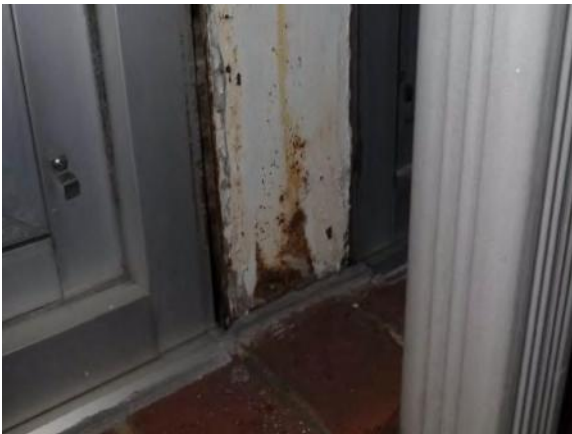
Figure 3: Deterioration of exposed structural steel col.

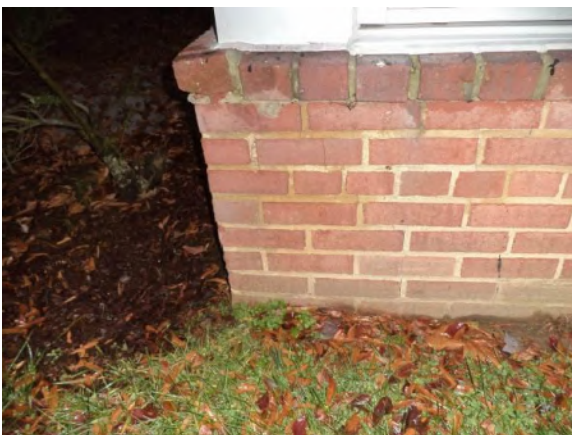
Figure 4: Step Cracking in mortar joint below exposed column (see Figure 5).

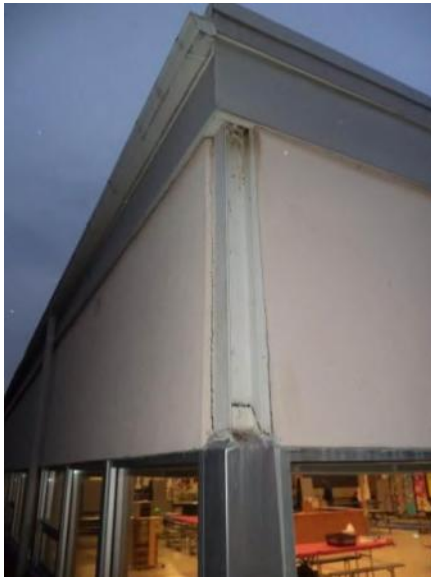
Figure 5: Exposed structural steel column @ Cafeteria.

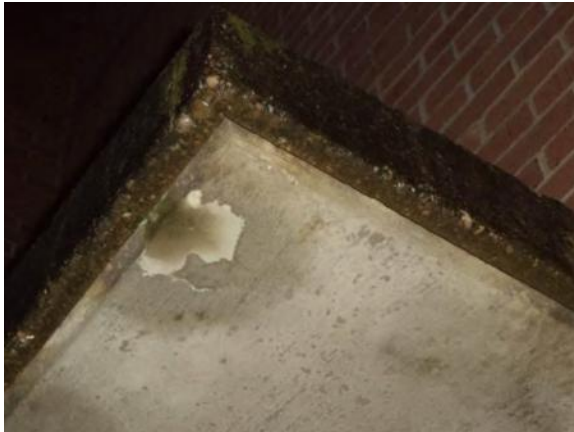
Figure 6: Efflorescence staining at Gym Canopy

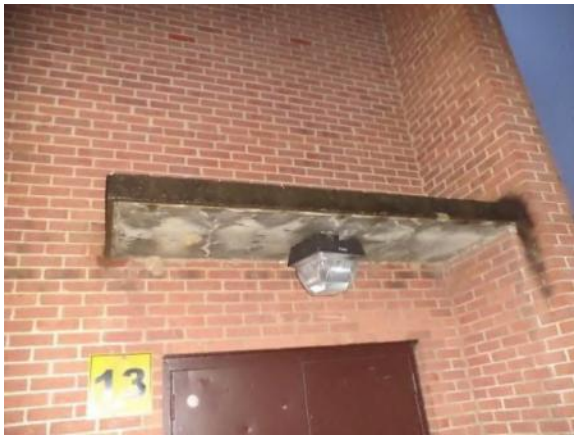
Figure 7: South Gym Canopy Condition

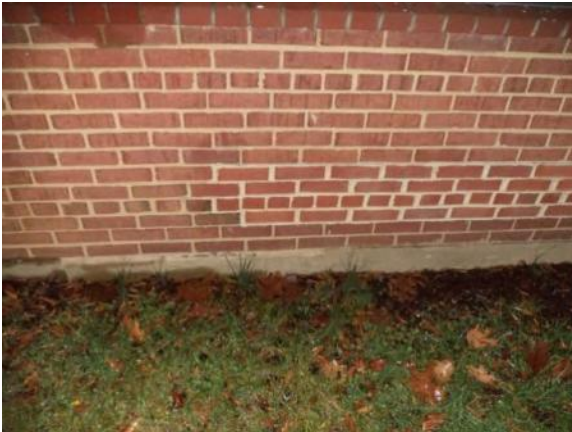
Figure 8: Negative Drainage & Exposed Foundation Wall.

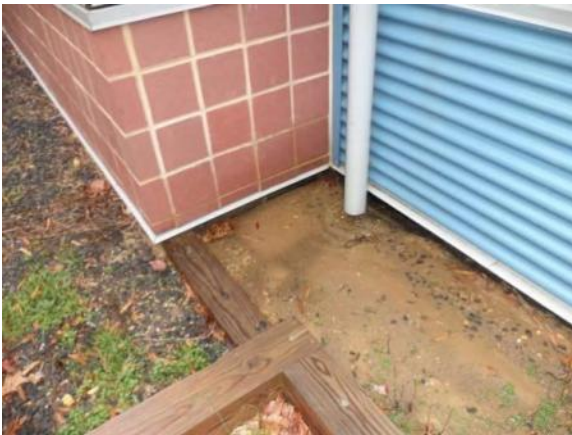
Figure 9: Pooling of drainage at modular foundation walls (clogged)

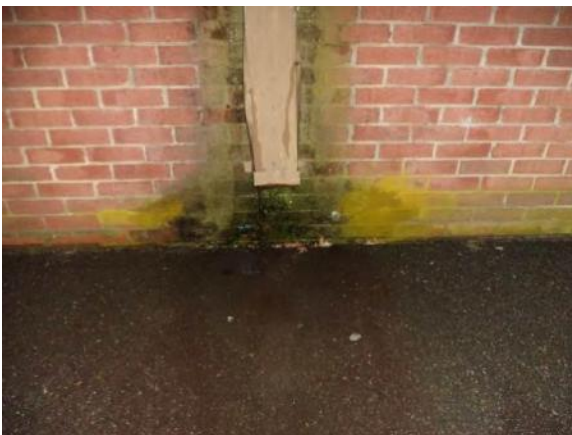
Figure 10: Lack of connection to foundation drainage system.

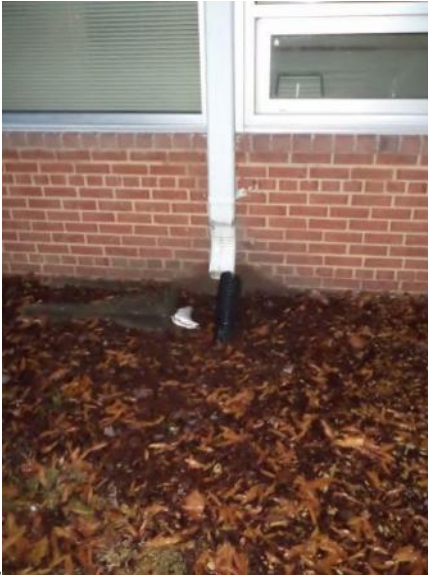
Figure 11: Inadequate attachment to foundation drain.

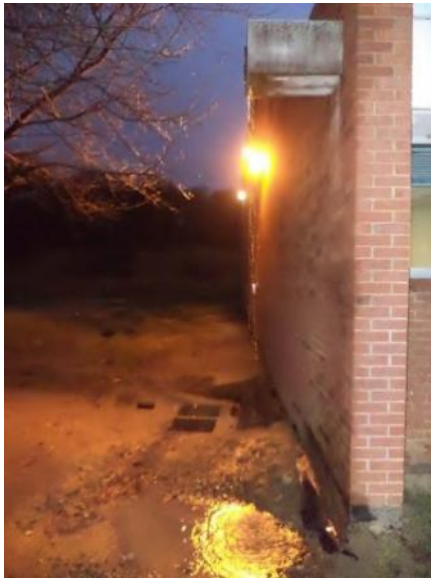
Figure 12: Lack of attachment to foundation drain system.

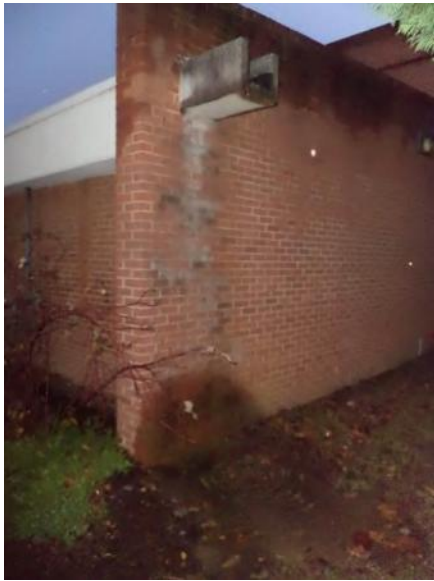
Figure 13: Lack of attachment to foundation drain system.

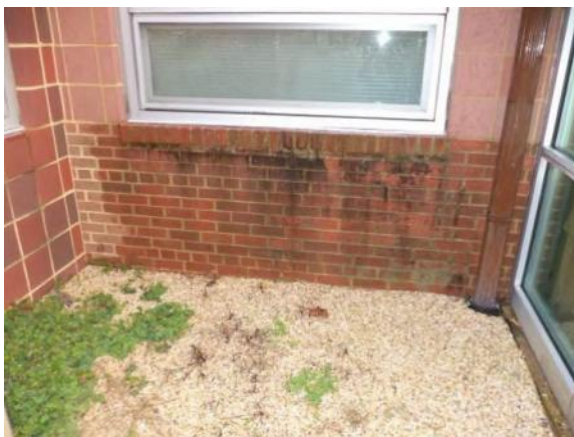
Figure 14: Moisture staining of brick.

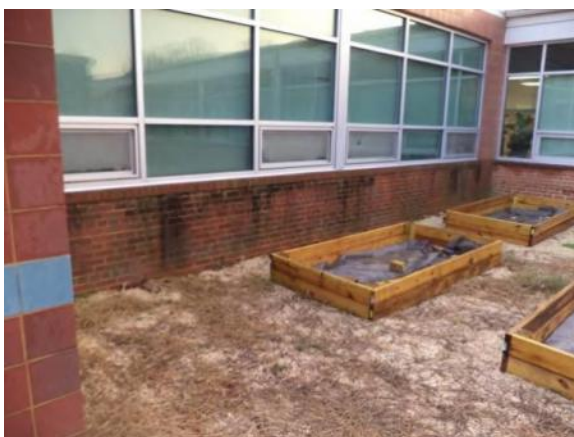
Figure 15: Moisture staining of brick

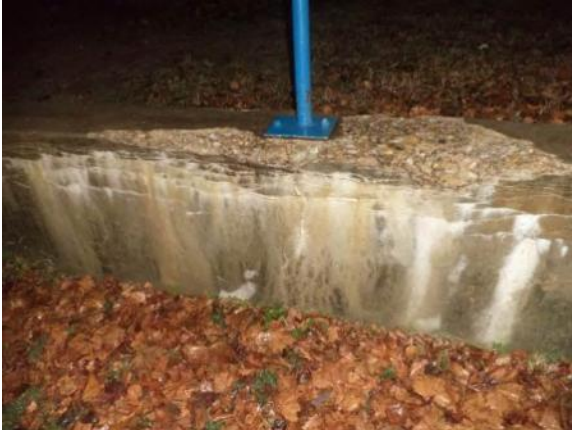
Figure 16: Deteriorated Concrete Retaining Wall.

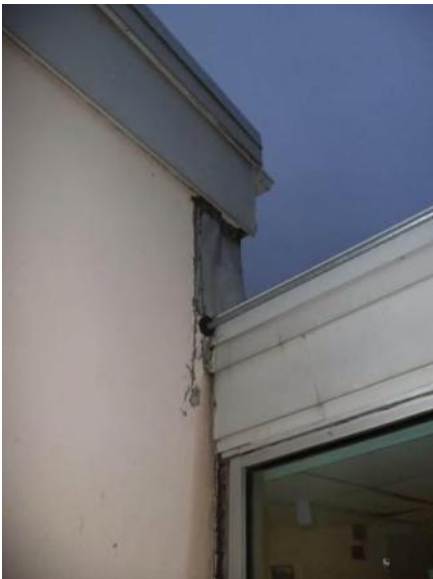
Figure 17: Deteriorated Flashing at Bldg Return.

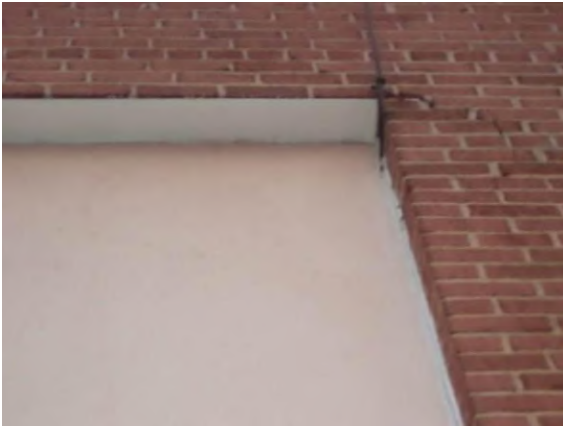
Figure 18: Cracking at lintel steel lintel bearing.

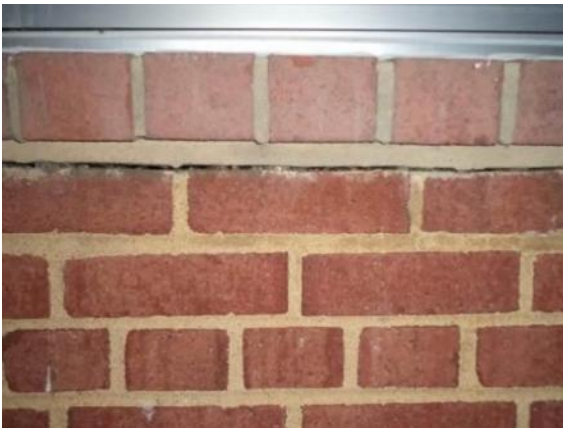
Figure 19: Open mortar joints.

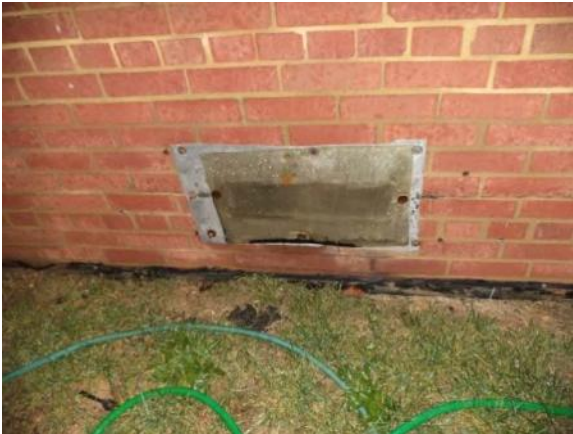
Figure 21: Unventilated crawl space.

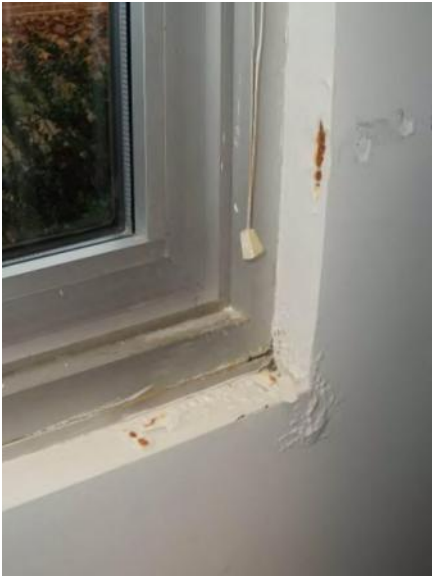
Figure 22: Plaster cracking at window.

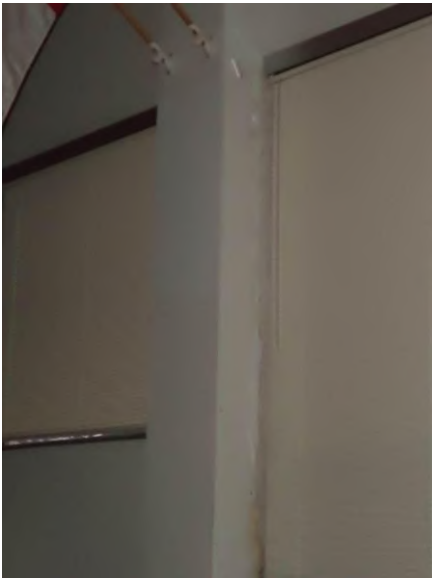
Figure 23: Signs of moisture infiltration at Auditorium Column.

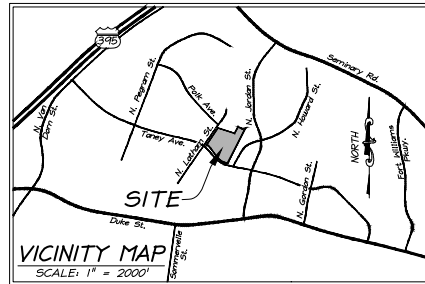
SURVEYOR'S CERTIFICATION

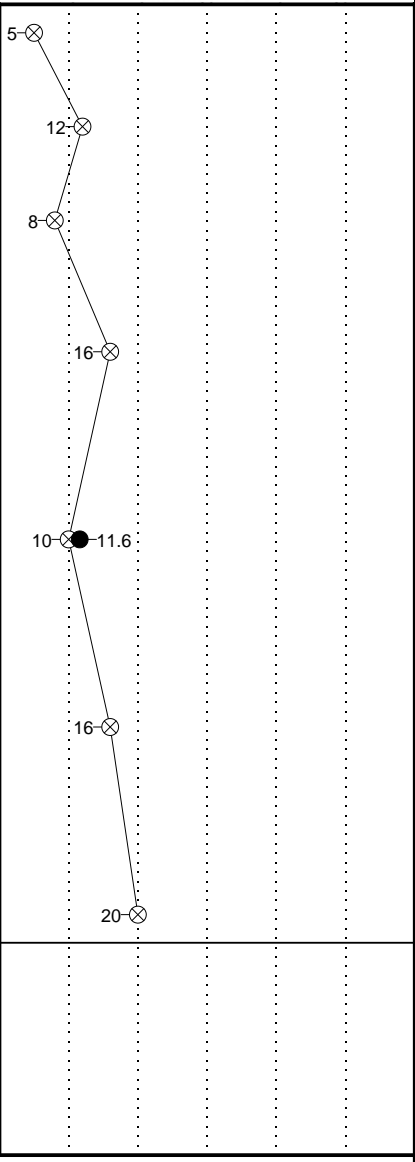
THE STRATIFICATION LINES REPRESENT THE APPROXIMATE BOUNDARY LINES BETWEEN SOIL TYPES. IN-SITU THE TRANSITION MAY BE GRADUAL.

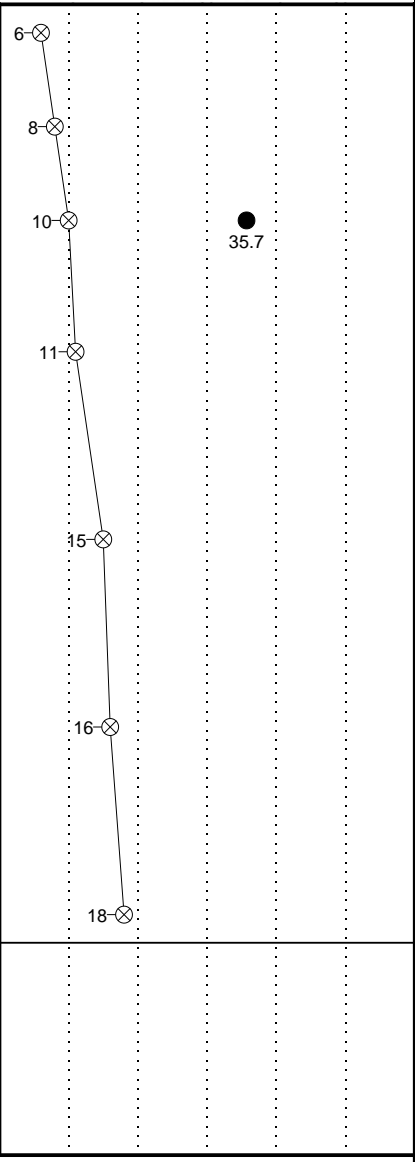
THE STRATIFICATION LINES REPRESENT THE APPROXIMATE BOUNDARY LINES BETWEEN SOIL TYPES. IN-SITU THE TRANSITION MAY BE GRADUAL.

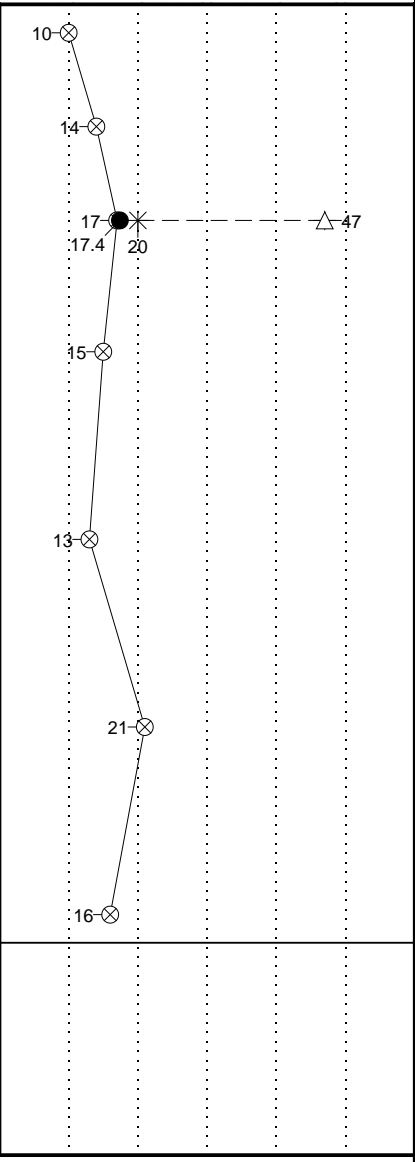
THE STRATIFICATION LINES REPRESENT THE APPROXIMATE BOUNDARY LINES BETWEEN SOIL TYPES. IN-SITU THE TRANSITION MAY BE GRADUAL.

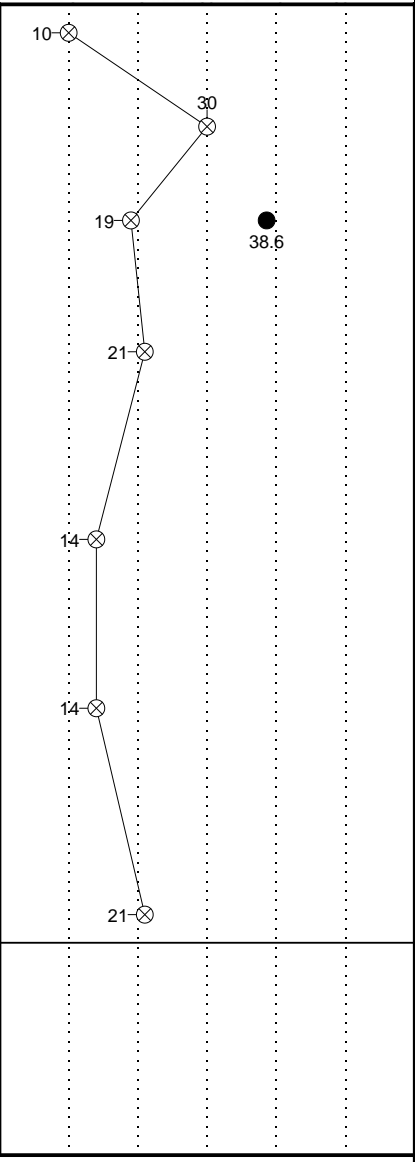
THE STRATIFICATION LINES REPRESENT THE APPROXIMATE BOUNDARY LINES BETWEEN SOIL TYPES. IN-SITU THE TRANSITION MAY BE GRADUAL.

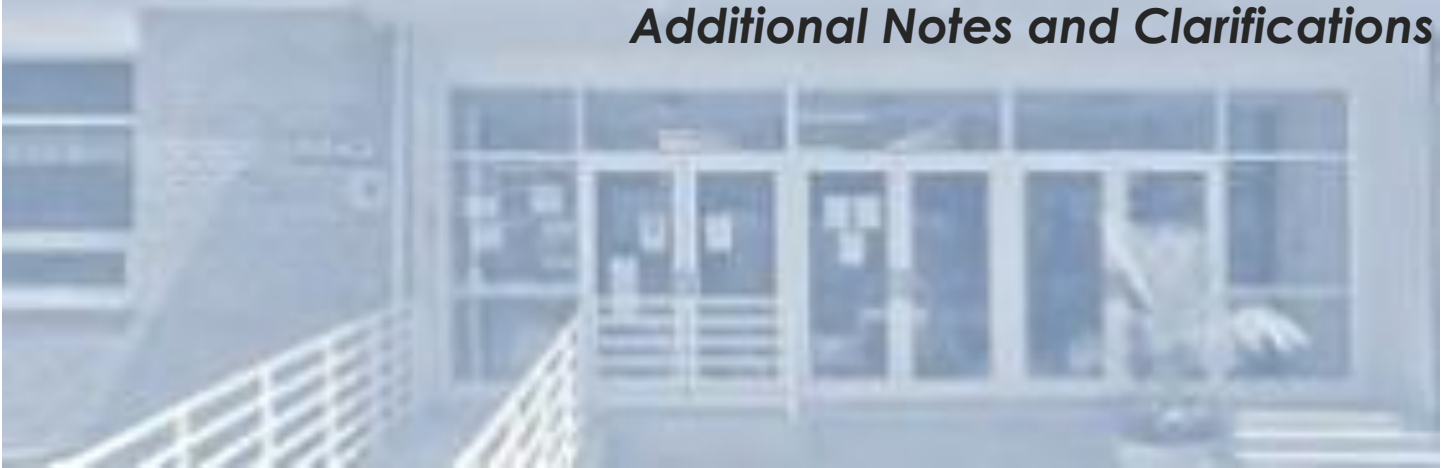
ADDITIONAL NOTES & EXCLUSIONS
