**FROM: JOINT CITY-SCHOOLS FACILITY INVESTMENT TASK FORCE
Lynn Hampton, Chair, Mignon Anthony¹, Elliott Branch, Micheline Castan-
Smith, Marshall Cook, Dwight Dunton, Amy Liu, Dave Millard, Eric Wagner**

SUBJECT: TASK FORCE FINAL REPORT (DELIVERABLE 2 OF 2)

A2 Services, Inc. Facility Survey of City of Alexandria - City Hall

A2 Services, Inc.
Facility Survey of the City of Alexandria – Public Safety Center

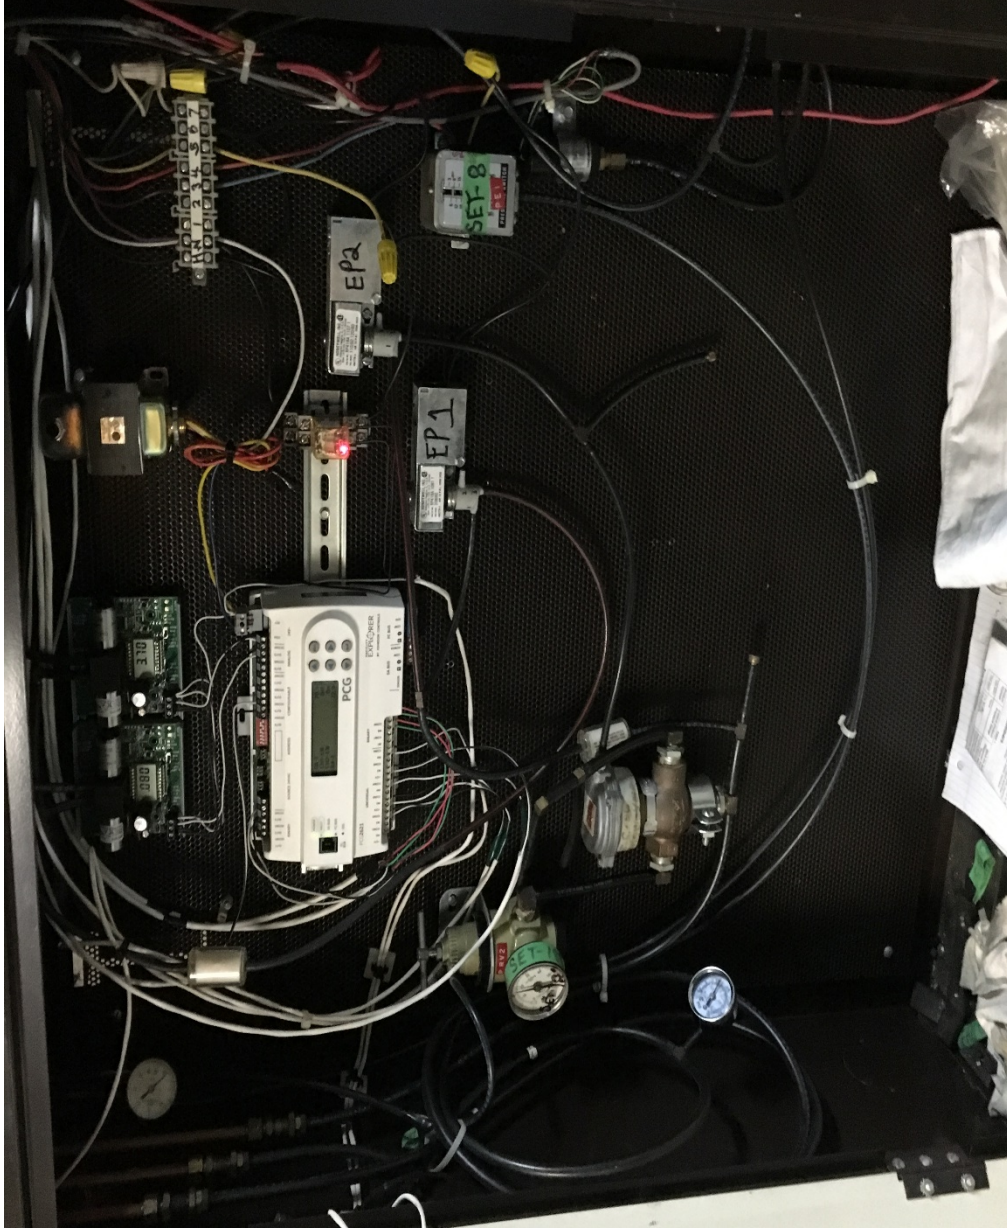
Finding # - 6. The central plant and air handler controls are pneumatic. The controls are operating but will eventually need to be replaced. There is at least one actuator which should be replaced now. The steam control valve and actuator for the hot water convertor are in poor shape. If this device fails during the winter, the facility will not have heat.

Finding # 6 Photo. The picture is an example of the old pneumatic controls used to operate the boiler room systems and the air handlers systems in the building.

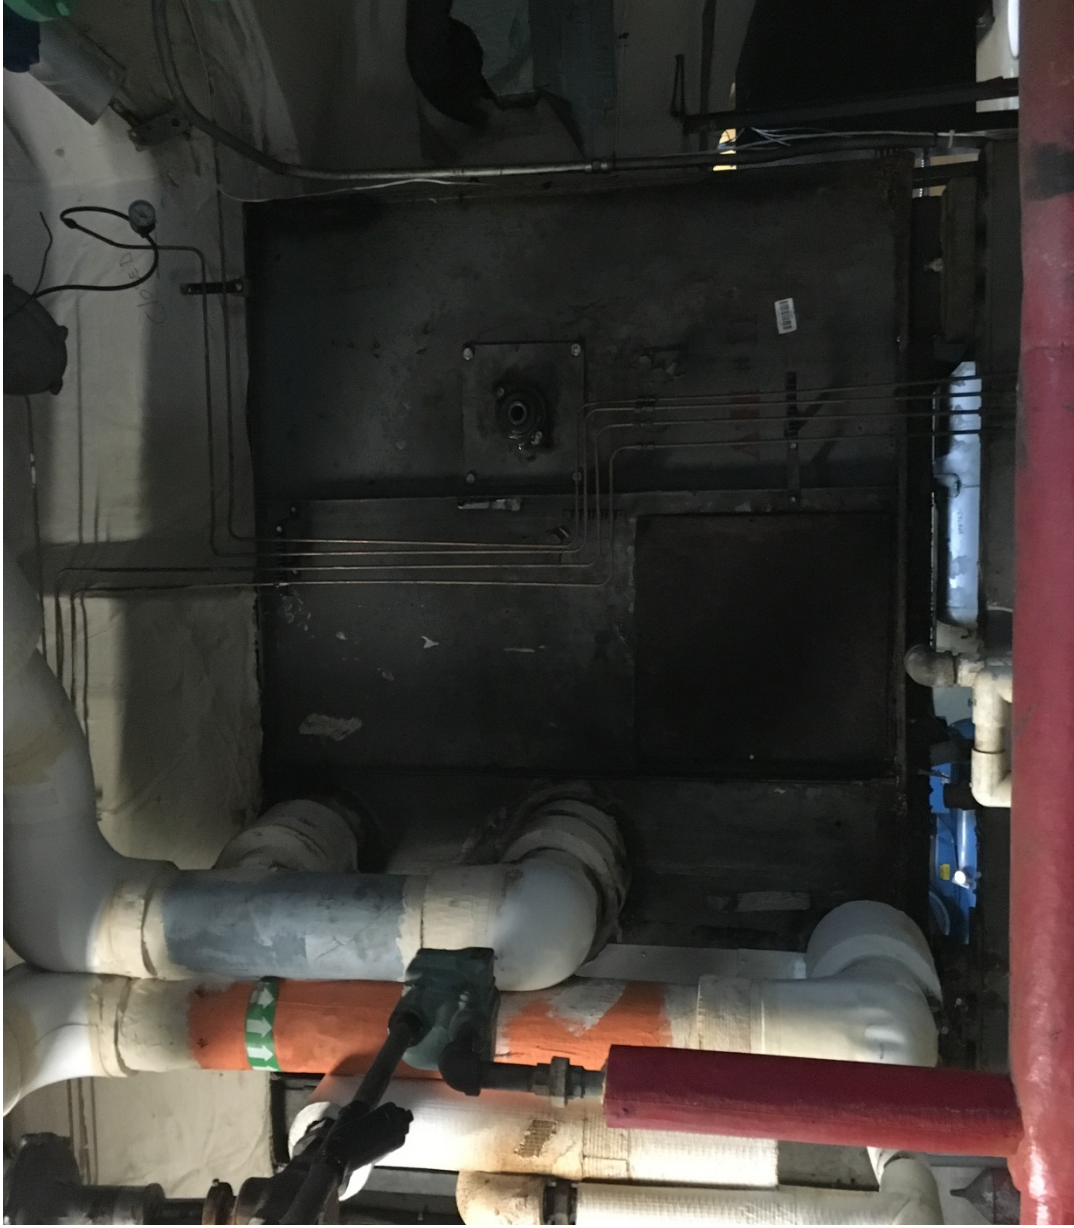
Finding # - 8. The main outside air fan for the building is small and only dumps conditioned outside air into the central corridor of the building. It appears that the fan coils do not have outside air vents and the ceiling hung air handlers do not have outside air fed to them either. This should be further investigated to make sure this finding is correct. The concern is a possibility that the office areas in the building may not be getting good fresh air ventilation.

Finding # 8 Photo. This picture is of the main outside air fan which filters, heats or cools the incoming air for building ventilation.

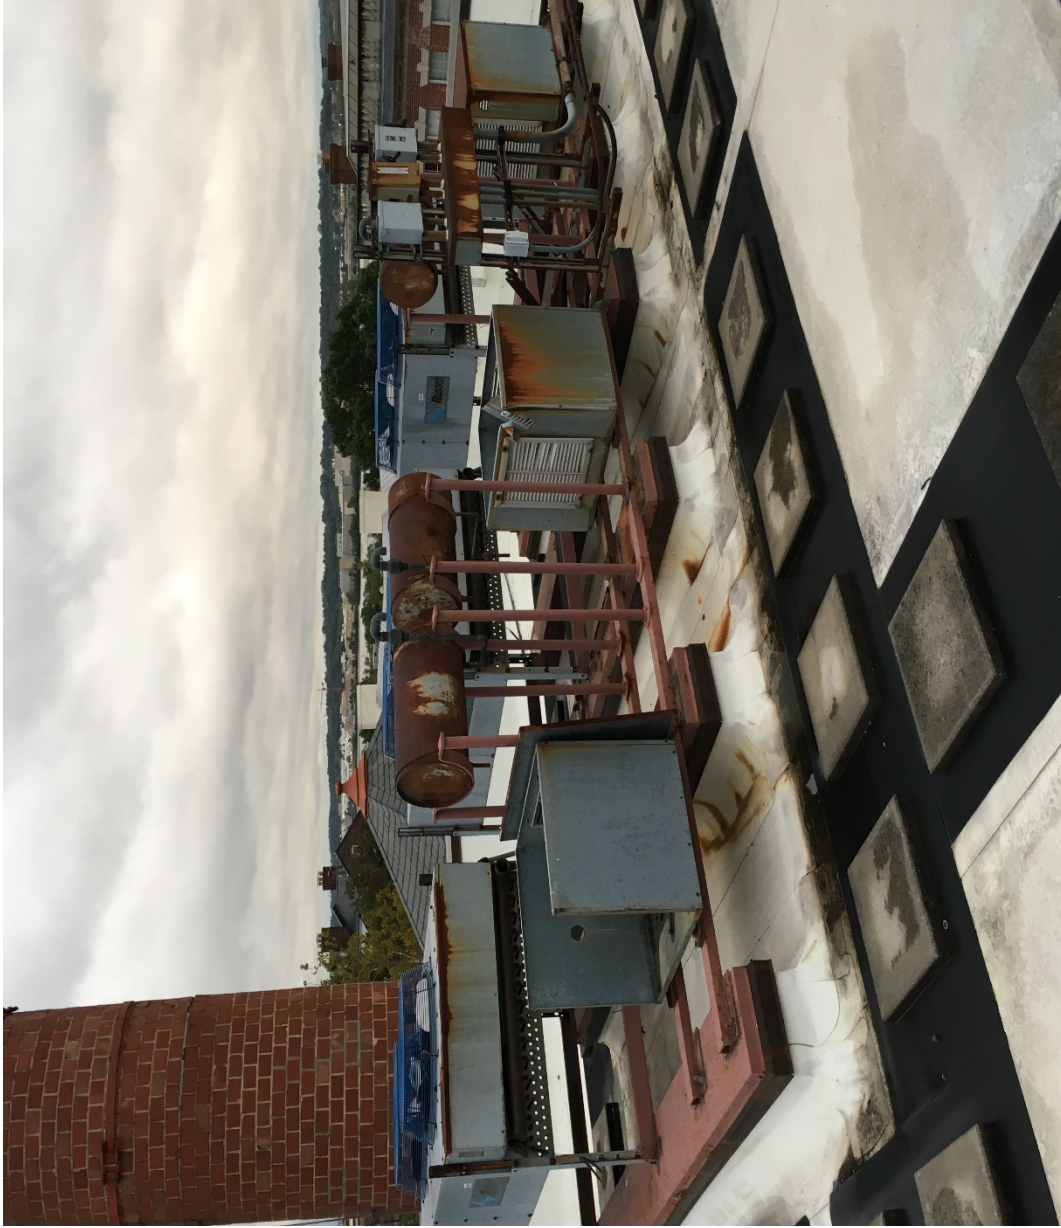
Finding # – 12. Two old dry coolers have been abandoned in place on the roof. This equipment should be removed and the roof penetrations patched and sealed over. This condition may start to cause leaks into the site.

Finding # 12 Photo. This picture notes the old dry cooler equipment abandoned in place.

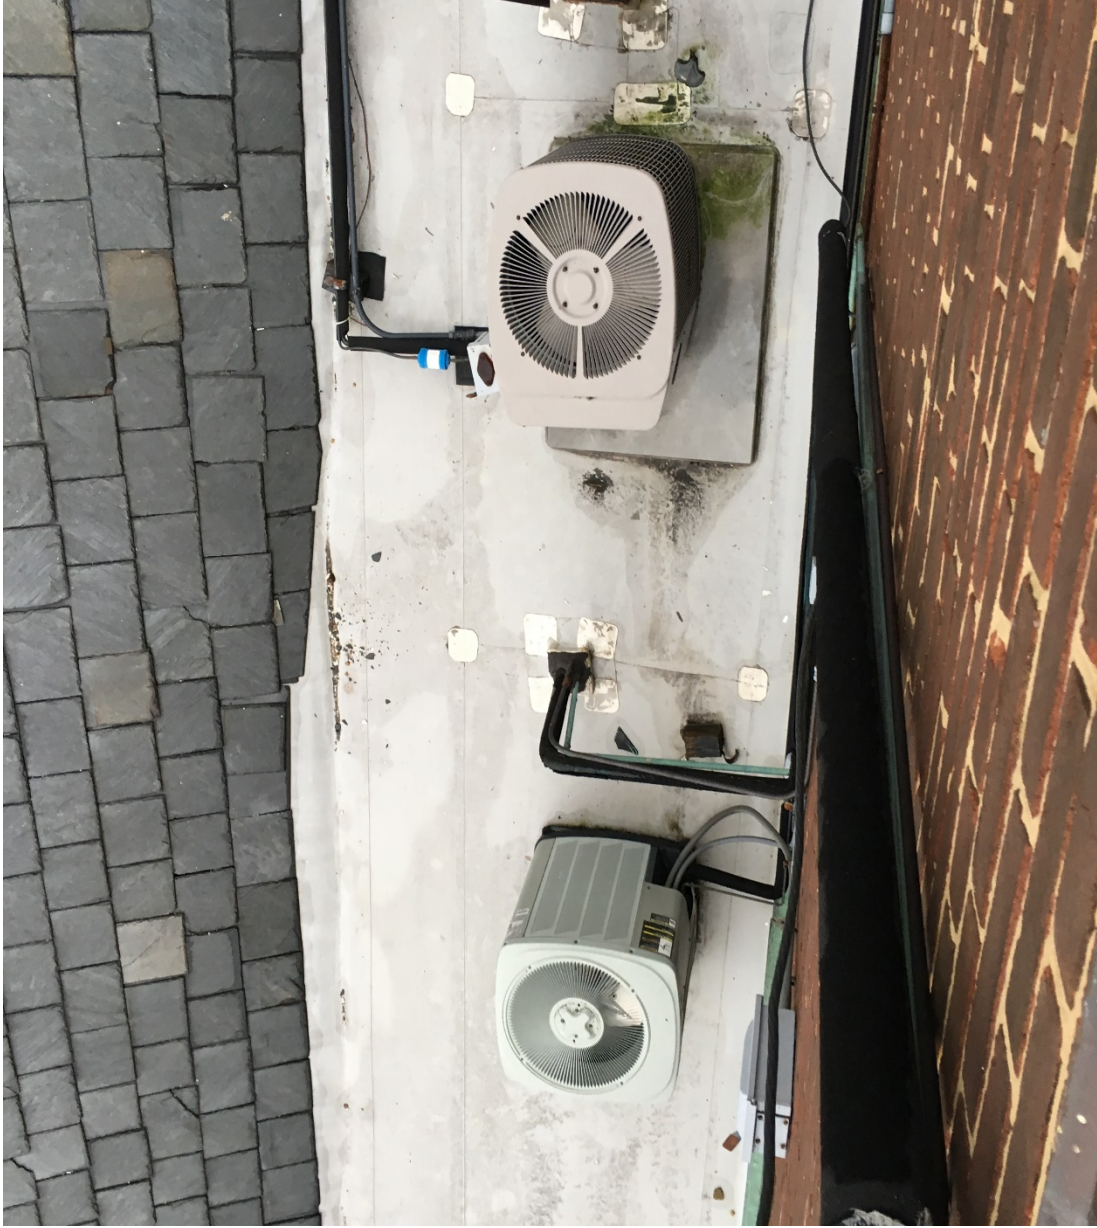
Finding # - 13. There are 24 split system heat pumps which are placed around the building to handle extra heating and cooling requirements in the building. Many of these units are very hard to access for repairs or service.

Finding # 13 Photo. This picture notes the difficult access to the HVAC units.

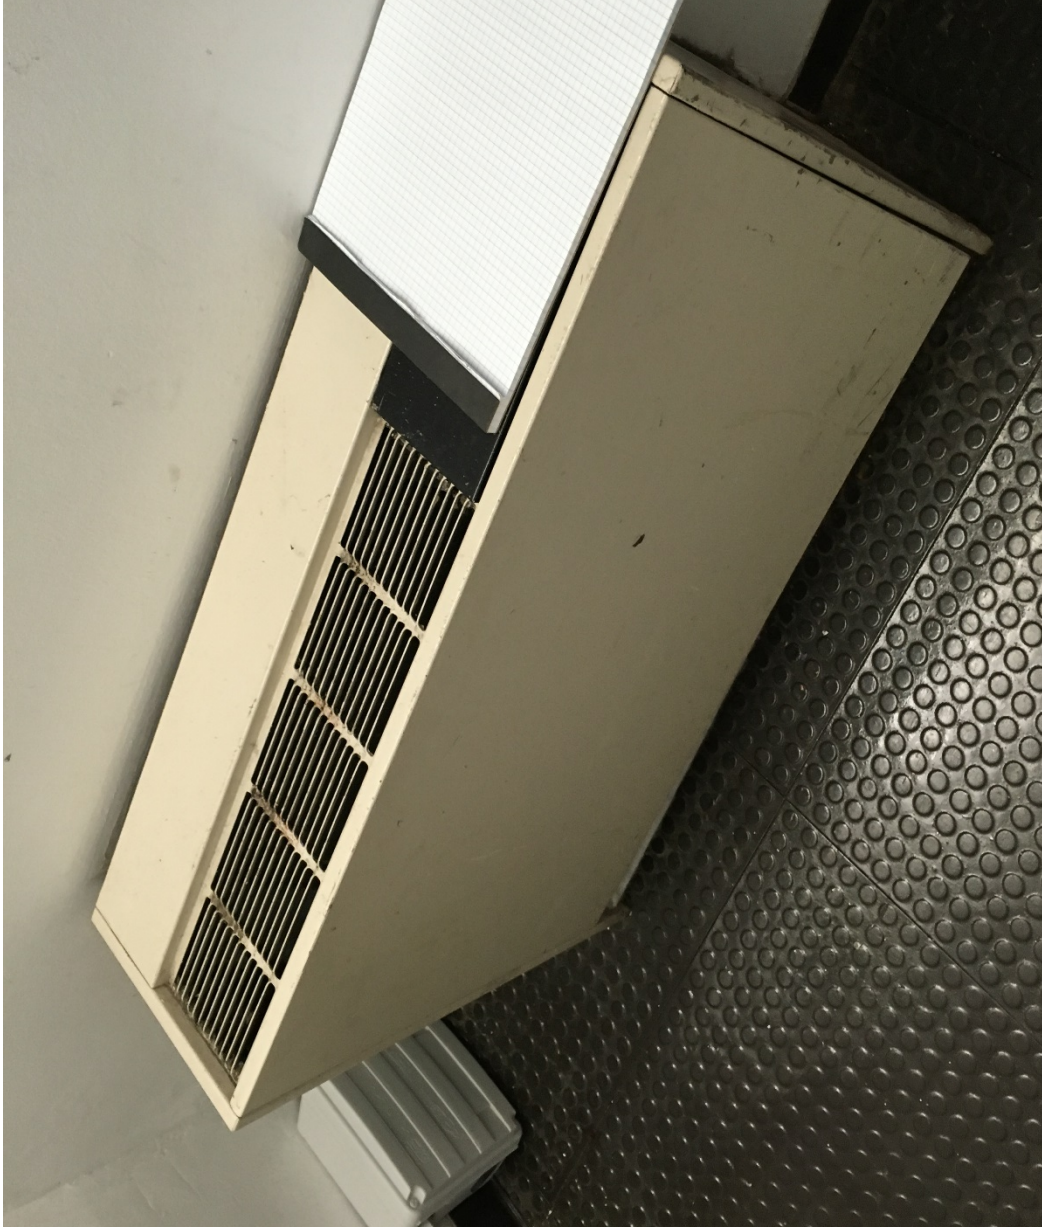
Finding # - 14. There are 180 fan coil units which are located under windows in offices and in areas around the building perimeter. These units need to be serviced and flushed regularly to eliminate condensate leaks. In many offices the staff have furniture in front of this equipment or covered so they cannot operate properly. This condition adds a lot of preparation time to get these units open for service. This equipment also causes condensate leaks in summer. The unit's condensate pans and drains should be flushed 2 to 3 times throughout the summer to eliminate the leaks.

Finding # 14 Photo. This picture is an example of one perimeter fan coil unit. This one is in an entrance way off the courtyard.

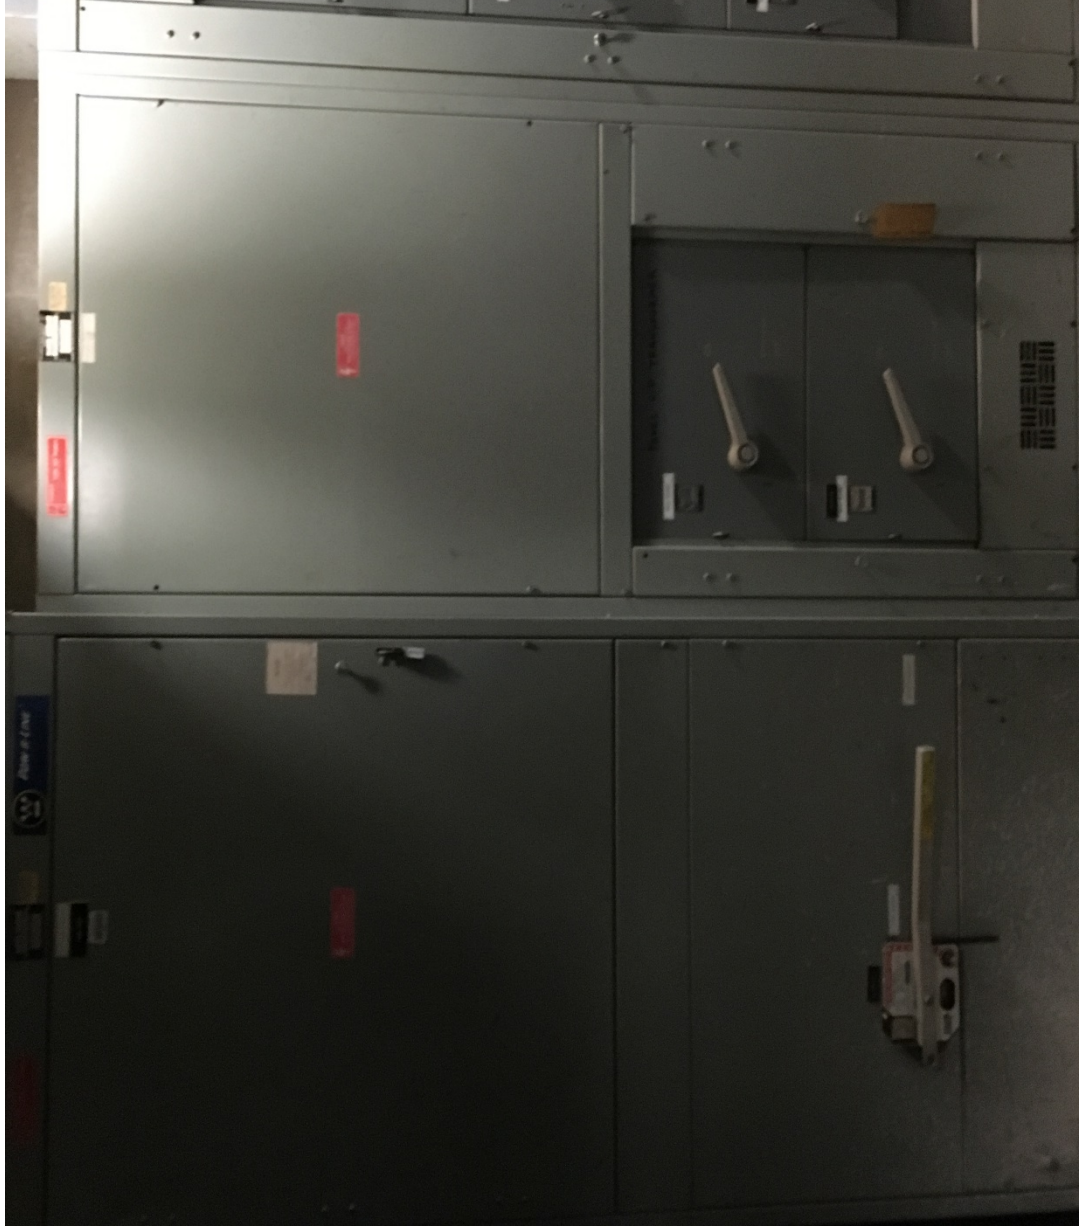
Finding # - 15. The main electrical panels and breakers panels at the site do not look as if they are being tested and serviced. All electrical systems should be thermally scanned with an infra-red camera to identify any overheating components or loose connections. This testing will identify such issues before a failure of the electrical system occurs. A2 recommends that all electrical gear be opened, thermally scanned then cleaned and all terminations checked of tightness every 2 to 3 years at a minimum. This an important risk management task that should be implemented. This maintenance is a code requirement. **REVISION – Per DGS an extensive survey of the electrical gear was performed in 2013-2014. A2 requests a copy of the report. Additionally, per DGS the gear is inspected by the DGS Master Electrician. There is no evidence of these inspections. In the future, A2 recommends that inspections stickers be affixed to the gear to denote the review. Finally, please see the attached electrical maintenance code requirements. The City of Alexandria is required to be in compliance with NFPA 70B.**

Finding # 15 Photo. This picture is an example of one main switch gear which does not look like it has been shut down for cleaning and tighten-up work. Infra-Red testing should also be implemented.

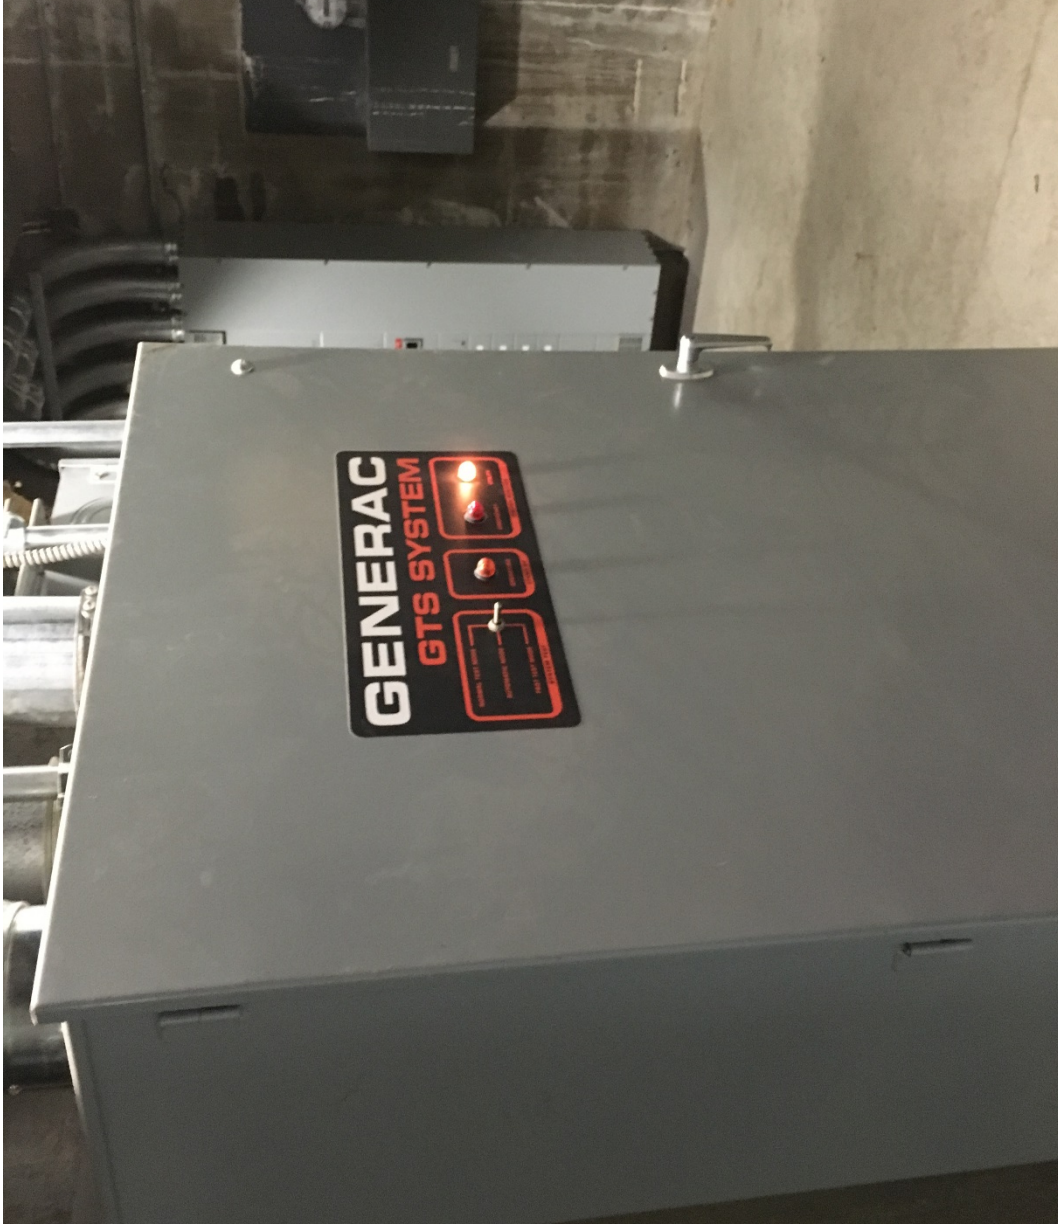
Finding # 16 Photos Continued. This picture is of one of the emergency transfer switches which should be tested.

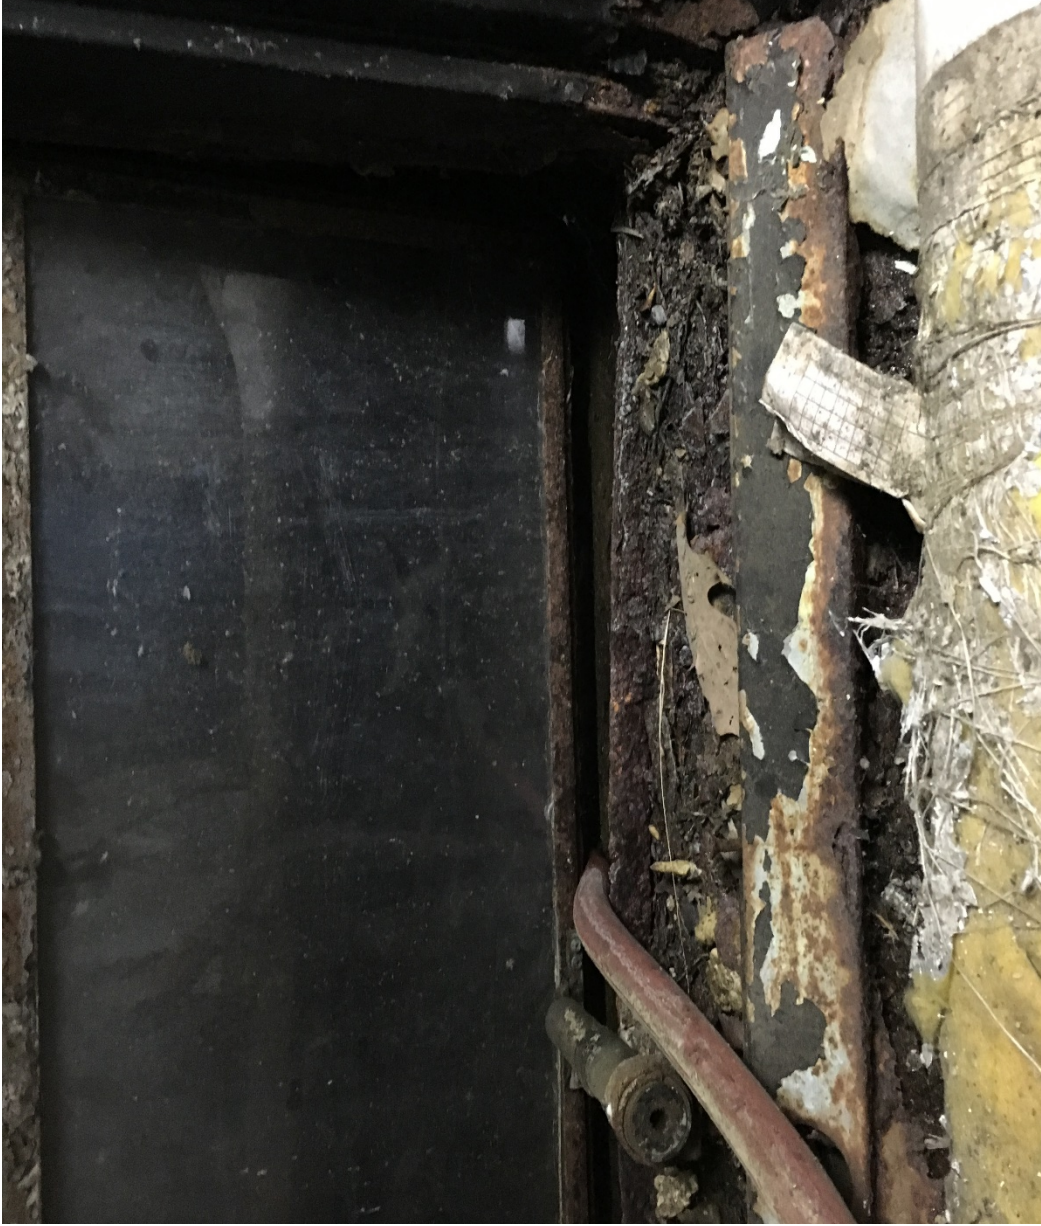
Finding # - 17. The outside air shaft drain outside the boiler room is plugged up allowing water to enter the boiler room through a window. This drain should be snaked or repaired.

Finding # 17 Photo. This picture notes the window where water is entering the boiler room from the outside air shaft.

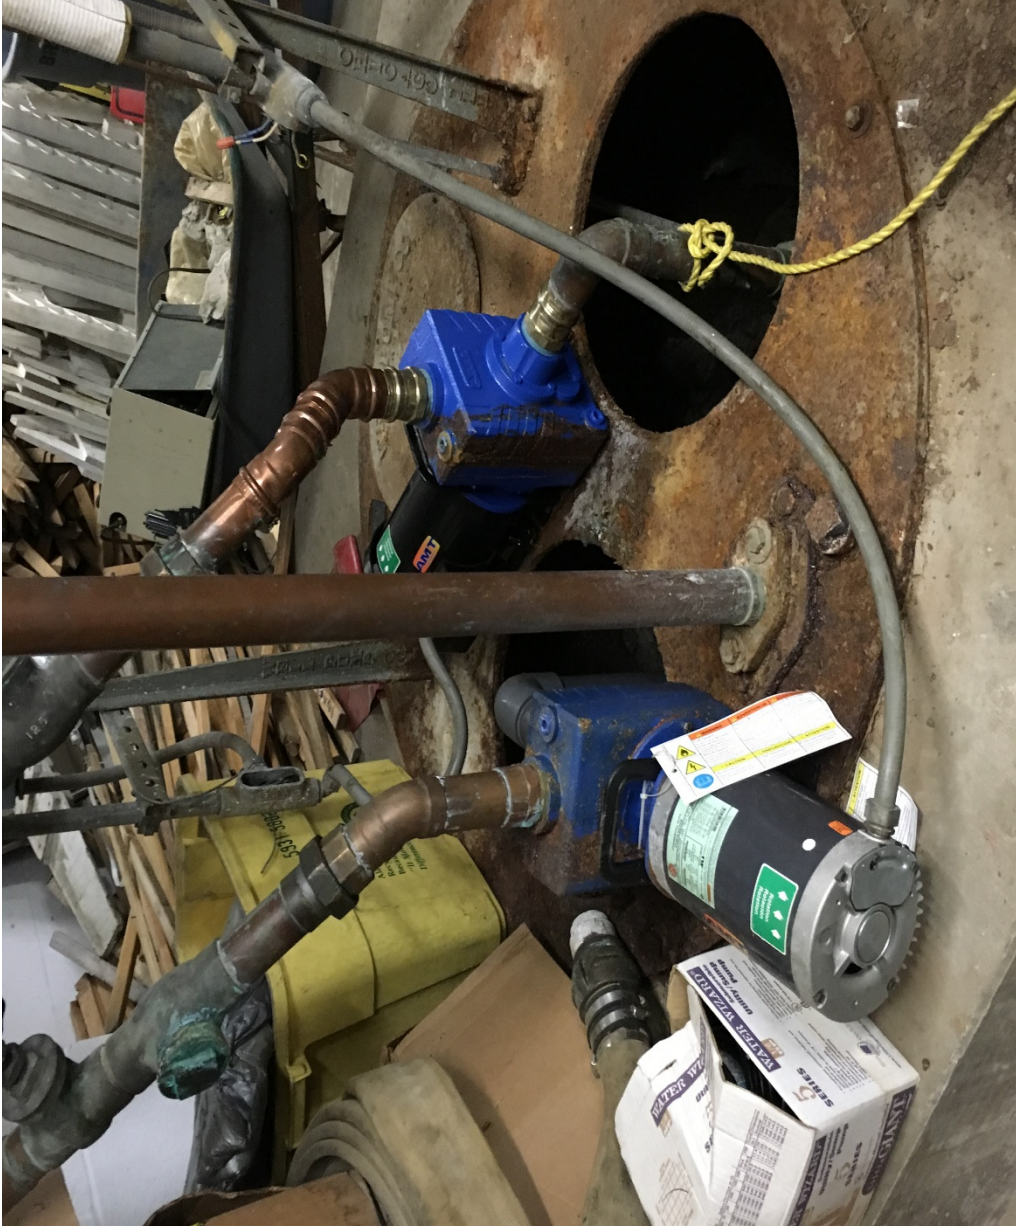
Finding # - 19. Two new sump pumps were recently installed in the upper garage ground water sump. These two pumps are not the correct pump for the application. These two new pumps are standard well pumps with foot valves instead of the correct submersible type pump. The problem is when the foot valve sticks and these pumps loose suction these units will stop pumping.

Finding # 19 Photo. This picture notes the two new pumps being used at the upper garage sump pit. These should have been submersibles.

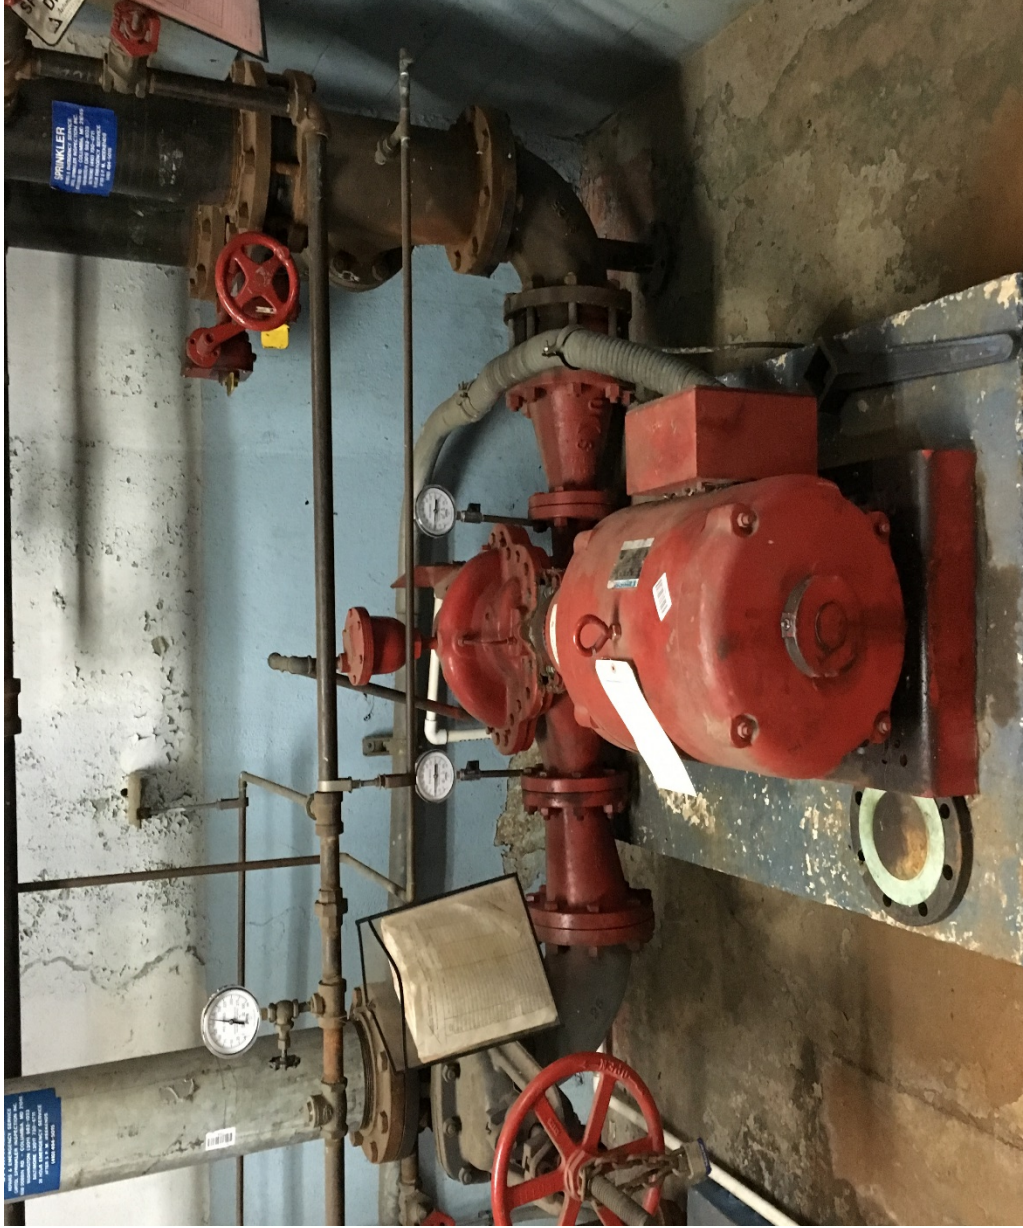
Finding # - 21. The building Fire Pump is located in the boiler room. NFPA code requires that this pump be tested weekly with no flow. An annual flow test to the street is also required. No test tags are shown on the pump showing that this PM was being done. **REVISION - Per DGS an annual inspection had been completed. A2 requests a copy of the report. A2 recommends that the annual test tags be installed to signify the inspection.**

Finding # 21 Photo. This picture notes the fire pump in the boiler room. The pump needs to be tested weekly with no flow and once a year with full flow to the street. This is required to make sure the pump will operate correctly in an actual fire event.

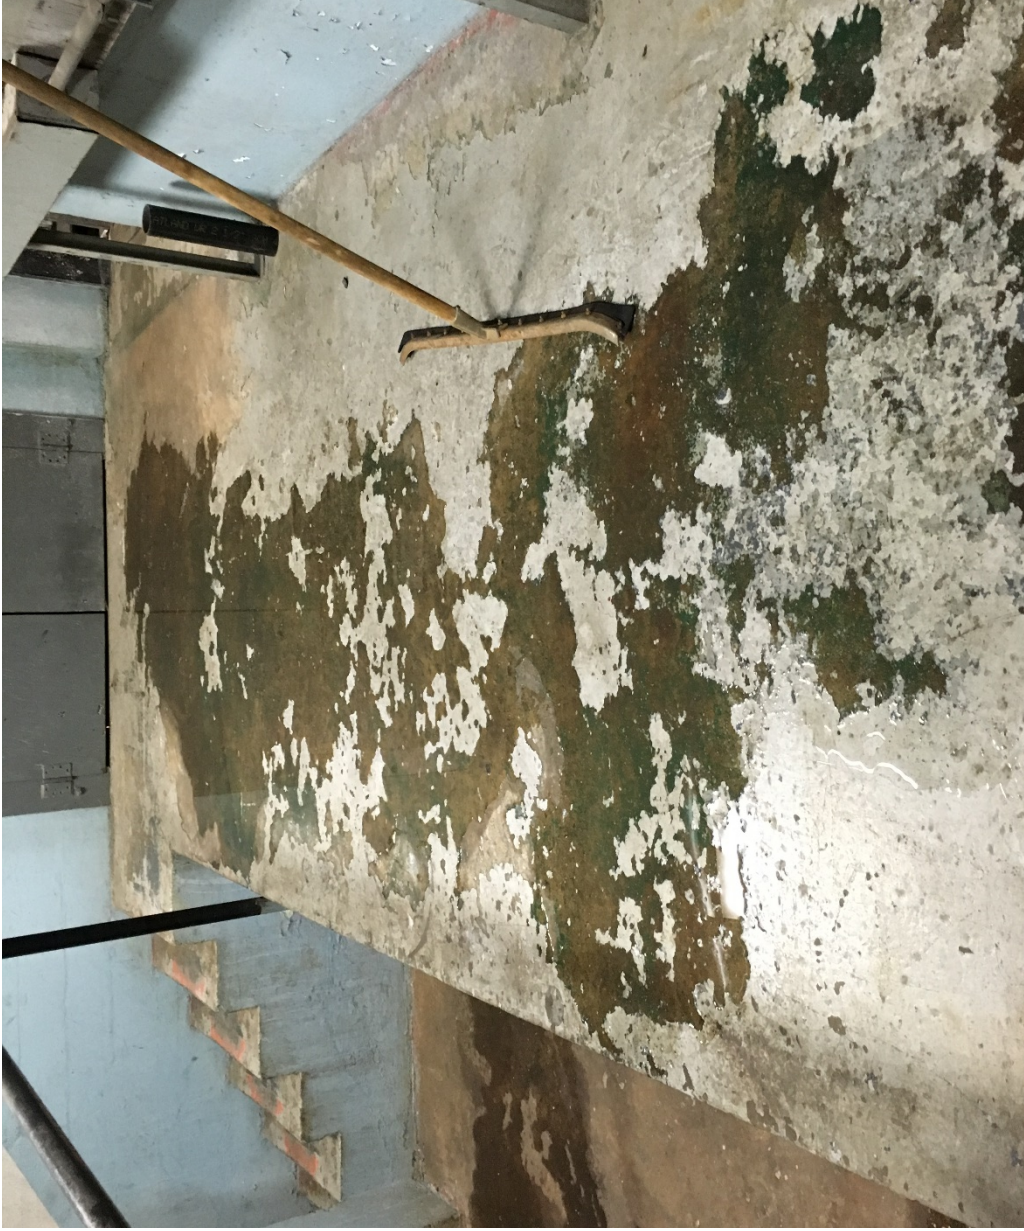
Finding # - 22. Ground water is entering the boiler room through the floor slab at the boilers causing problems. This should be investigated and corrected. This type of water infiltration will damage the building matt slab.

Finding # 22 Photo. This picture notes the water on the boiler room floor which is coming in through the floor slab.

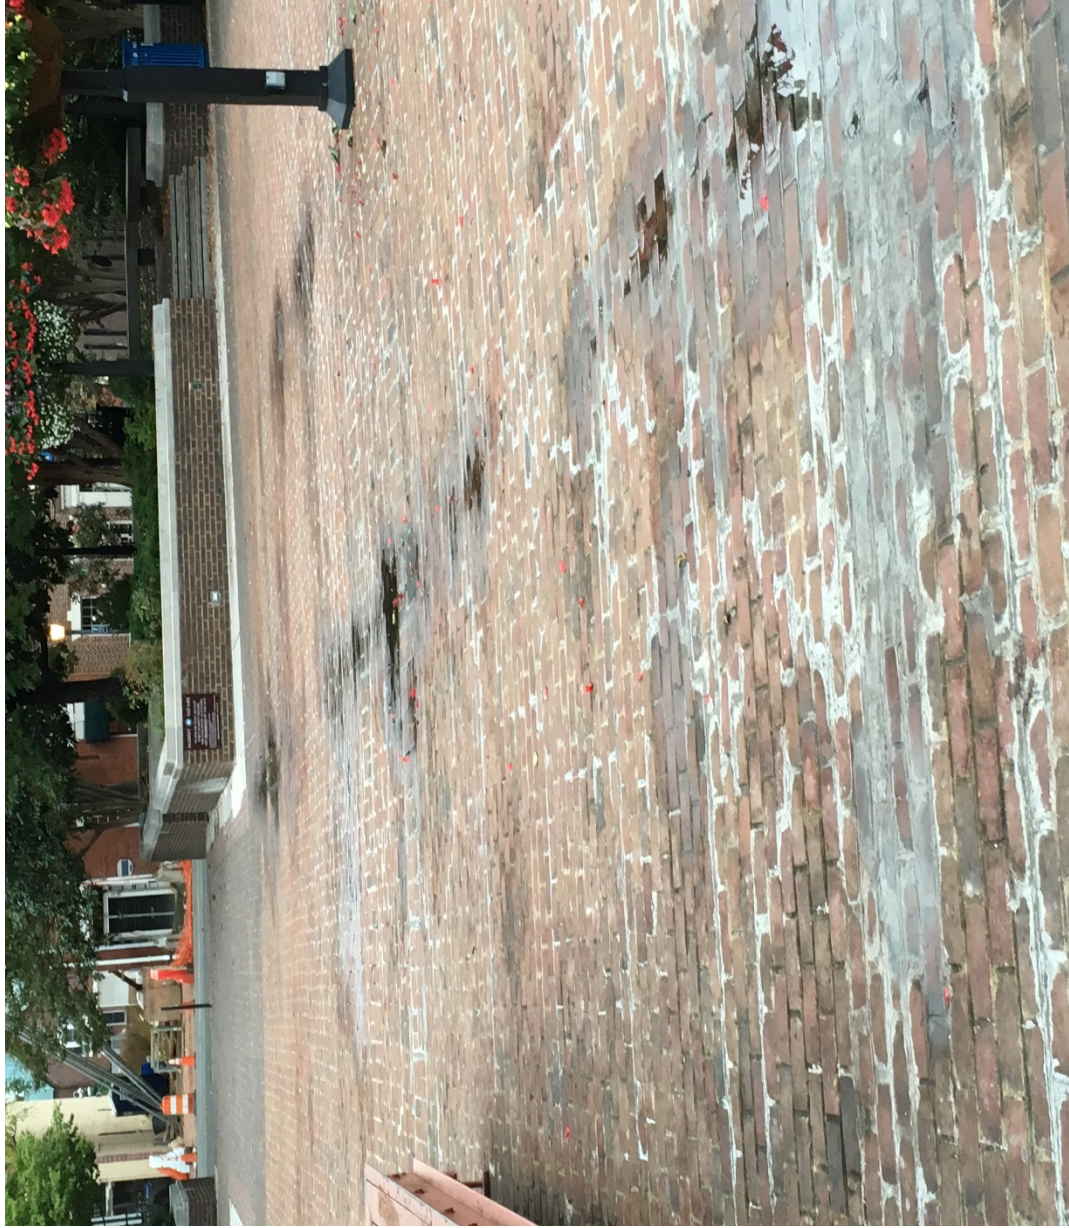
Finding # - 25. The courtyard brick work has a few areas where it looks as if water is also getting into the garage. The water leaks into the garage are causing noticeable damage.

Finding # 25 Photo. This picture notes a section of the brick work on the courtyard deck which looks to be adding to the water issues in the garage.

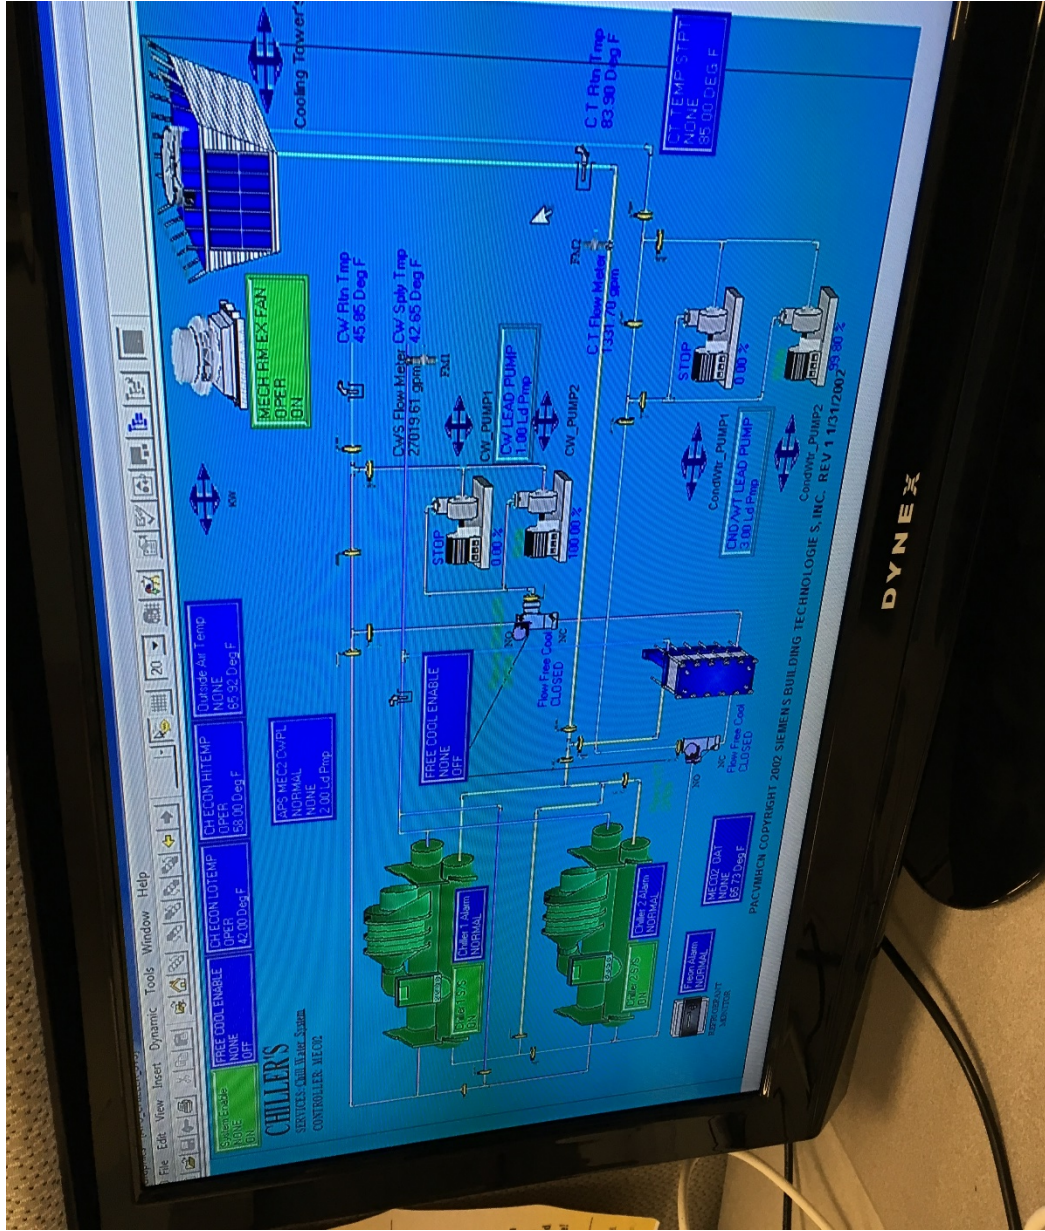
Finding # - 6 This picture notes the chilled water and heating systems differential control via the BAS system. There is no control point for differential pressure. However because the pumps are at 100% speed it appears that there may be a concern with the pump sizing.

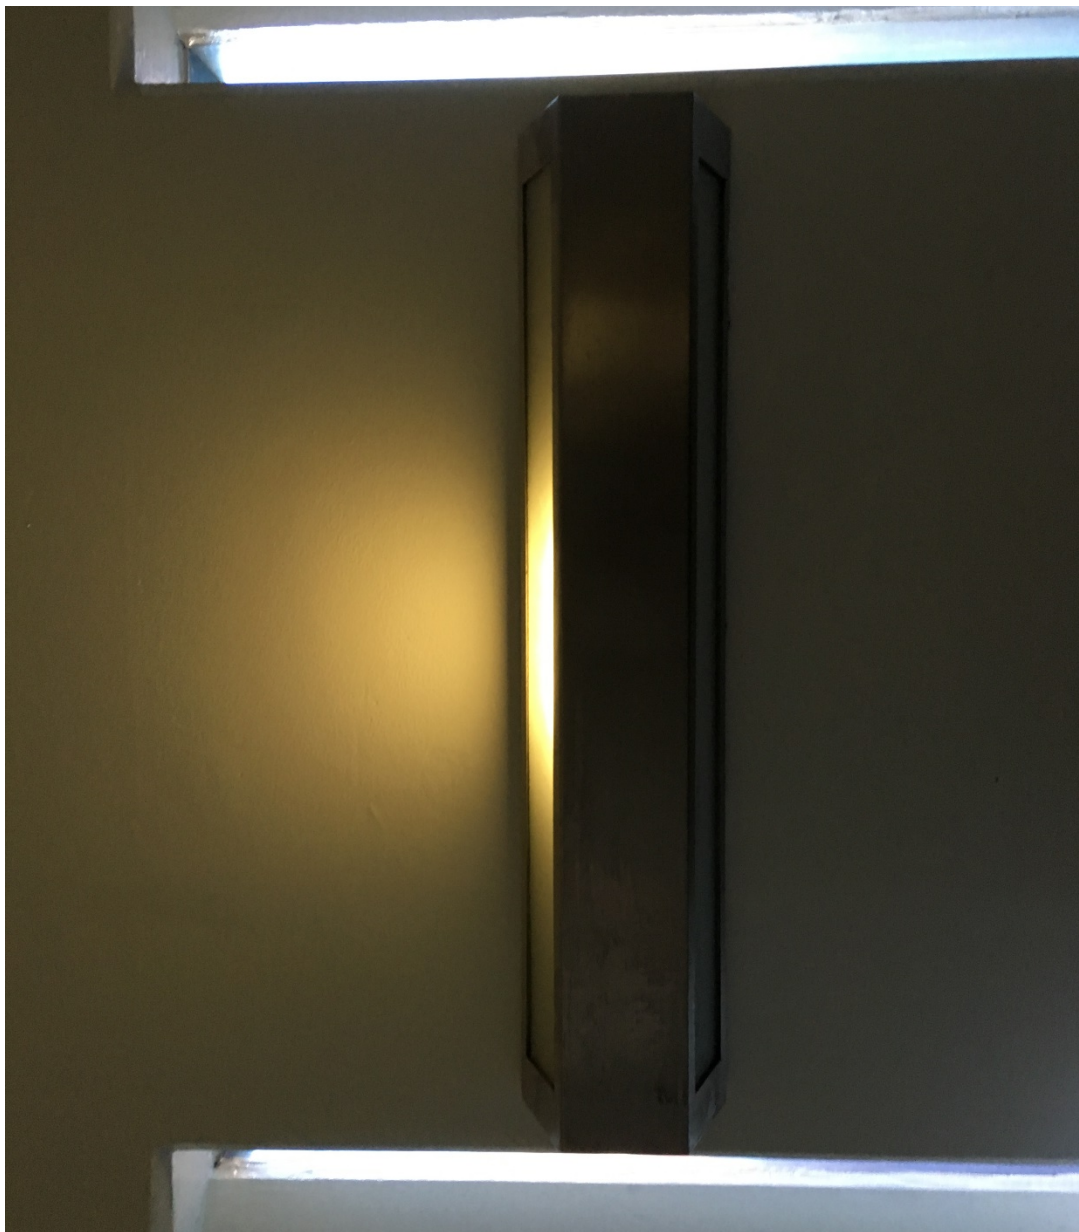
Finding # - 14 The specialized light fixtures in the Cells are outdated. Parts and bulbs are becoming unavailable.

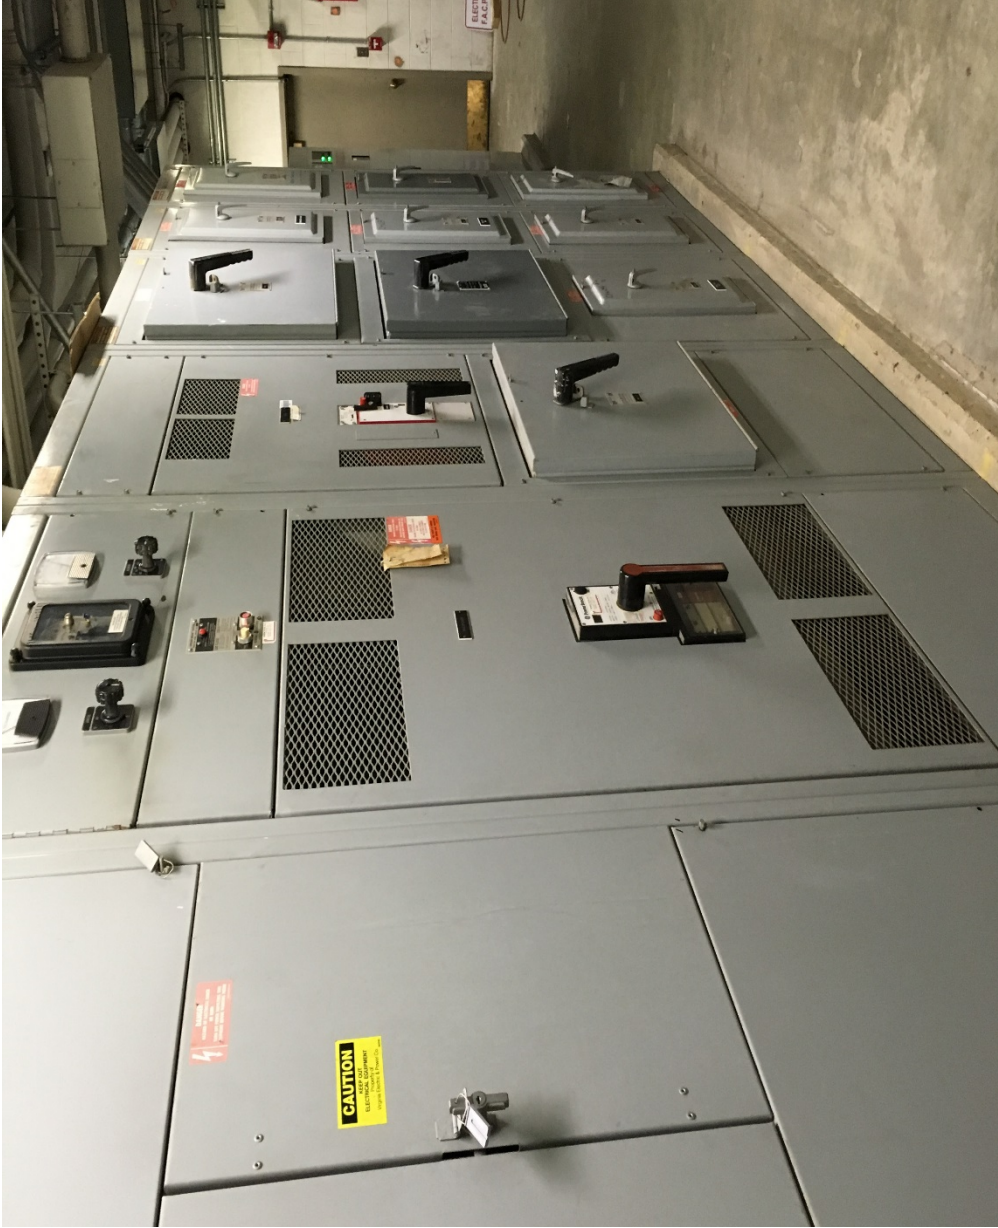
Finding # - 15 There is no inspection stickers noting that the electrical system maintenance has been completed.

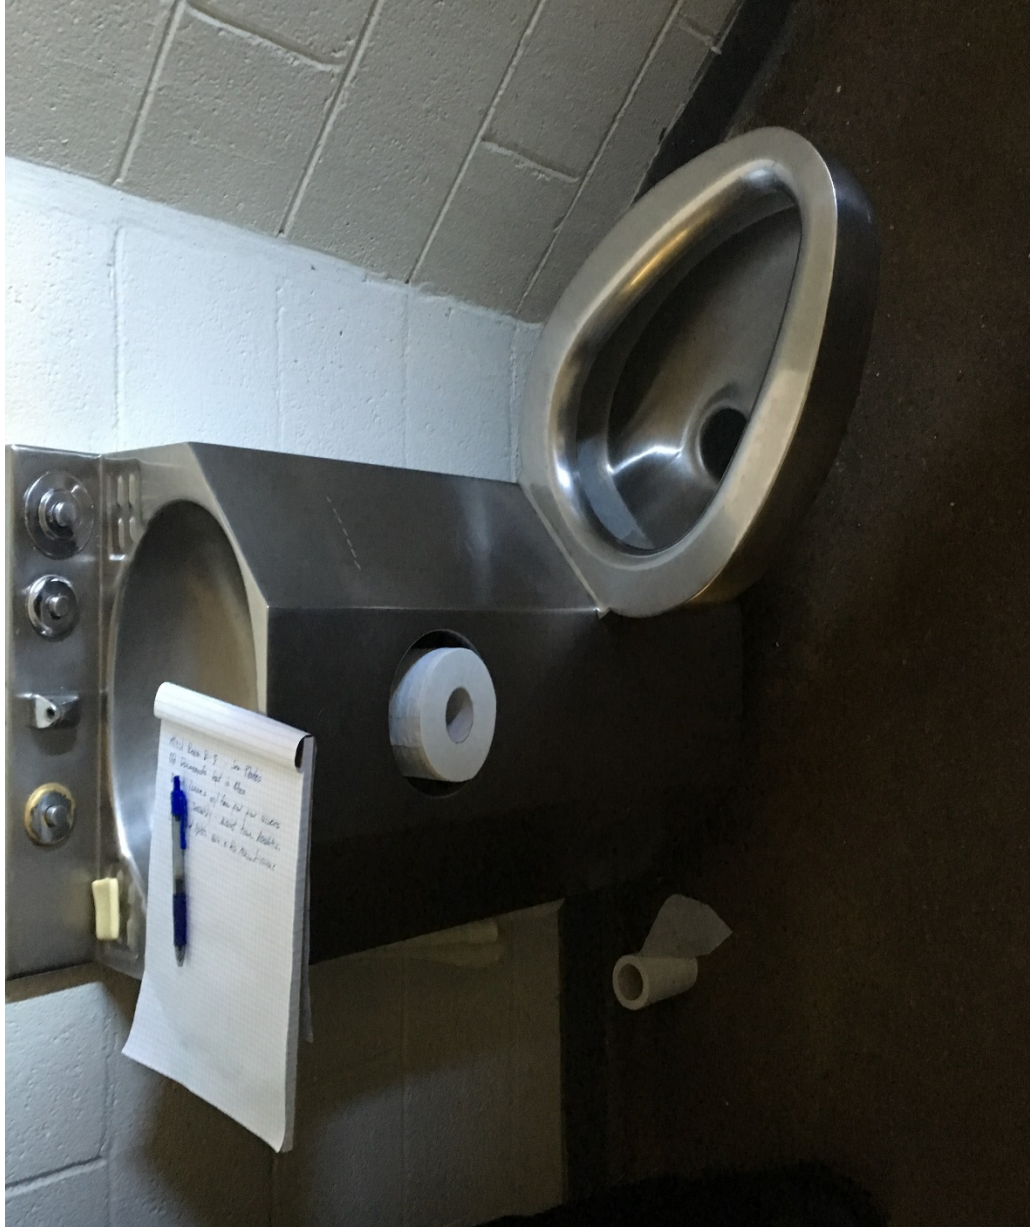
Finding # - 21 This picture is of the toilet sink combination used in the jail cells. It may be possible to retro-fit these with faucets and flush valves that would be off the shelf items.
