**FROM: JOINT CITY-SCHOOLS FACILITY INVESTMENT TASK FORCE
Lynn Hampton, Chair, Mignon Anthony¹, Elliott Branch, Micheline Castan-
Smith, Marshall Cook, Dwight Dunton, Amy Liu, Dave Millard, Eric Wagner**

SUBJECT: TASK FORCE FINAL REPORT (DELIVERABLE 2 OF 2)

A2 Services, Inc. Facility Survey of City of Alexandria - City Hall

A2 Services, Inc.
Facility Survey of the City of Alexandria – Public Safety Center

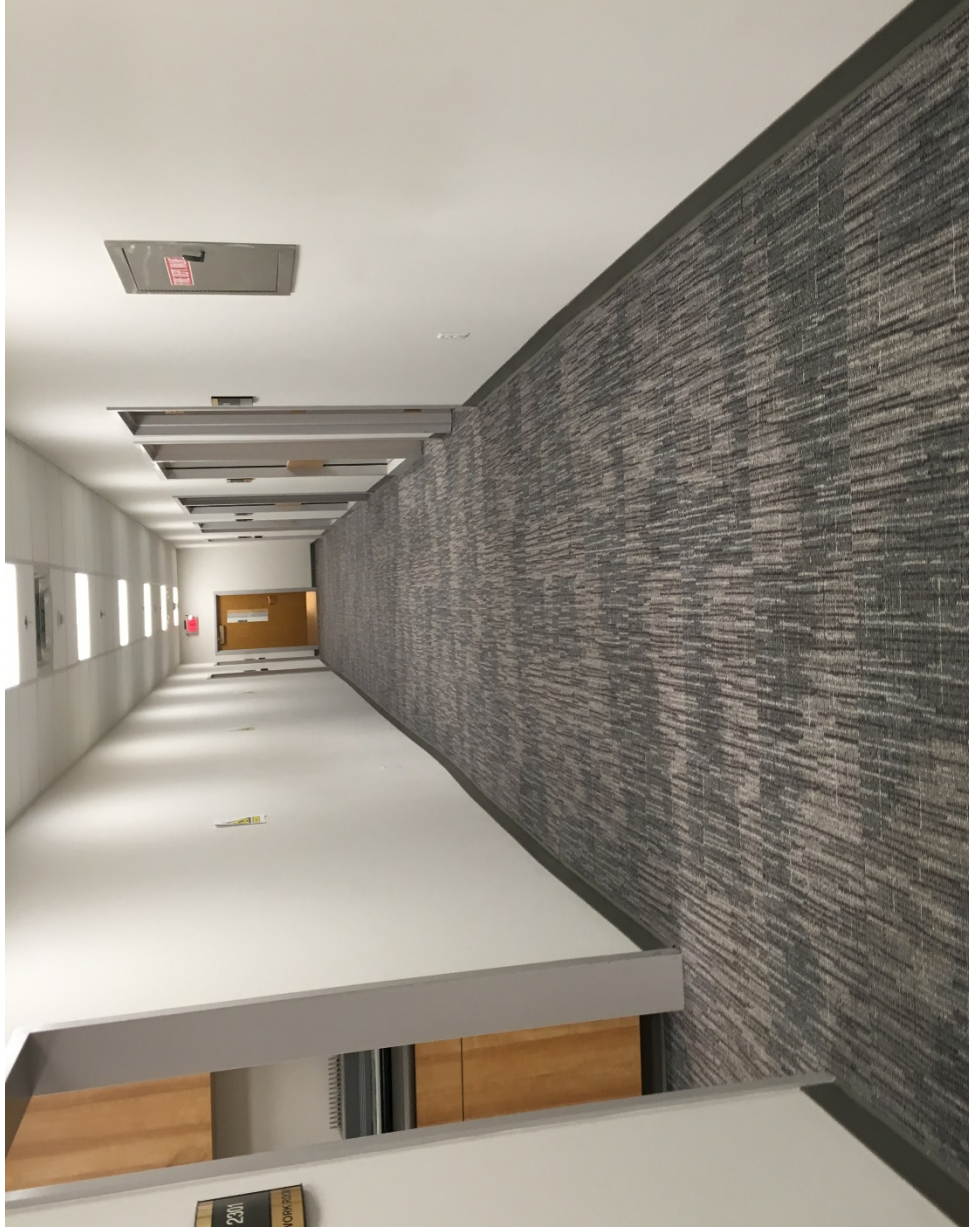
Finding # - 28 This picture is of one area in the sheriff's office building where the concrete floor slabs appear not to be level.

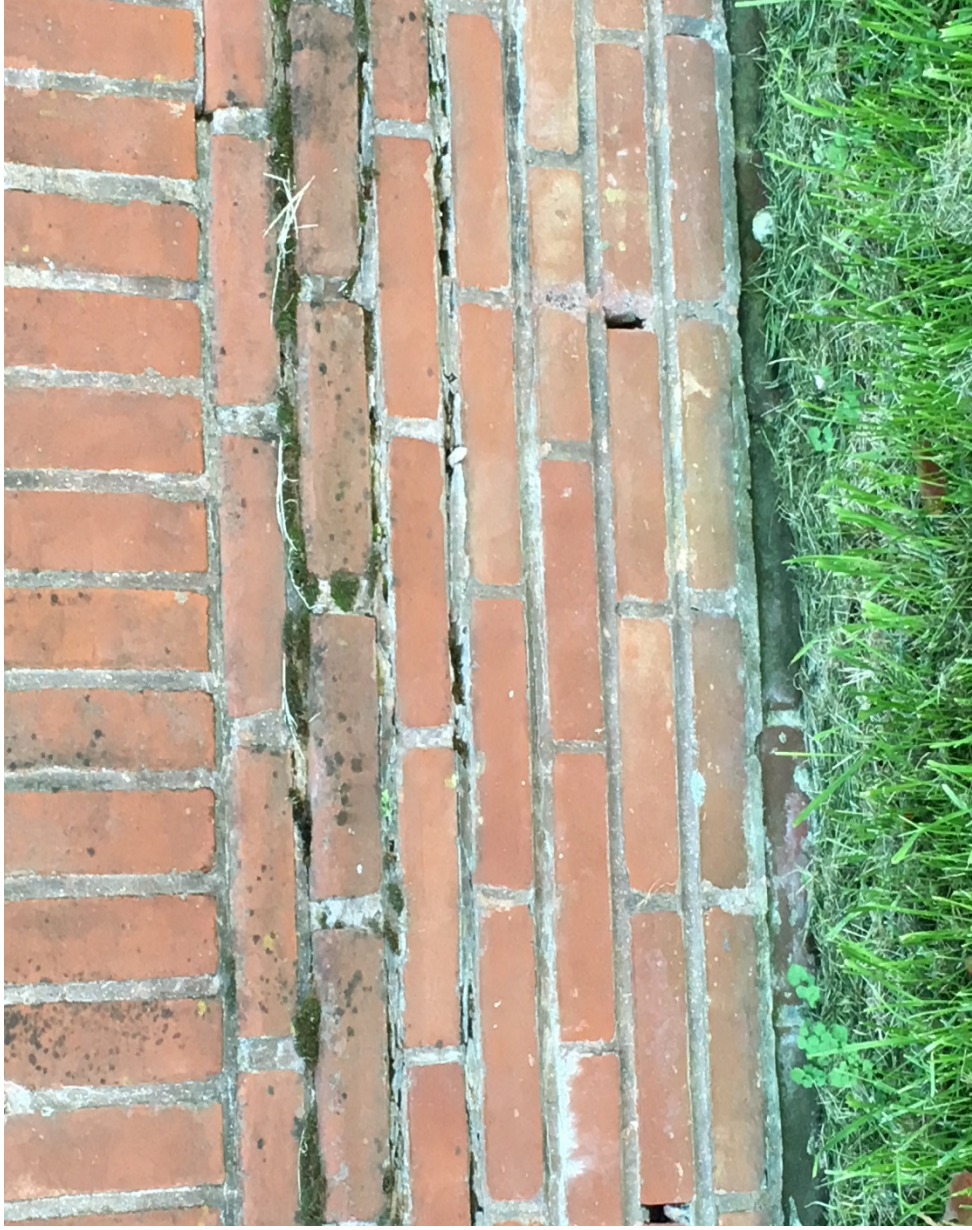
Finding # - 31 This picture is of an area of the brick façade on the north side of the sheriff's building which should be tuck-pointed. This area is just below the window shown above.

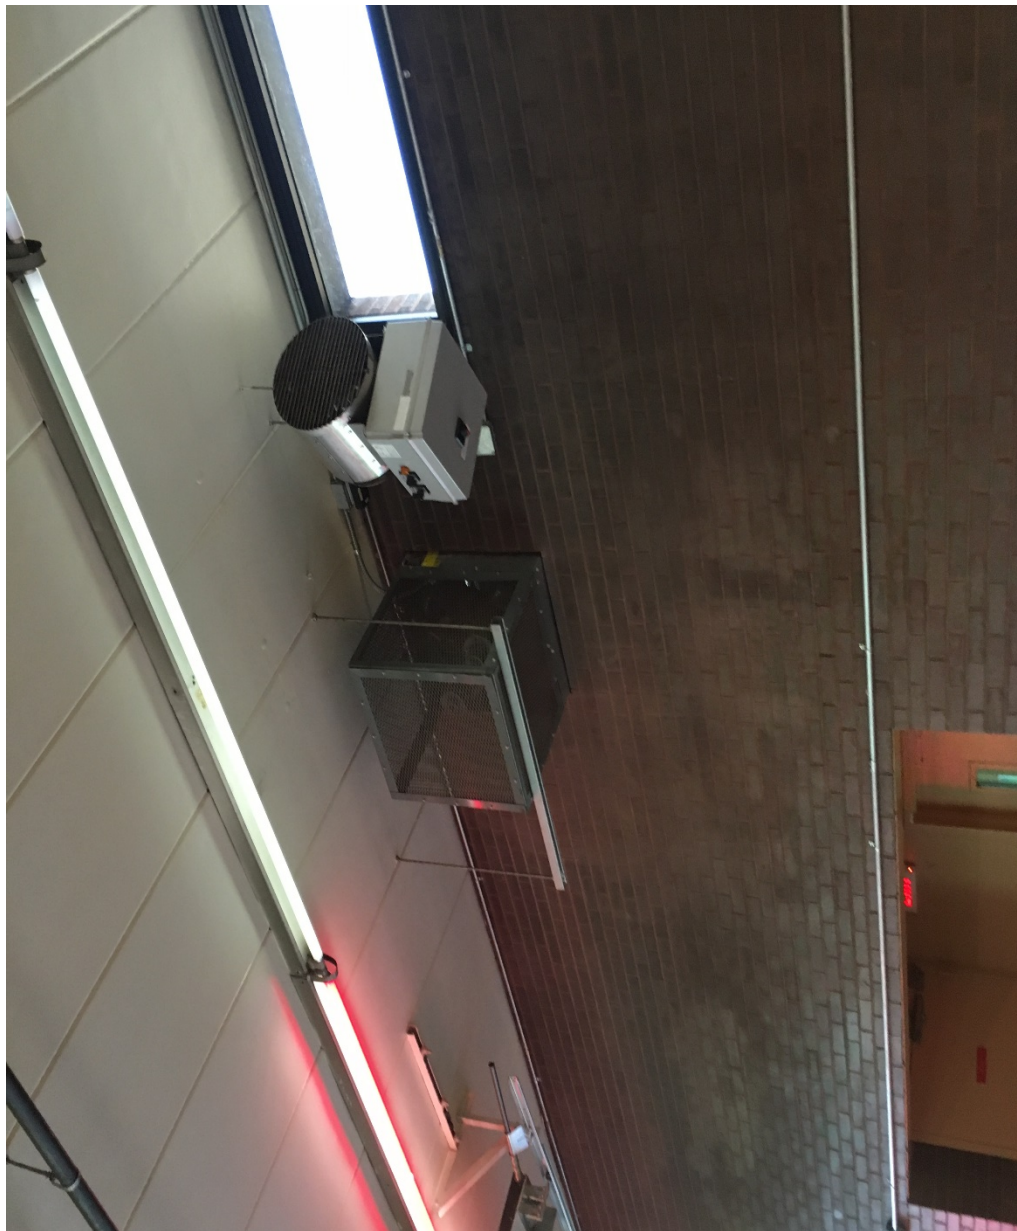
Photo # - 1. This picture is of the wall mounted engine exhaust fan which removes the truck exhaust fumes from the engine bay.

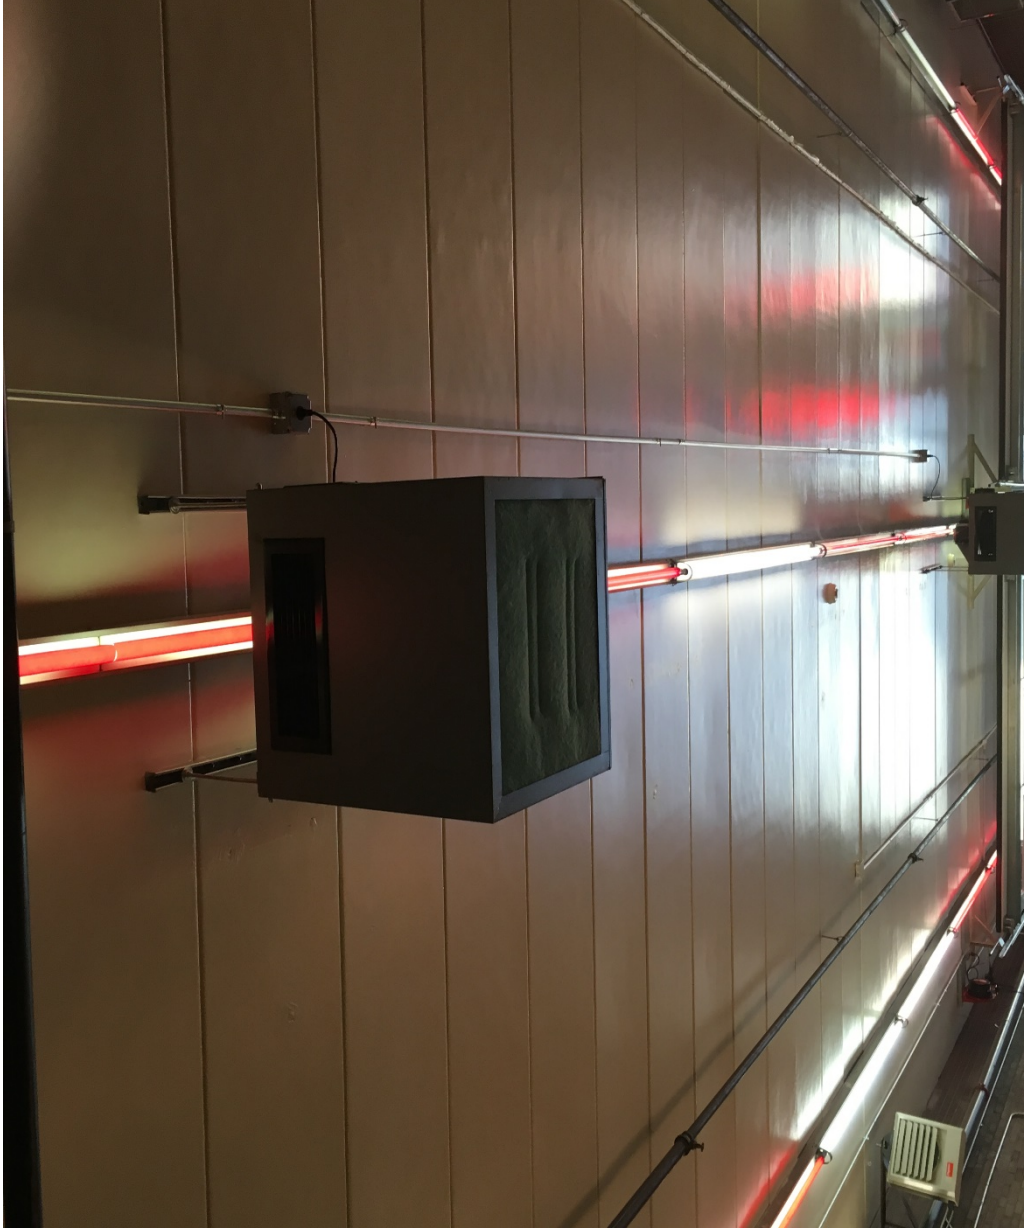
Photo # - 2. This picture is of one of the main electric unit heaters which heat the engine bay area.

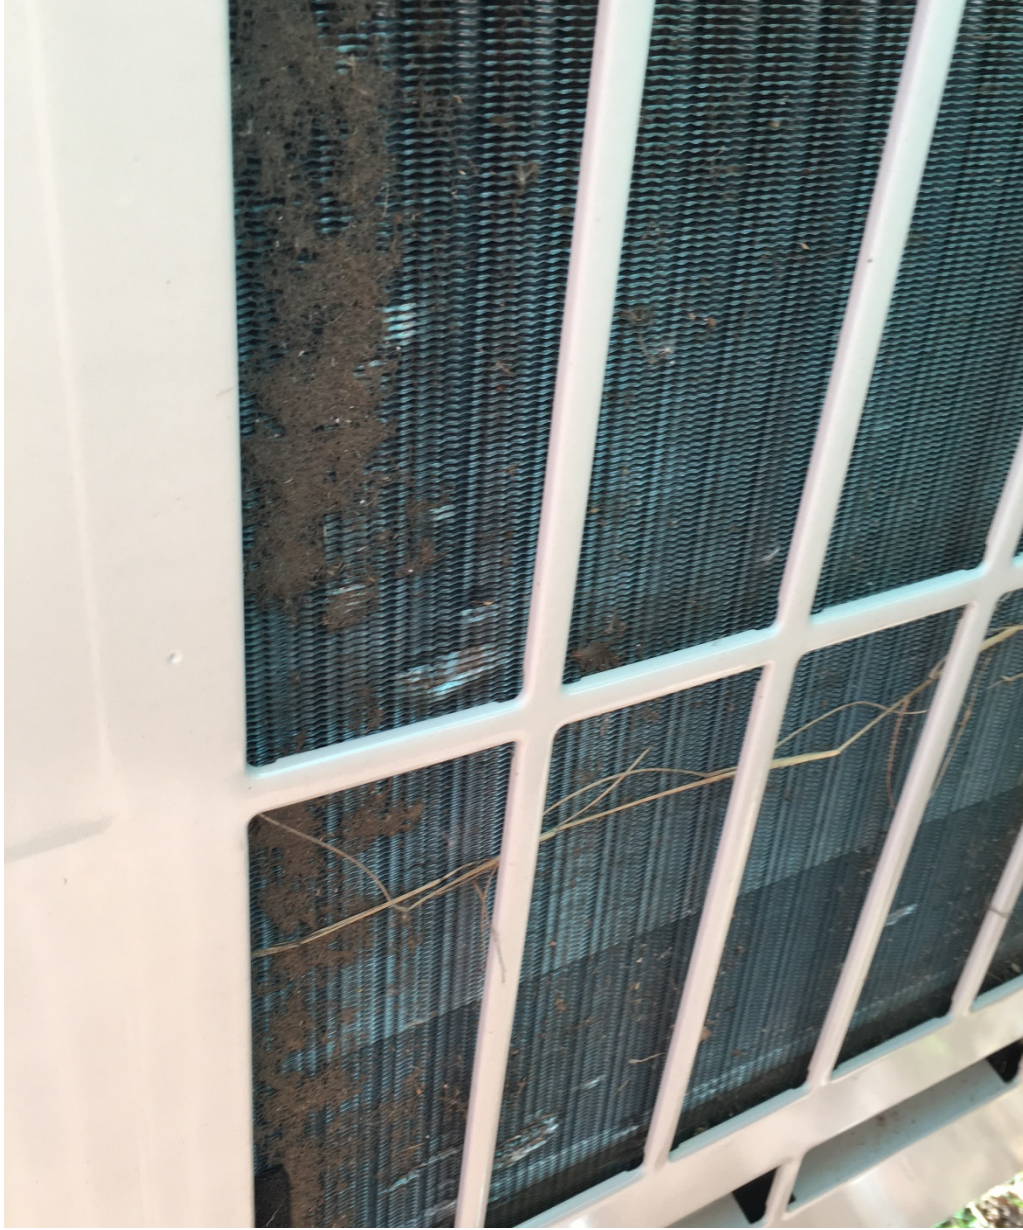
Photo # - 3. This picture is of one of the VRF condensing coils which needs to be cleaned. Clean coils on an air cooled split system is critical to efficient heating and cooling.

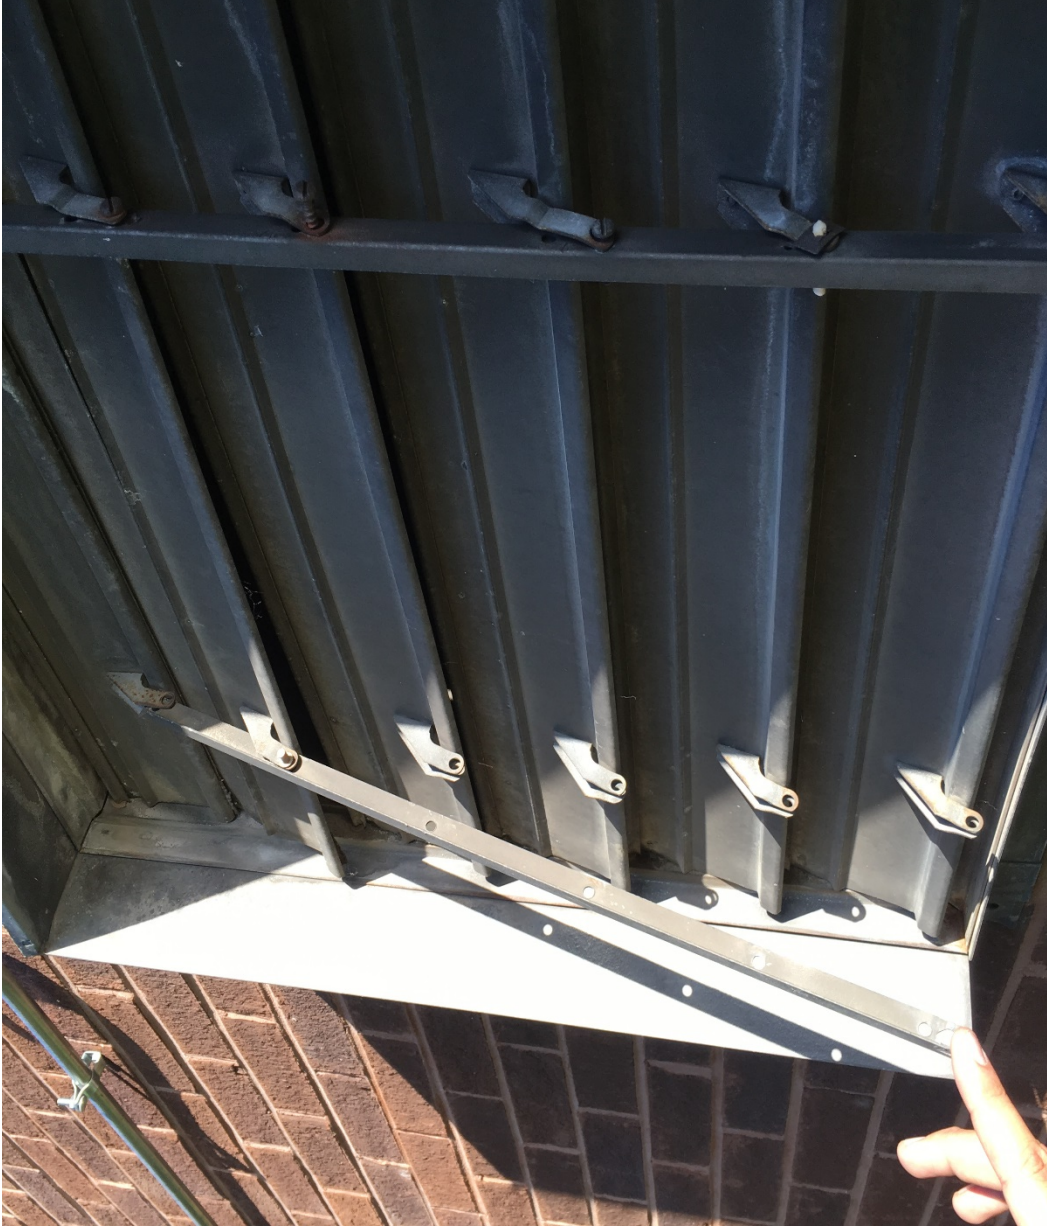
Photo # - 4. This picture is of the mechanical room exhaust fans backdraft damper which is falling apart.

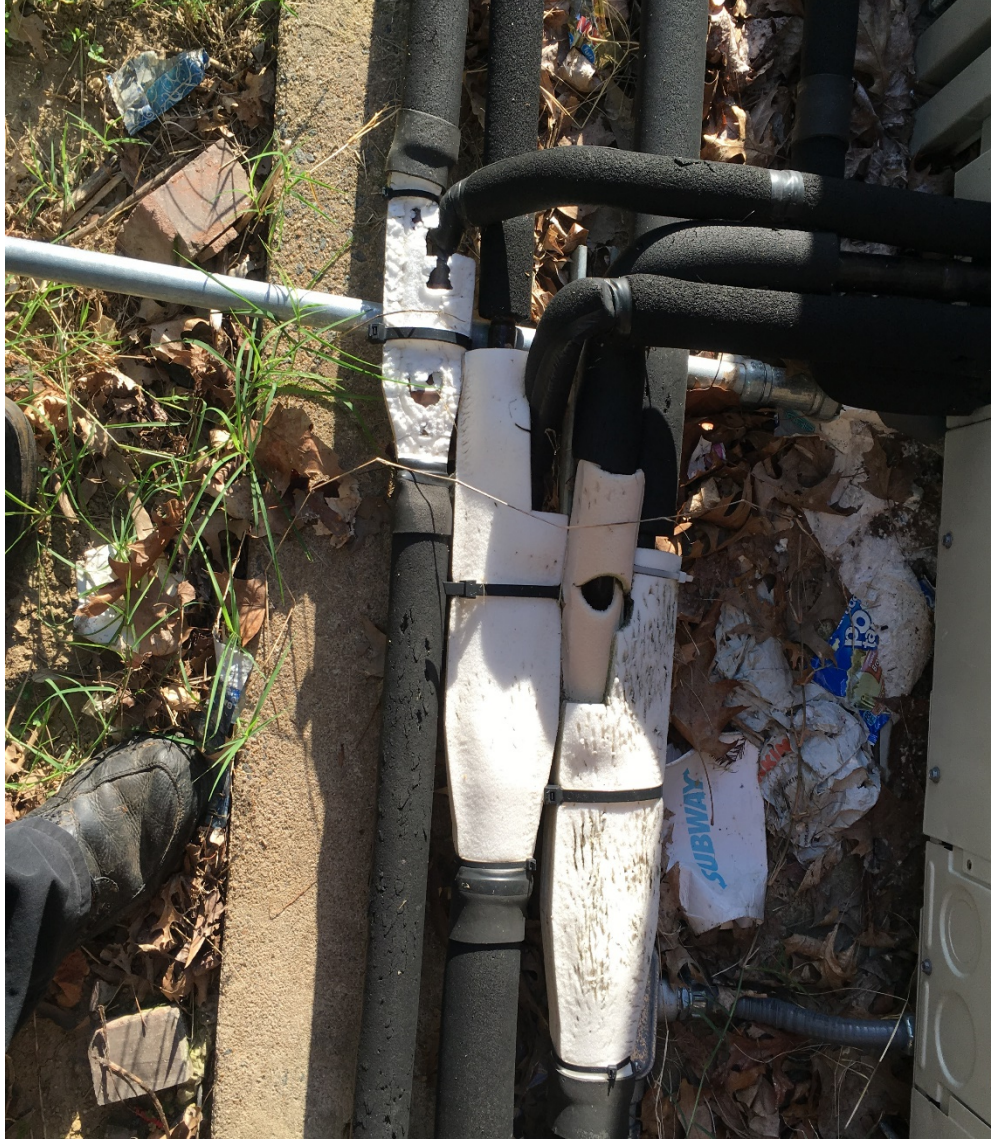
Photo # - 5. This picture notes the refrigerant piping where the thermal insulation has failed. The white sections need to be replaced and then all the outdoor piping needs to be wrapped in vinyl.

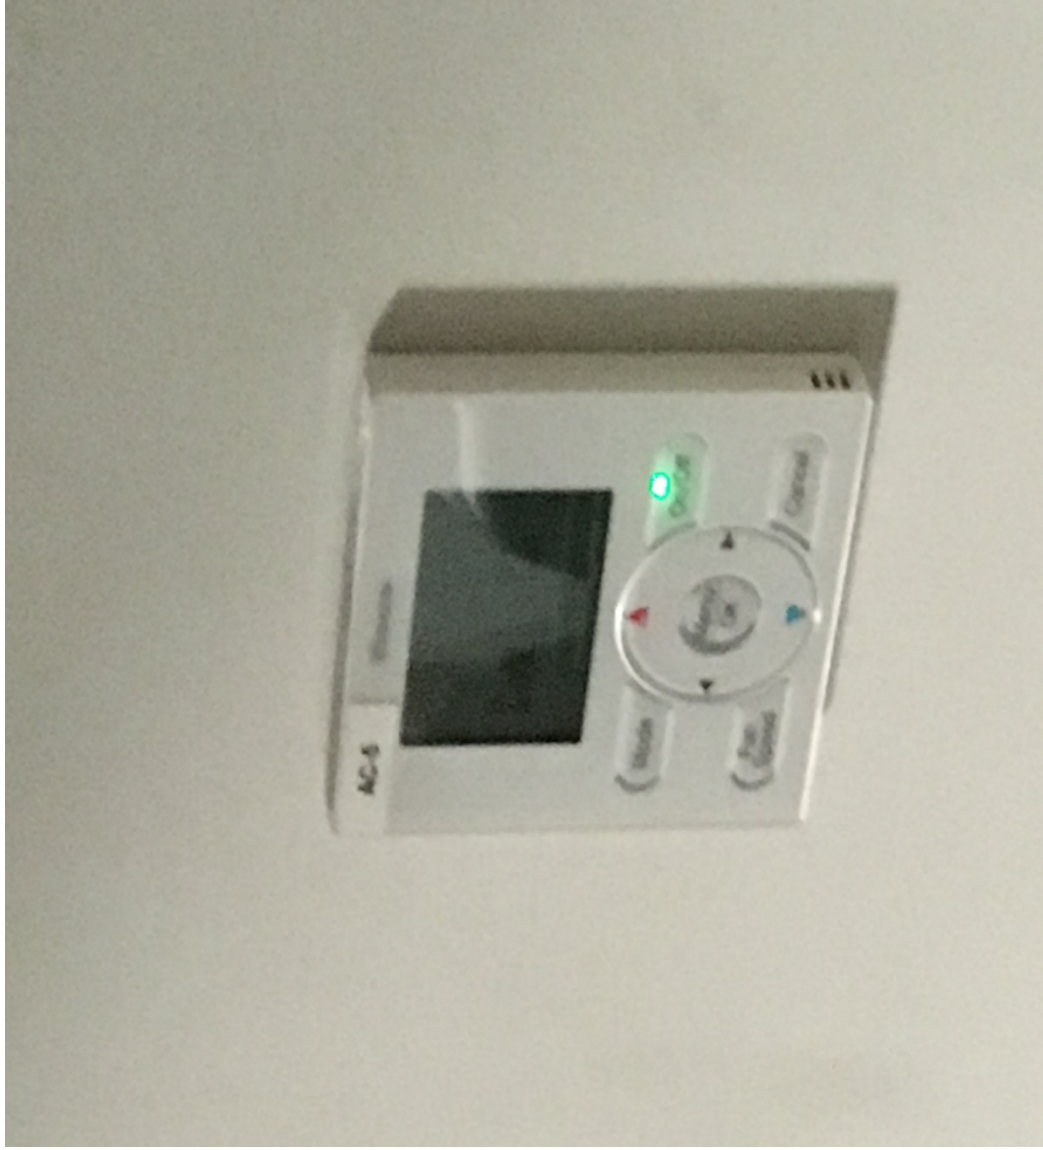
Photo # - 6. This picture is of the thermostat for the weight room which also controls the unit next door in the storage area. Installing one new t-stat on the unit next door will help control temperatures in both areas.

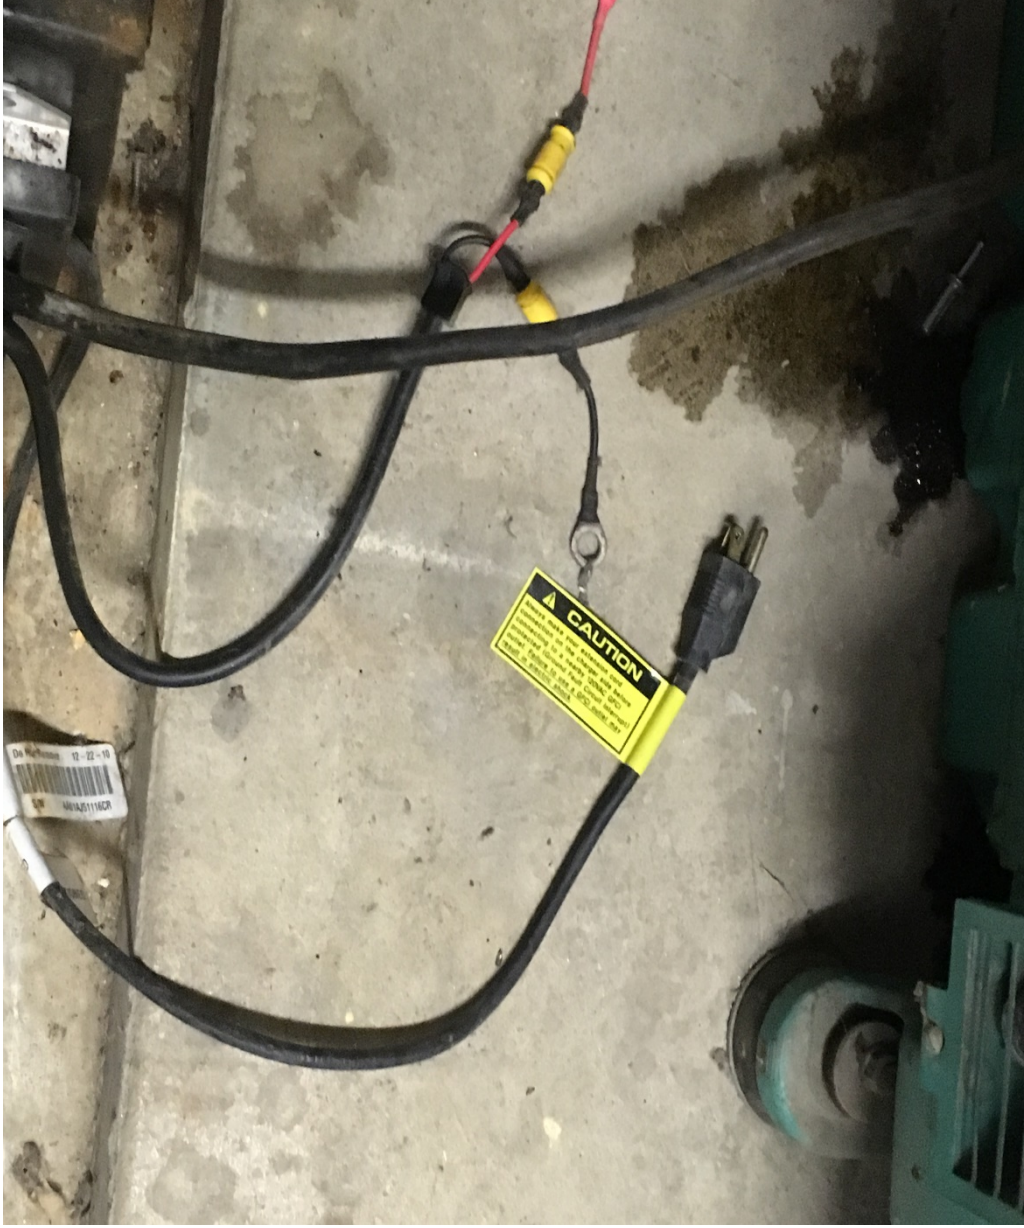
Photo # - 7. This picture is of the power disconnected from the emergency generator battery charger.

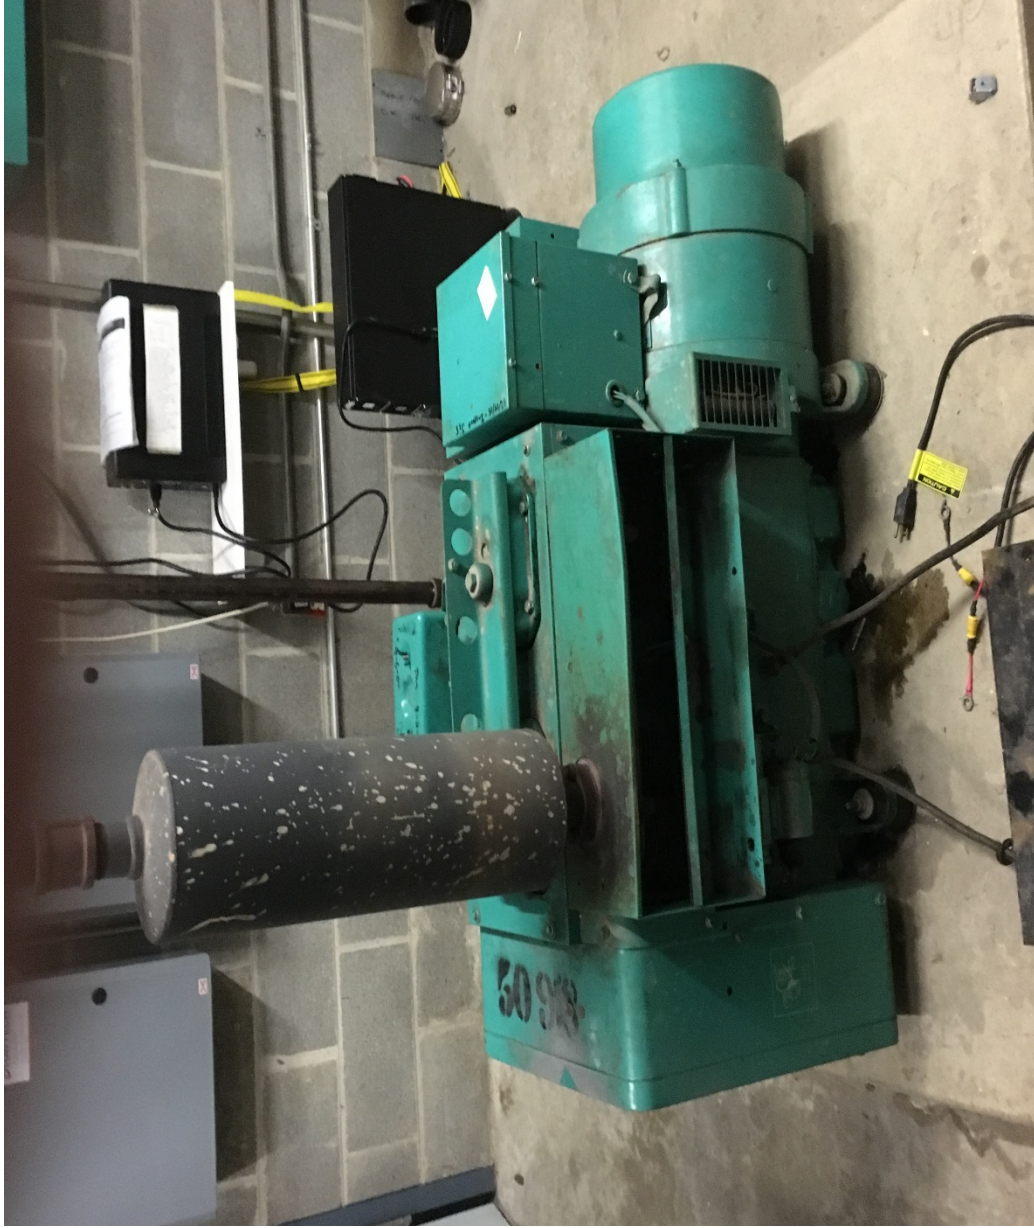
Photo – 8 and 9. This picture is of the gas fired emergency generator. This is not sized to handle the whole facility and has not been tested under load.

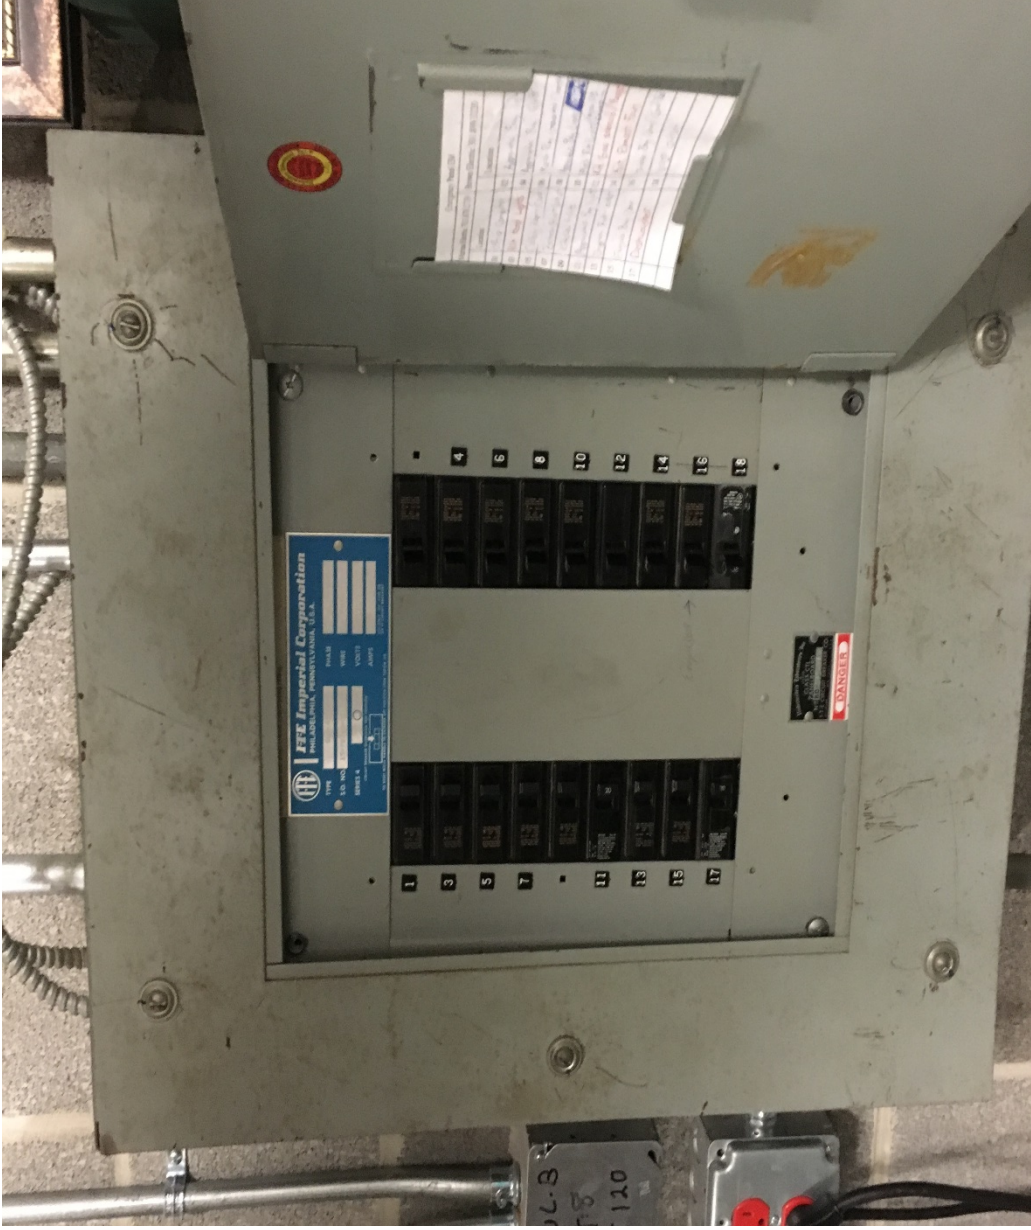
Photo # - 10. This picture is an example of one electric panel which should be thermally scanned, cleaned and tightened up annually.

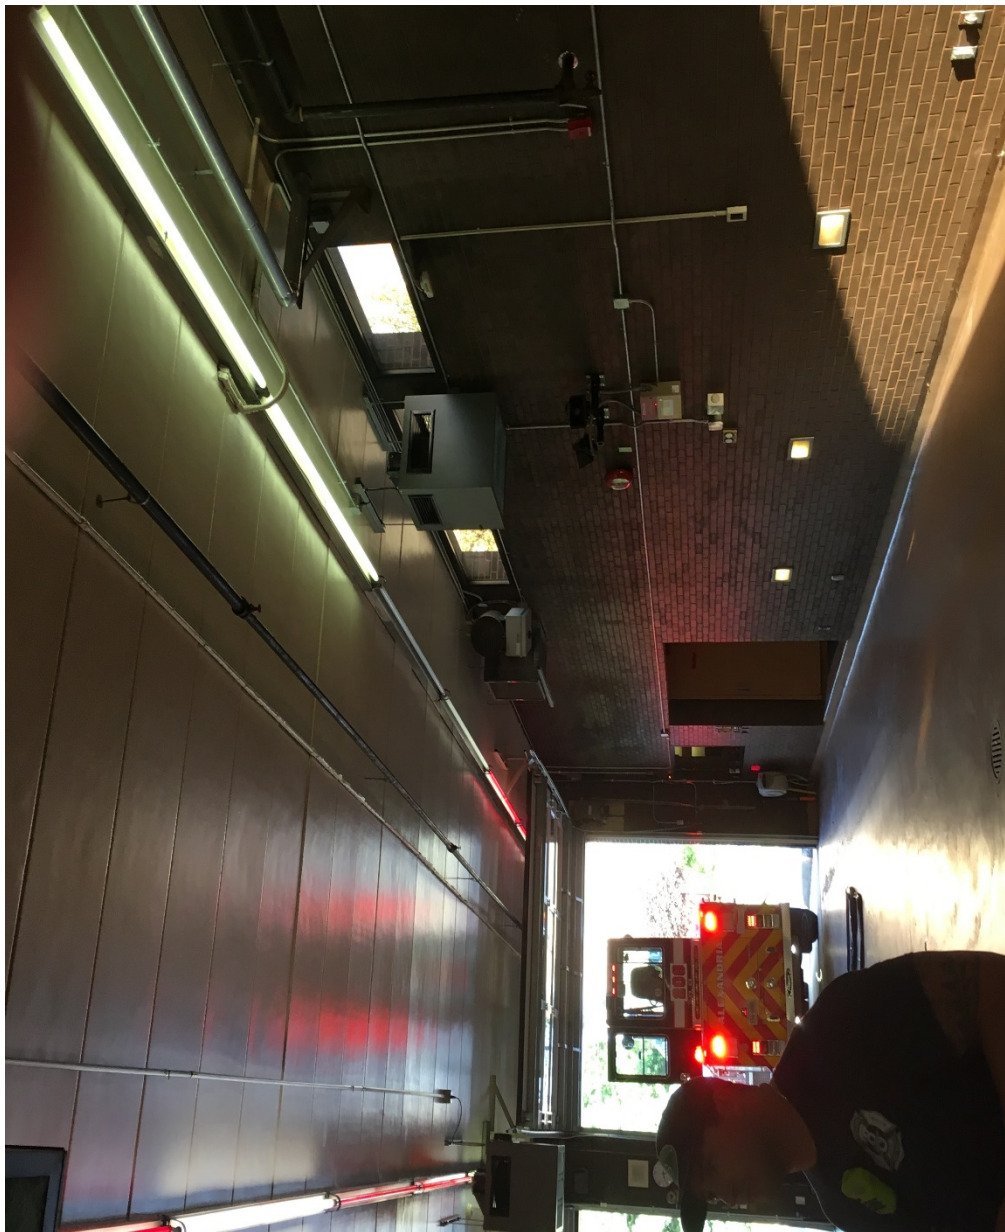
Photo # - 11. This picture is of the engine bay ceiling area where the roof is leaking.

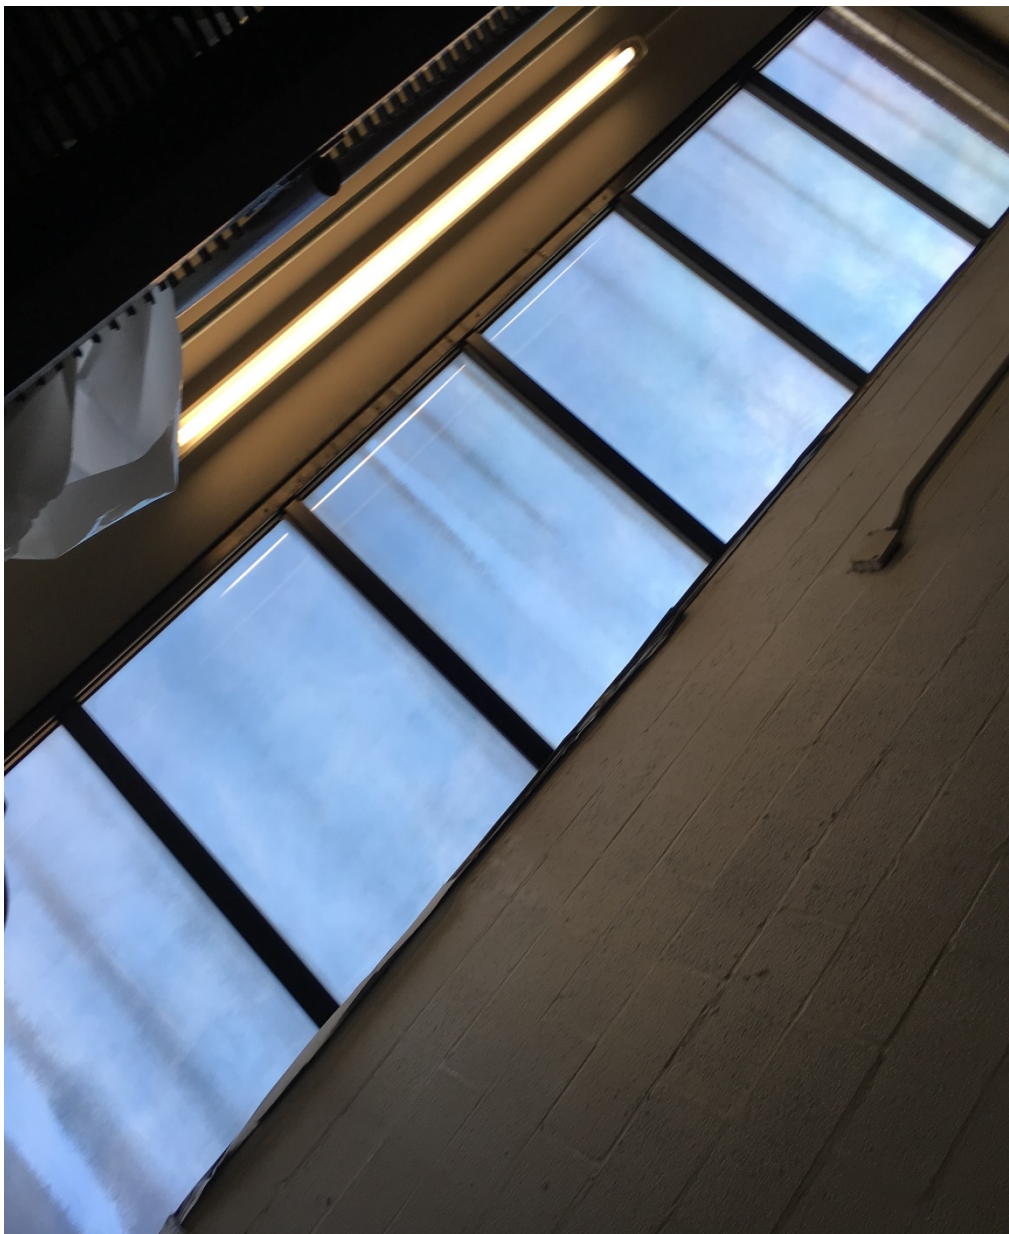
Photo – 12. This picture is of the firemen's equipment and gear room skylight which is leaking on the equipment.

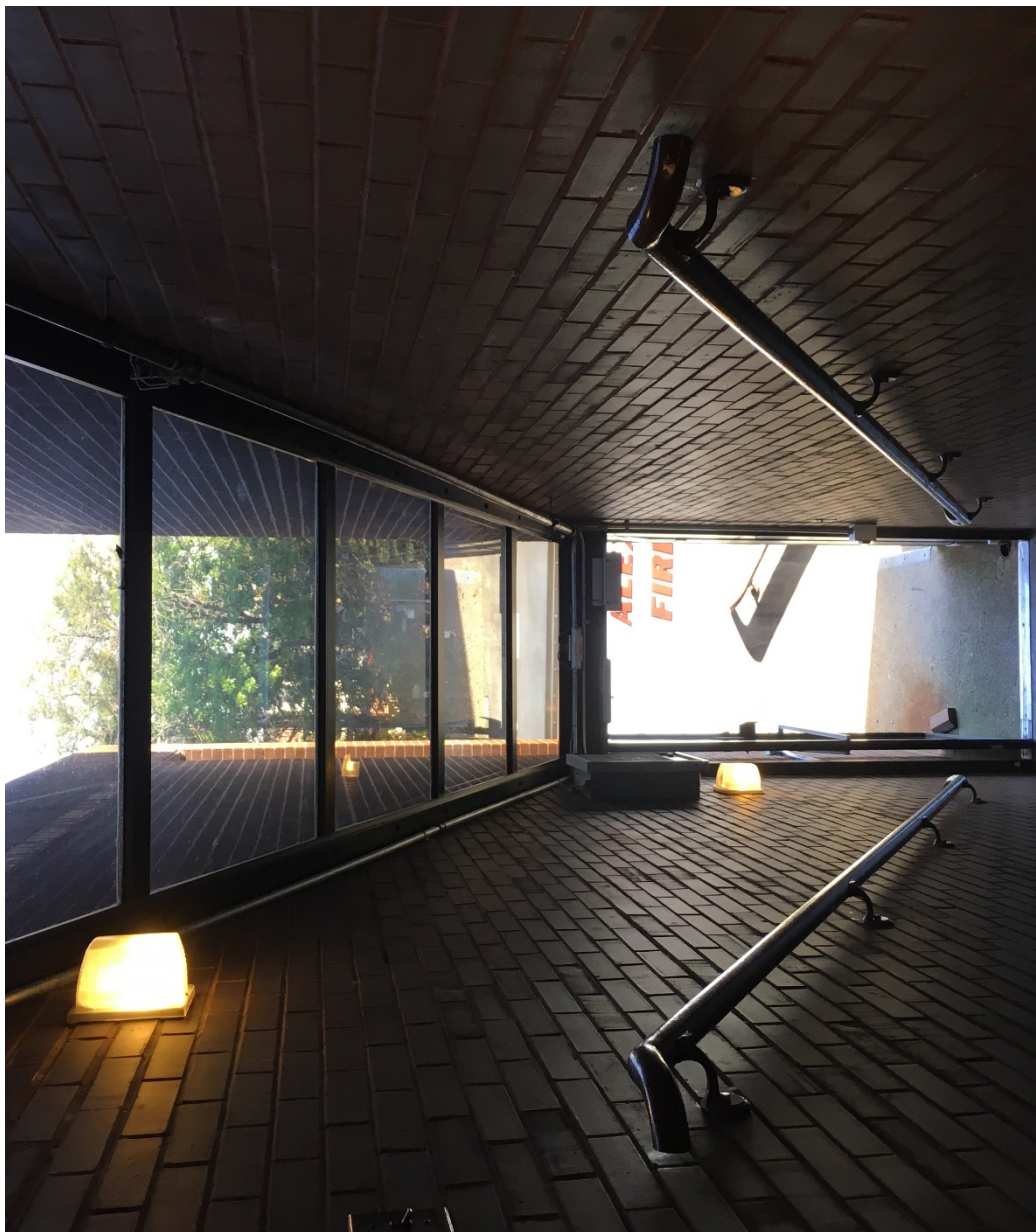
Photo – 13. This picture notes the second skylight in the stairwell which is also leaking.

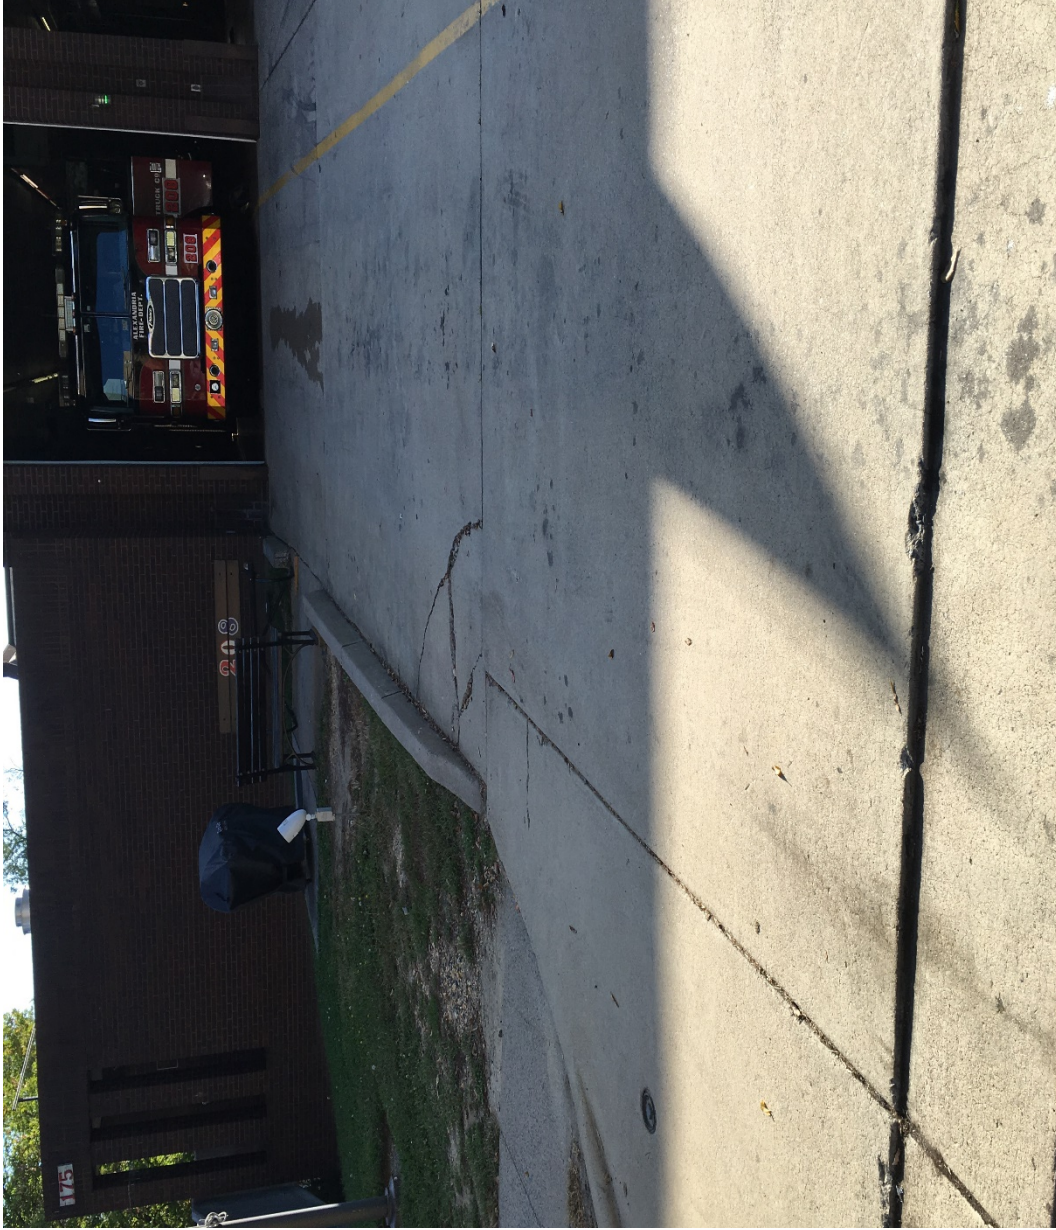
Photo – 14. This picture notes the concrete driveway damage which will need repair.

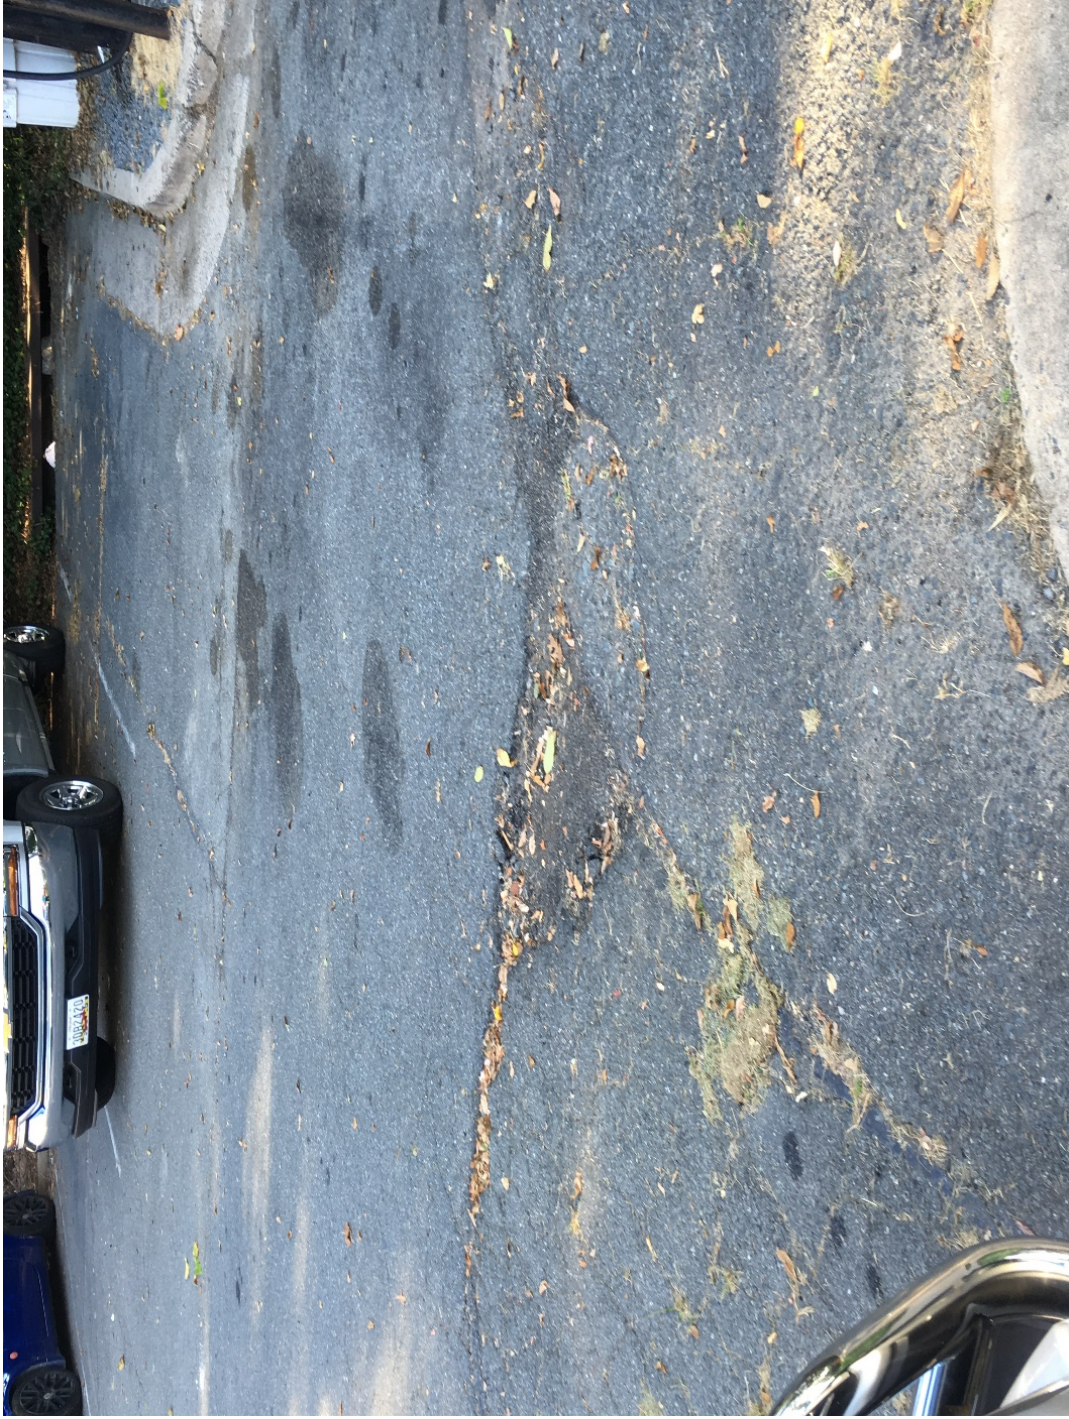
Photo – 15. This picture is an example of the cracked and damaged asphalt at the parking lot area.

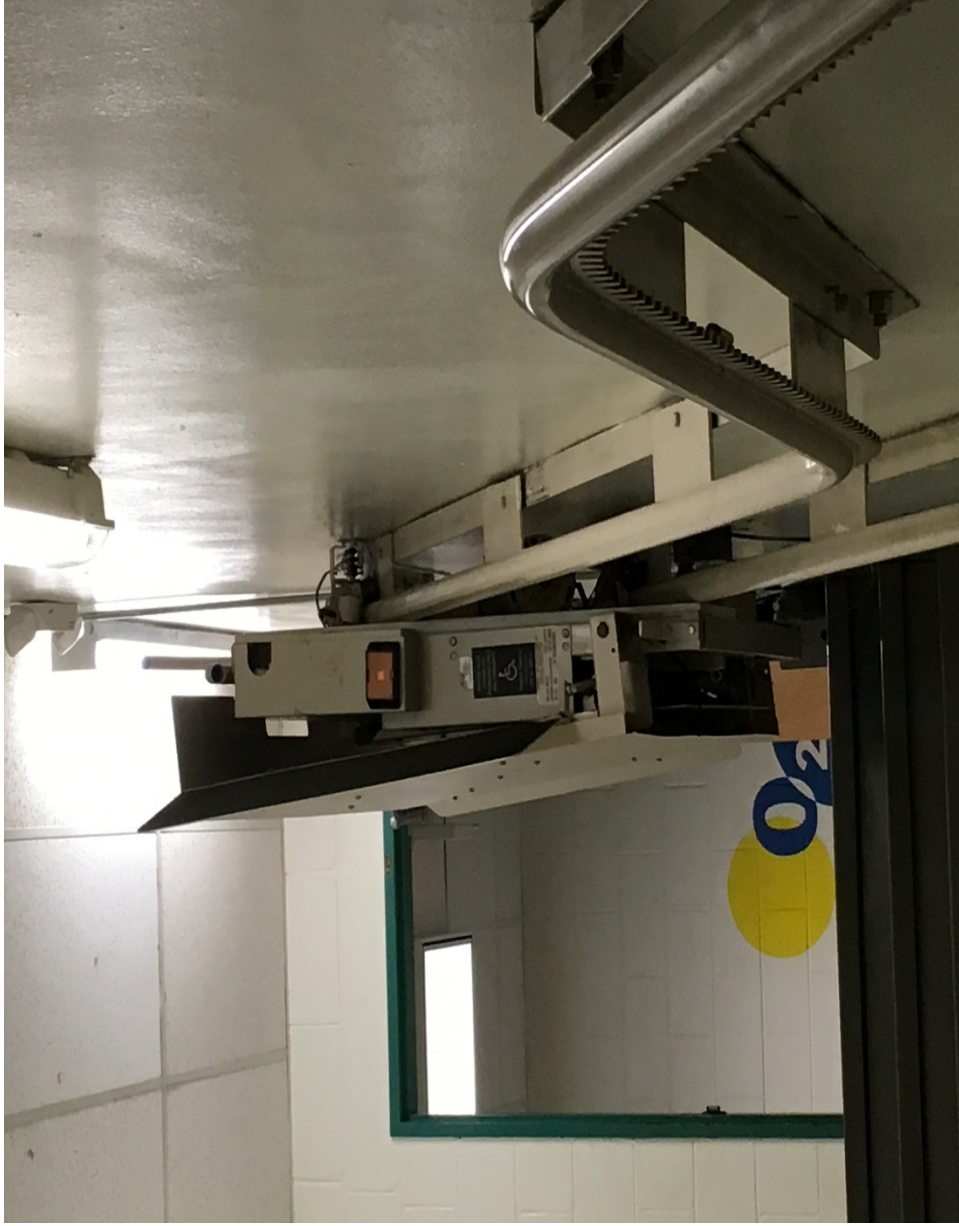
Finding # - 1. This picture shows the failed stair lift which will need to be replaced.
