**FROM: JOINT CITY-SCHOOLS FACILITY INVESTMENT TASK FORCE
Lynn Hampton, Chair, Mignon Anthony¹, Elliott Branch, Micheline Castan-
Smith, Marshall Cook, Dwight Dunton, Amy Liu, Dave Millard, Eric Wagner**

SUBJECT: TASK FORCE FINAL REPORT (DELIVERABLE 2 OF 2)

A2 Services, Inc. Facility Survey of City of Alexandria - City Hall

A2 Services, Inc.
Facility Survey of the City of Alexandria – Public Safety Center

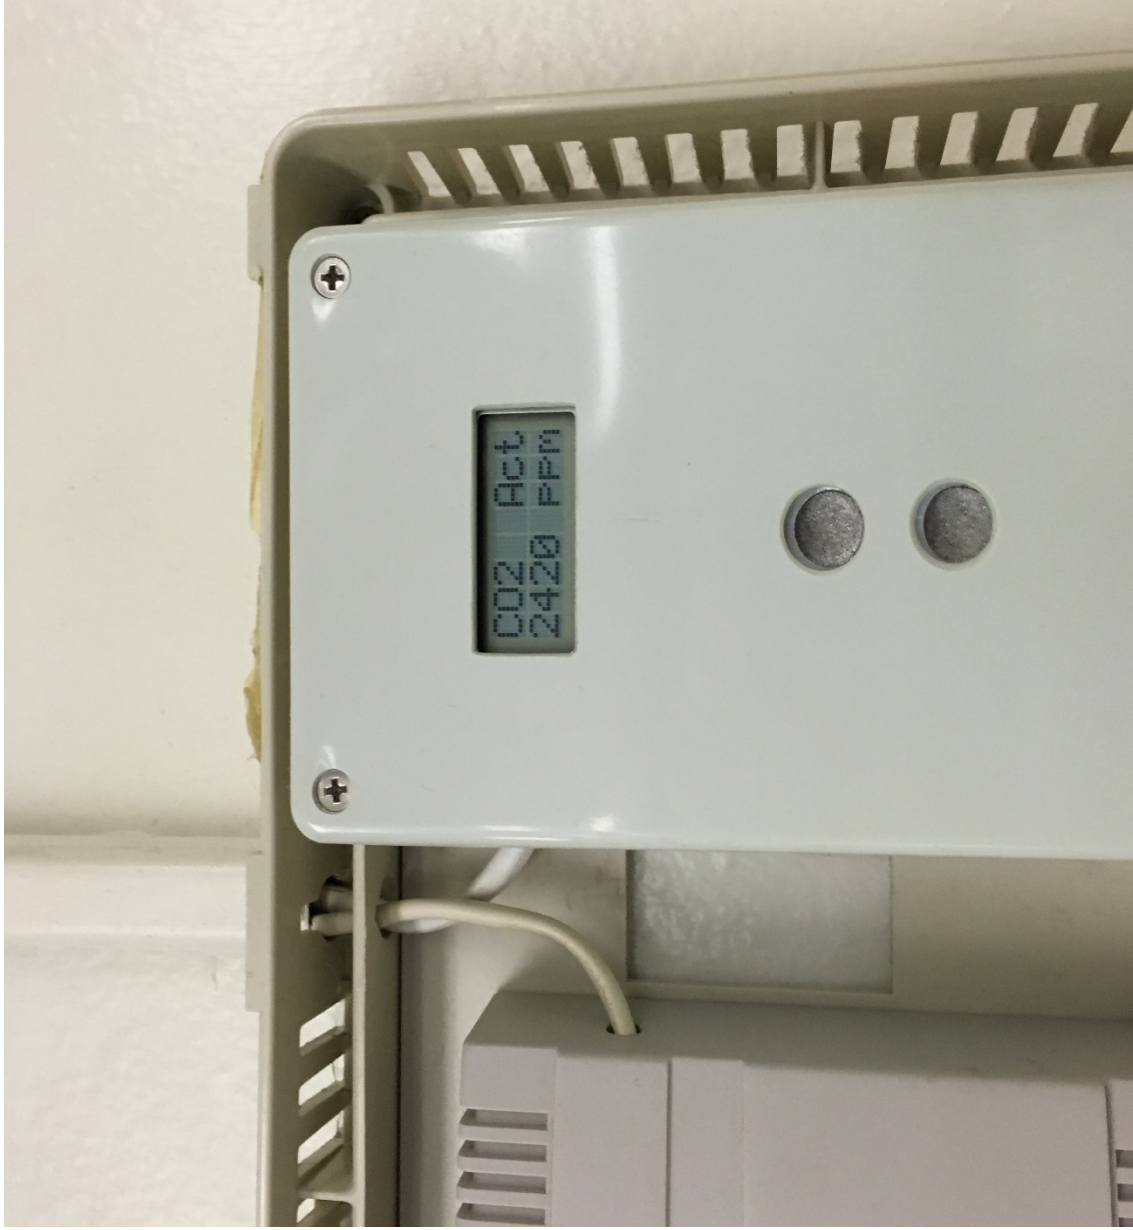
Finding # - 3. This picture shows the CO2 monitor in the 1st floor Art Class.

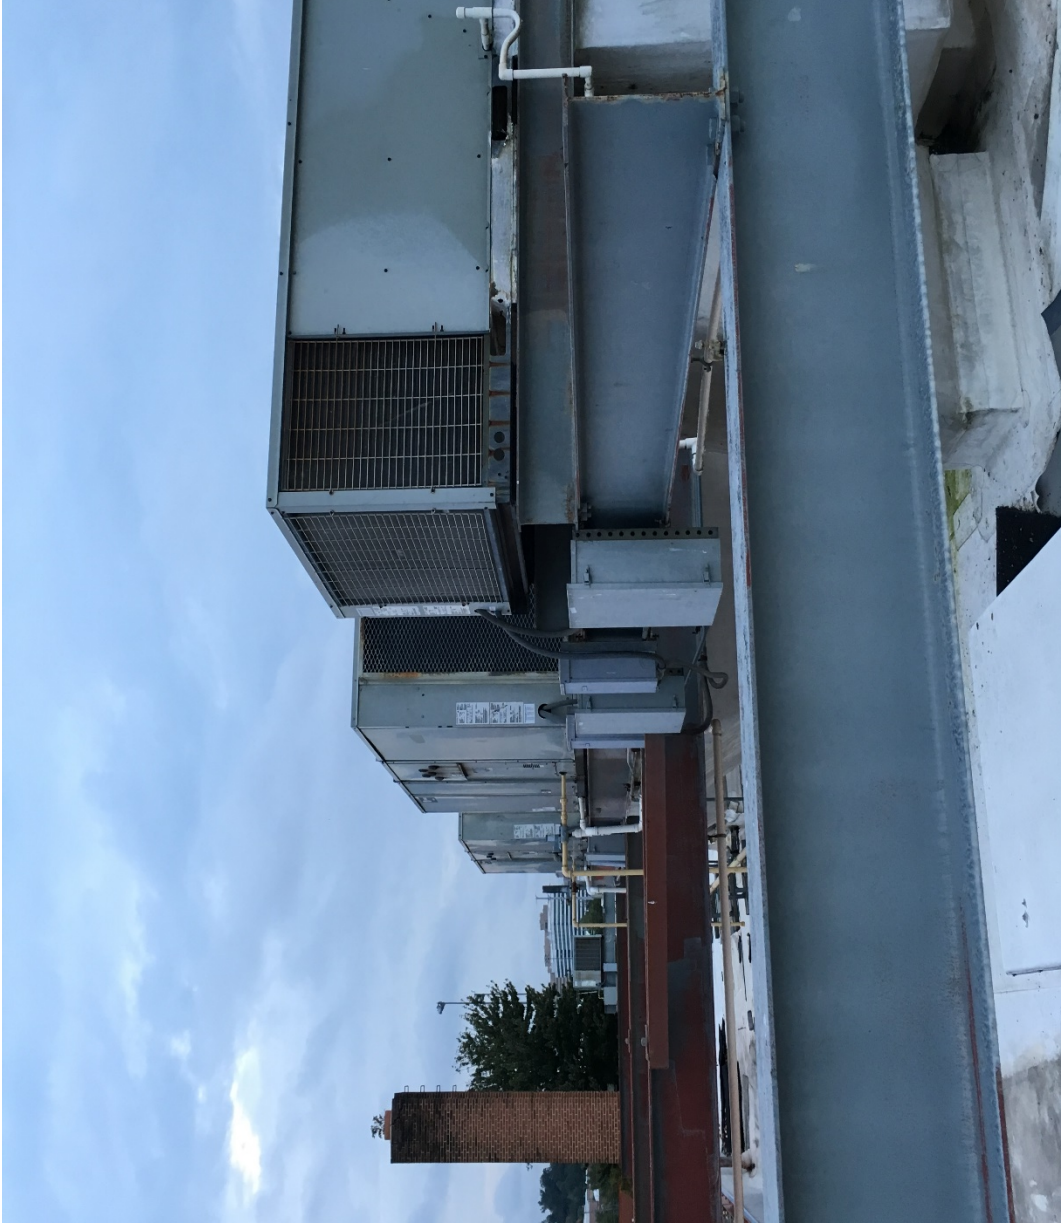
Finding # - 4. This picture is an example of the roof top units at Cora Kelly ES.

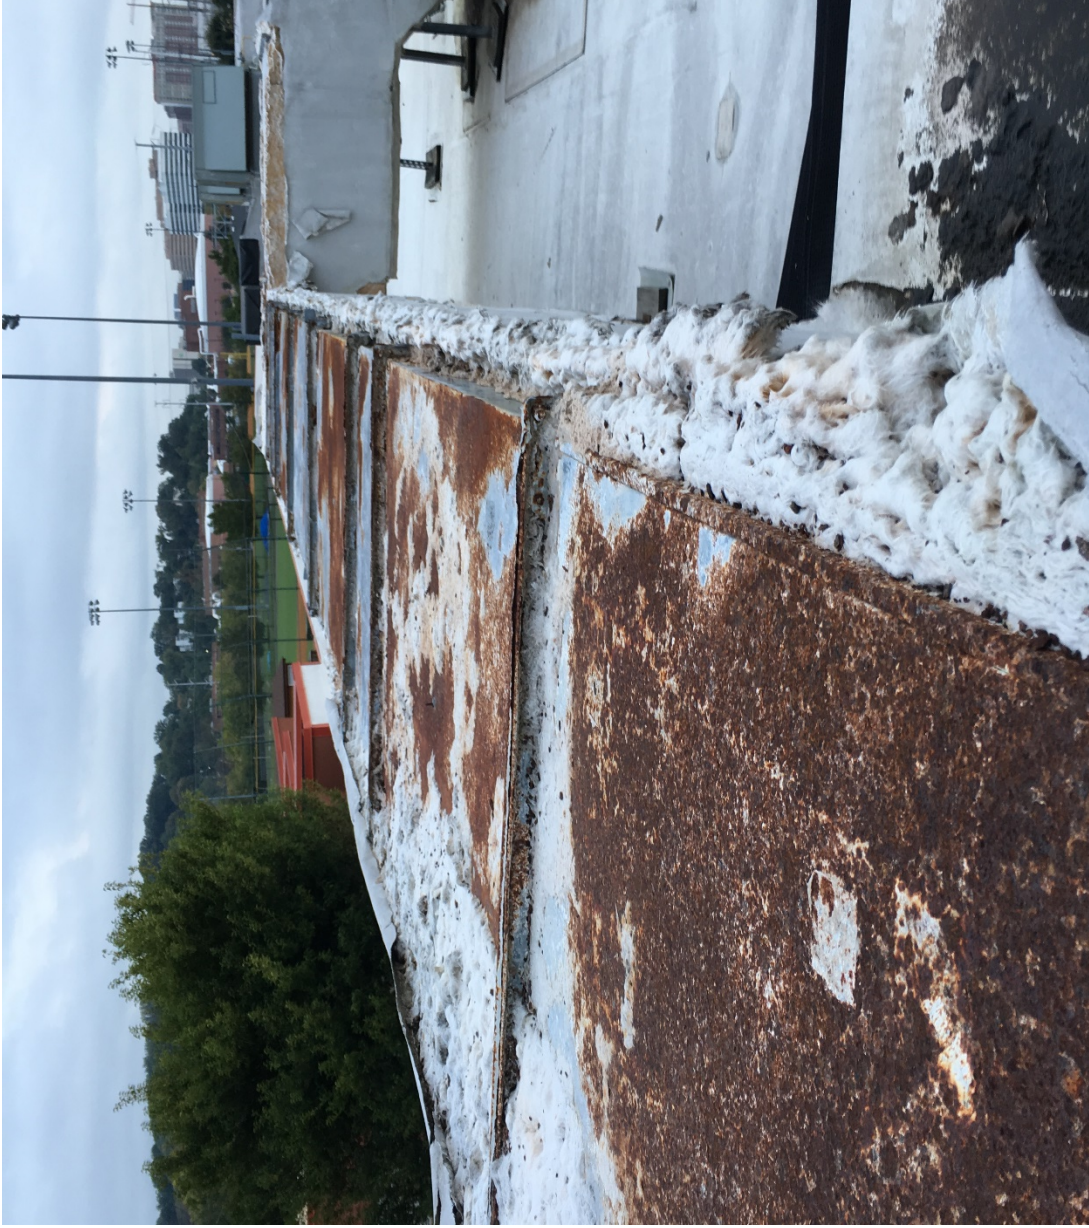
Finding # - 4 & 5. This picture is an example of the roof top units damaged duct work.

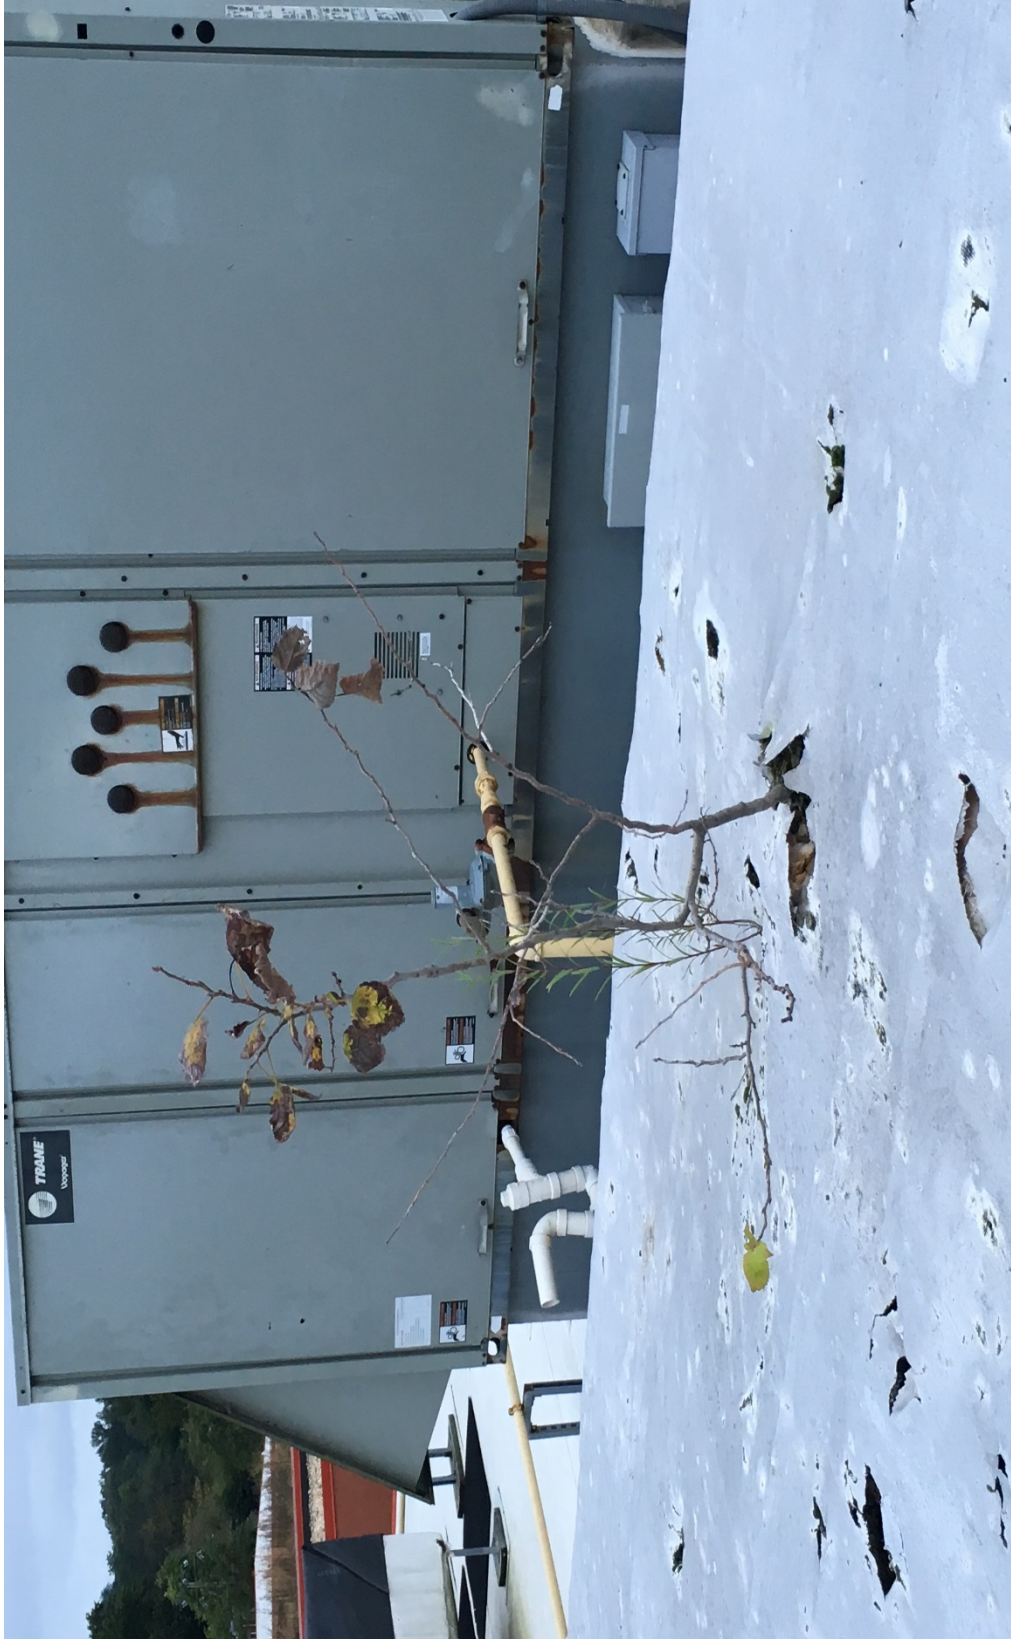
4. The building's roof top units are in poor condition but seem to be operating properly. The building indoor temperatures were quite comfortable when A2 toured the site. The supply air duct work is in very bad condition. The thermal insulation which covers the duct work has failed and in many cases has completely fallen off leaving the metal duct exposed to the weather and outdoor conditions. This does two things. First, it drastically reduces the energy efficiency of the unit while it tries to heat and cool the space. Second, it allows rain to get between the insulation and the duct where it then can enter the building below.

Finding # - 4 & 5. This picture is another example of the roof top units damaged duct work.

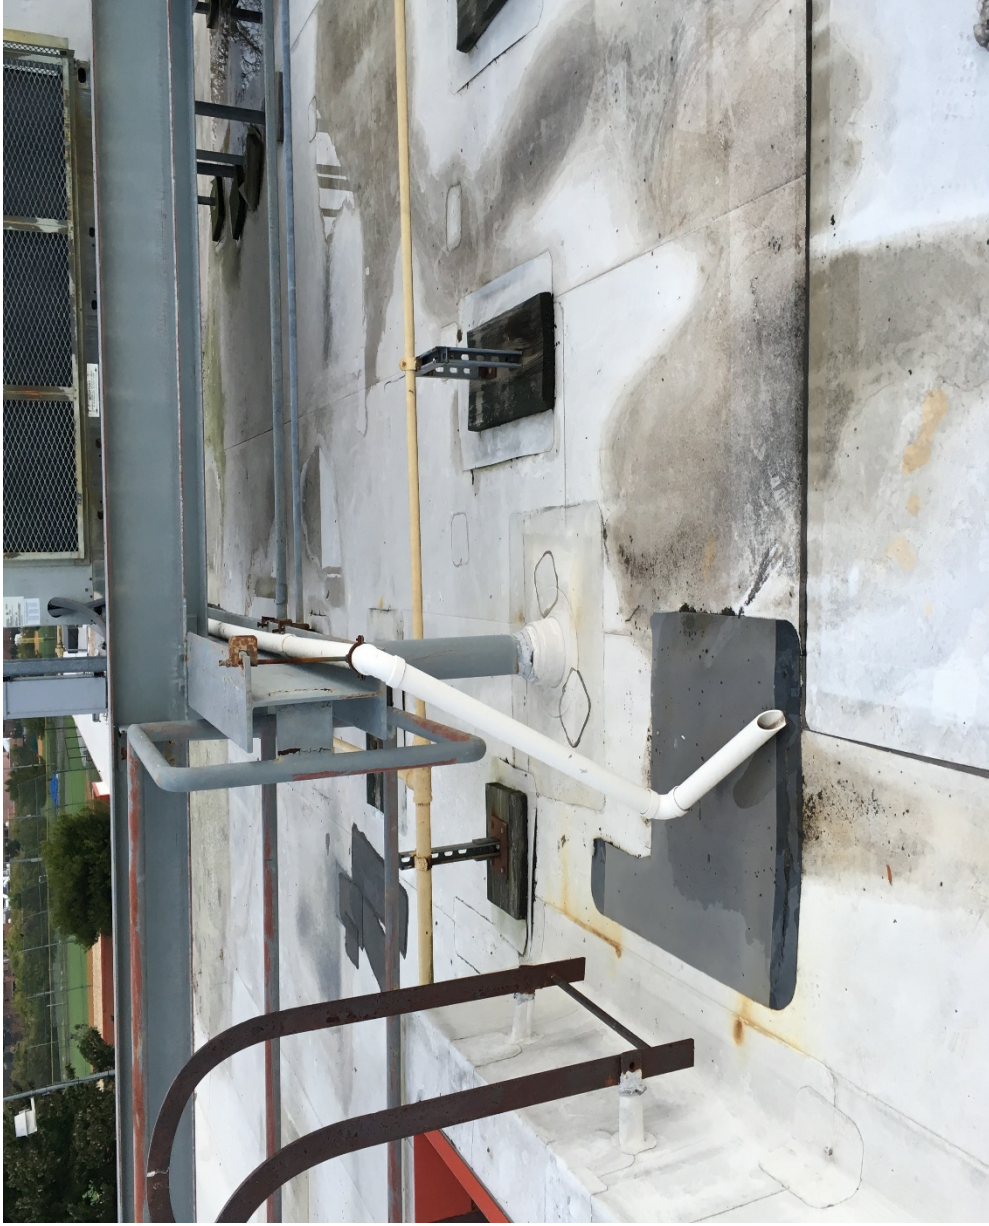
Finding # - 6. This picture notes one condensate drain (the white PVC pipe) simply draining onto the roof. These lines should be run to the nearest roof drain. This would help eliminate water on the roof.

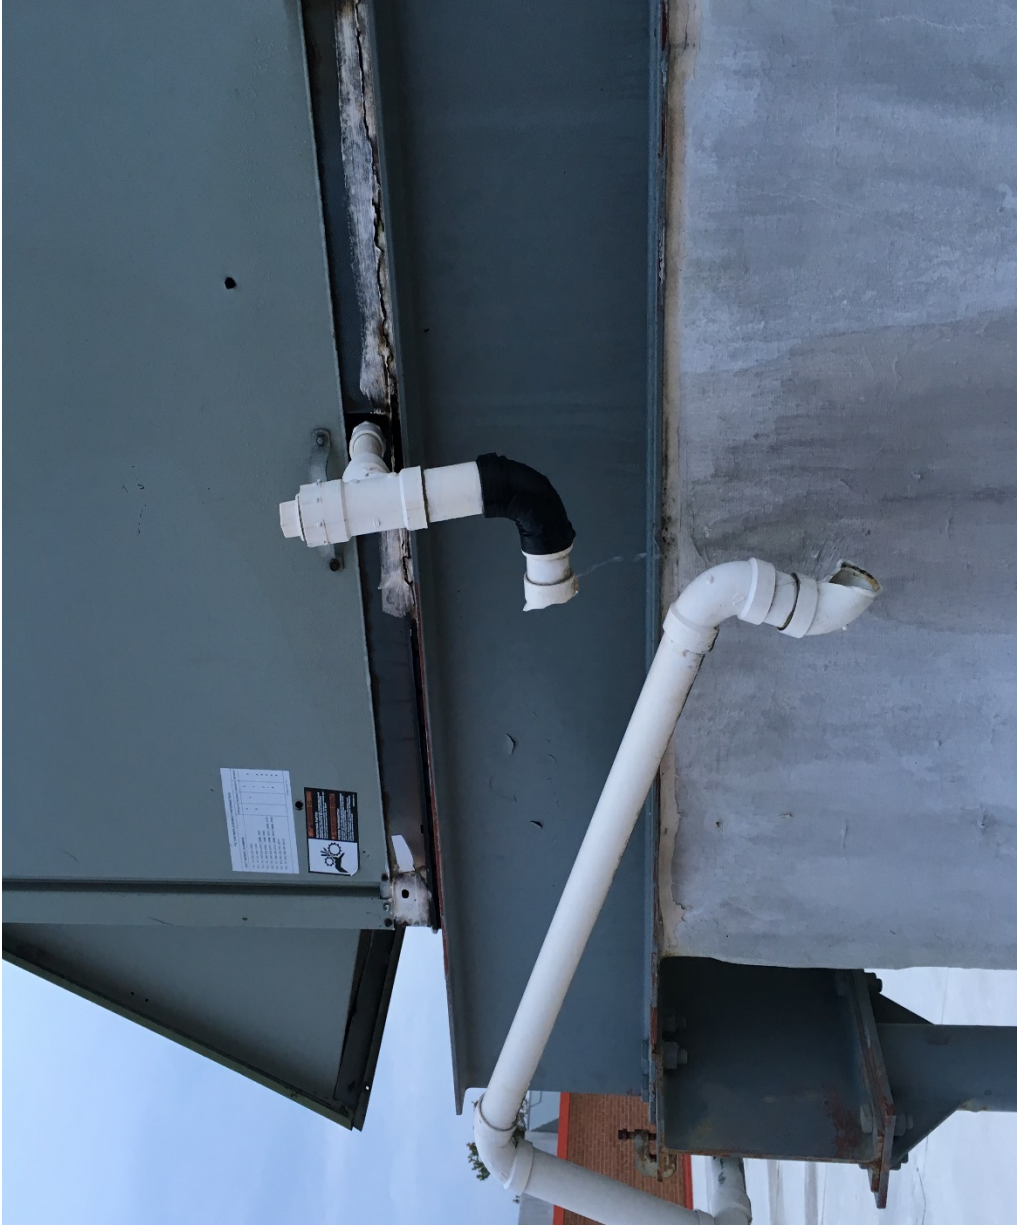
6. The condensate drain on RTU # 12 is broken in half and will need to be repaired.
7. One concern A2 noted while touring the roof was related to the quality of work being done for the school by contractors. One issue previously addressed above was with the condensate drains. It was noted that repair parts such as burnt out fan motors

Finding # - 7. This picture is of a broken condensate line on RTU #-12.

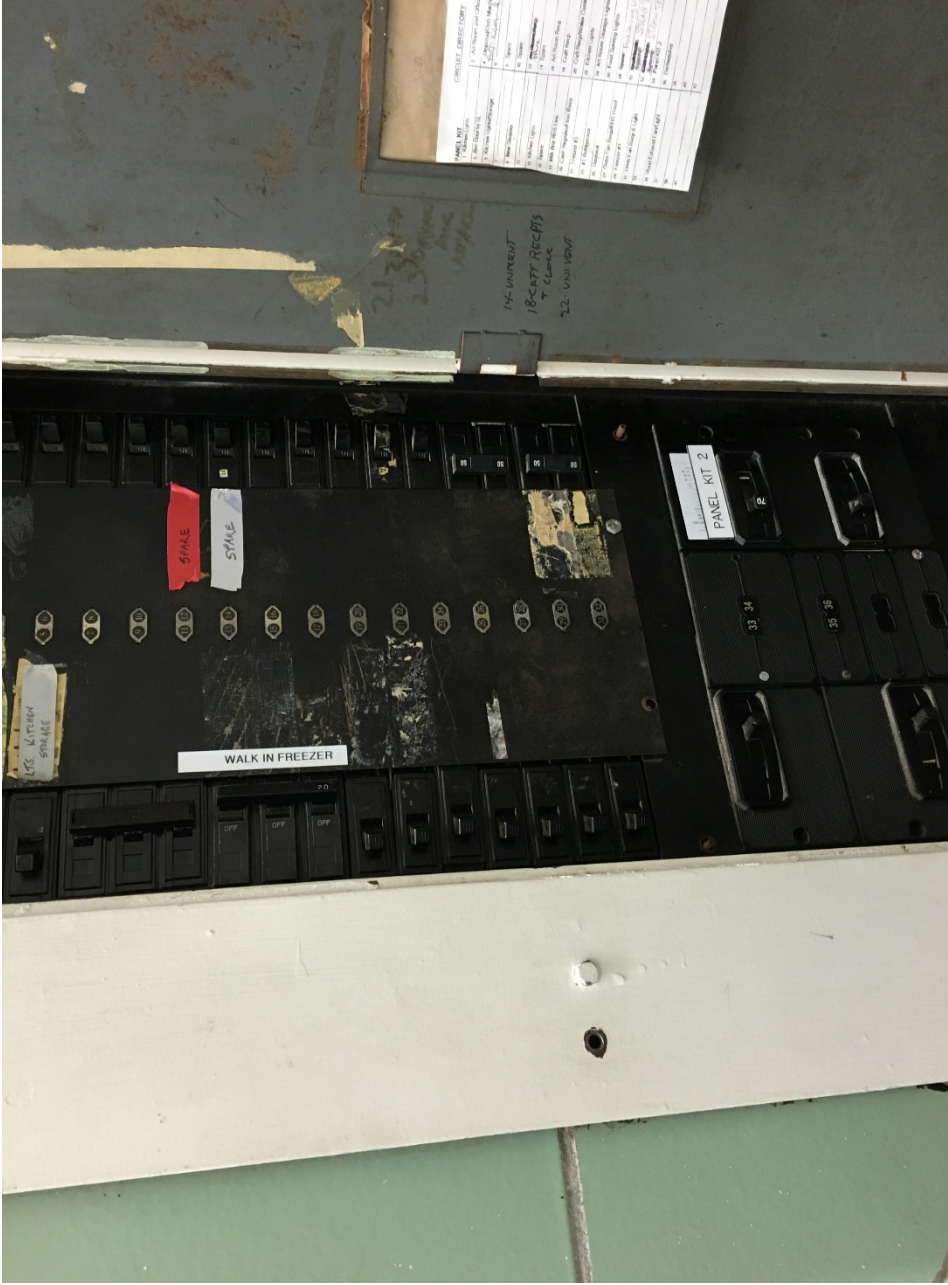
Finding # - 9. This picture is one of the breaker panels in the cafeteria.

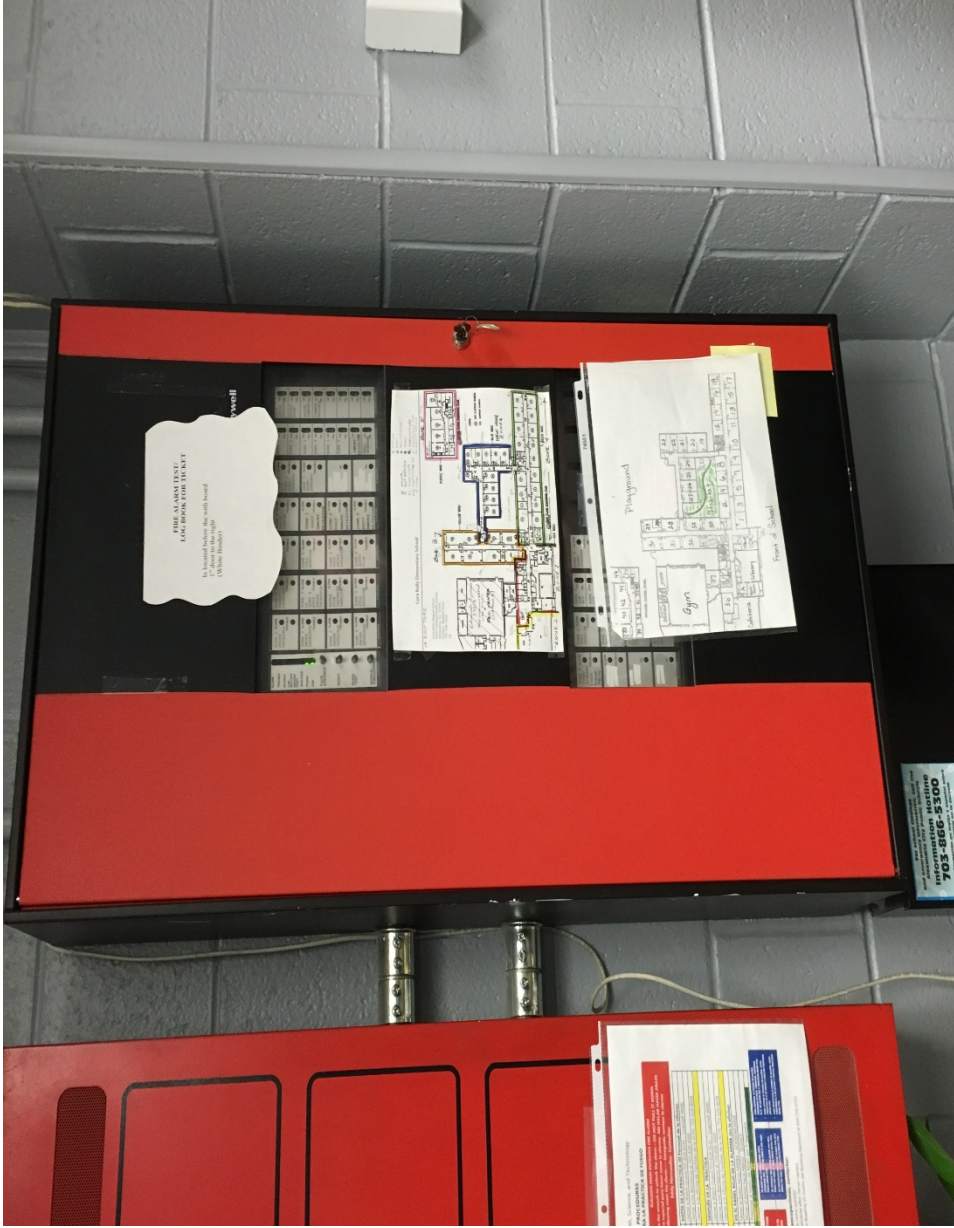
Finding # - 10. This picture is of the fire alarm systems in Cora Kelly E.S. This systems will need to be tied into the new recreation facilities system.

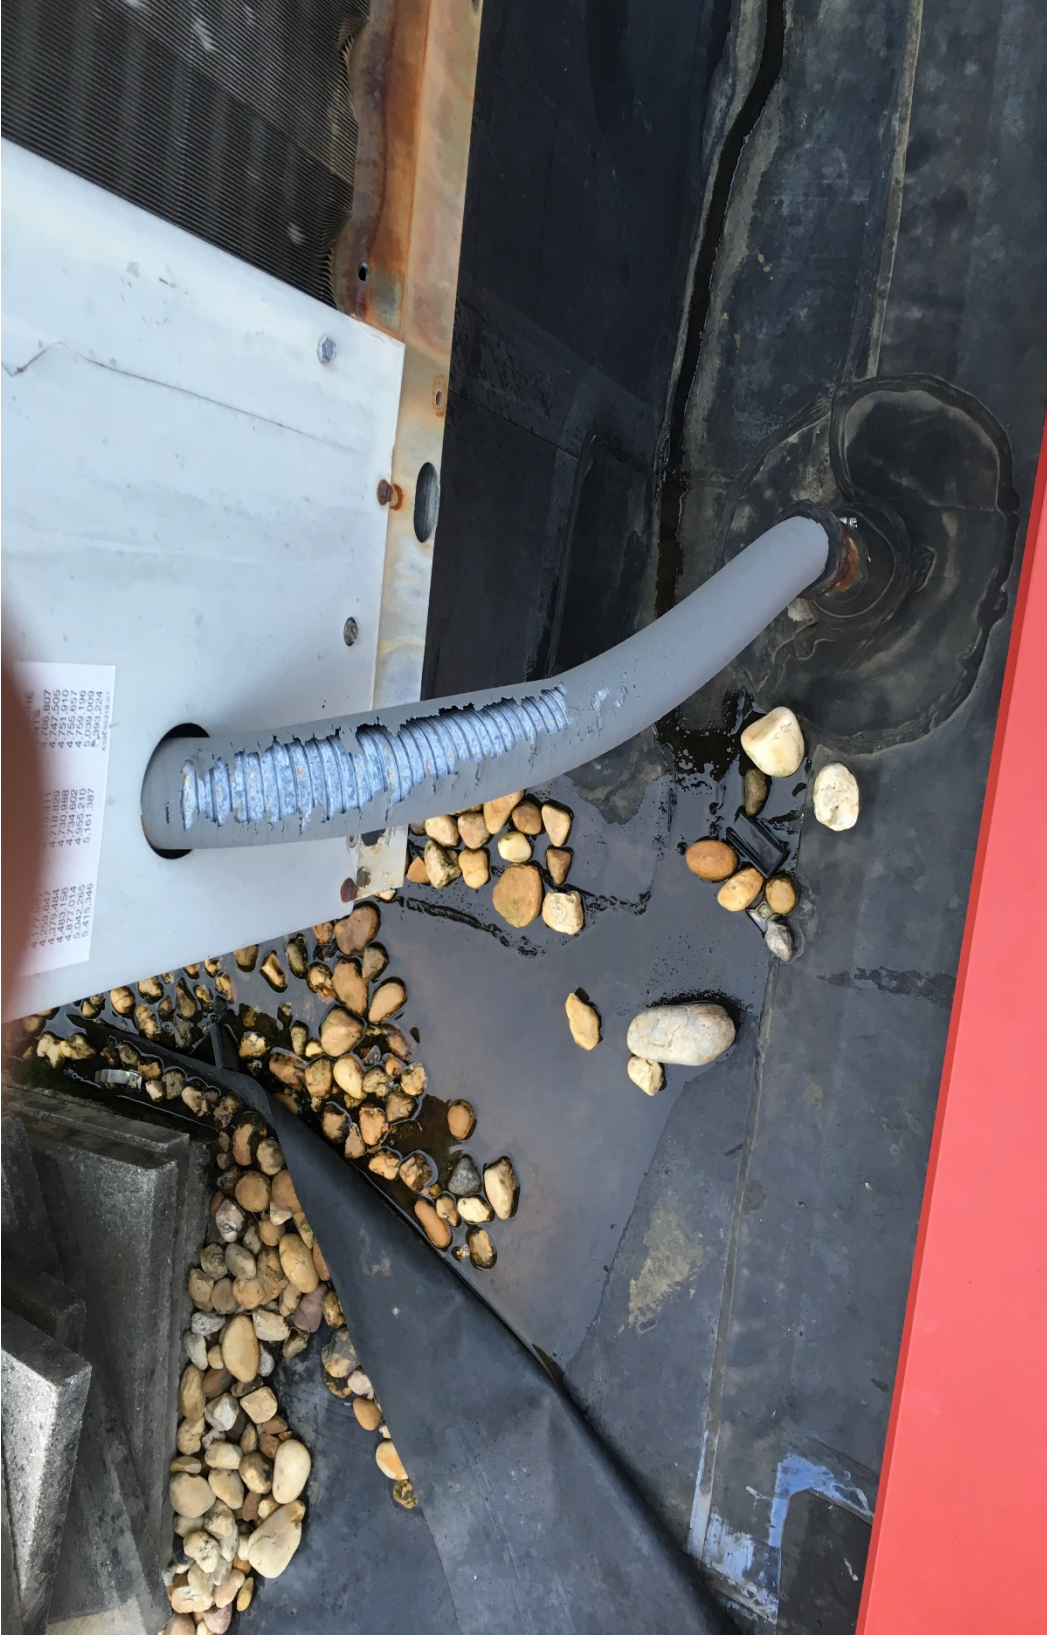
10. The roof top units are fed power through water tight flexible conduits. Several of these electrical feeds have failed and can allow water to get inside the electrical conduit. This is a problem because depending on how the conduit is piped across the ceiling below, water can reach junction boxes and leak out or cause a short circuit and failure of the equipment. A2 recommends that these be repaired.

Finding # - 11. This picture is of one of the failed water tight electrical feeds to a roof top unit.

11	Water tight electrical whips feeding RTU's have failed causing leaks.	Roof
	12	No electrical maintenance is being done. IR testing and torque and cleaning needs to be done.	Electrical systems throughout
Photo	#	Description of Deficiency/Issues	Location - Floor/Room
PLUMBING	13	The domestic hot water recirculation pumps are not working.	Electric / Mechanical room

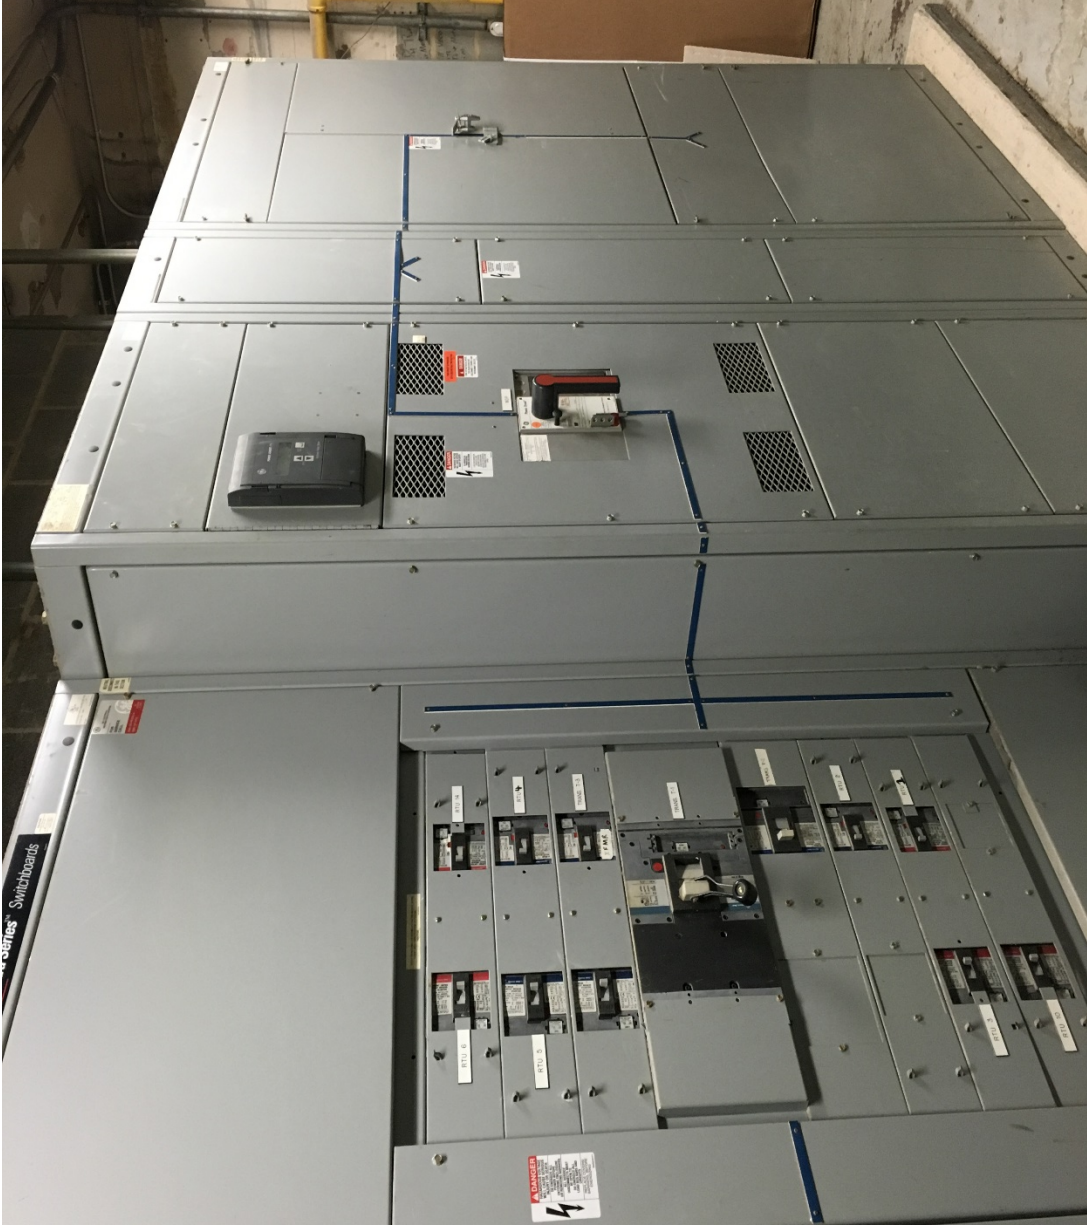
11. The main electrical panel and breakers panels at the site do not look as if they are being tested and serviced. All electrical systems should be thermally scanned with an infra-red camera to identify any overheating components or loose connections. This testing will identify such issues before they cause a failure of the electrical system. A2 recommends that all electrical gear be opened, thermally scanned then cleaned and all terminations checked of tightness on an annual basis. This an important risk management task that should be implemented.

Finding # - 12. This picture is of some of the main electrical gear.

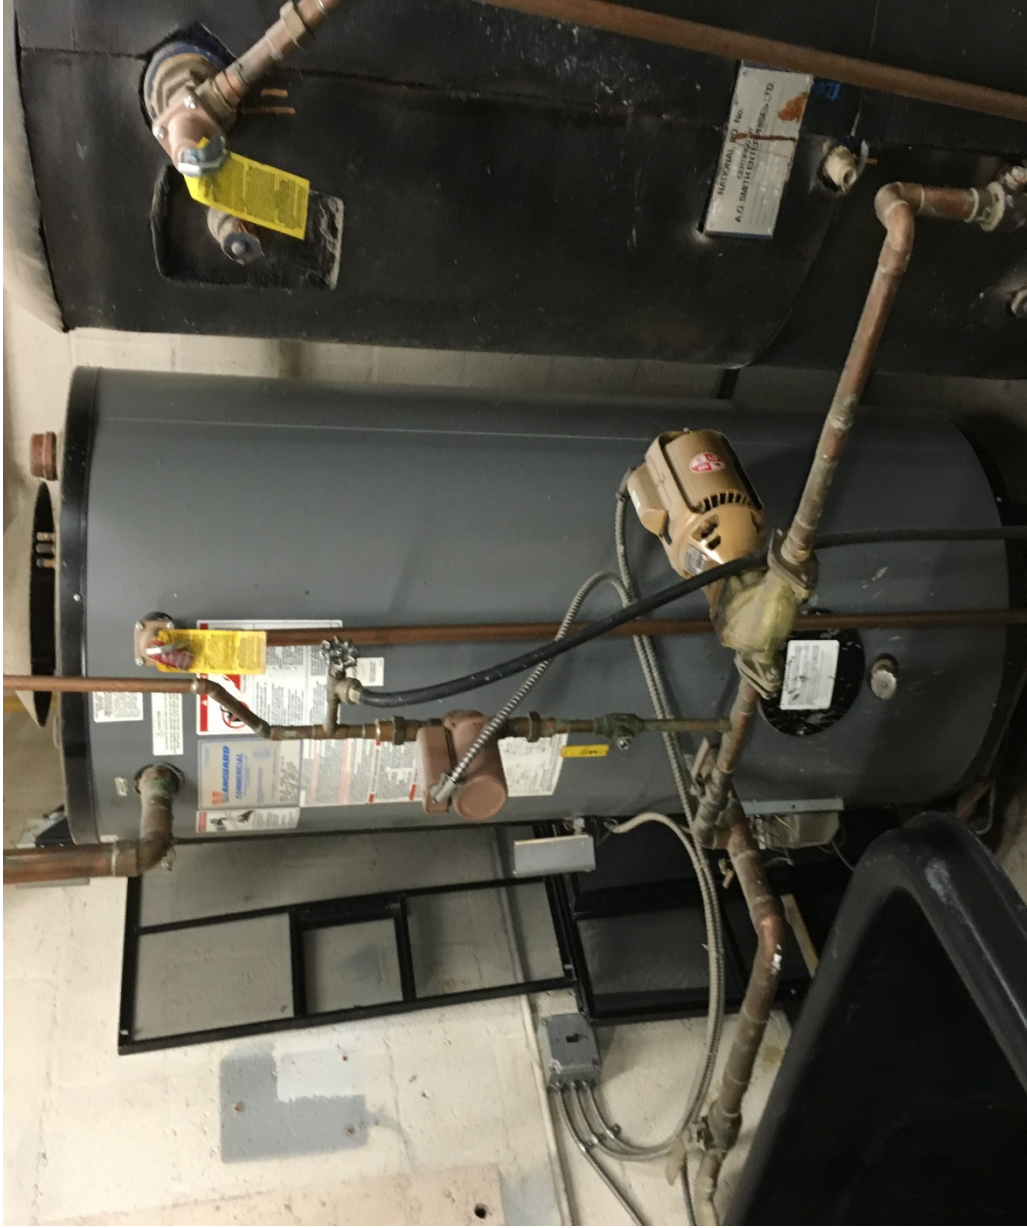
12. The buildings domestic hot water is generated by one 91 gallon capacity gas fired hot water heater. This system also has a 250 gallon hot water storage tank. There are two circulation pumps, one circulates hot water to all the restrooms and sinks in the building while the other circulates water from the heater to the storage tank. Neither of these pumps were running during our inspection. This condition will cause loss of hot water to the buildings hot water fixtures.

Finding # - 13. This picture is of the domestic hot water heater for the site with its storage tank and pumps.

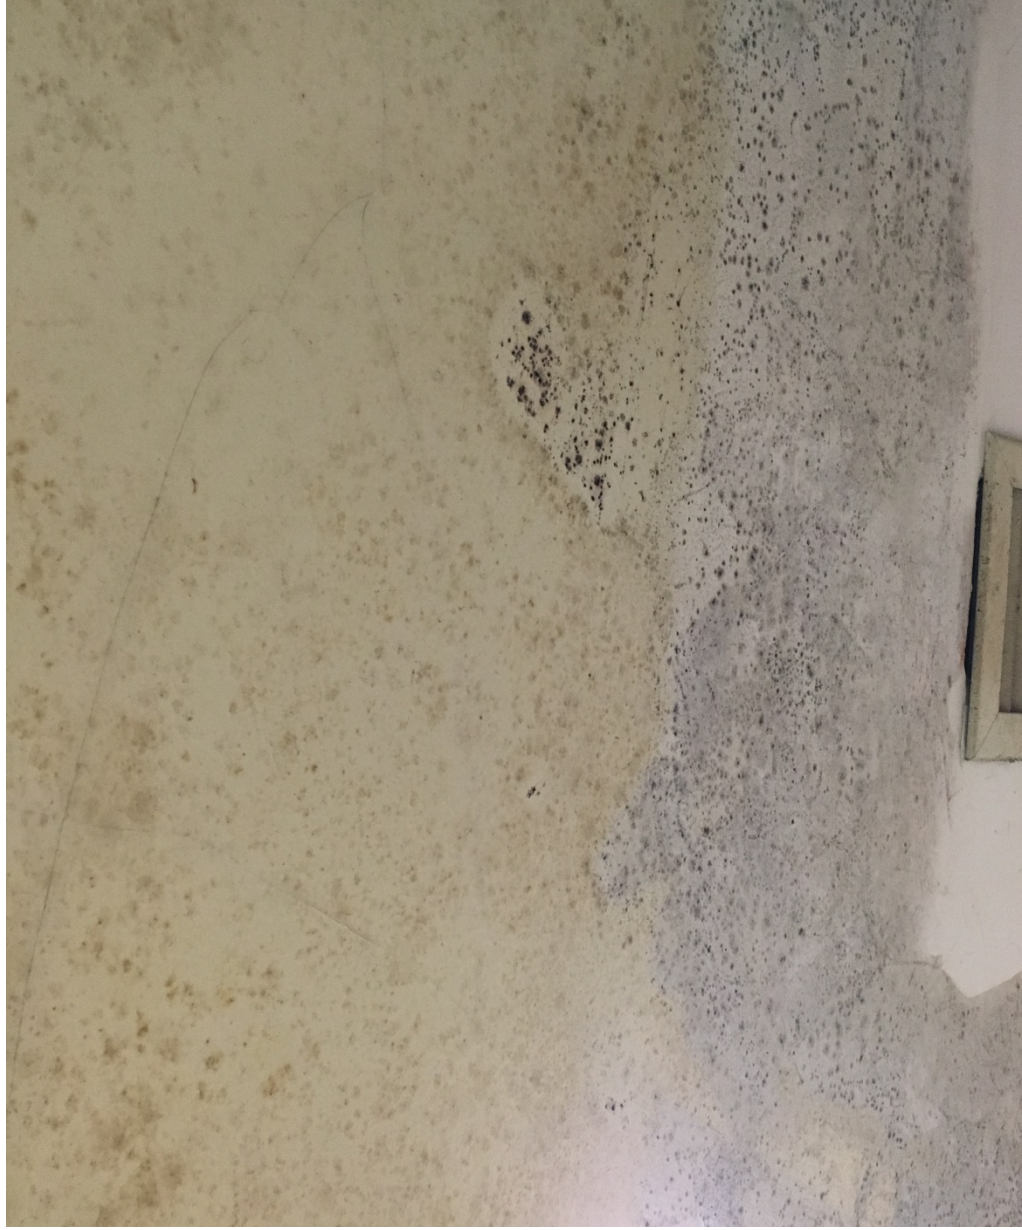
Finding – 14 – This picture of an example of possible micro-biological growth within the walls from water infiltration.

Photo	#	Description of Deficiency/Issues	Location - Floor/Room
STRUCTURAL	14	Water infiltration from the roof and through the walls and around the windows is causing micro-biological growth as shown in this photo.	1st floor janitors closet
	15	Many roof areas where water ponds and cannot drain.	Roof
	16	The main roof is poor condition. Ponding of water and roof penetrations are allowing leaks.	Roof
	17	.Skylights are broken in the 1st floor north corridor	Roof
	18	The screen wall on top of the modular building section is causing leaks into the building.	Roof
	19	Many areas in the building have stained ceiling tile. However you would expect worse conditions after seeing the roof.	Inside the building
	20	Perimeter envelope water infiltration problems.	Perimeter of building
	21	Window caulking has failed in many areas.	Perimeter of building
	22	The Front entrance roof has been damaged.	Front of building

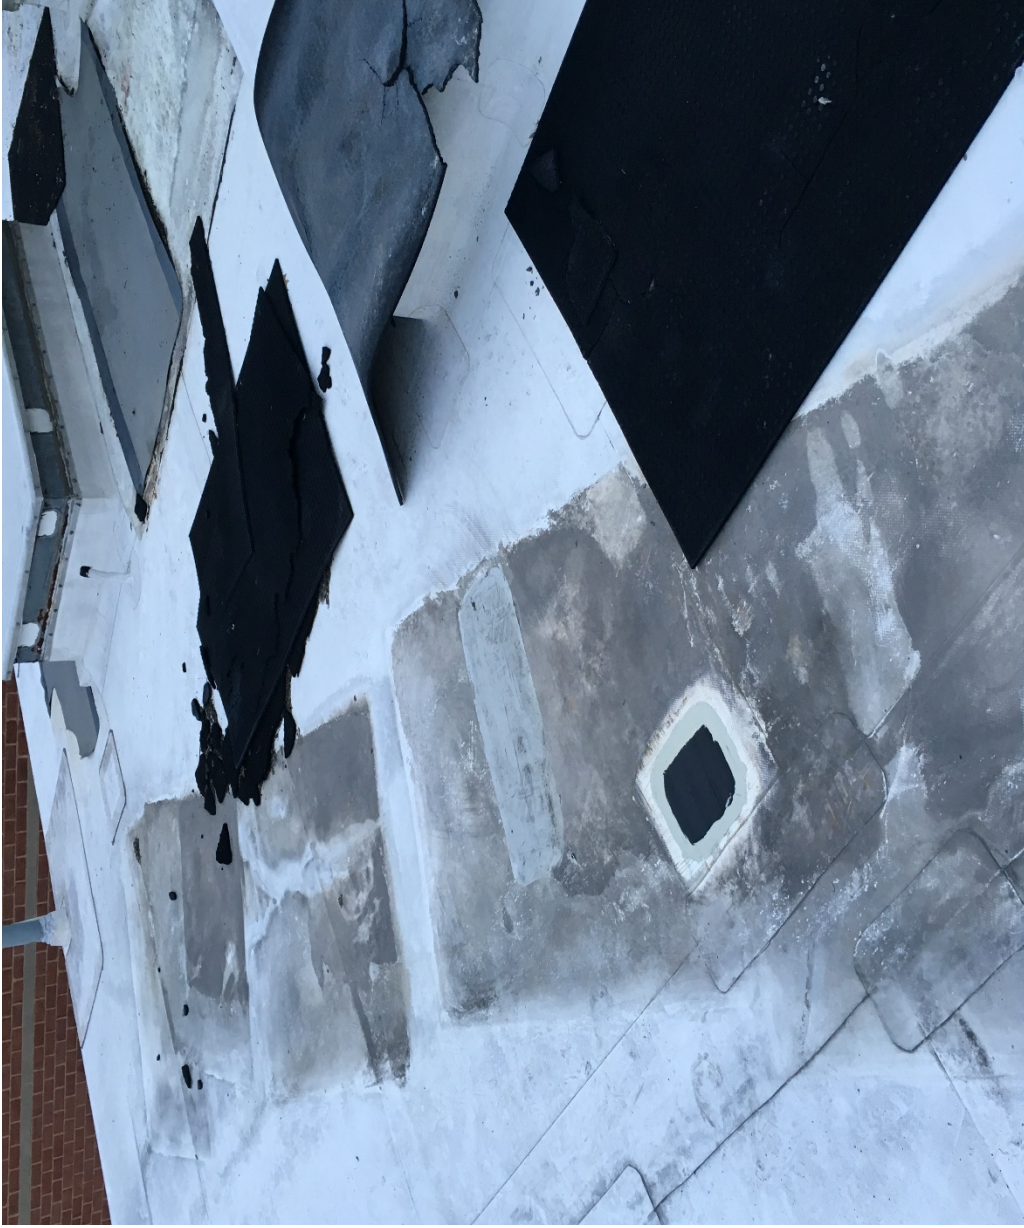
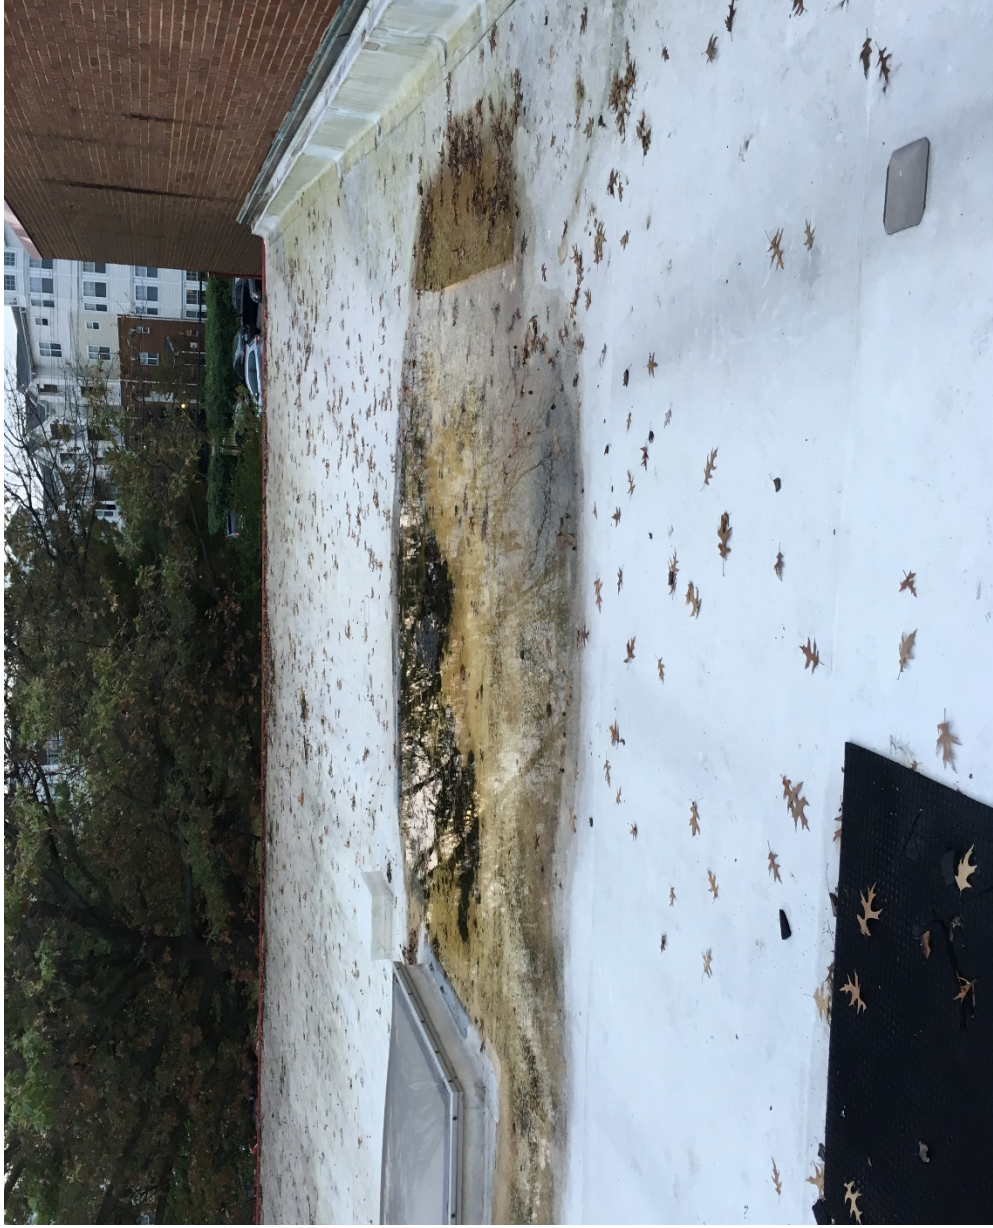
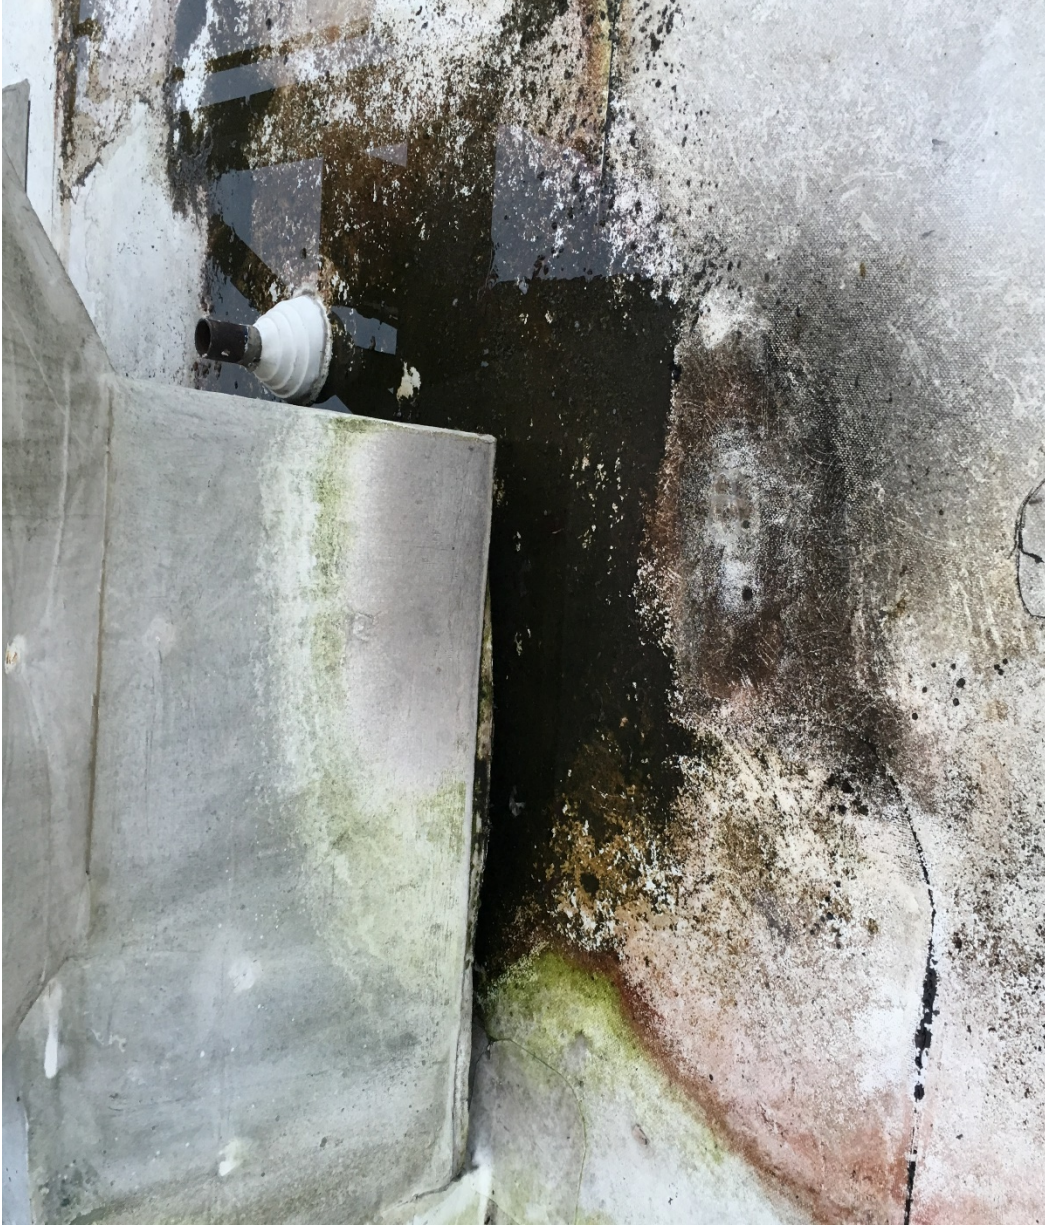
13. Cora Kelly ES has a built-up membrane roof system. As with any large flat roof the water doesn't always get to the roof drains and creates ponds. At Cora Kelly this condition is worse than most. Anytime water is allowed to pond on a roof leakage below will occur. The main roof is in poor condition and because of the ponding and the duct work penetrations there are leaks and water entering the building. In touring the building interior, one can note wet ceiling tiles.

Finding # - 15 & 16. The next set of pictures note the roof condition at Cora Kelly E.S.

Finding # - 15 & 16 continued. This is another view of the roof.

Finding # - 15 & 16 continued. The following is another view of the roof.
