**FROM: JOINT CITY-SCHOOLS FACILITY INVESTMENT TASK FORCE
Lynn Hampton, Chair, Mignon Anthony¹, Elliott Branch, Micheline Castan-
Smith, Marshall Cook, Dwight Dunton, Amy Liu, Dave Millard, Eric Wagner**

SUBJECT: TASK FORCE FINAL REPORT (DELIVERABLE 2 OF 2)

A2 Services, Inc. Facility Survey of City of Alexandria - City Hall

A2 Services, Inc.
Facility Survey of the City of Alexandria – Public Safety Center

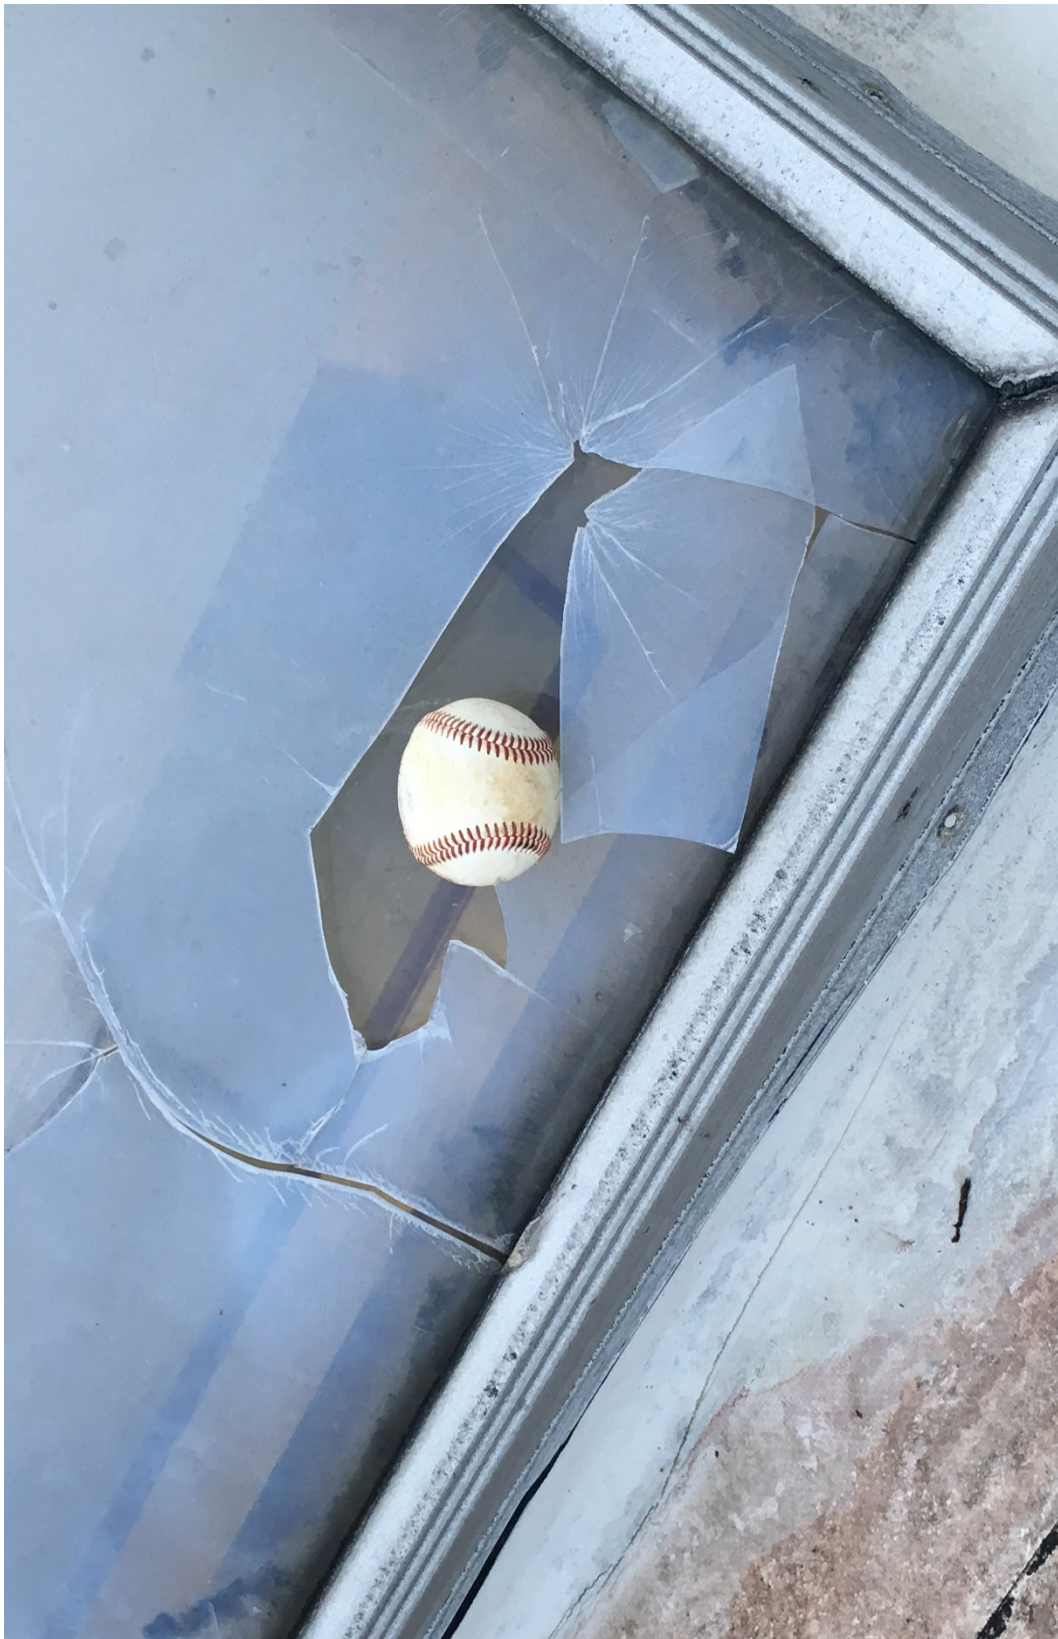
14. Two skylights in the roof near the baseball field are cracked and broken. The students are hitting foul balls which hit the roof and the skylights. Mr. Stallings is looking into having the angled section of fence on top of the back stop modified to help stop this issue.

Finding # - 17. This picture notes one of the broken skylights which are being hit by baseballs.

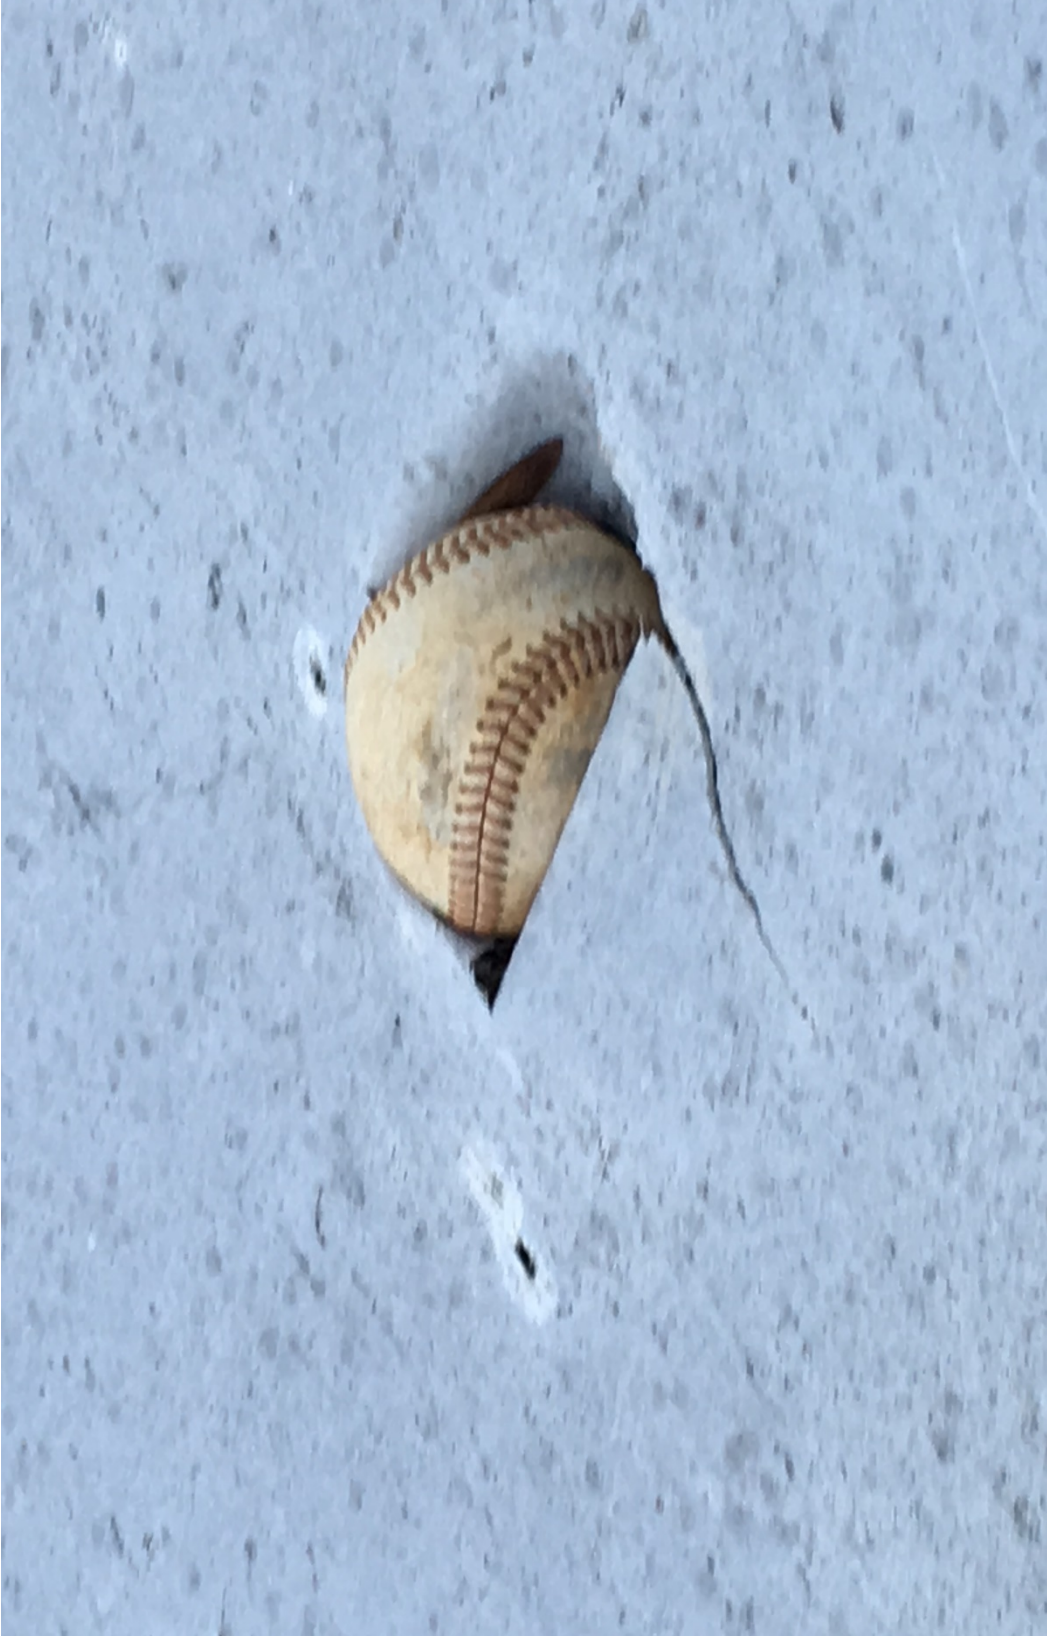
Finding # - 17. This picture is of roof top unit duct work insulation being hit by a baseball.

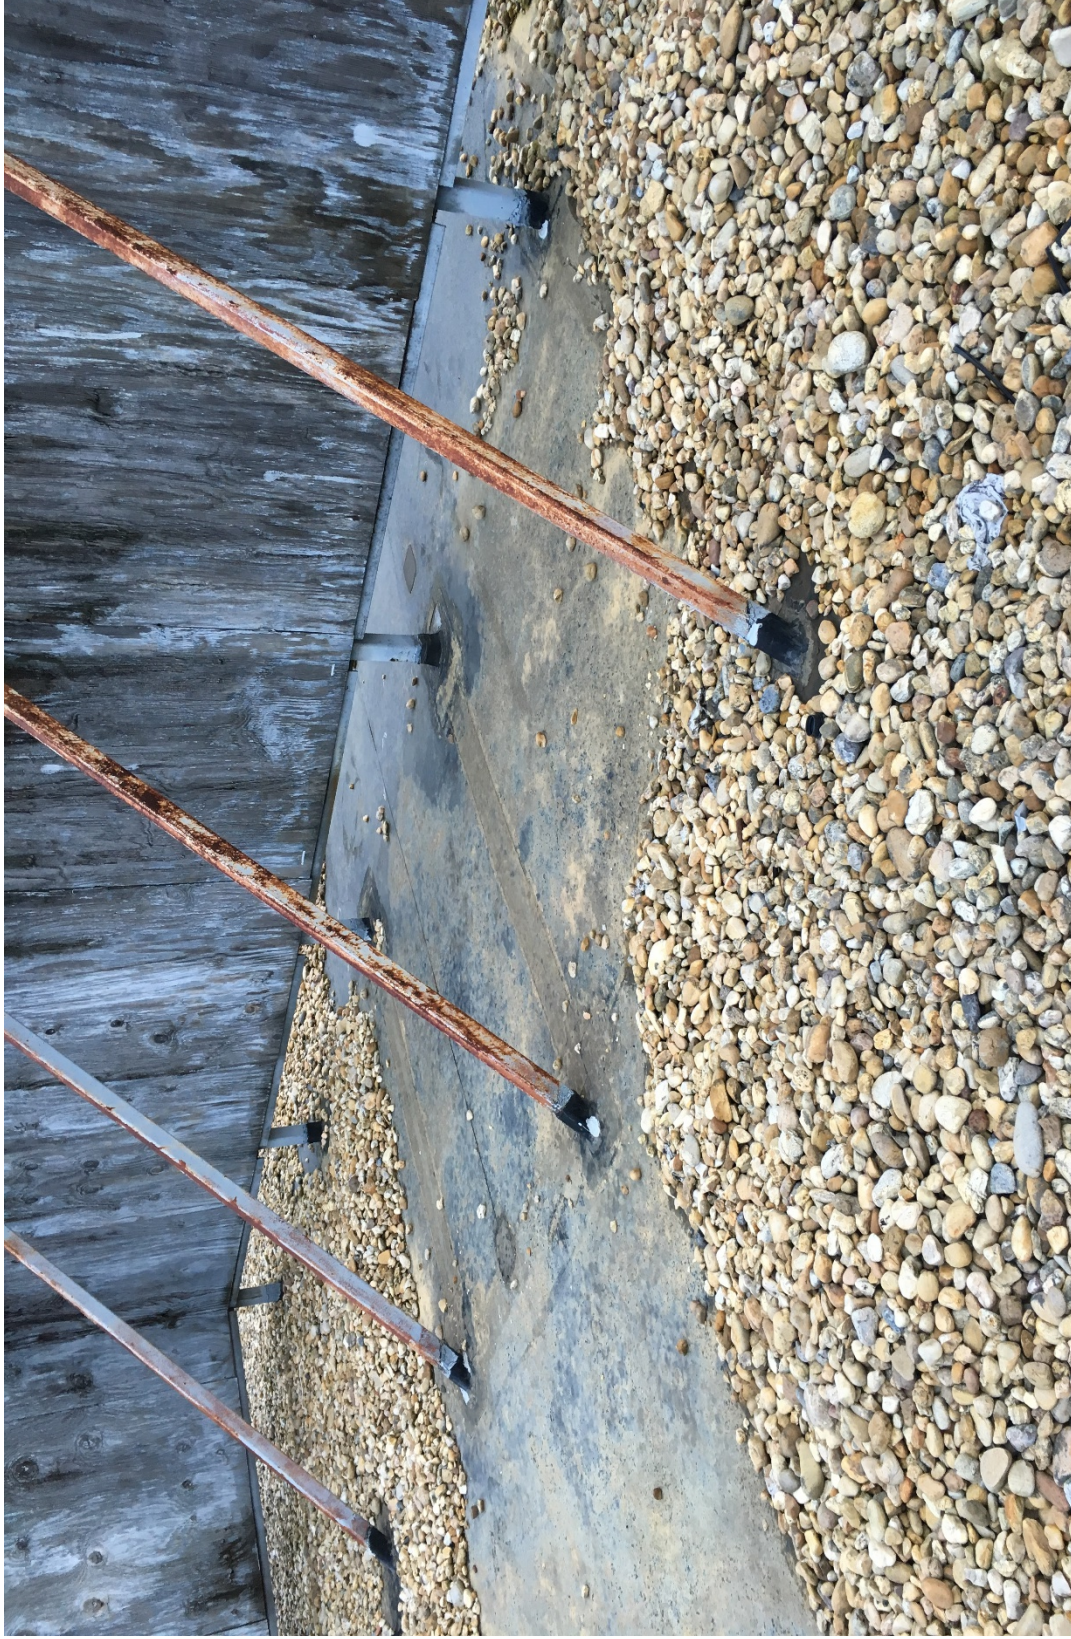
15. There is a screen wall on top of the modular section of classrooms. The steel supports for this wall are causing leaks into the hallway and classes below. It was noted that there is ongoing roof repairs and patches. The entire roof should be replaced.

Finding # - 18. This picture notes the screen wall on the modular section of the building with ongoing roof repairs.

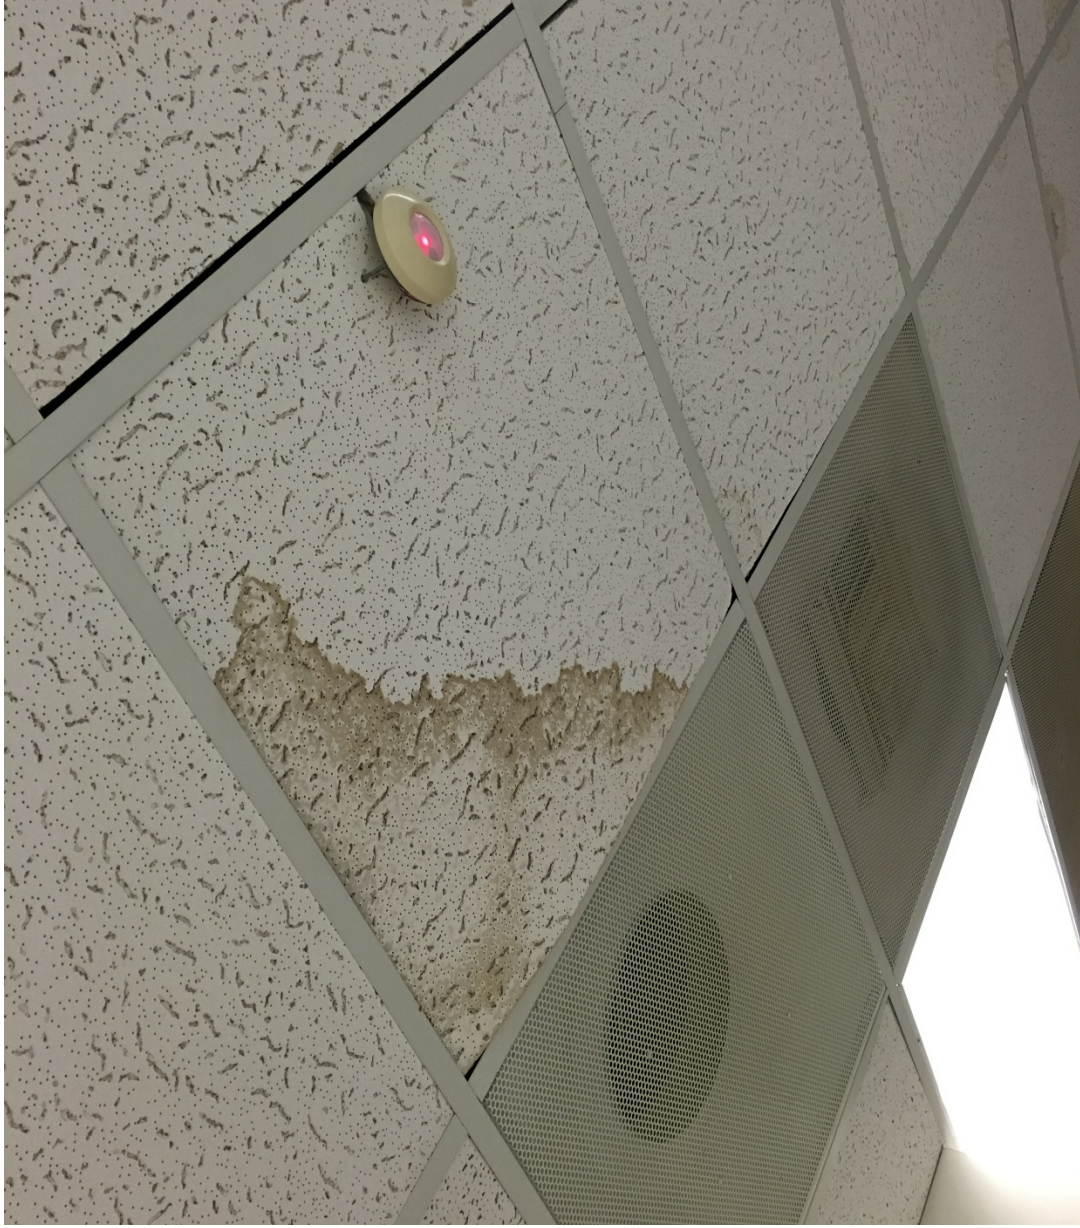
Finding # - 19. This picture is an example of water damaged ceiling tiles.

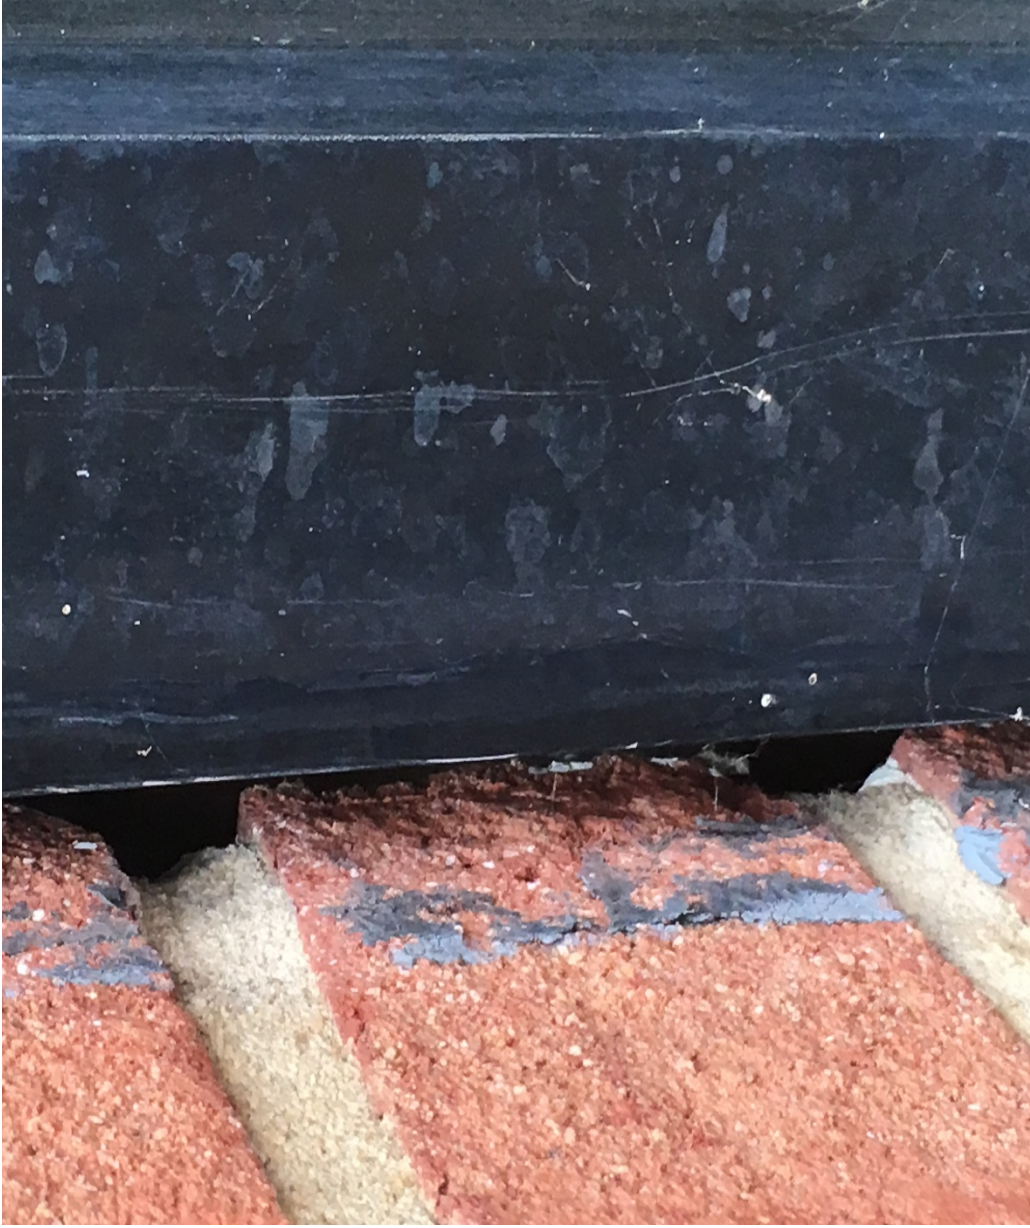
16. The building envelope appears to be a brick over block construction. The brick tuck-pointing condition is good and several sections can be identified as being repaired. A set of casement window systems were installed or inserted in the perimeter walls around the facility and are caulked at the walls. The condition of the window caulk is poor and in some spots the exterior of the building is visible for inside. At this time, perimeter window caulking is needed at this time before increased damage occurs.

Finding # - 20 & 21. This picture is an example of the missing window caulk allowing water entry into the walls.

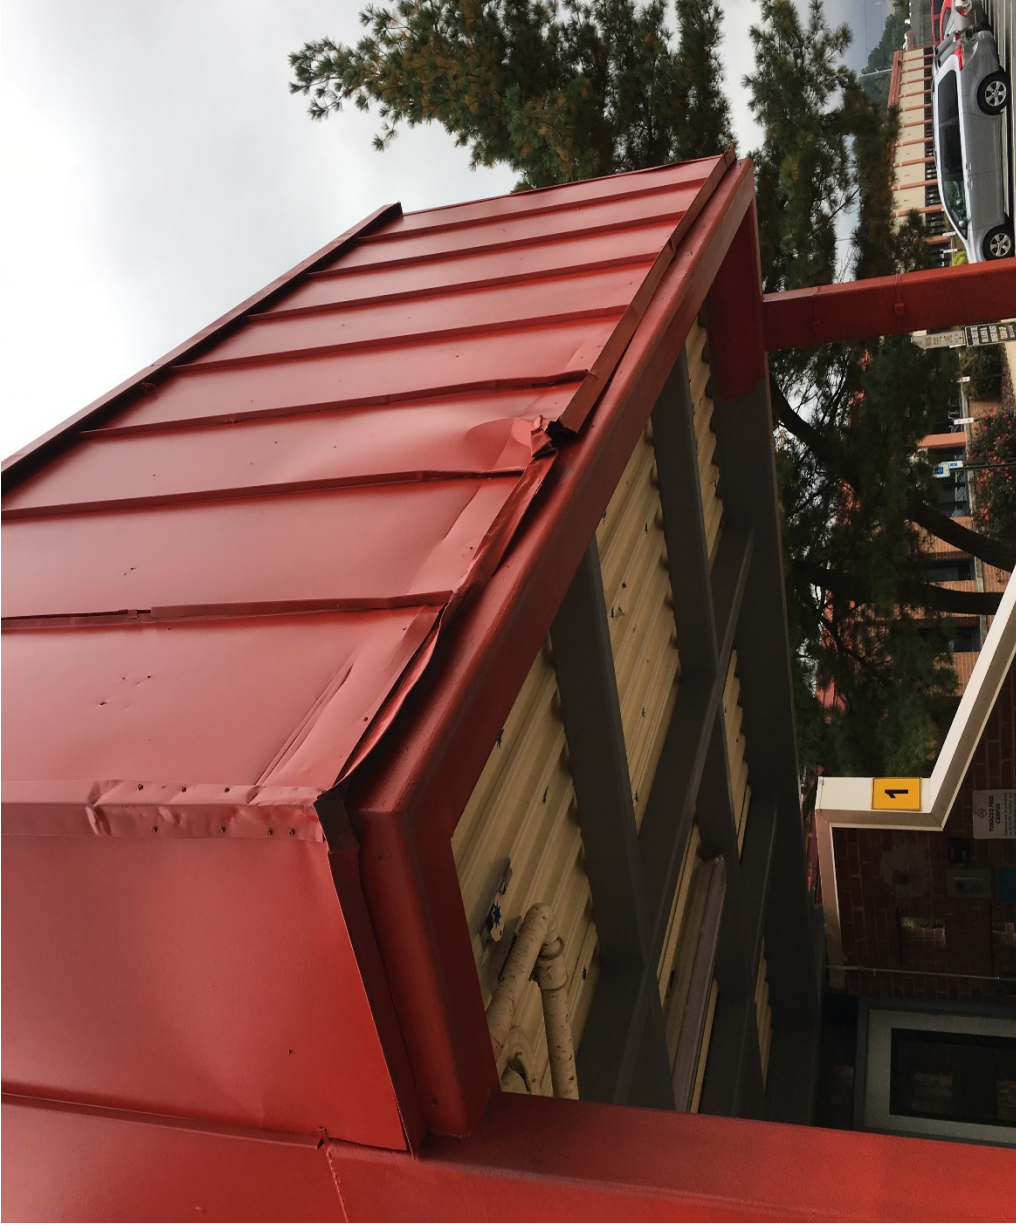
17. The main school entrance roof is damaged where a truck or other vehicle hit and bent the metal covering. This is not causing any water infiltration but is simply aesthetic concern.

Finding # - 22. This picture is of the damaged metal at the schools main entrance.

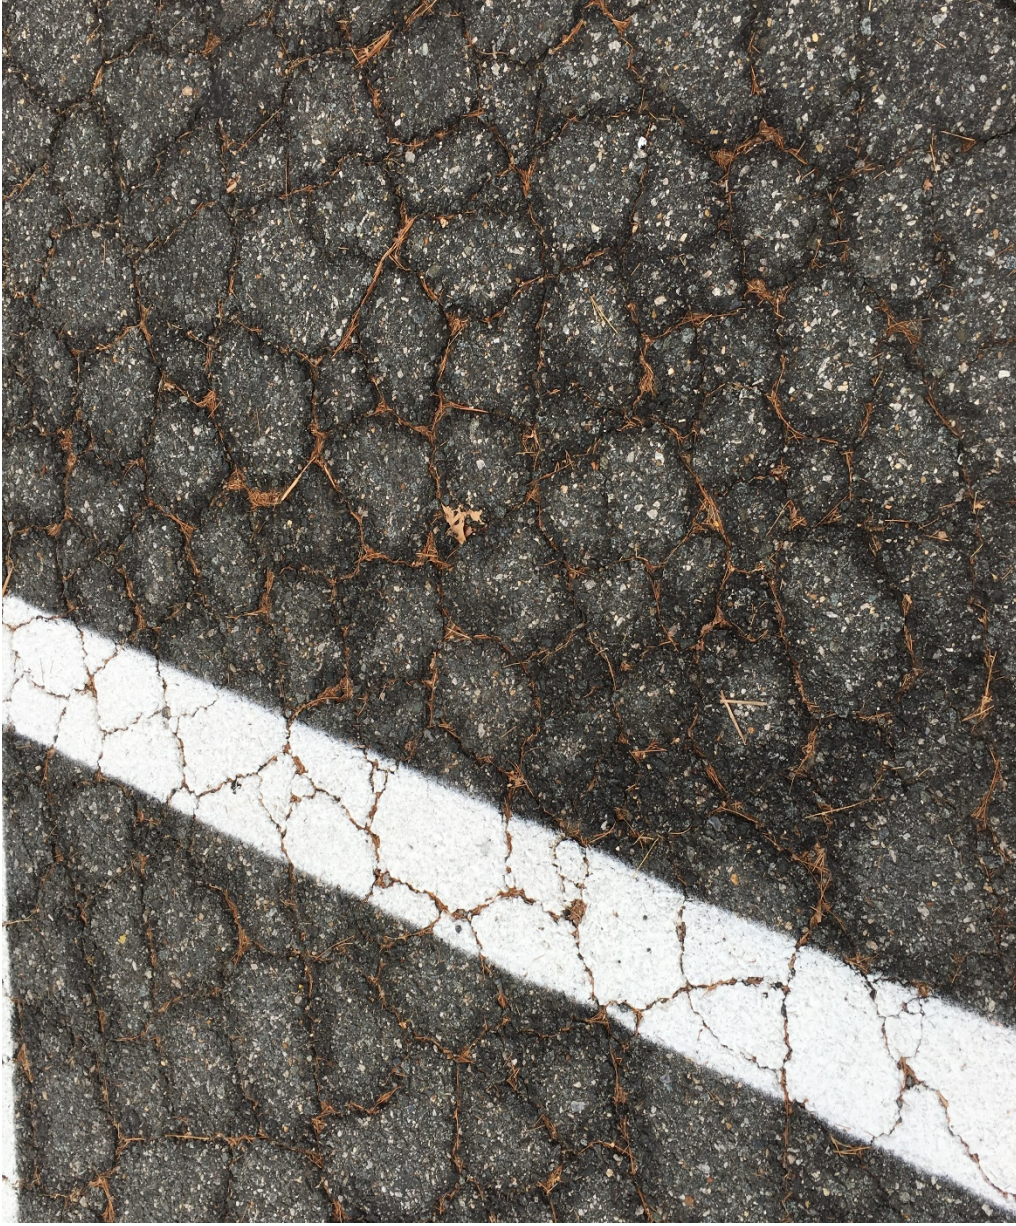
18. The parking lots and asphalt areas around the building were recently restriped. However the asphalt lots themselves are in poor condition and should have at least been liquid sealed before they were striped. The asphalt is spalling and cracked. As rain water gets under the asphalt and freezes it will cause pot holes, also when snow plows hit these areas this winter the asphalt may ripped up requiring larger repairs. Hopefully the lots will make it through this winter season and can be sealed or replaced next summer.

Finding # - 23 & 24. This picture is an example of the asphalt parking lot condition.

24	Asphalt damage at the drive ways and parking lots. Parking lot asphalt damage.	Front of building Parking areas
ARCHITECTURAL	#	Description of Deficiency/Issues	Location - Floor/Room
