ALEXANDRIA CITY PUBLIC SCHOOLS  
COMPREHENSIVE CONDITION AUDITS

- CORA KELLY ELEMENTARY SCHOOL
- FRANCIS C. HAMMOND MIDDLE SCHOOL
- GEORGE MASON ELEMENTARY SCHOOL
- GEORGE WASHINGTON MIDDLE SCHOOL
- MATTHEW MAURY ELEMENTARY SCHOOL
- TRANSPORTATION FACILITY

**Final Report - DRAFT**

**August 9, 2019**

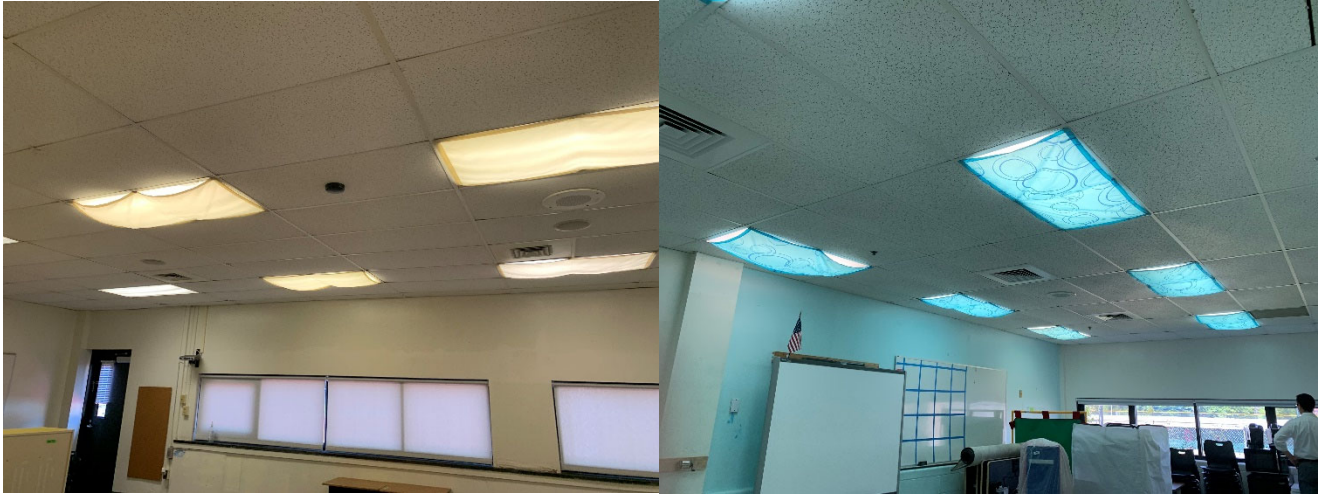
*Figure 10: Light dimmers required*

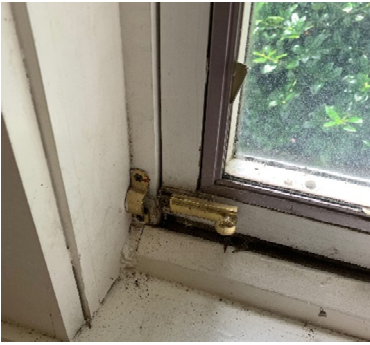
Figure 16 Inoperable Window Hardware

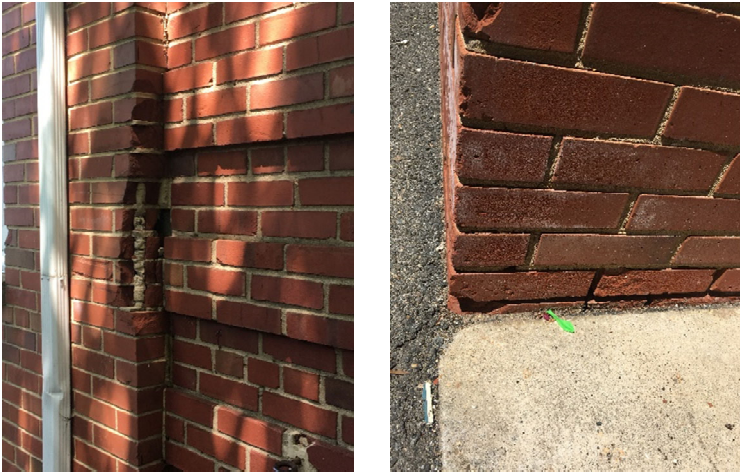
Figure 21 Exterior Walls (weathering and mortar vanishing)

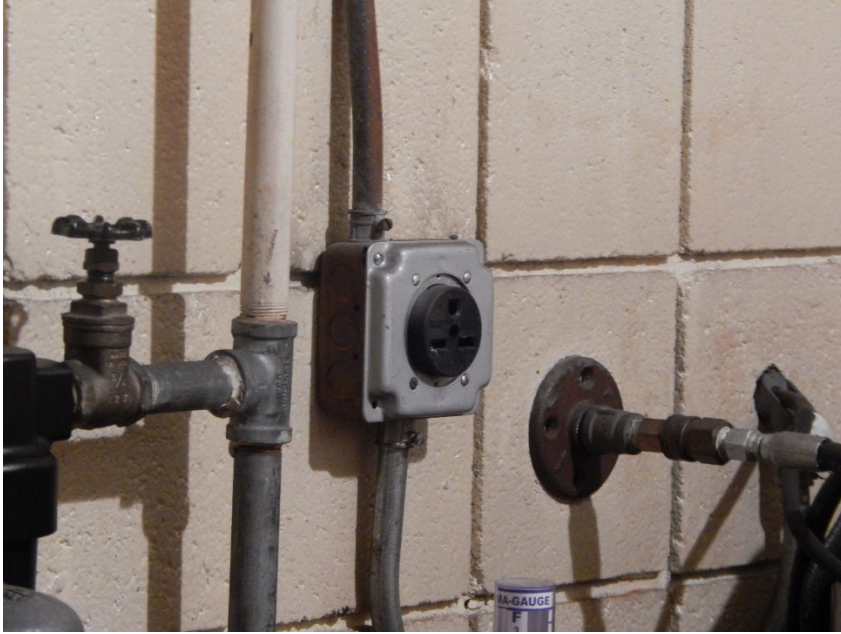
Figure 10: Non-Explosionproof Outlet Located in the Flammable Liquids Storage Space
