SUBJECT: Final Report

Playground Condition Assessment - Alexandria City Public Schools

Purchase Order No. 240256 FEA Project No. R01.2023.009971

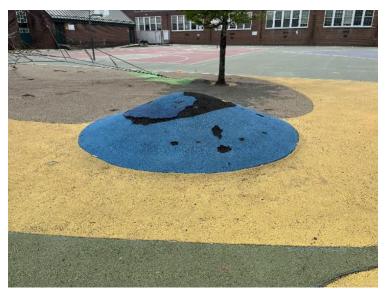
Elements in the site assessment included concrete curbs, unpaved paths (the mulch material under the equipment), the wood barrier surrounding the playground, raised planters, basketball courts, the poured-in-place rubber surface, playground elements, and exterior furnishings. The calculated Site Condition Index for the playground was 0.370, which indicates an overall "Poor" condition. This rating is primarily driven by the failed poured-in-place surface. Individual elements were rated as either good, fair, or

crisis (failed) condition. Total site system renewal needs in the next ten years are estimated at approximately \$766,461, as detailed on the following pages.

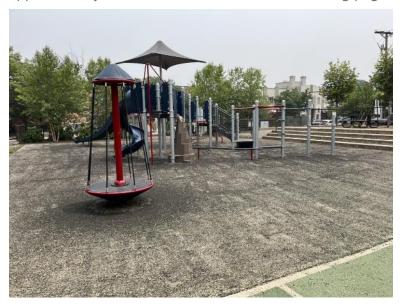
SYSTEM OBSERVATIONS
Site Systems	Rating	Observations
G2010.305 - CURBS AND BERMS	4	Defects on less than 10% of the system. Minor cracking observed.
G2020.213 - PERMEABLE PARKING LOTS	-	
G2030.110 - BITUMINOUS PAVING	-	·
G2030.120 - CONCRETE WALKWAYS	4	Defects on less than 10% of the system. The surface is performing as intended with no major potholes or defects.
G2030.130 - UNPAVED PATHS	3	Defects on 15% of the system. Some areas have significant depressions that require attention. There is compaction throughout and material is wearing thing.
G2030.150 - PLAZAS	-	
G2030.310 - STAIRS	4	Defects on less than 10% of the system. The surface is performing as intended with no major potholes or defects.
G2030.400 - PEDESTRIAN BRIDGES	4	Defects on less than 10% of the surface. Limited cracking observed. ADDITION There are two bridge types on the playground. 320 sf. of composite and 40 sf. of older wood decking. I've chosen to use composite only.

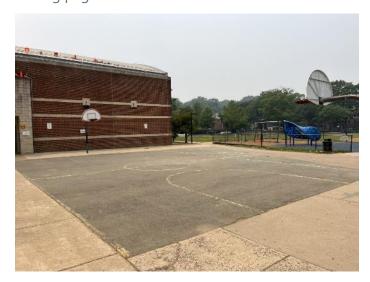
Elements in the site assessment included concrete walkways, unpaved paths (the mulch material under the equipment), a plaza, chain link fences and gates, athletic courts, playground elements, and area lighting. The calculated Site Condition Index for the playground was 0.553, which indicates an overall "Poor" condition. This rating is primarily driven by the poor condition of the asphalt basketball court. Individual elements were rated as either good, fair, or poor condition. Total site system renewal needs in the next ten years are estimated at approximately \$422,187, as detailed on the following pages.

SYSTEM OBSERVATIONS
Site Systems	Rating	Observations
G2010.305 - CURBS AND BERMS	-	-
G2020.213 - PERMEABLE PARKING LOTS	-	
G2030.110 - BITUMINOUS PAVING	-	
G2030.120 - CONCRETE WALKWAYS	4	Defects on less than 10% of the system. The surface is performing as intended with no major potholes or defects.
G2030.130 - UNPAVED PATHS	4	Defects on less than 10% of the system. The surface is generally uniform and smooth. Limited depressions, or ruts were observed.
G2030.150 - PLAZAS	4	Defects on less than 10% of the system. There are a few deteriorated or cracked bricks. The joints are generally uniform, and the finished surface is generally flushed.
G2030.310 - STAIRS	-	·
G2030.400 - PEDESTRIAN BRIDGES	-	
G2040.120 - CHAIN LINK FENCES AND GATES	3	Defects on less than 25% of the system. Some degradation of metal poles is visible. Some areas of bent wire were observed.
G2040.130 - DECORATIVE METAL FENCES AND GATES	-

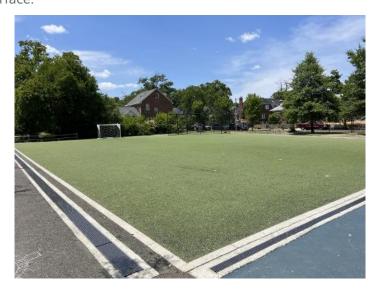
SYSTEM OBSERVATIONS
Site Systems	Rating	Observations
G2010.305 - CURBS AND BERMS	4	Defects on less than 10% of the system. Minor cracks observed. Combination of concrete curbing throughout the playground.
G2020.213 - PERMEABLE PARKING LOTS	4	Defects on less than 10% of the system. The surface is performing as intended.
G2030.110 - BITUMINOUS PAVING	3	Defects on less than 25% of the system. Some cracking and uplift observed, some potholes.
G2030.120 - CONCRETE WALKWAYS	4	Defects on less than 10% of the system. The surface is performing as intended with no major potholes or defects.
G2030.130 - UNPAVED PATHS	3	Defects on less than 25% of the system. Surface depressions are significant around play equipment.
G2030.150 - PLAZAS	-	
G2030.310 - STAIRS	4	Defects on less than 10% of the system. Limited surface cracks are observed in concrete.
G2030.400 - PEDESTRIAN BRIDGES	-	
G2040.120 - CHAIN LINK FENCES AND GATES	3	Defects on less than 25% of the system. Some degradation of metal poles and some poles are not securely mounted. There are areas of bent wire mesh. 🟲 Local Project: Fence Replacement
