ALEXANDRIA CITY PUBLIC SCHOOLS
COMPREHENSIVE CONDITION AUDITS

- CORA KELLY ELEMENTARY SCHOOL
- FRANCIS C. HAMMOND MIDDLE SCHOOL
- GEORGE MASON ELEMENTARY SCHOOL
- GEORGE WASHINGTON MIDDLE SCHOOL
- MATTHEW MAURY ELEMENTARY SCHOOL
- TRANSPORTATION FACILITY

Final Report - DRAFT

August 9, 2019

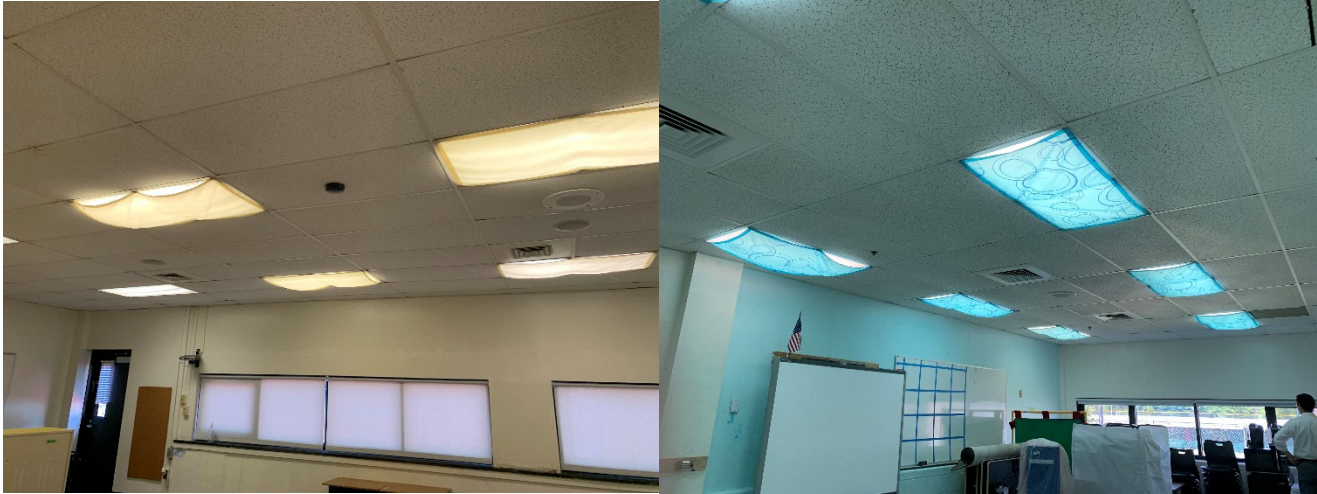
Figure 10: Light dimmers required

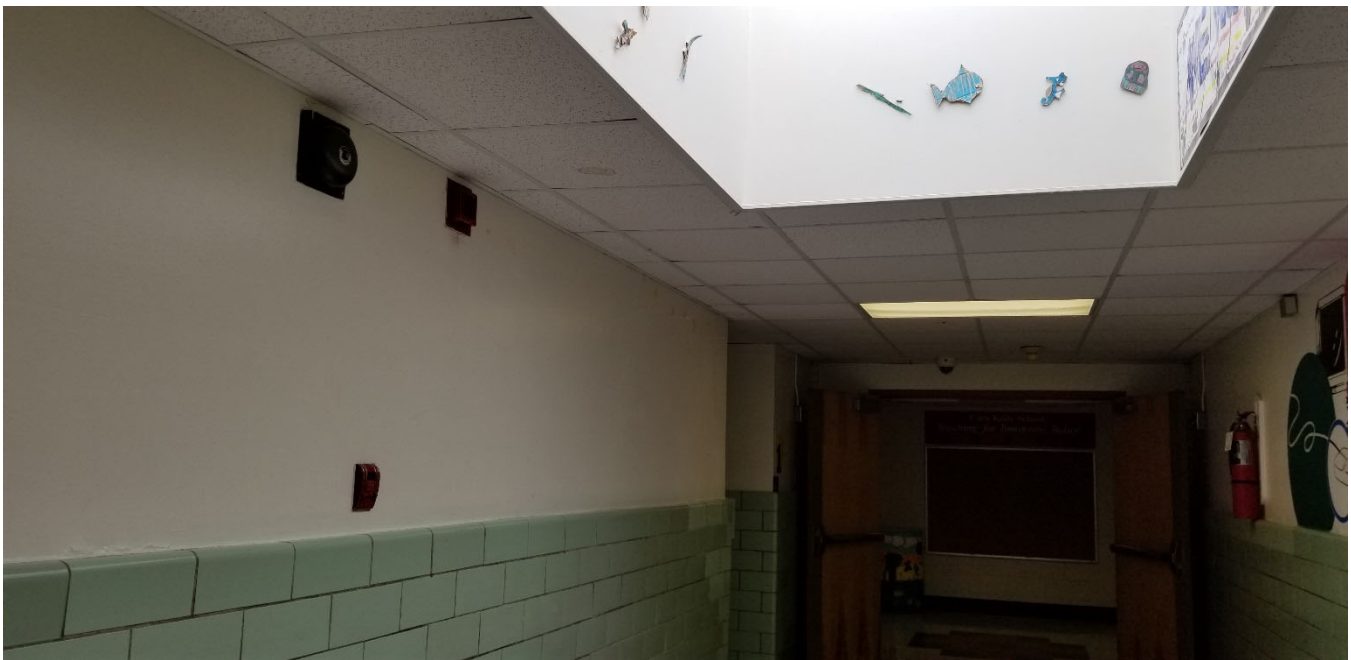
Figure 11: Fire Alarm Pull Station / Horn / Bell – No Strobes or Emergency Battery Pack

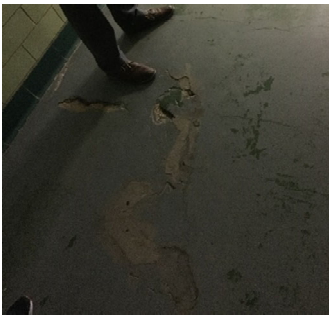
At the basement locker room corridor, there has been chronic flooding from sub-surface water in the crawl spaces that build up in an uncontrolled fashion during heavy rain events. This translates to water penetrating through the basement wall and flooding occurring in this corridor (Figure 7). The slab at this corridor is failing. The area is under review by a structural engineer.

Figure 7. Floor slab and sub-structure in locker room corridor

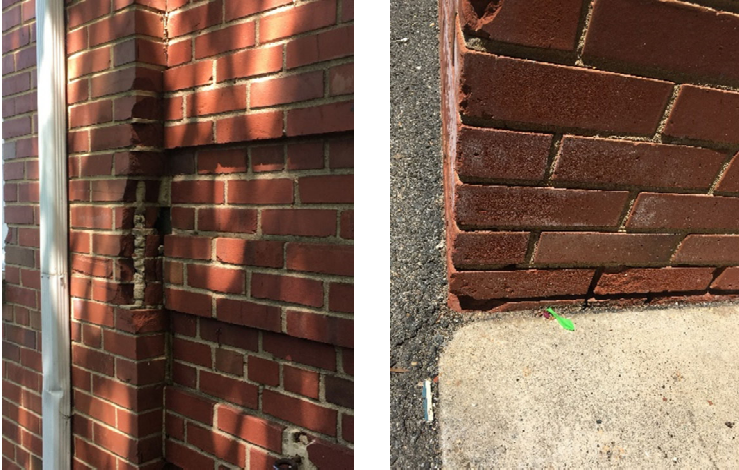
Figure 21 Exterior Walls (weathering and mortar vanishing)

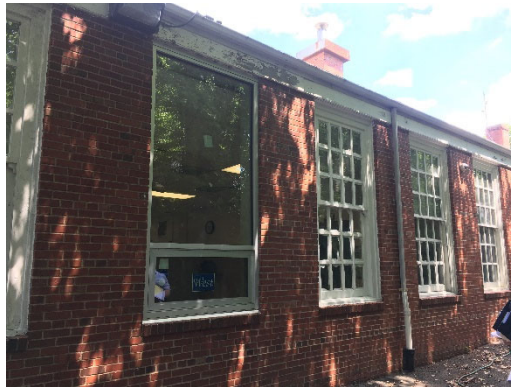
Figure 4 Stormwater Drains at Window Edge

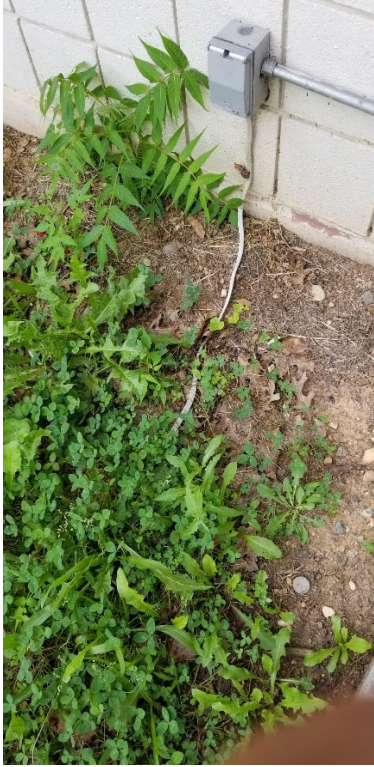
Figure 14: Exposed Wiring to Parking Lot Light Fixture
