EXHIBITS

EXHIBIT 1:

JOINT TASK FORCE & SUBCOMMITTEE MEETINGS

A2 Services, Inc. Facility Survey of City of Alexandria - City Hall

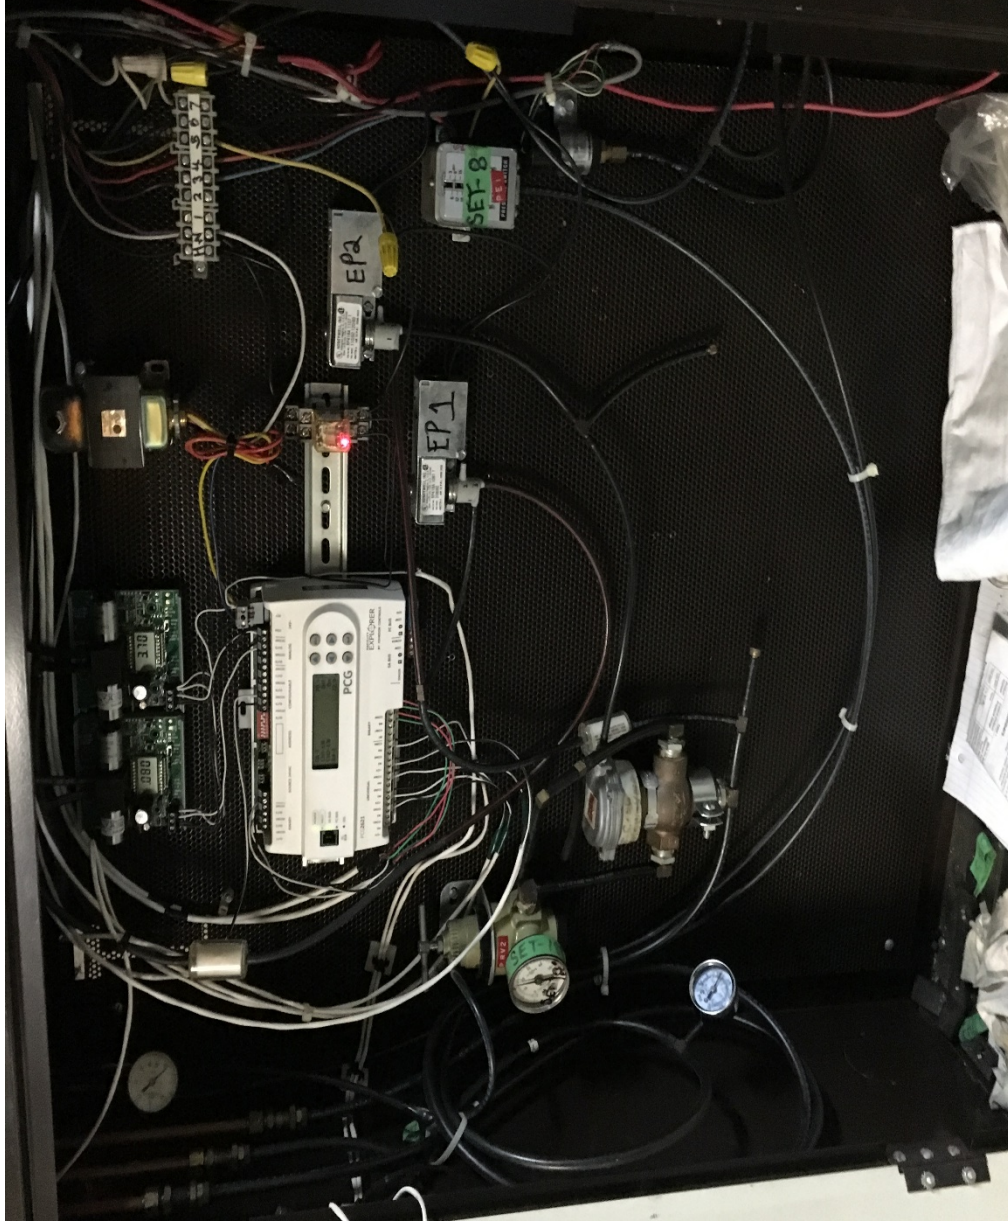
- Finding # - 6. The central plant and air handler controls are pneumatic. The controls are operating but will eventually need to be replaced. There is at least one actuator which should be replaced now. The steam control valve and actuator for the hot water convertor are in poor shape. If this device fails during the winter, the facility will not have heat.

Finding # 6 Photo. The picture is an example of the old pneumatic controls used to operate the boiler room systems and the air handlers systems in the building.

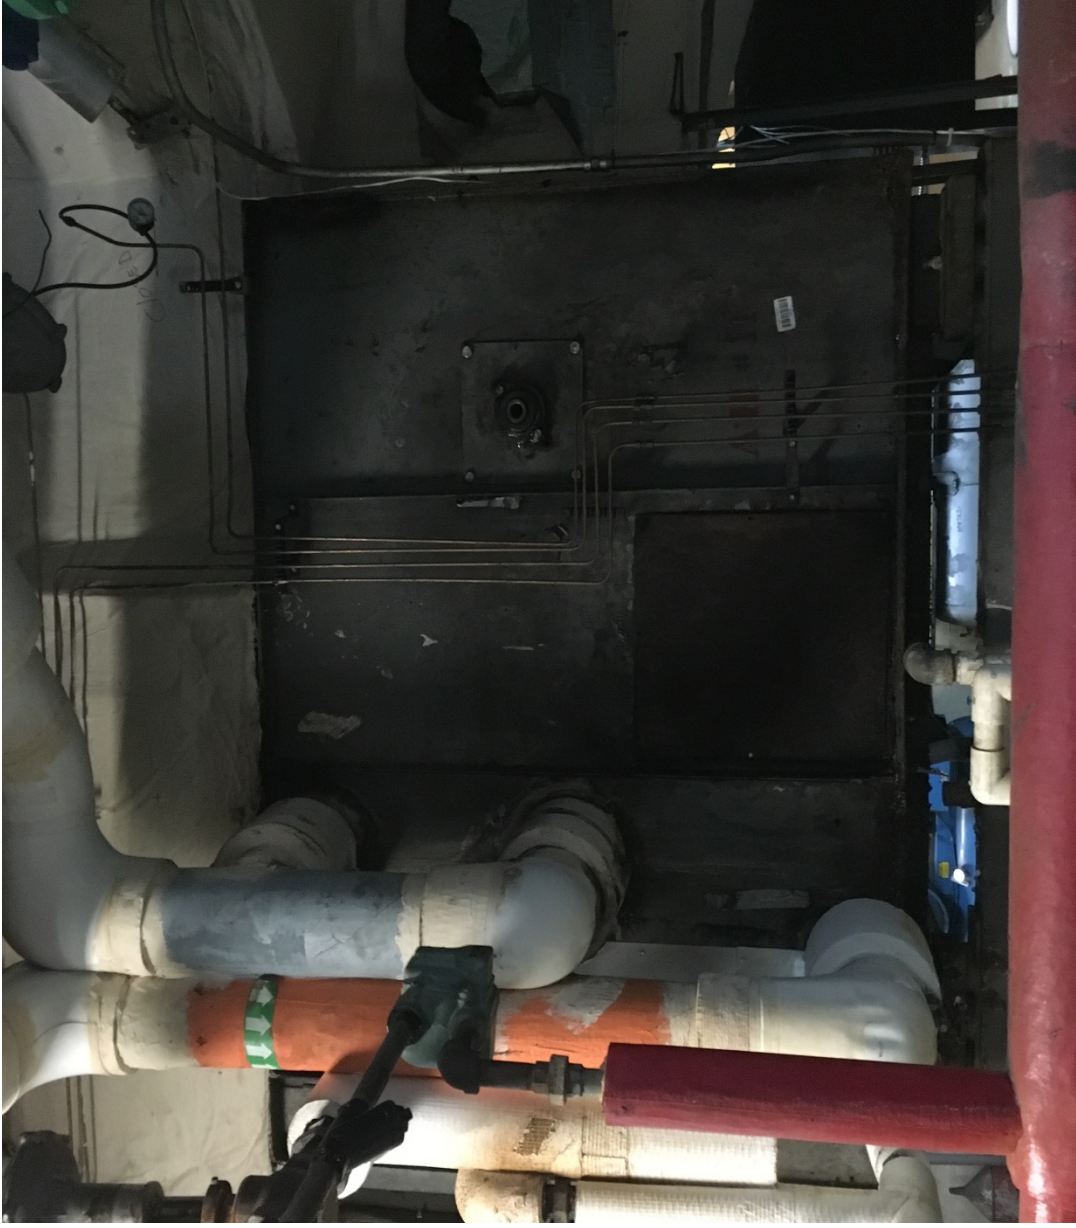
Finding # - 8. The main outside air fan for the building is small and only dumps conditioned outside air into the central corridor of the building. It appears that the fan coils do not have outside air vents and the ceiling hung air handlers do not have outside air fed to them either. This should be further investigated to make sure this finding is correct. The concern is a possibility that the office areas in the building may not be getting good fresh air ventilation.

Finding # 8 Photo. This picture is of the main outside air fan which filters, heats or cools the incoming air for building ventilation.

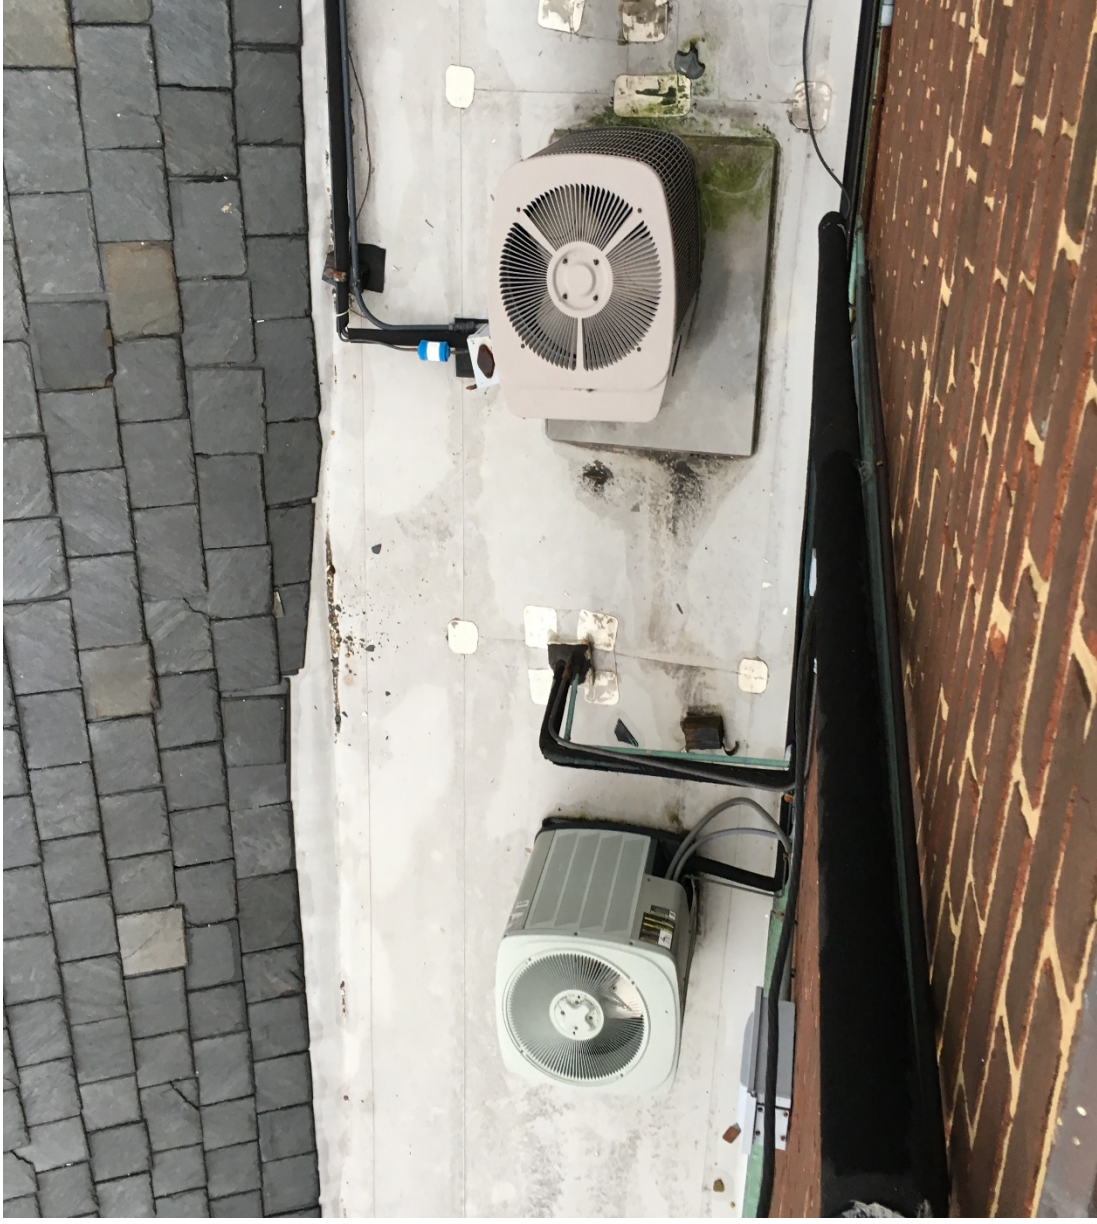
Finding # - 13. There are 24 split system heat pumps which are placed around the building to handle extra heating and cooling requirements in the building. Many of these units are very hard to access for repairs or service.

Finding # 13 Photo. This picture notes the difficult access to the HVAC units.

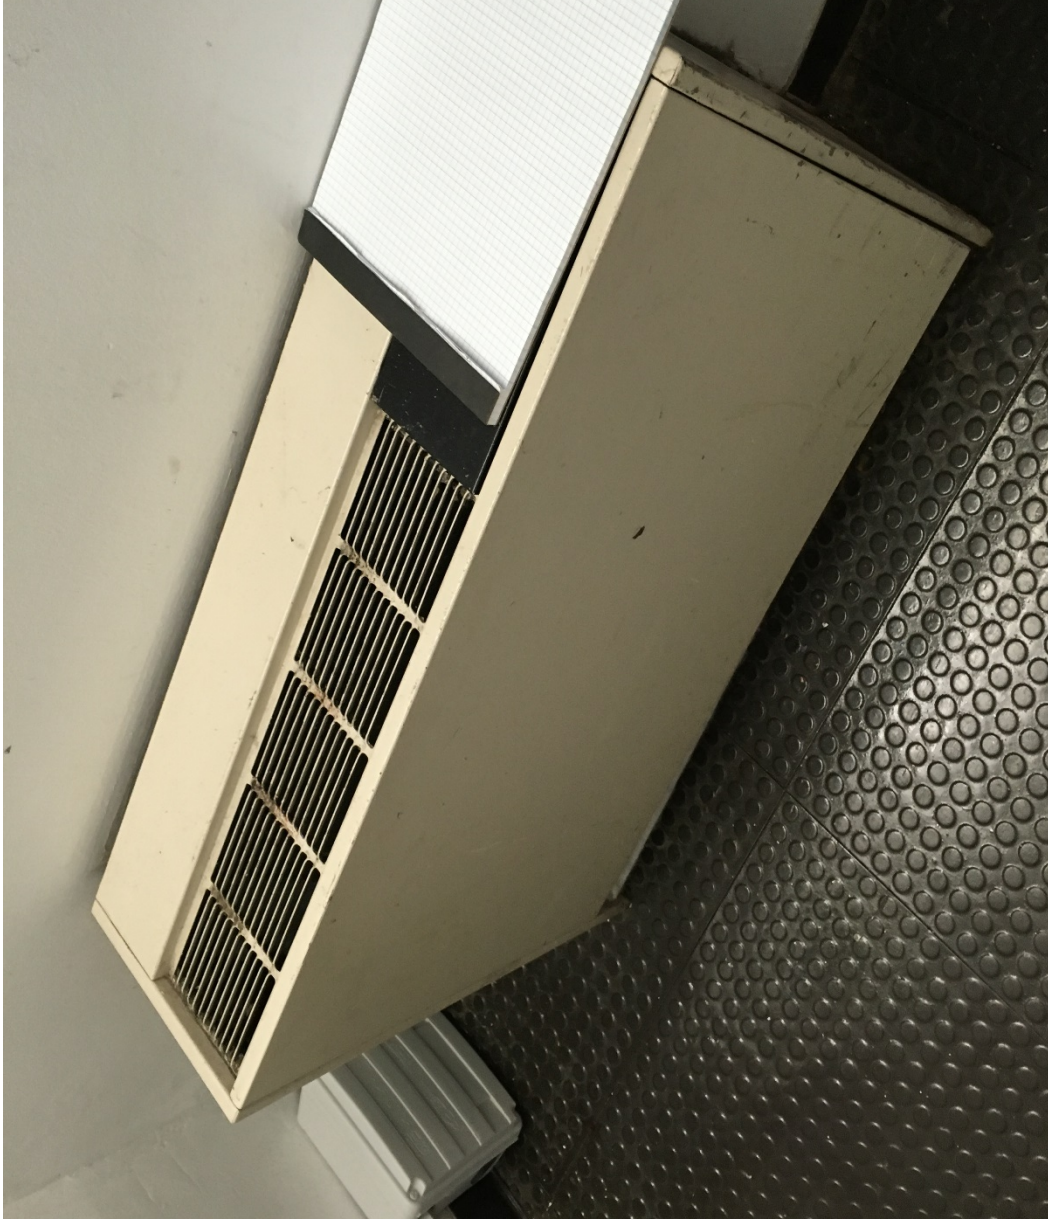
Finding # - 14. There are 180 fan coil units which are located under windows in offices and in areas around the building perimeter. These units need to be serviced and flushed regularly to eliminate condensate leaks. In many offices the staff have furniture in front of this equipment or covered so they cannot operate properly. This condition adds a lot of preparation time to get these units open for service. This equipment also causes condensate leaks in summer. The unit's condensate pans and drains should be flushed 2 to 3 times throughout the summer to eliminate the leaks.

Finding # 14 Photo. This picture is an example of one perimeter fan coil unit. This one is in an entrance way off the courtyard.

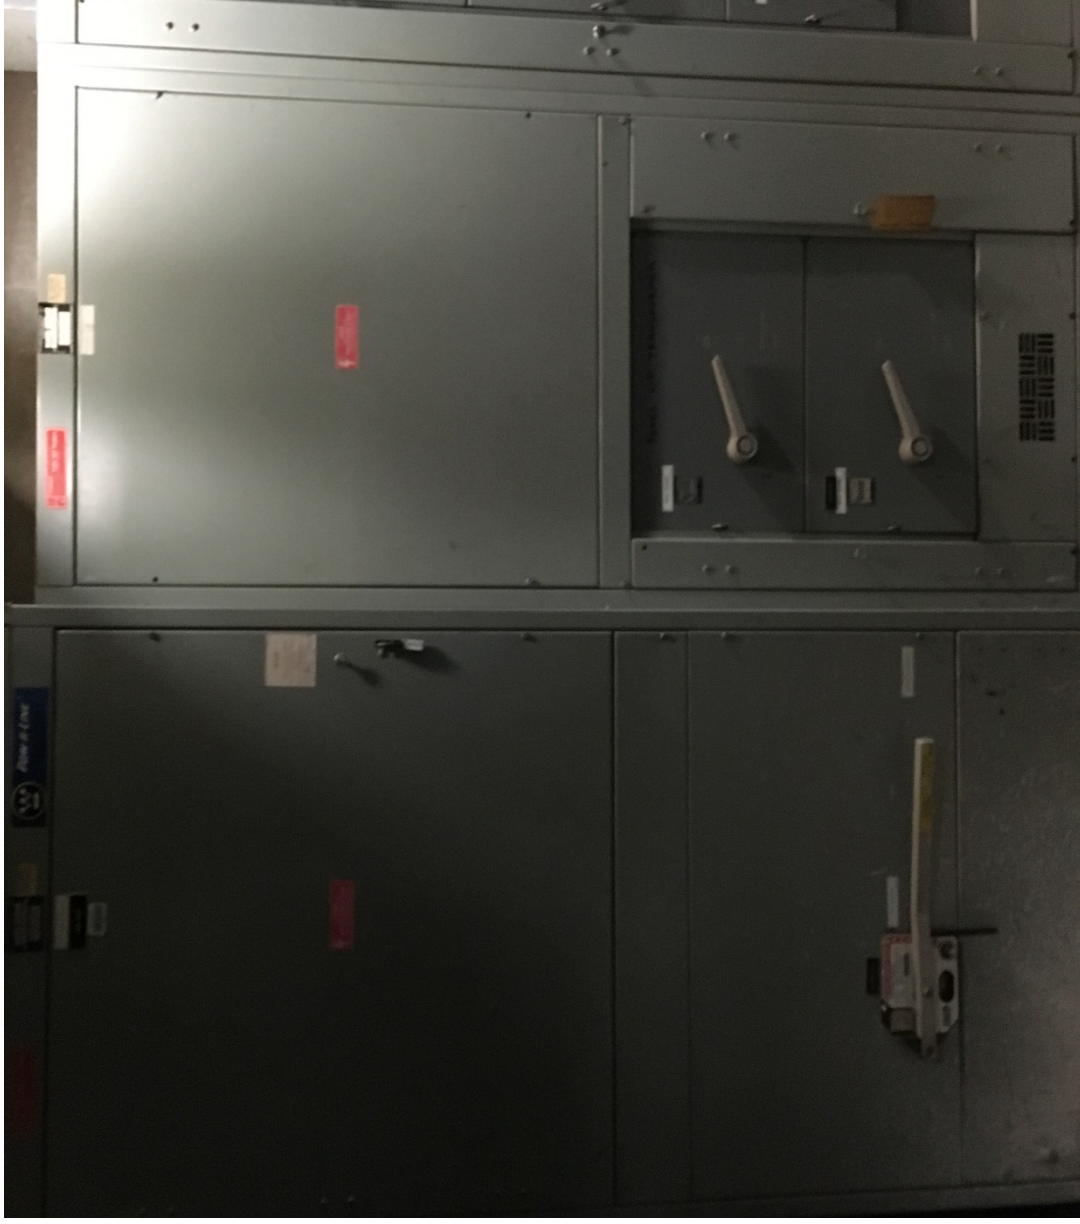
Finding # - 15. The main electrical panels and breakers panels at the site do not look as if they are being tested and serviced. All electrical systems should be thermally scanned with an infra-red camera to identify any overheating components or loose connections. This testing will identify such issues before a failure of the electrical system occurs. A2 recommends that all electrical gear be opened, thermally scanned then cleaned and all terminations checked of tightness every 2 to 3 years at a minimum. This an important risk management task that should be implemented. This maintenance is a code requirement. **REVISION – Per DGS an extensive survey of the electrical gear was performed in 2013-2014. A2 requests a copy of the report. Additionally, per DGS the gear is inspected by the DGS Master Electrician. There is no evidence of these inspections. In the future, A2 recommends that inspections stickers be affixed to the gear to denote the review. Finally, please see the attached electrical maintenance code requirements. The City of Alexandria is required to be in compliance with NFPA 70B.**

Finding # 15 Photo. This picture is an example of one main switch gear which does not look like it has been shut down for cleaning and tighten-up work. Infra-Red testing should also be implemented.

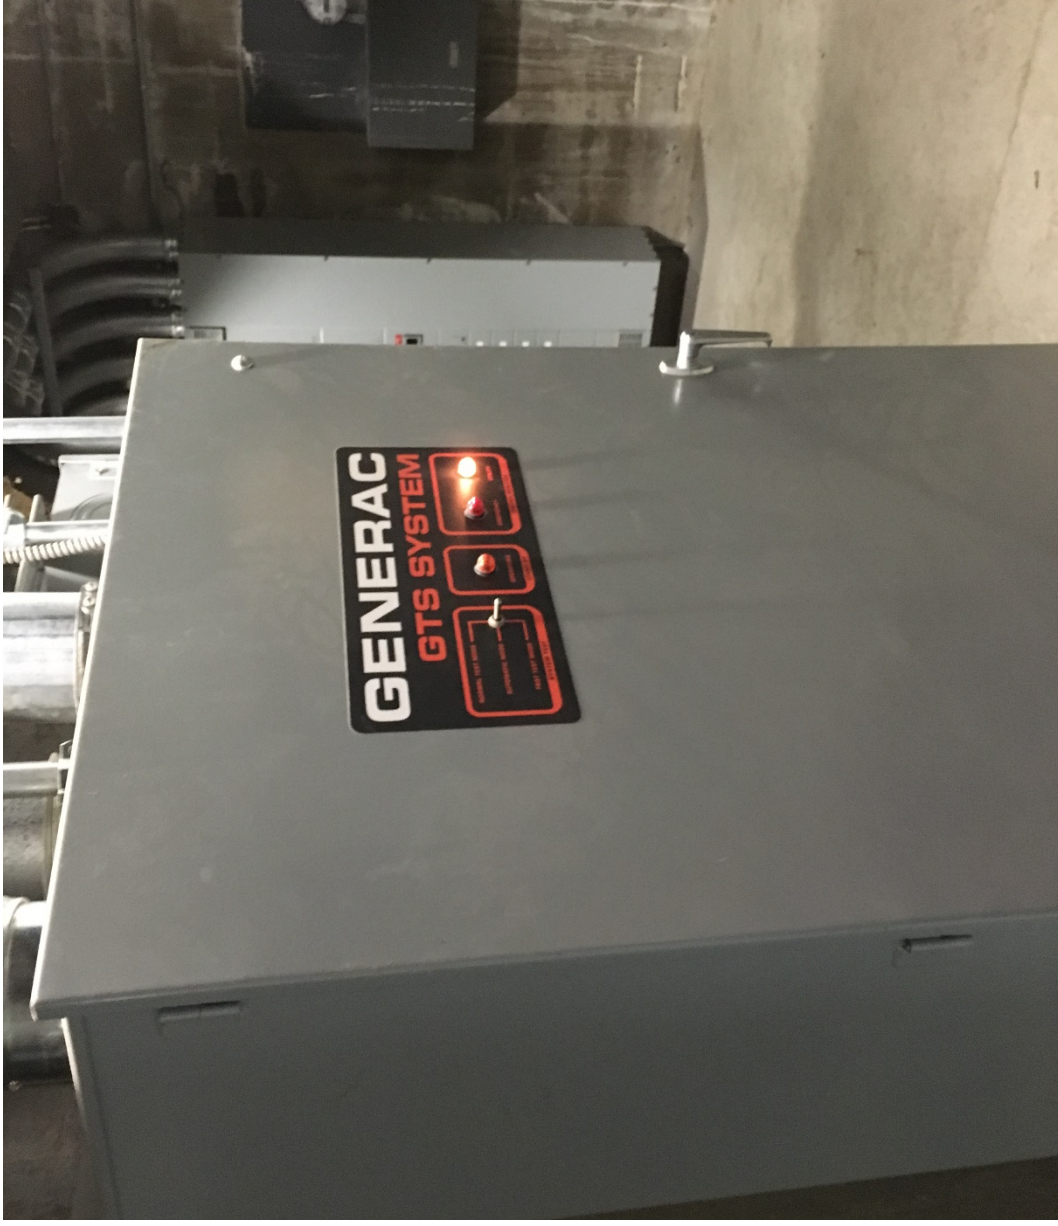
Finding # 16 Photos Continued. This picture is of one of the emergency transfer switches which should be tested.

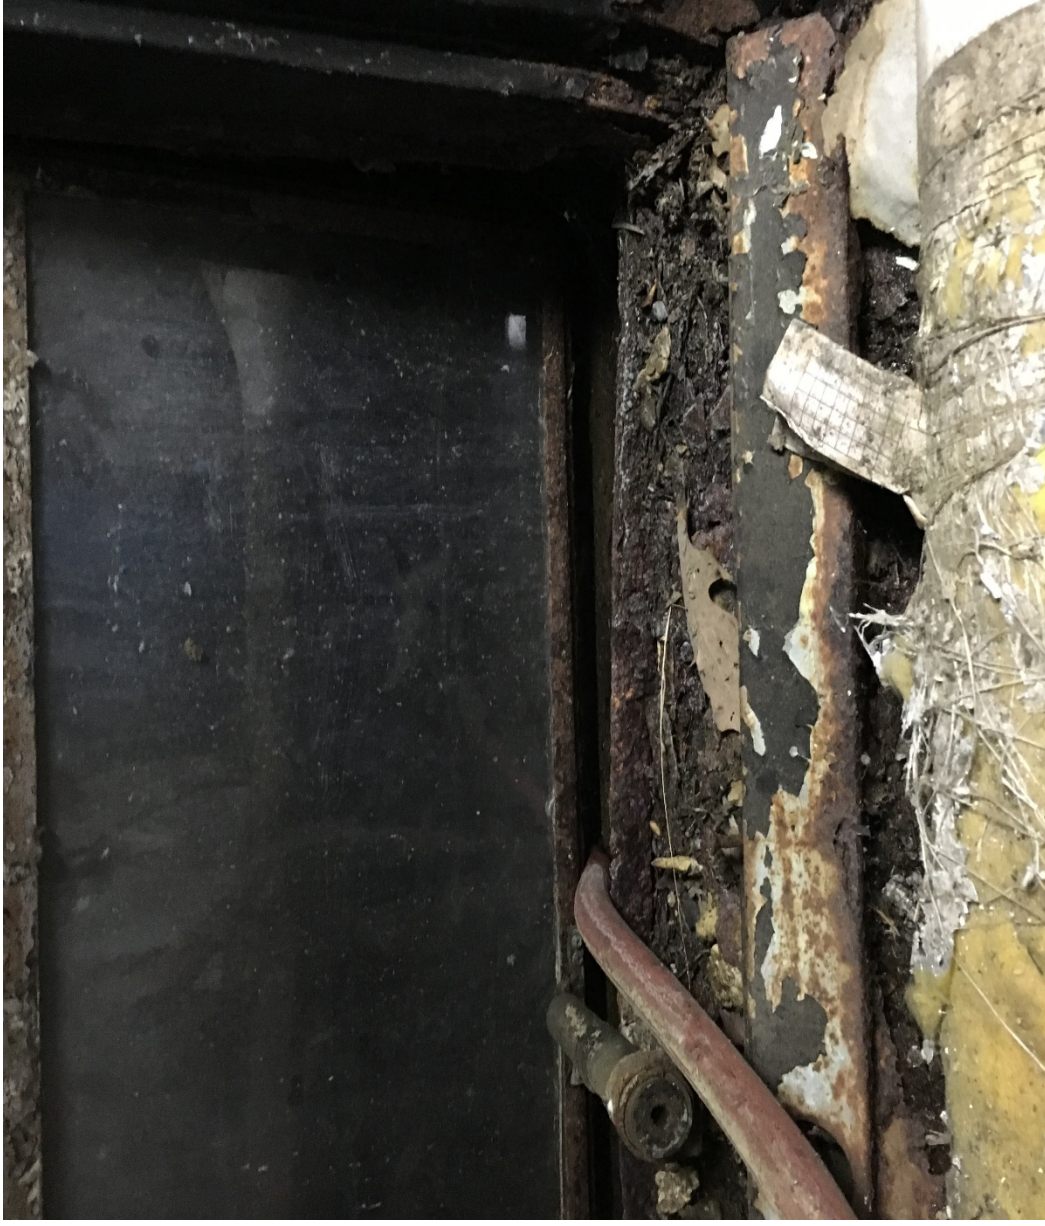
Finding # - 17. The outside air shaft drain outside the boiler room is plugged up allowing water to enter the boiler room through a window. This drain should be snaked or repaired.

Finding # 17 Photo. This picture notes the window where water is entering the boiler room from the outside air shaft.

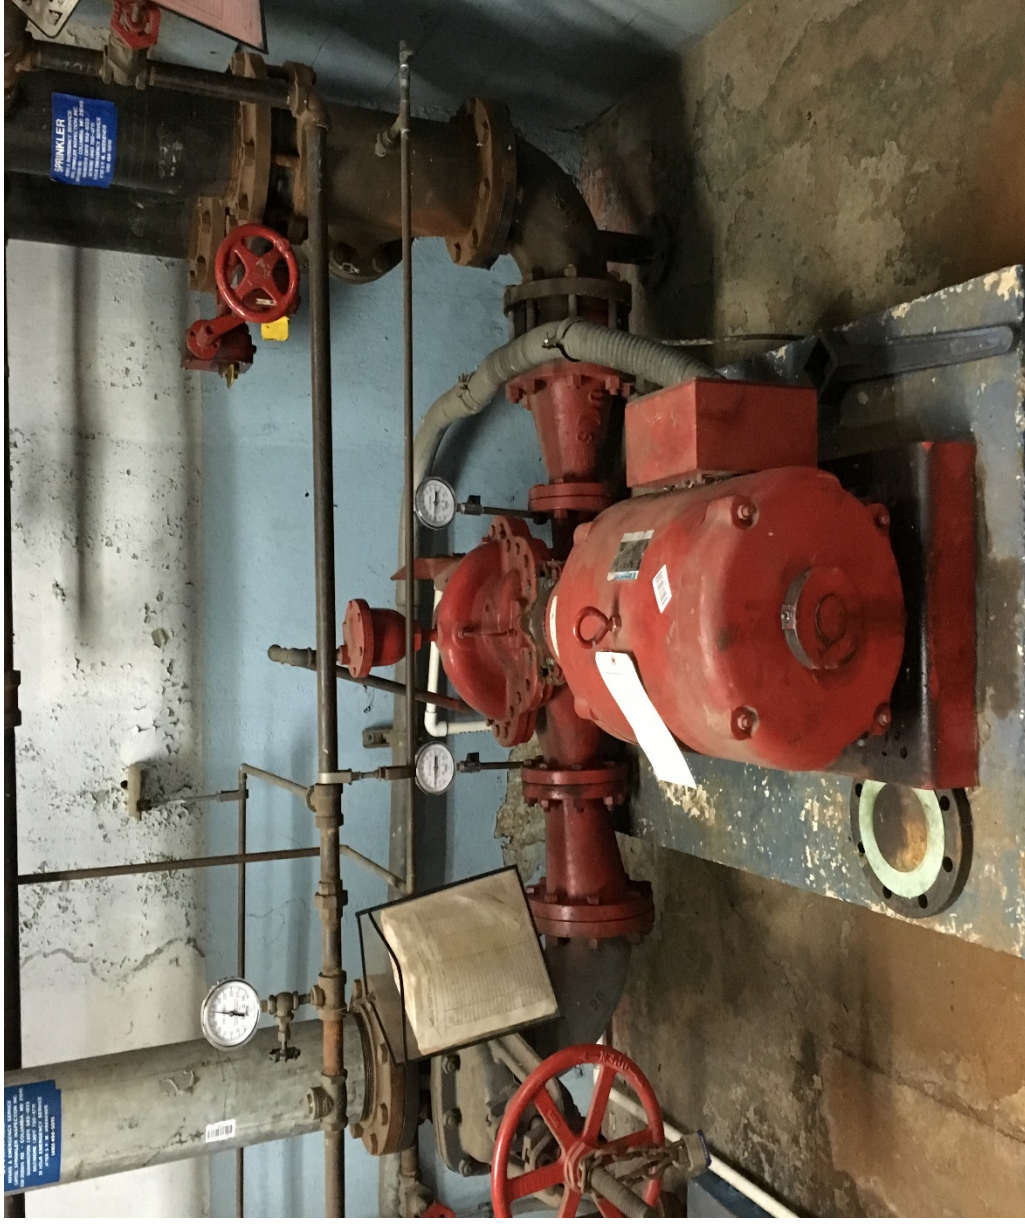
Finding # - 21. The building Fire Pump is located in the boiler room. NFPA code requires that this pump be tested weekly with no flow. An annual flow test to the street is also required. No test tags are shown on the pump showing that this PM was being done. **REVISION - Per DGS an annual inspection had been completed. A2 requests a copy of the report. A2 recommends that the annual test tags be installed to signify the inspection.**

Finding # 21 Photo. This picture notes the fire pump in the boiler room. The pump needs to be tested weekly with no flow and once a year with full flow to the street. This is required to make sure the pump will operate correctly in an actual fire event.

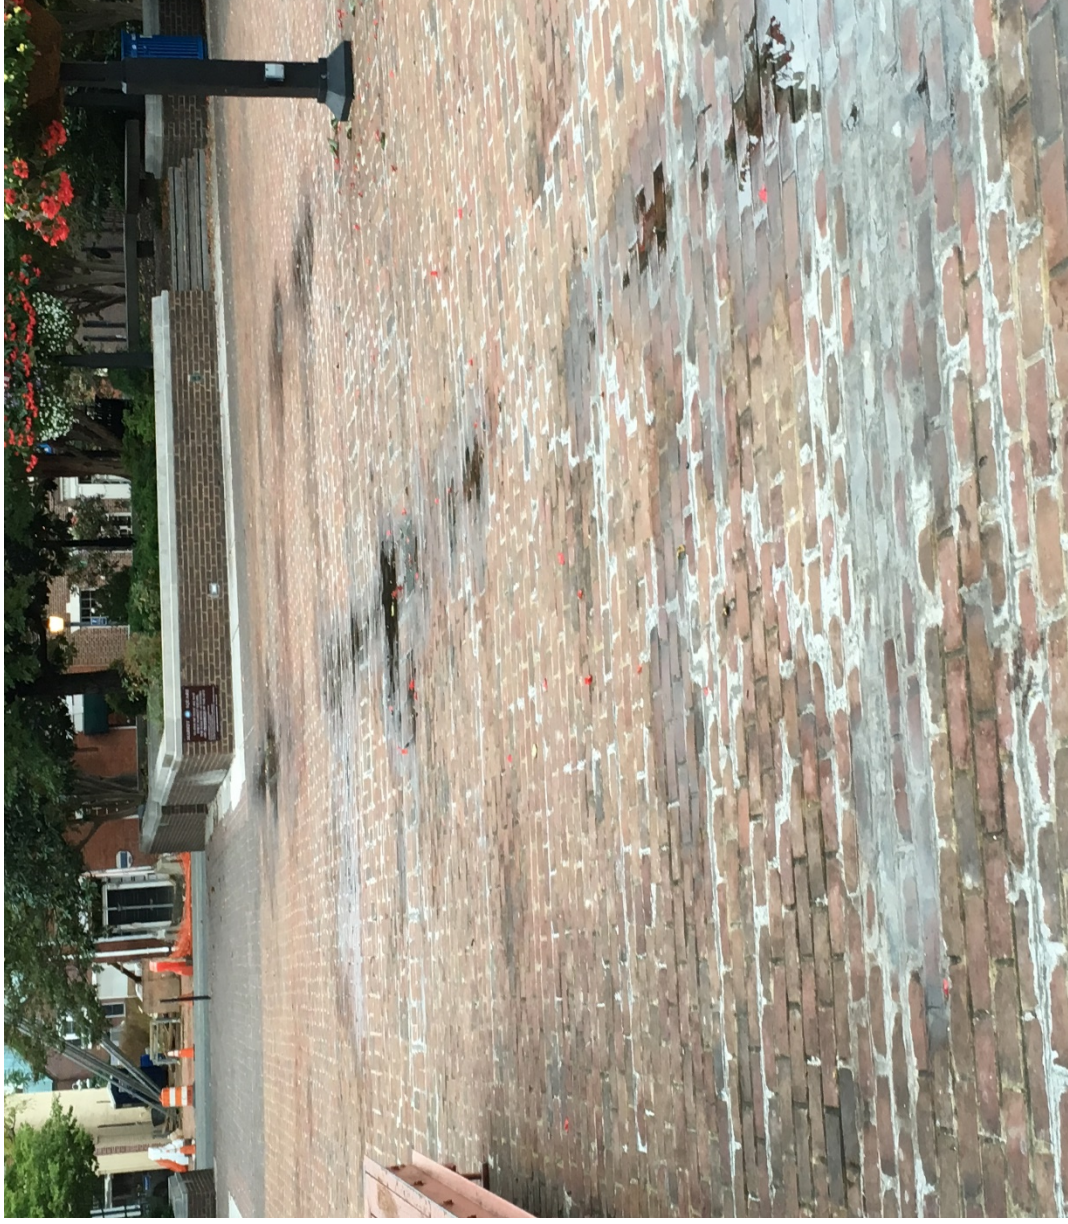
Finding # - 25. The courtyard brick work has a few areas where it looks as if water is also getting into the garage. The water leaks into the garage are causing noticeable damage.

Finding # 25 Photo. This picture notes a section of the brick work on the courtyard deck which looks to be adding to the water issues in the garage.

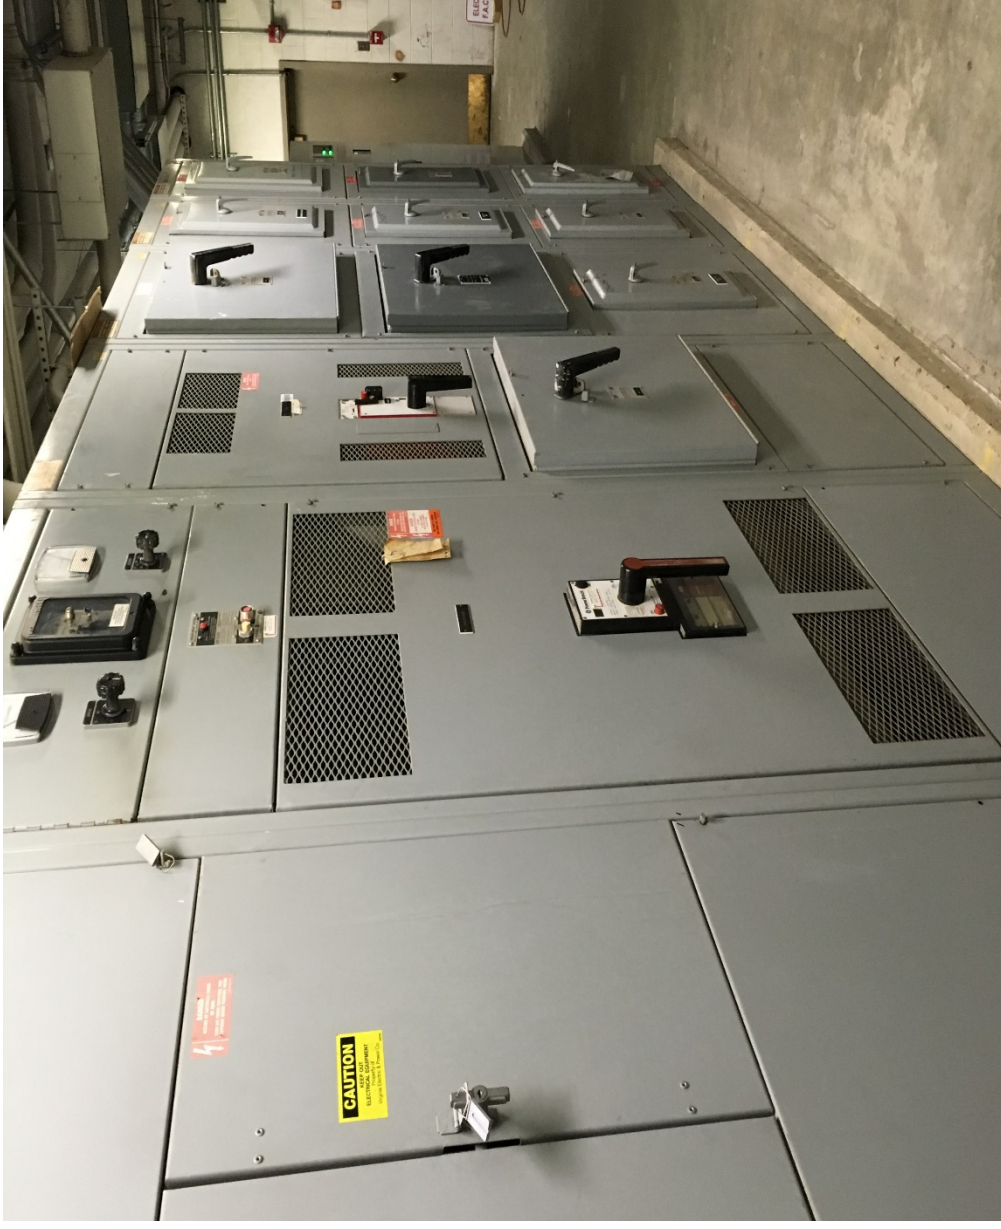
Finding # - 15 There is no inspection stickers noting that the electrical system maintenance has been completed.

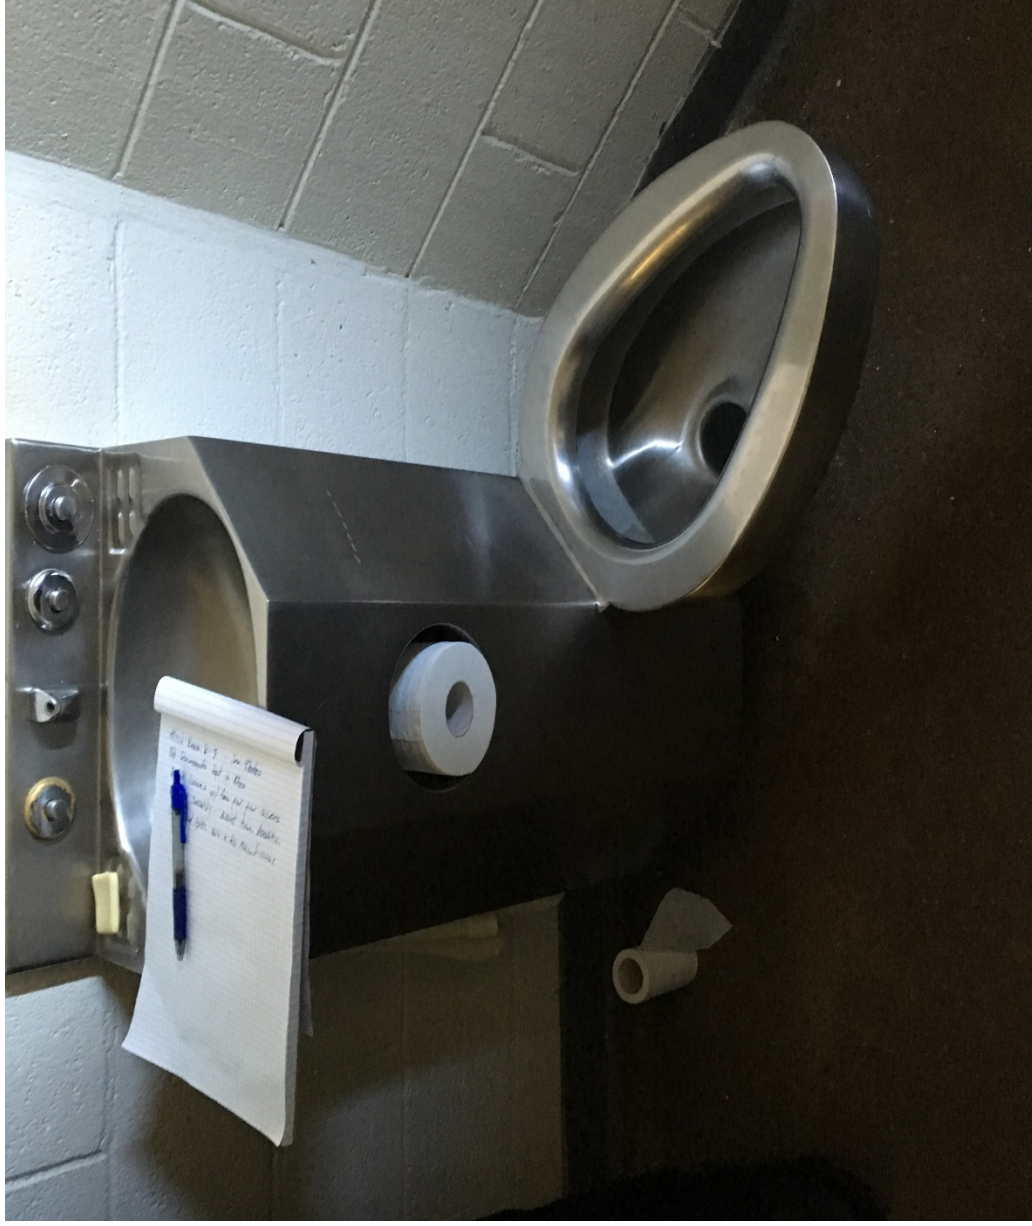
Finding # - 21 This picture is of the toilet sink combination used in the jail cells. It may be possible to retro-fit these with faucets and flush valves that would be off the shelf items.

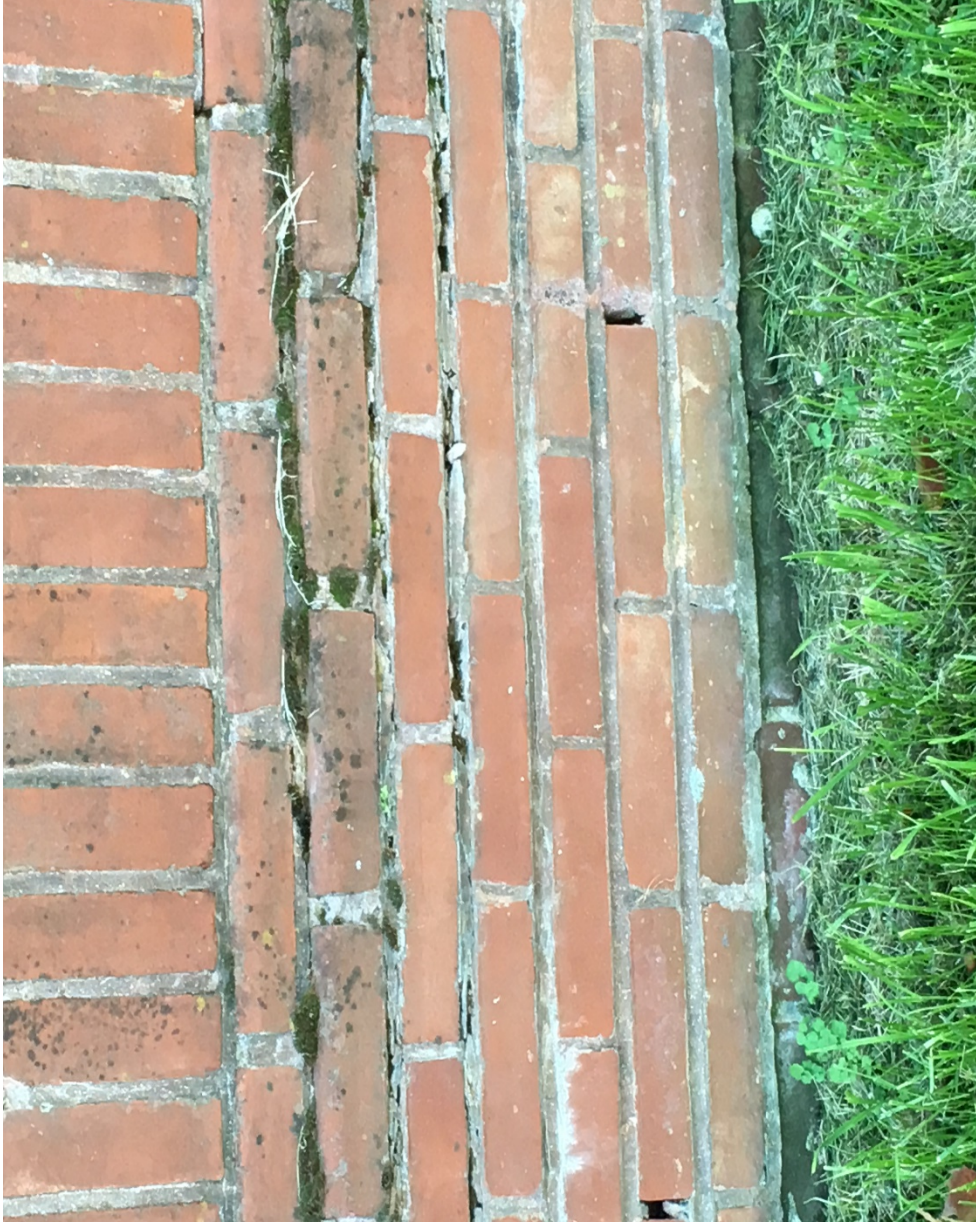
Finding # - 31 This picture is of an area of the brick façade on the north side of the sheriff's building which should be tuck-pointed. This area is just below the window shown above.

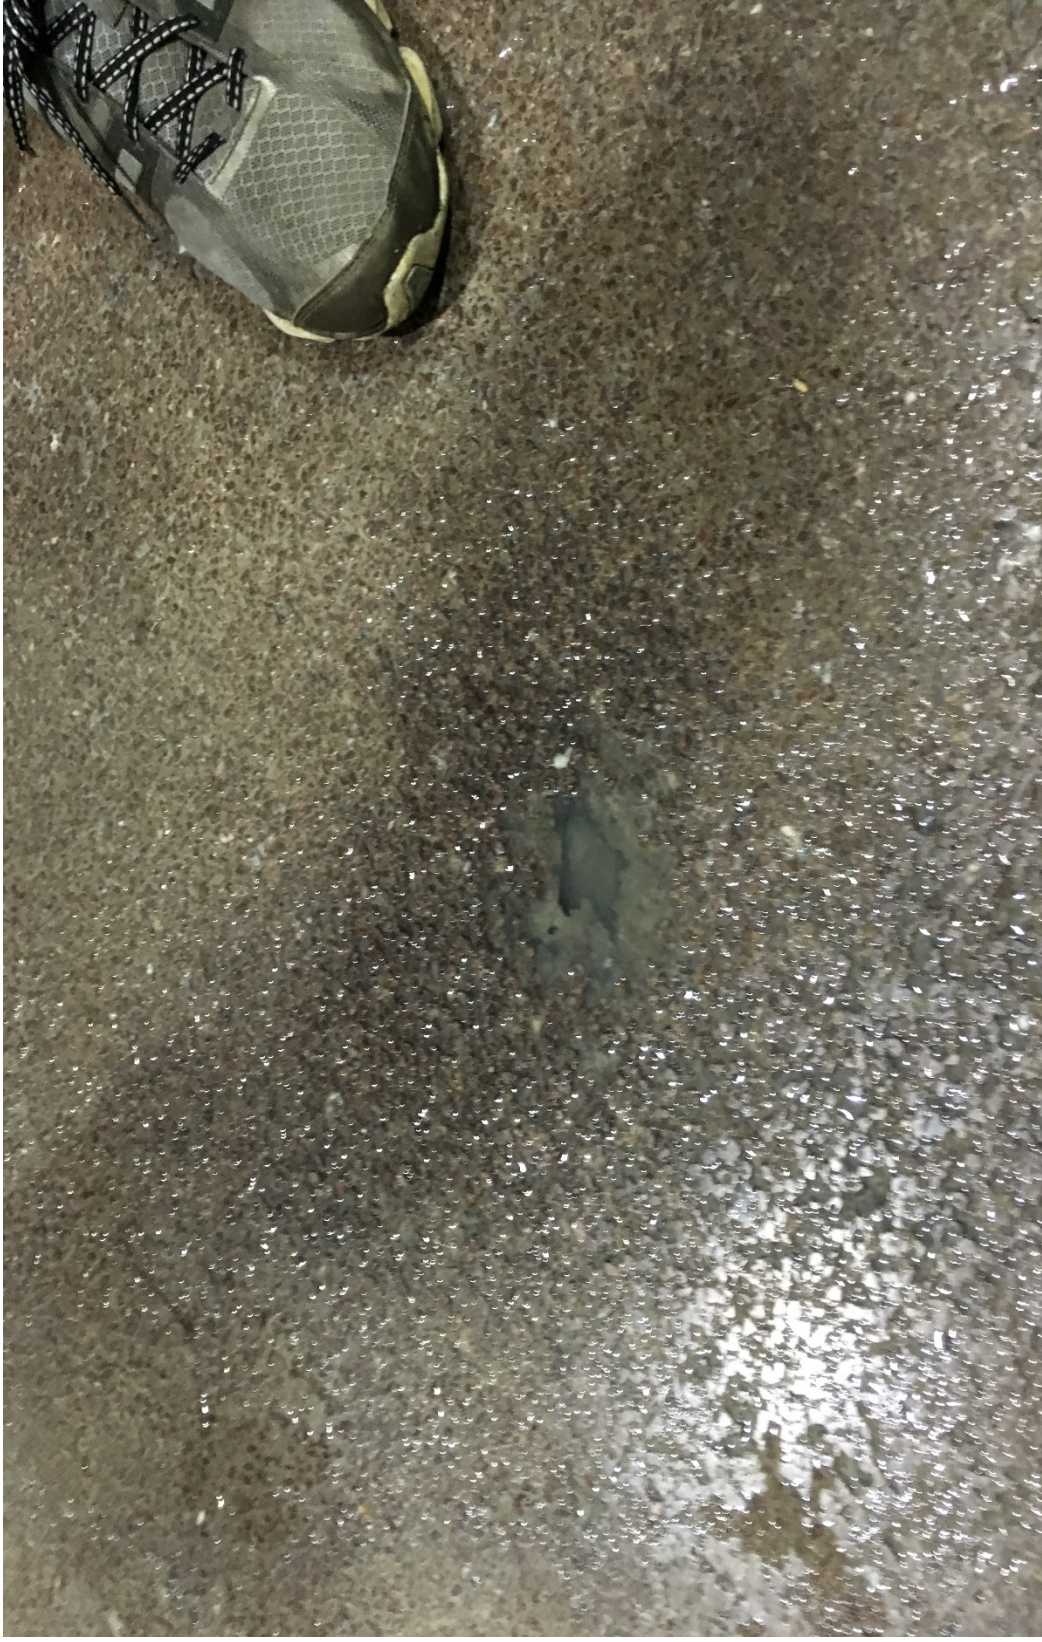
Finding # - 32 This picture is of the epoxy /coating used in the shower stall areas floors which is in need of repair or replacement.

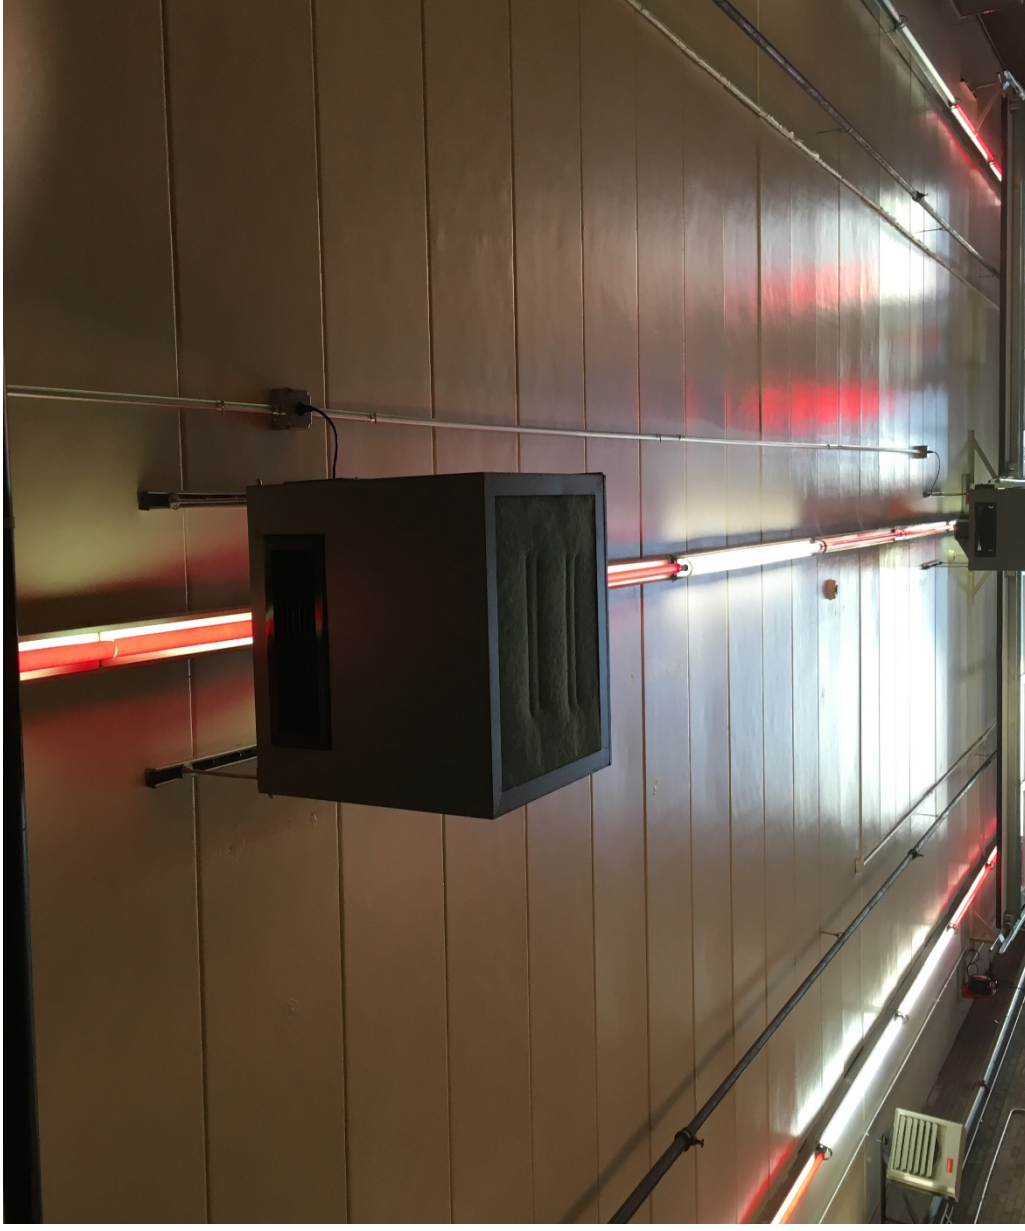
Photo # - 2. This picture is of one of the main electric unit heaters which heat the engine bay area.

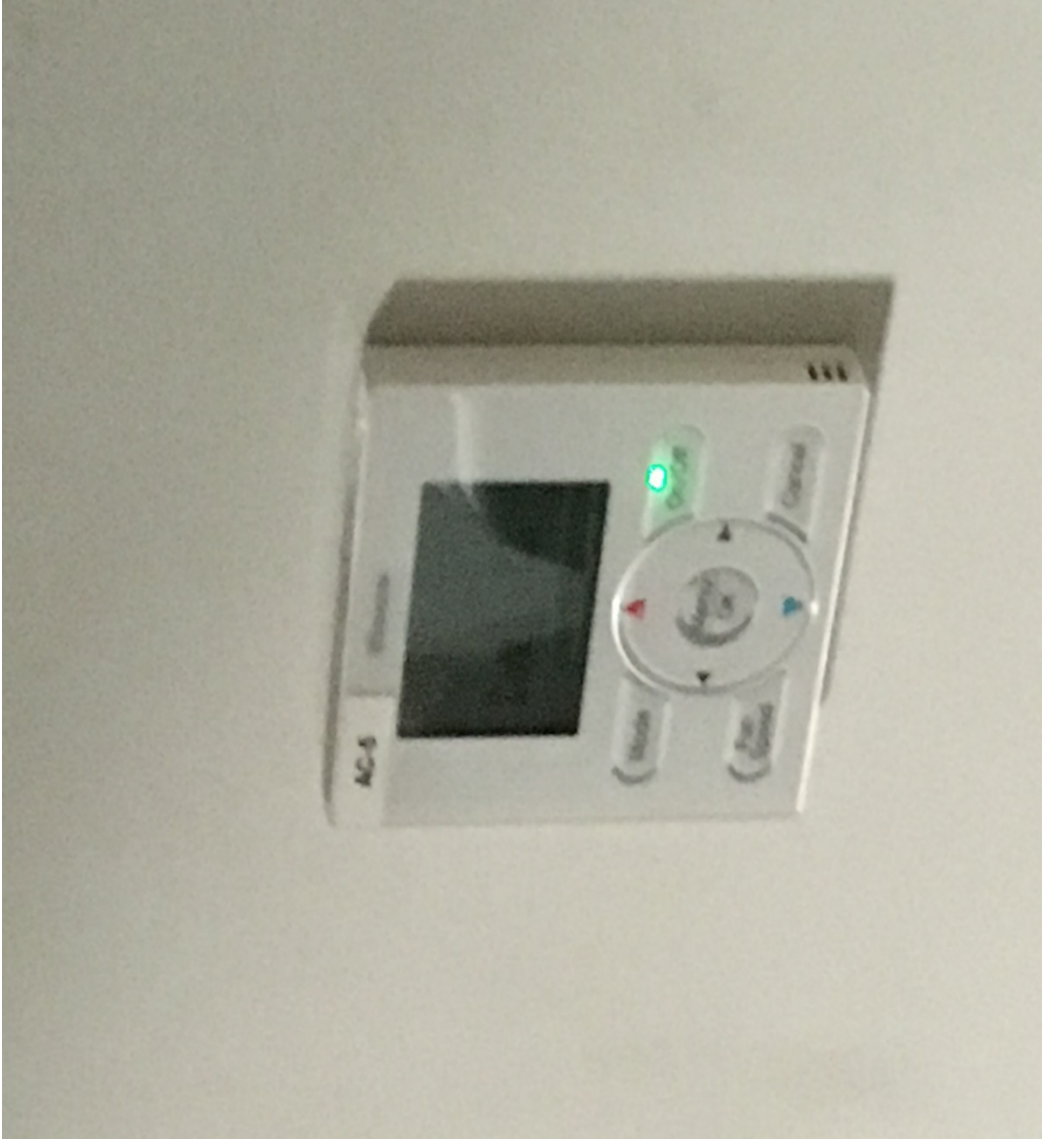
Photo # - 6. This picture is of the thermostat for the weight room which also controls the unit next door in the storage area. Installing one new t-stat on the unit next door will help control temperatures in both areas.

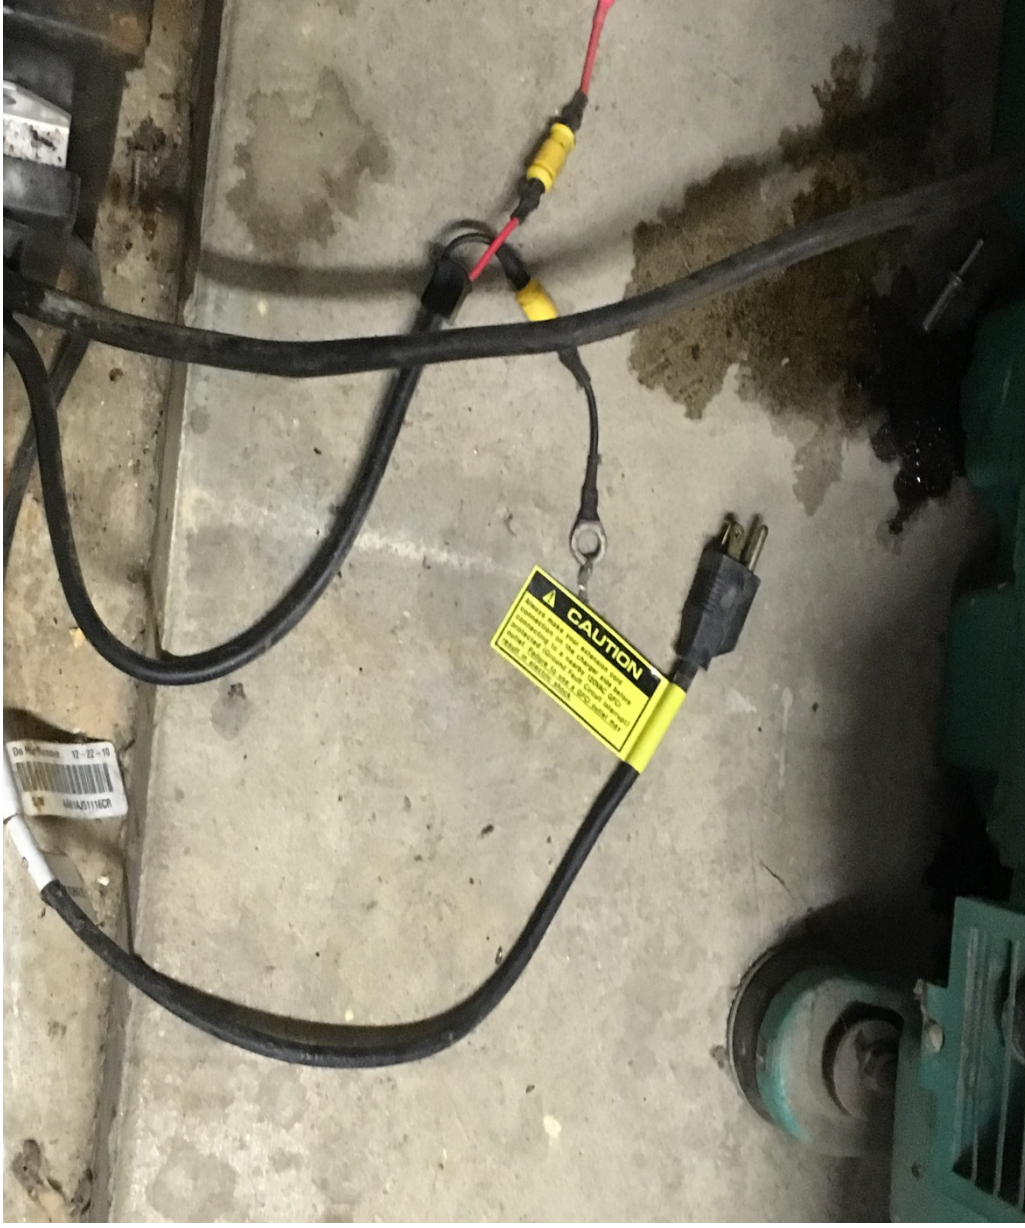
Photo # - 7. This picture is of the power disconnected from the emergency generator battery charger.
