EXHIBITS

EXHIBIT 1:

JOINT TASK FORCE & SUBCOMMITTEE MEETINGS

A2 Services, Inc. Facility Survey of City of Alexandria - City Hall

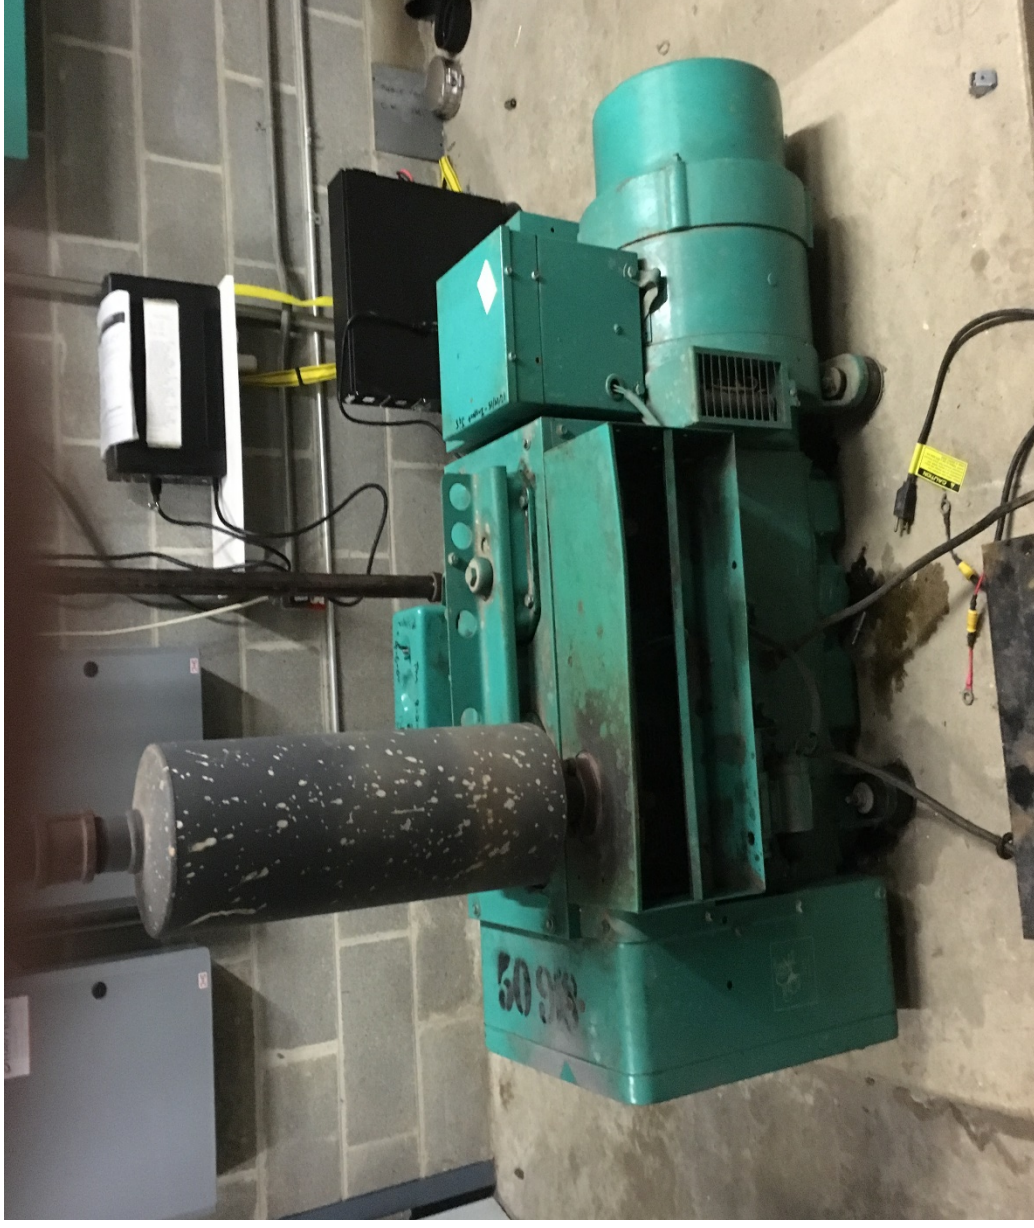
Photo – 8 and 9. This picture is of the gas fired emergency generator. This is not sized to handle the whole facility and has not been tested under load.

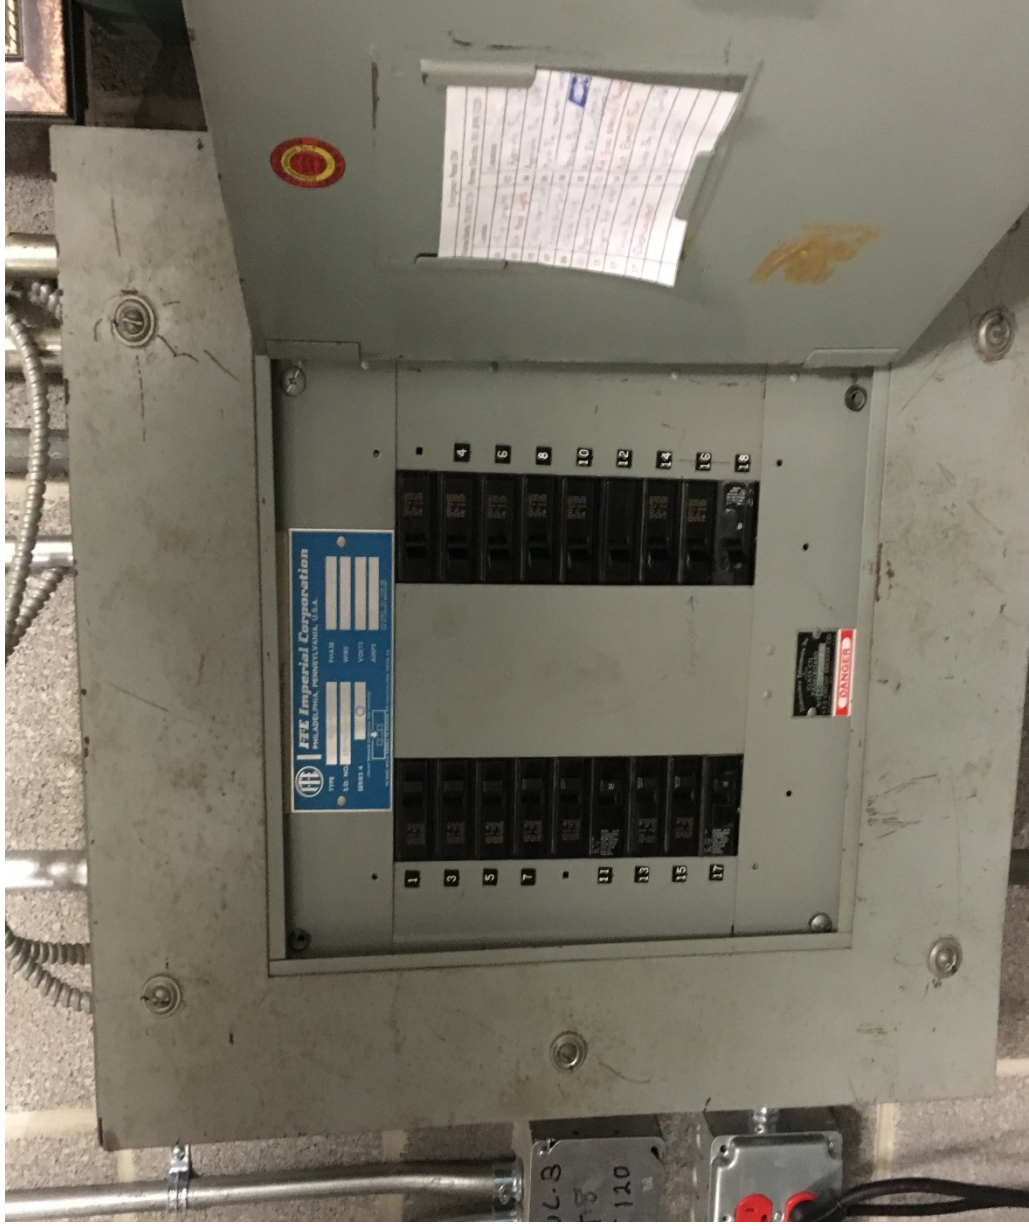
Photo # - 10. This picture is an example of one electric panel which should be thermally scanned, cleaned and tightened up annually.

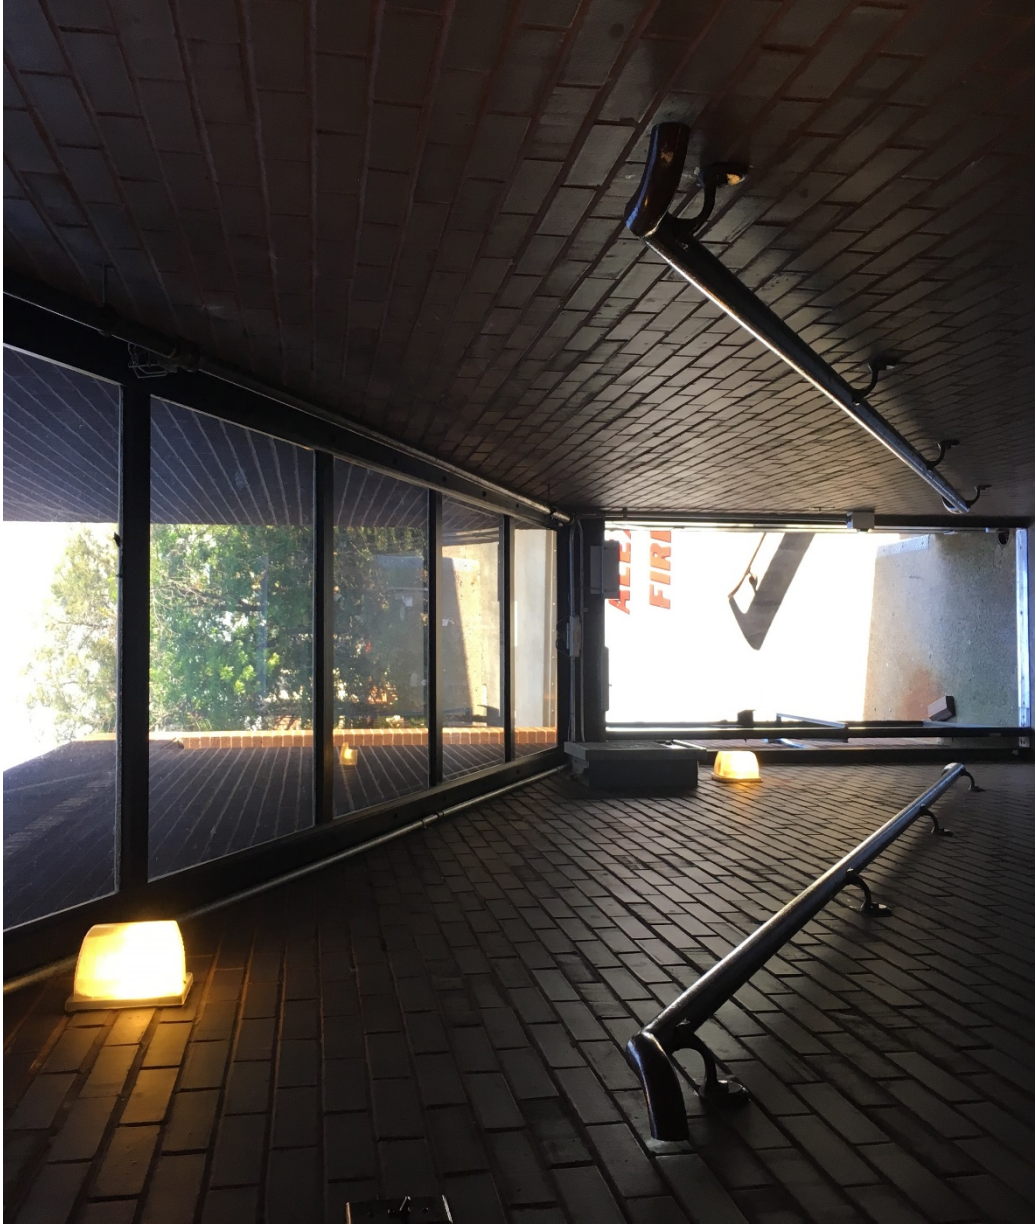
Photo – 13. This picture notes the second skylight in the stairwell which is also leaking.

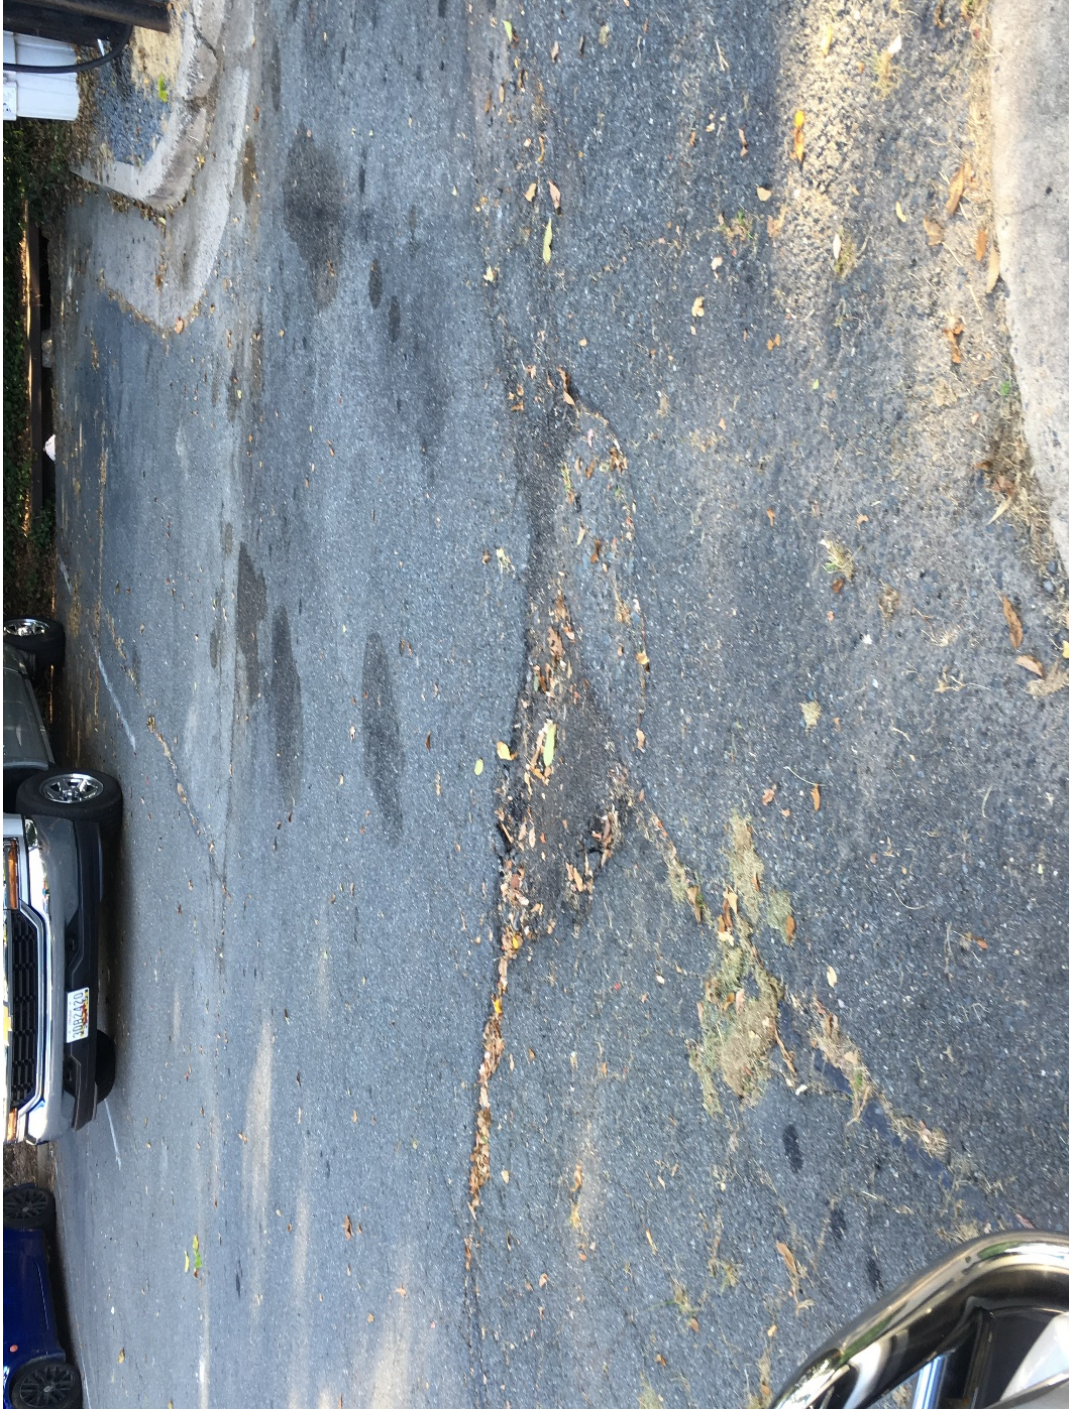
Photo – 15. This picture is an example of the cracked and damaged asphalt at the parking lot area.

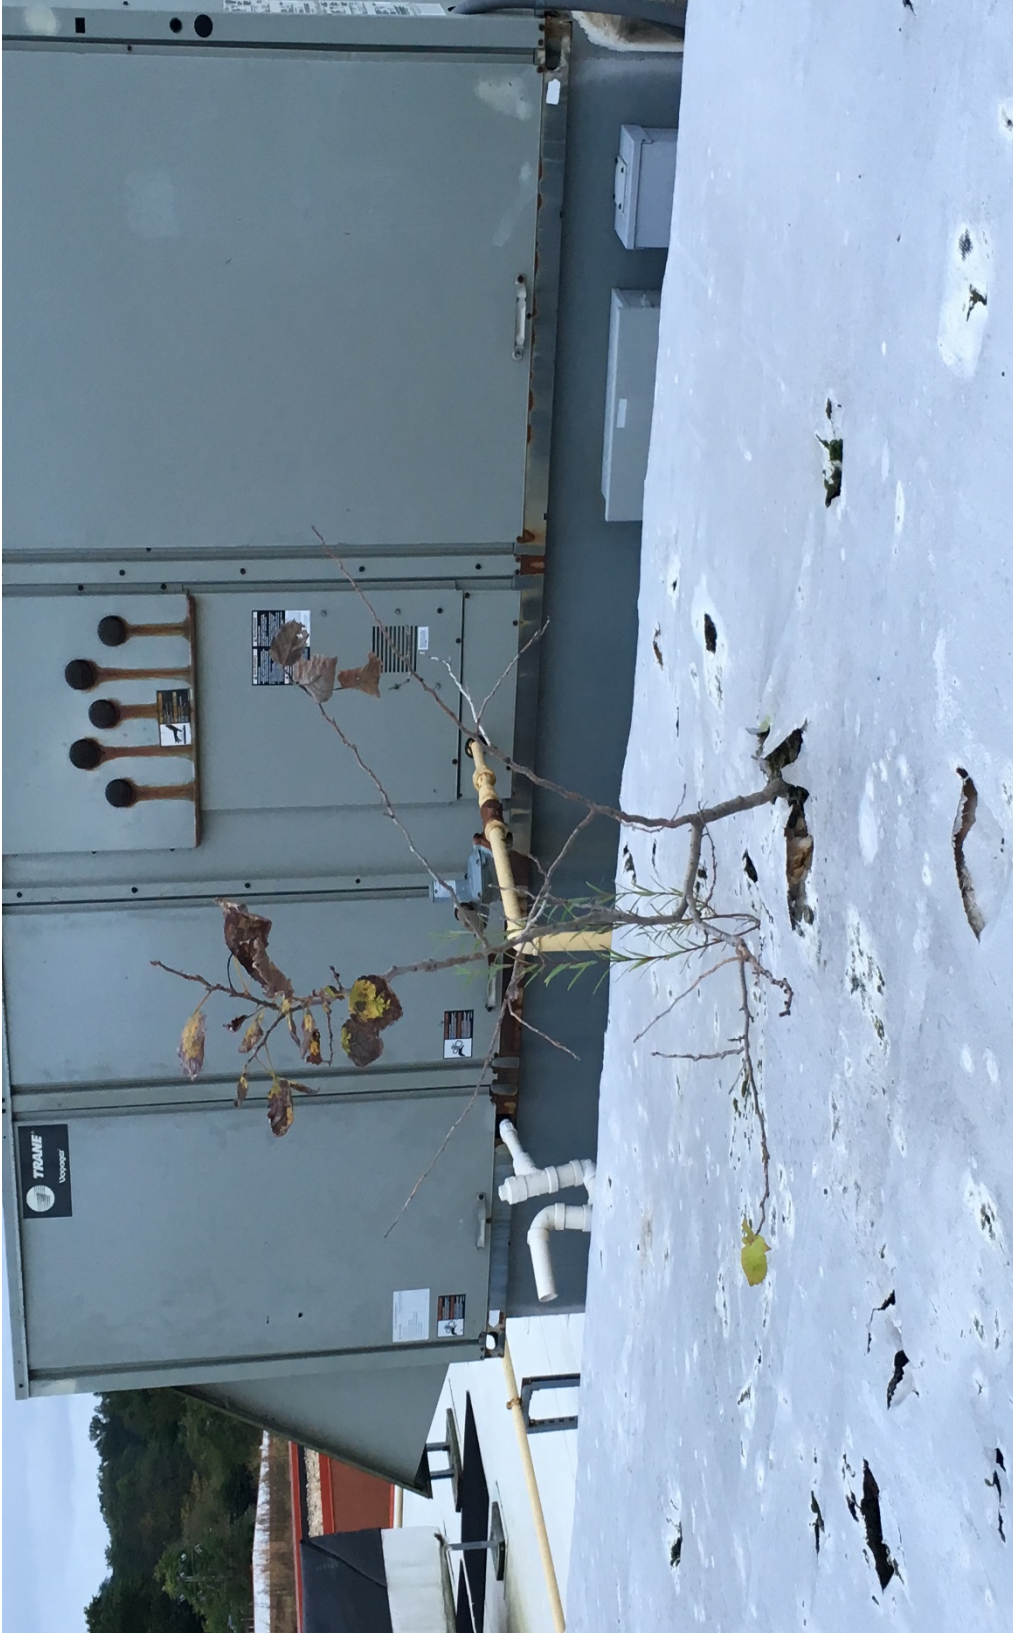
4. The building's roof top units are in poor condition but seem to be operating properly. The building indoor temperatures were quite comfortable when A2 toured the site. The supply air duct work is in very bad condition. The thermal insulation which covers the duct work has failed and in many cases has completely fallen off leaving the metal duct exposed to the weather and outdoor conditions. This does two things. First, it drastically reduces the energy efficiency of the unit while it tries to heat and cool the space. Second, it allows rain to get between the insulation and the duct where it then can enter the building below.

Finding # - 4 & 5. This picture is another example of the roof top units damaged duct work.

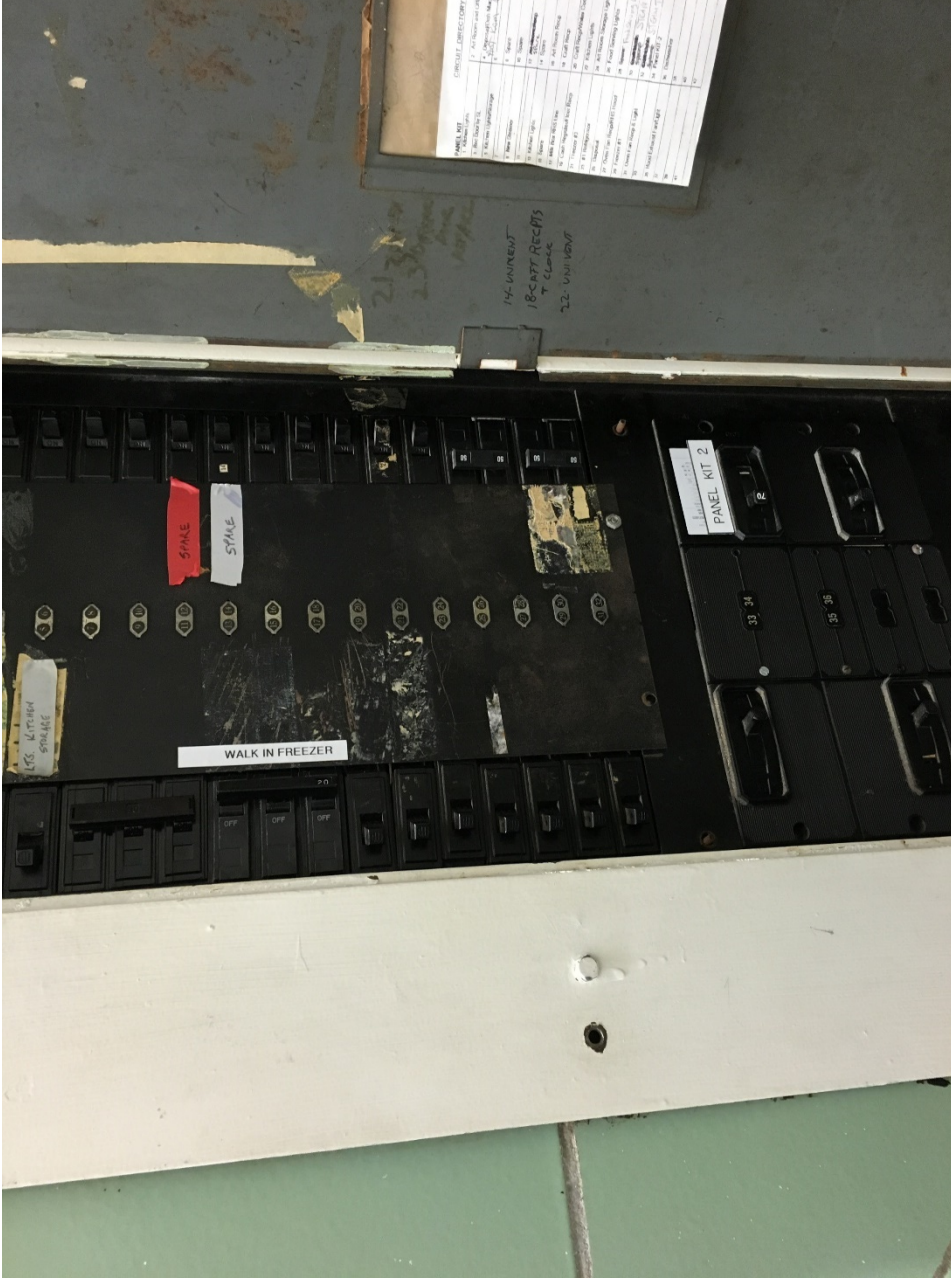
Finding # - 9. This picture is one of the breaker panels in the cafeteria.

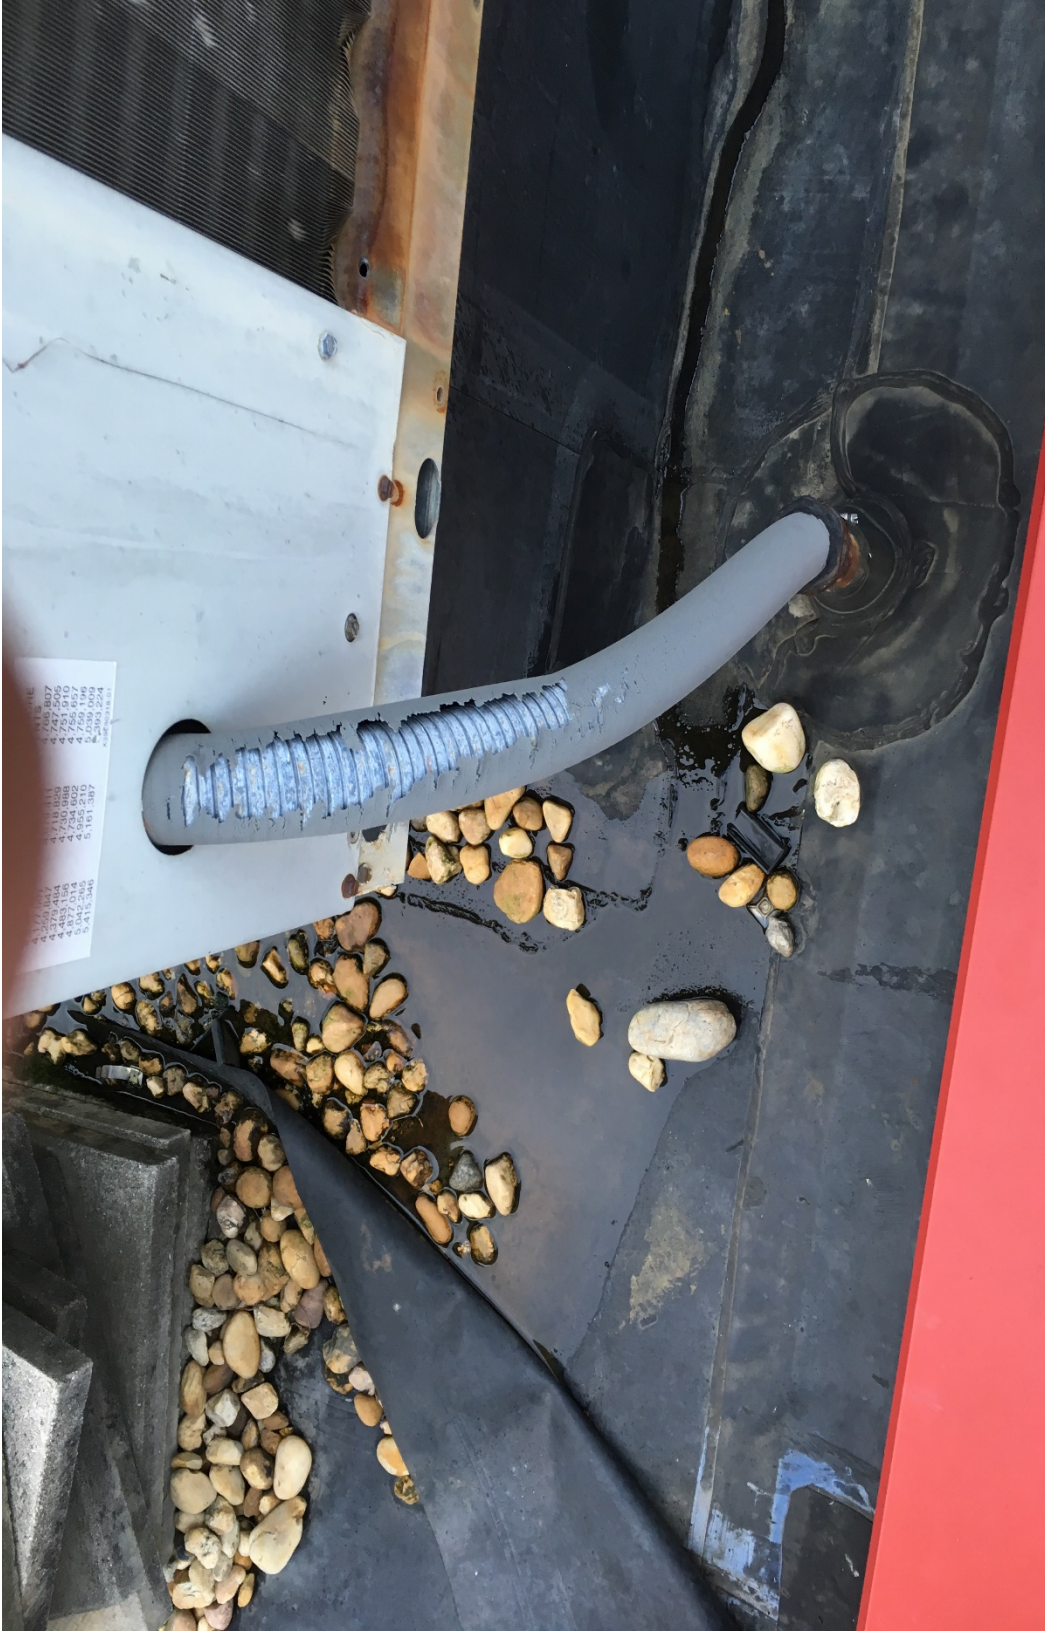
10. The roof top units are fed power through water tight flexible conduits. Several of these electrical feeds have failed and can allow water to get inside the electrical conduit. This is a problem because depending on how the conduit is piped across the ceiling below, water can reach junction boxes and leak out or cause a short circuit and failure of the equipment. A2 recommends that these be repaired.

Finding # - 11. This picture is of one of the failed water tight electrical feeds to a roof top unit.

11	Water tight electrical whips feeding RTU's have failed causing leaks.	Roof
	12	No electrical maintenance is being done. IR testing and torque and cleaning needs to be done.	Electrical systems throughout
<hr/>			
Photo	#	Description of Deficiency/Issues	Location - Floor/Room
PLUMBING	13	The domestic hot water recirculation pumps are not working.	Electric / Mechanical room

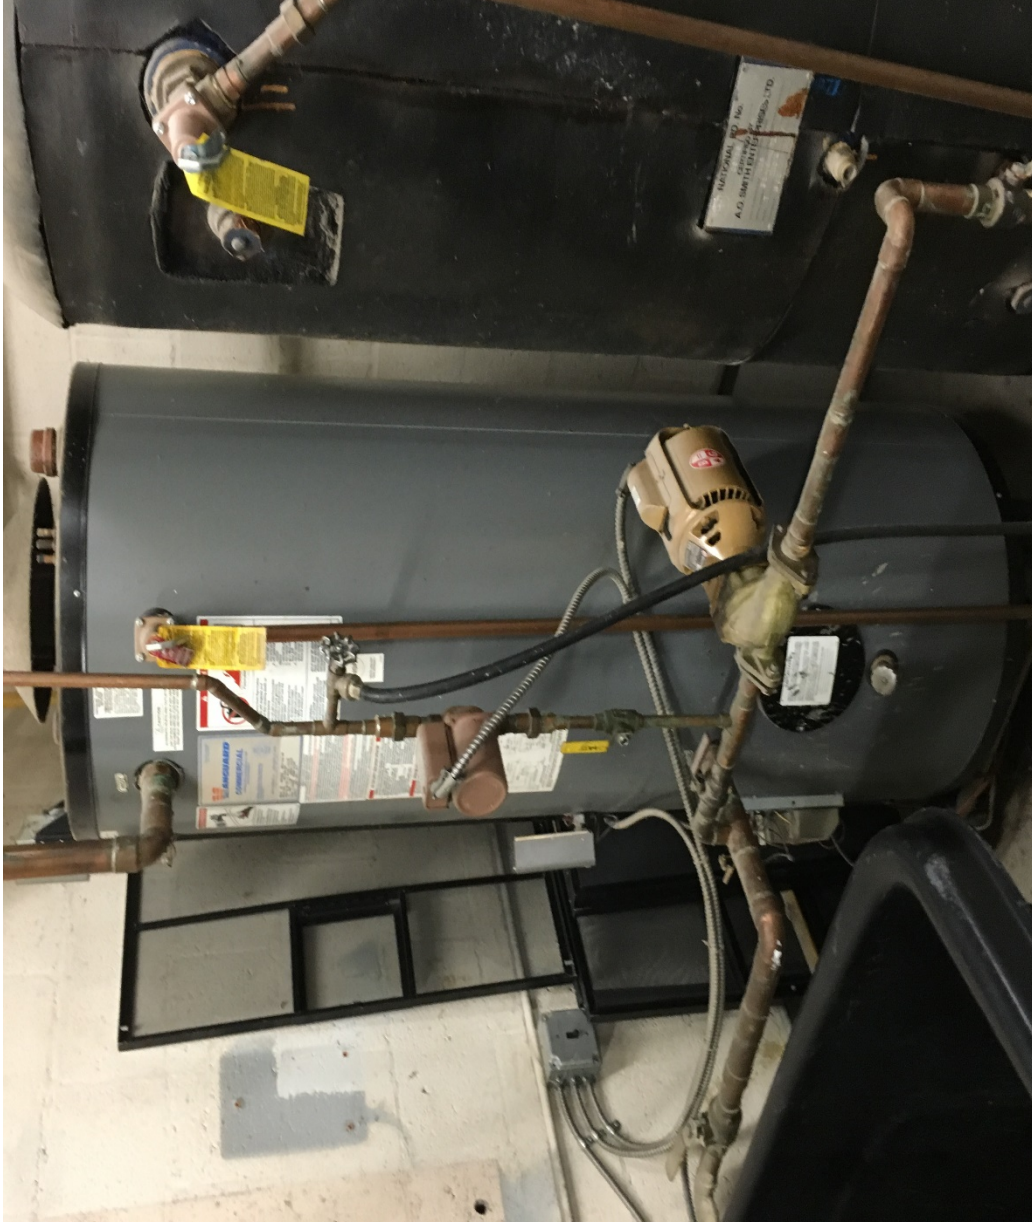
12. The buildings domestic hot water is generated by one 91 gallon capacity gas fired hot water heater. This system also has a 250 gallon hot water storage tank. There are two circulation pumps, one circulates hot water to all the restrooms and sinks in the building while the other circulates water from the heater to the storage tank. Neither of these pumps were running during our inspection. This condition will cause loss of hot water to the buildings hot water fixtures.

Finding # - 13. This picture is of the domestic hot water heater for the site with its storage tank and pumps.

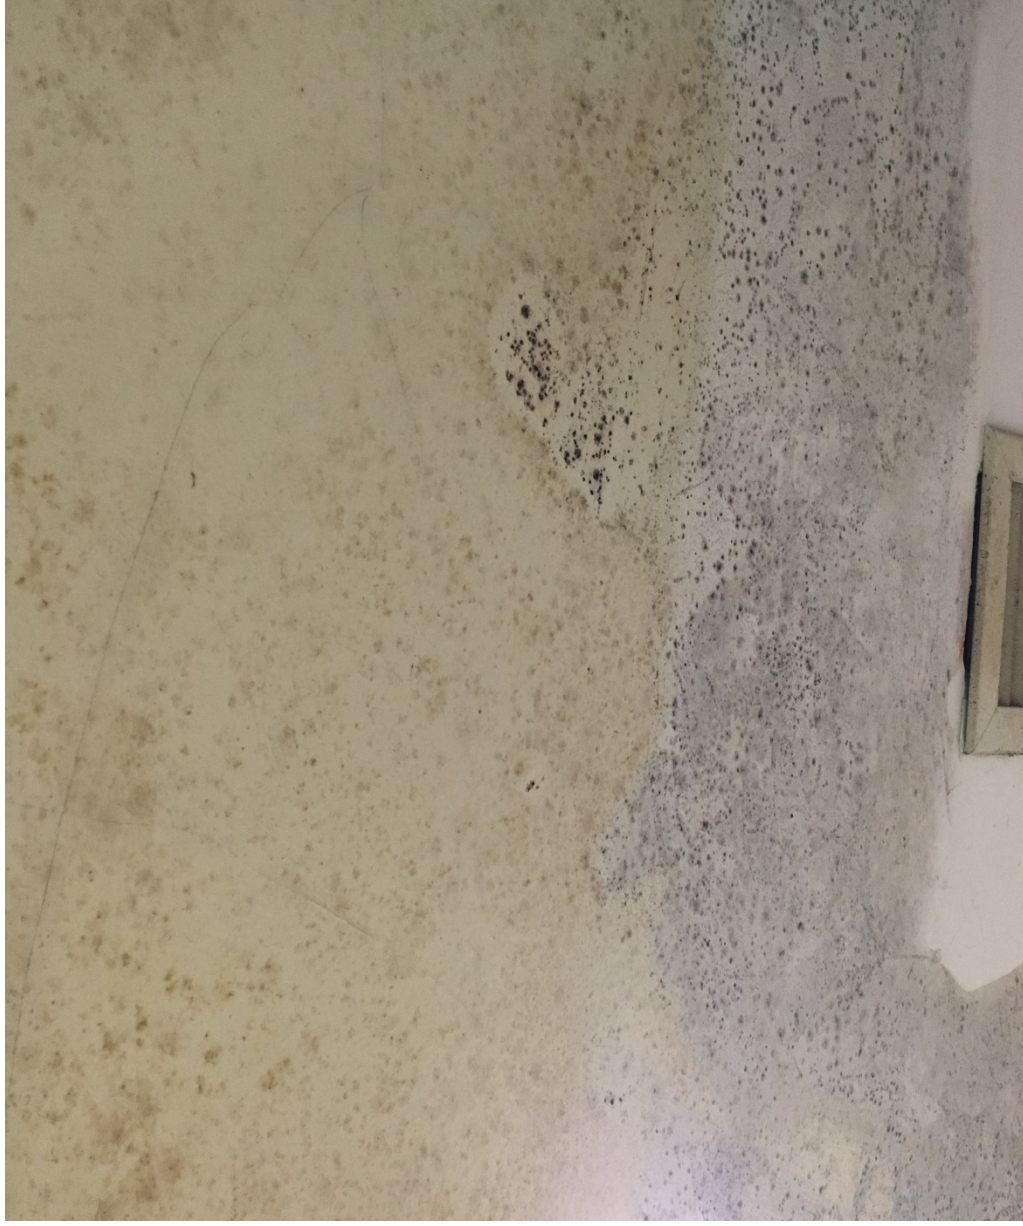
Finding – 14 – This picture of an example of possible micro-biological growth within the walls from water infiltration.

Photo	#	Description of Deficiency/Issues	Location - Floor/Room
STRUCTURAL	14	Water infiltration from the roof and through the walls and around the windows is causing micro-biological growth as shown in this photo.	1st floor janitors closet
	15	Many roof areas where water ponds and cannot drain.	Roof
	16	The main roof is poor condition. Ponding of water and roof penetrations are allowing leaks.	Roof
	17	.Skylights are broken in the 1st floor north corridor	Roof
	18	The screen wall on top of the modular building section is causing leaks into the building.	Roof
	19	Many areas in the building have stained ceiling tile. However you would expect worse conditions after seeing the roof.	Inside the building
	20	Perimeter envelope water infiltration problems.	Perimeter of building
	21	Window caulking has failed in many areas.	Perimeter of building
	22	The Front entrance roof has been damaged.	Front of building

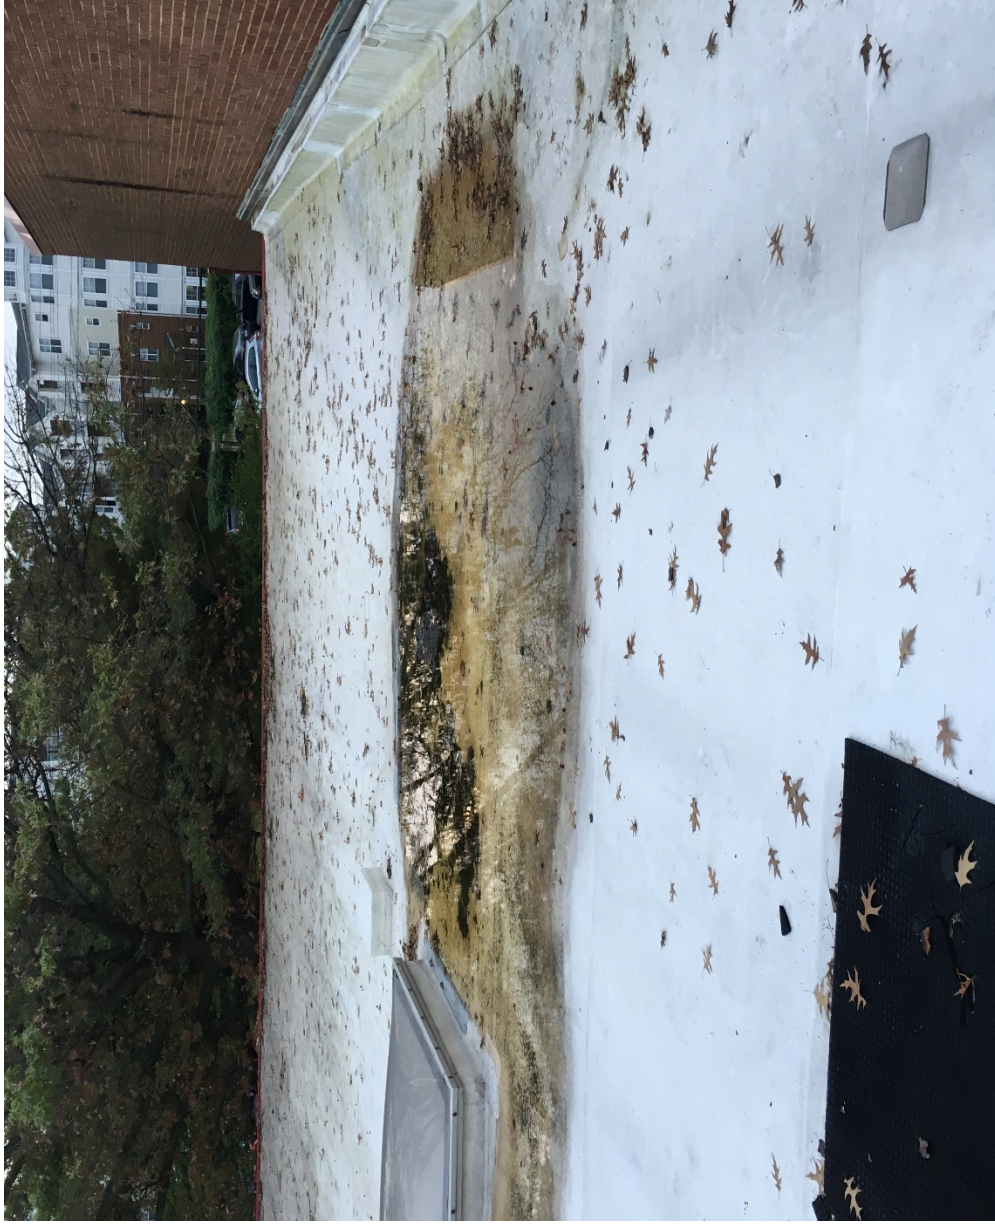
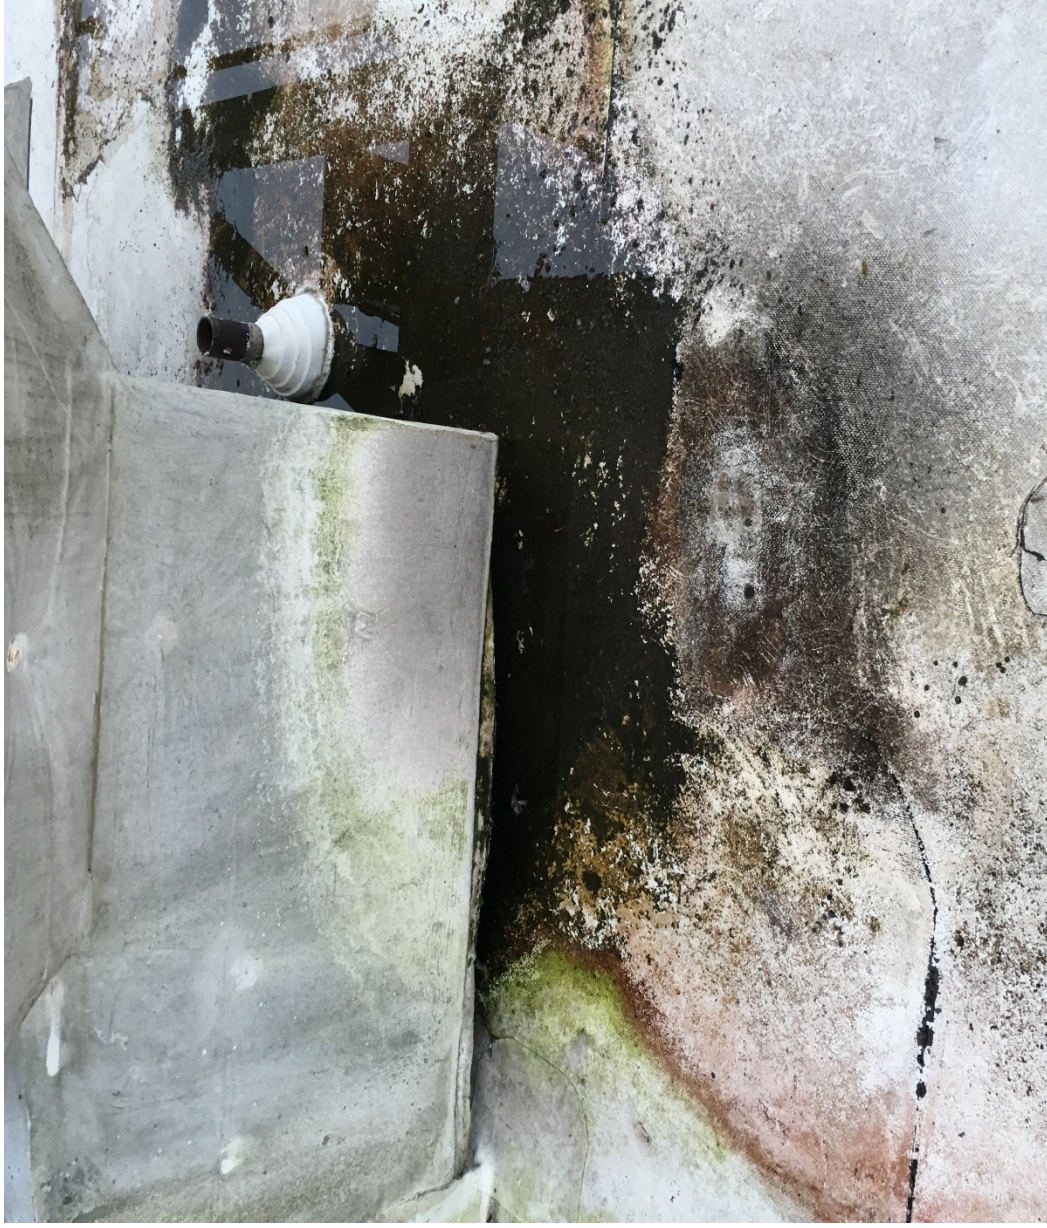
13. Cora Kelly ES has a built-up membrane roof system. As with any large flat roof the water doesn't always get to the roof drains and creates ponds. At Cora Kelly this condition is worse than most. Anytime water is allowed to pond on a roof leakage below will occur. The main roof is in poor condition and because of the ponding and the duct work penetrations there are leaks and water entering the building. In touring the building interior, one can note wet ceiling tiles.

Finding # - 15 & 16. The next set of pictures note the roof condition at Cora Kelly E.S.

Finding # - 15 & 16 continued. This is another view of the roof.

Finding # - 15 & 16 continued. The following is another view of the roof.

15. There is a screen wall on top of the modular section of classrooms. The steel supports for this wall are causing leaks into the hallway and classes below. It was noted that there is ongoing roof repairs and patches. The entire roof should be replaced.

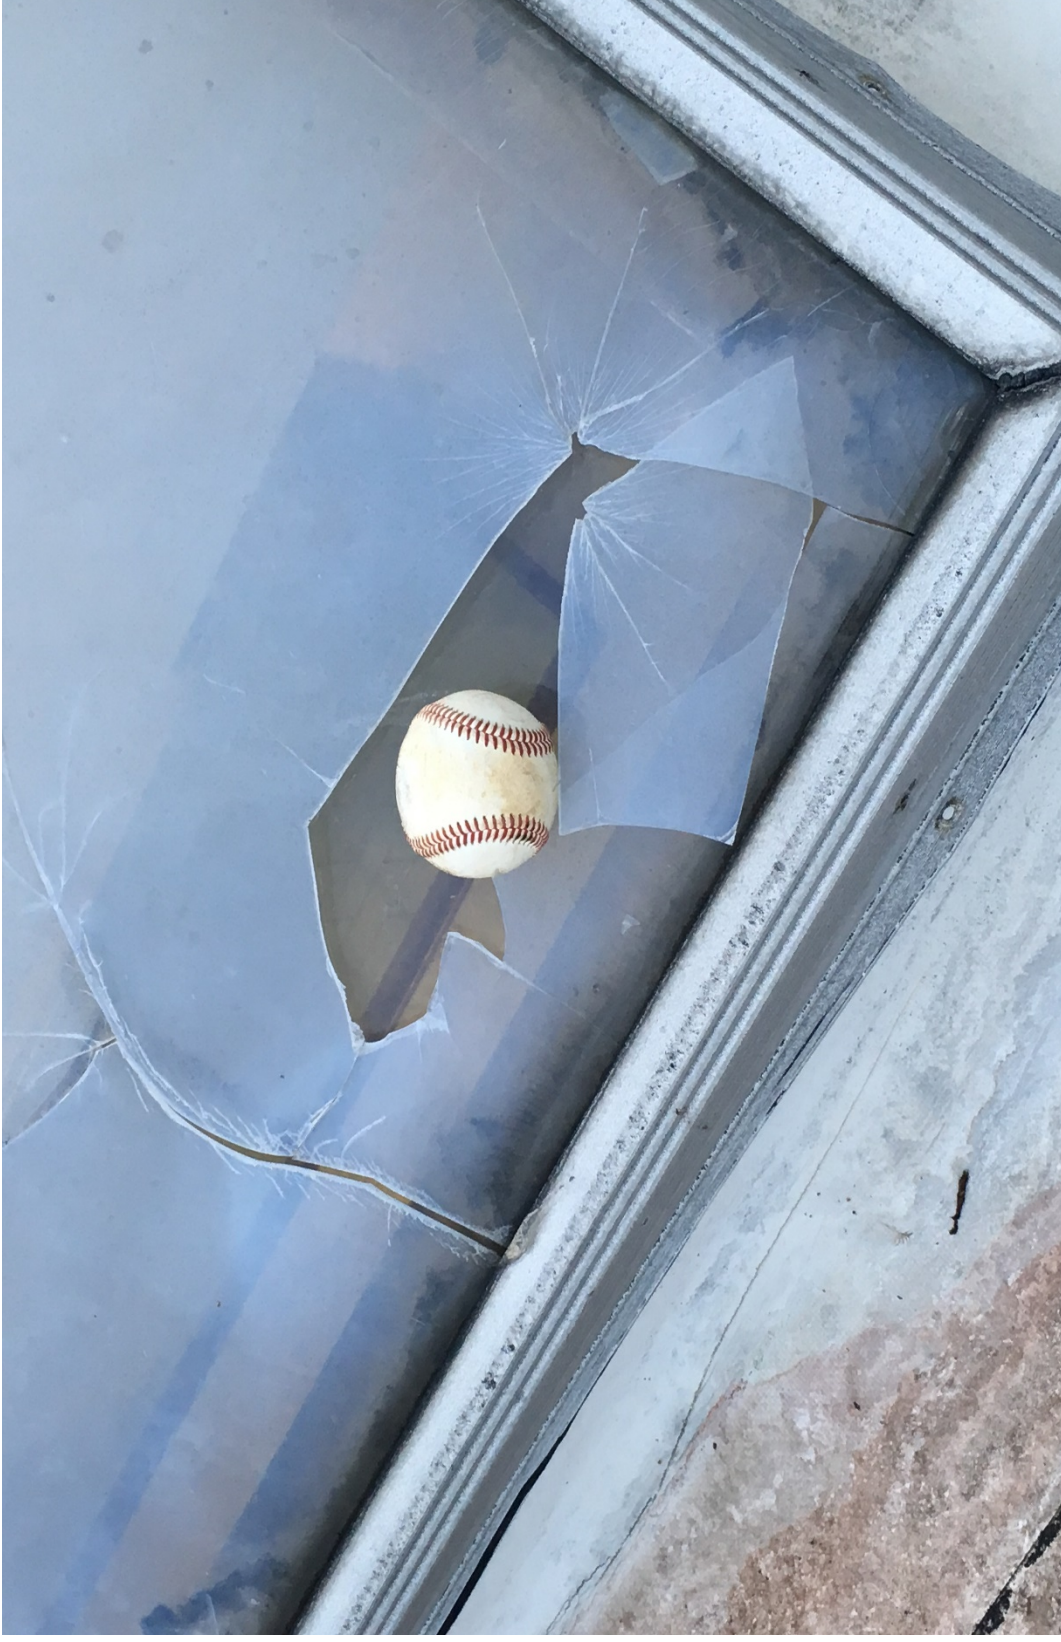
14. Two skylights in the roof near the baseball field are cracked and broken. The students are hitting foul balls which hit the roof and the skylights. Mr. Stallings is looking into having the angled section of fence on top of the back stop modified to help stop this issue.

Finding # - 17. This picture notes one of the broken skylights which are being hit by baseballs.

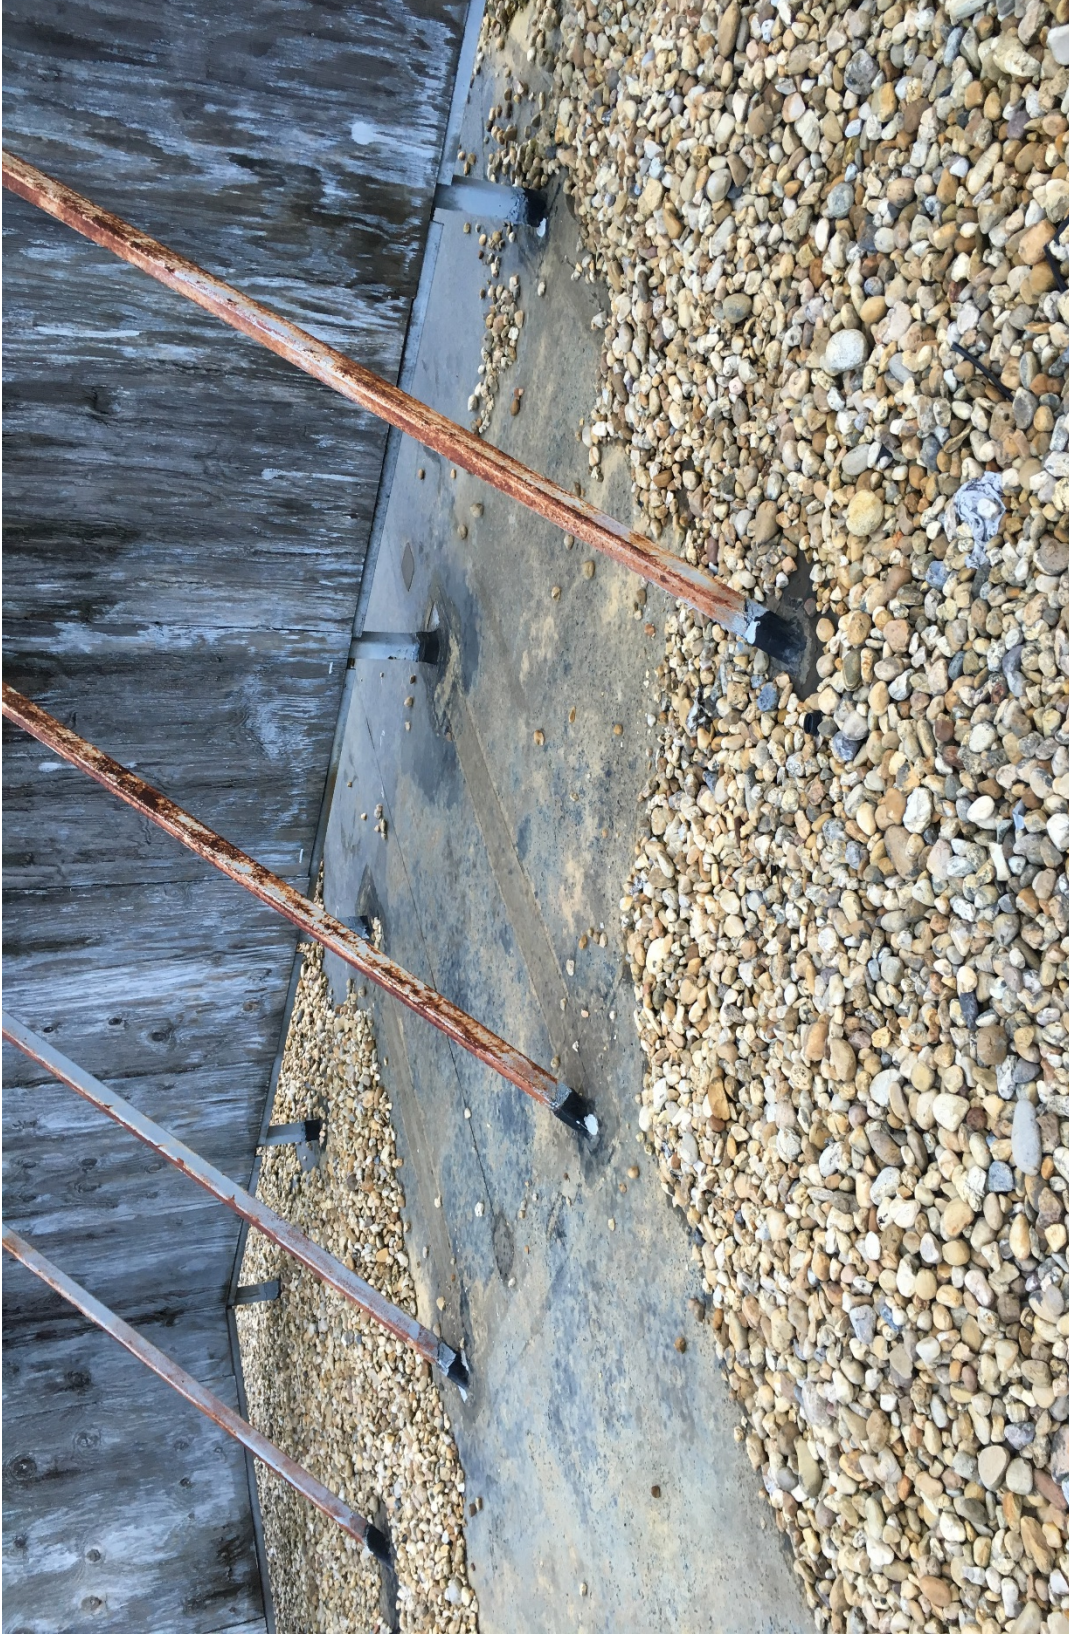
Finding # - 18. This picture notes the screen wall on the modular section of the building with ongoing roof repairs.

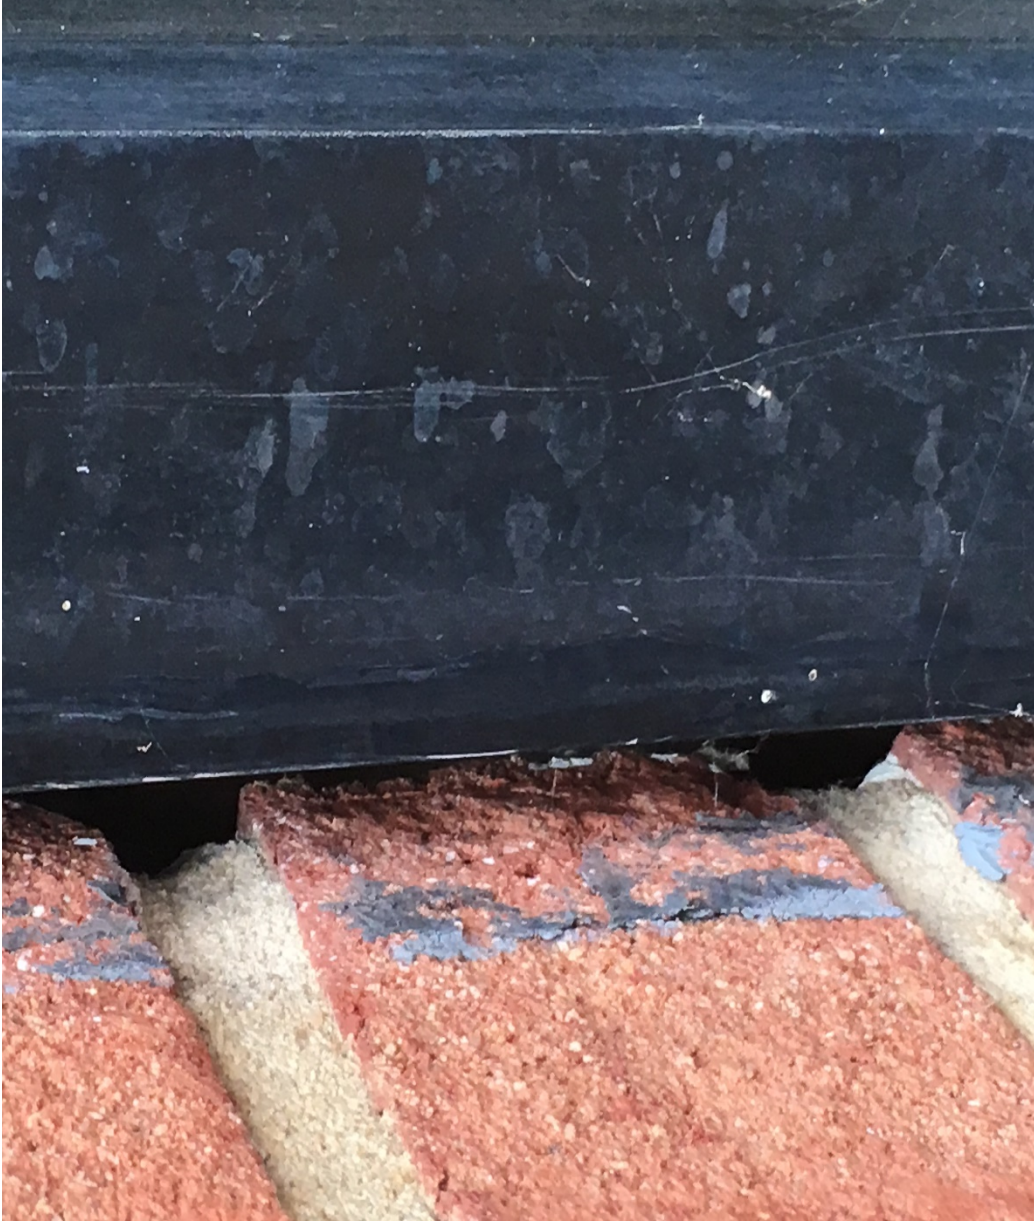
16. The building envelope appears to be a brick over block construction. The brick tuck-pointing condition is good and several sections can be identified as being repaired. A set of casement window systems were installed or inserted in the perimeter walls around the facility and are caulked at the walls. The condition of the window caulk is poor and in some spots the exterior of the building is visible for inside. At this time, perimeter window caulking is needed at this time before increased damage occurs.

Finding # - 20 & 21. This picture is an example of the missing window caulk allowing water entry into the walls.

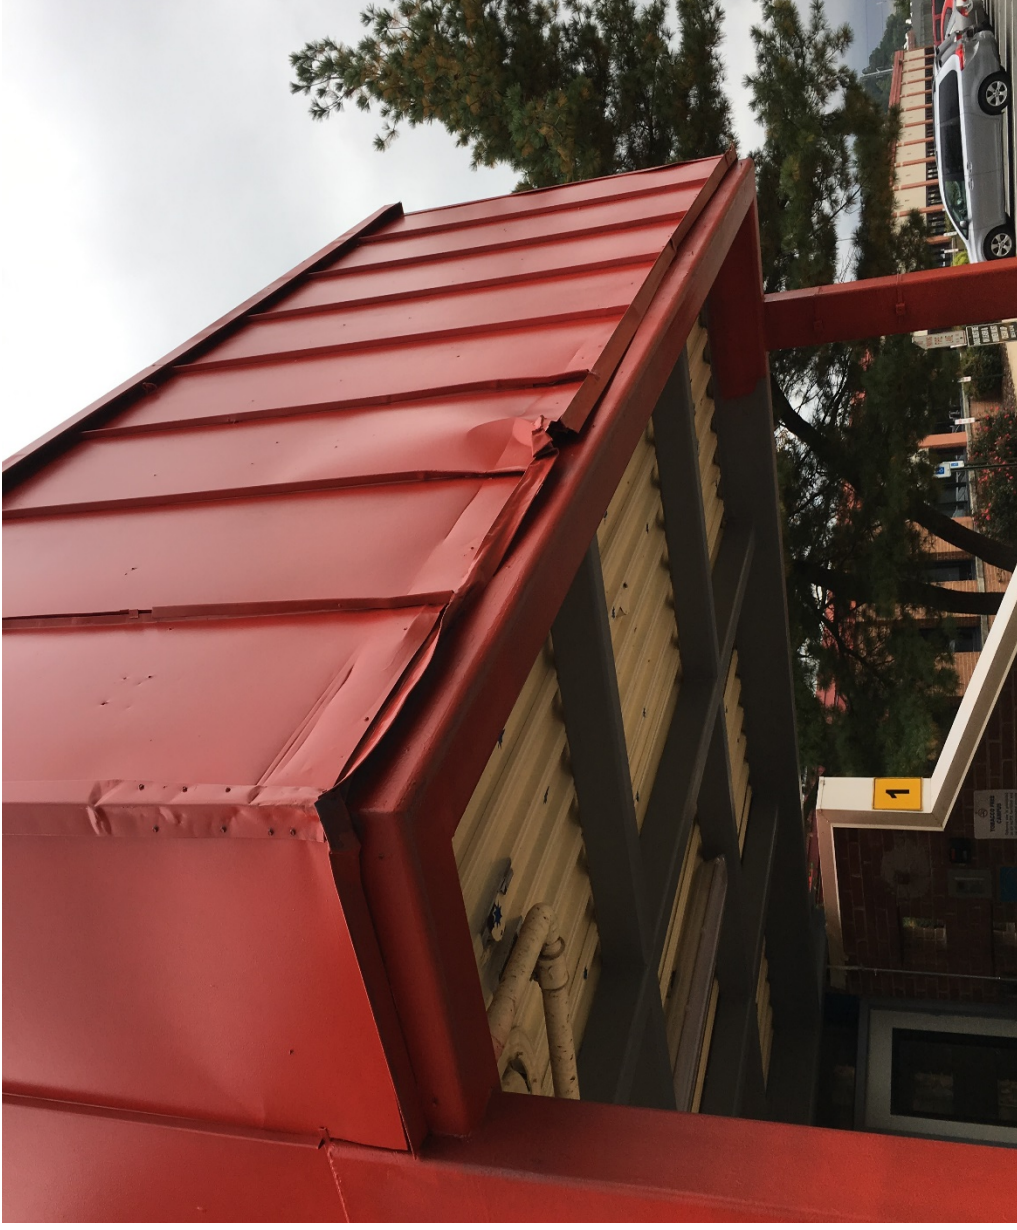
17. The main school entrance roof is damaged where a truck or other vehicle hit and bent the metal covering. This is not causing any water infiltration but is simply aesthetic concern.

Finding # - 22. This picture is of the damaged metal at the schools main entrance.
