# TC Williams – Parker Gray Stadium Project

12/23/20 – 1/26/21 - Construction

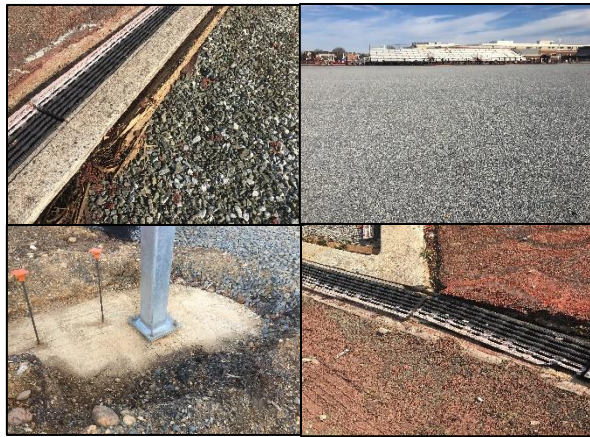
Clockwise top left: rotted header board, gravel base, field drain, awning footer/support.

- Installed steel supports for new scoreboard;
- Inspected gravel base of field for slope and drainage;
- Inspected nailer-boards along track curb;
- Cleaned field drain of rubber pellets and synthetic blades;

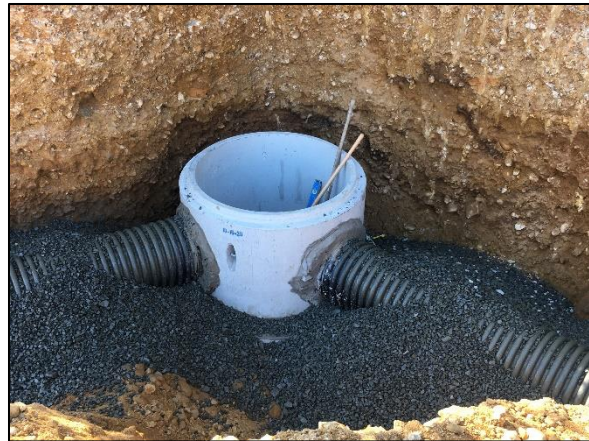
Sanitary flex PVC piping and concrete sewer doghouse structure.

- Installed sanitary lines from sanitary main to various locations, stubbed-up in both buildings;
- Installed water supply from supply main to various locations, stubbed-up in both buildings;

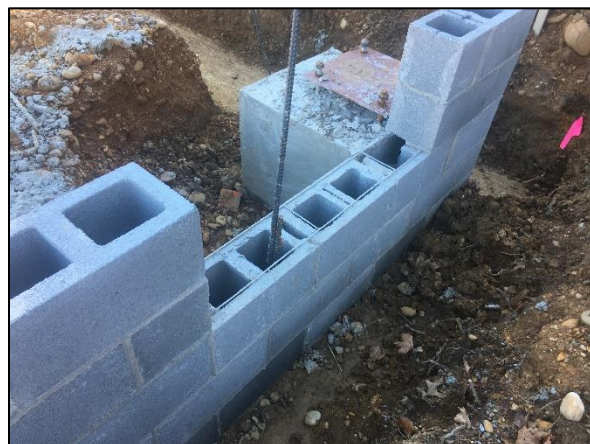
CMU wall being installed upon building footer and around corner support concrete footer.

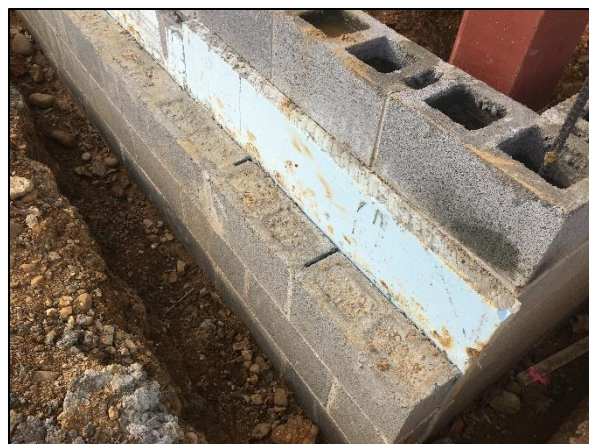
Foam insulation installed between concrete masonry unit courses.

- Commenced concrete masonry wall installation (including insulation and outer course);
- Removed existing synthetic turf field and hauled away;
- Removed rubberized surface of track and hauled away;

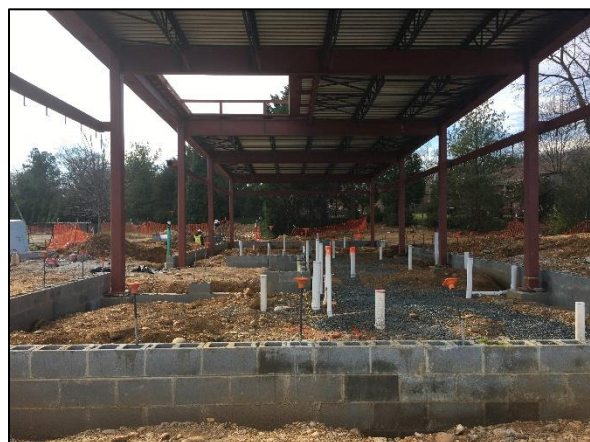
Steel supports and steel roof deck over foundation walls and plumbing stub-outs.
