ALEXANDRIA CITY PUBLIC SCHOOLS  
COMPREHENSIVE CONDITION AUDITS

- CORA KELLY ELEMENTARY SCHOOL
- FRANCIS C. HAMMOND MIDDLE SCHOOL
- GEORGE MASON ELEMENTARY SCHOOL
- GEORGE WASHINGTON MIDDLE SCHOOL
- MATTHEW MAURY ELEMENTARY SCHOOL
- TRANSPORTATION FACILITY

**Final Report - DRAFT**

**August 9, 2019**

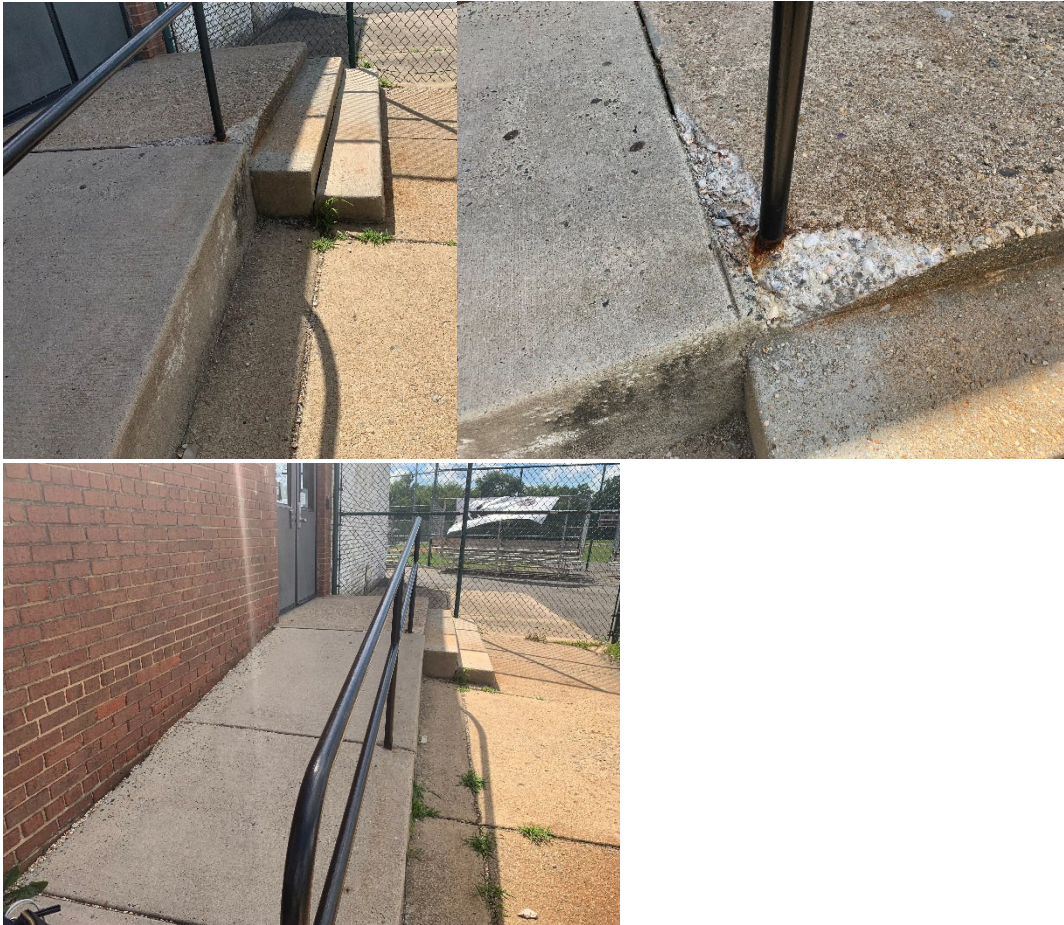
*Figure 4: Exterior ramp*

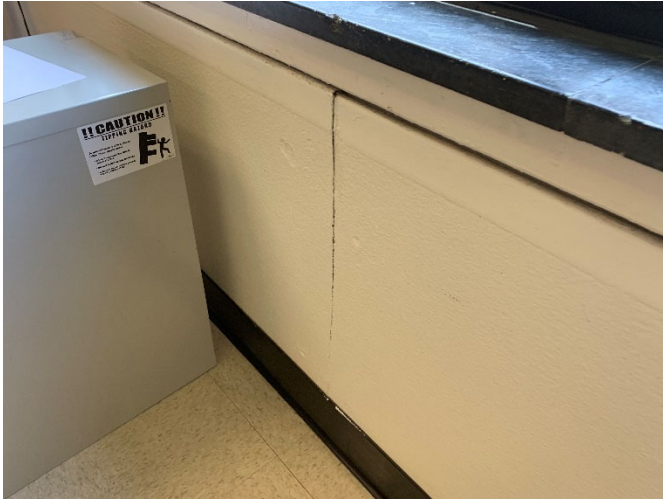
During the survey, the team looked for problems and failures in the window system. Approximately 10 percent of the windows are facing gasket failures, causing sweating on the window panels (Figure 3). We encountered this in nine classrooms (see survey matrix), lobby, and cafeteria.

*Figure 7: Window Sweating*

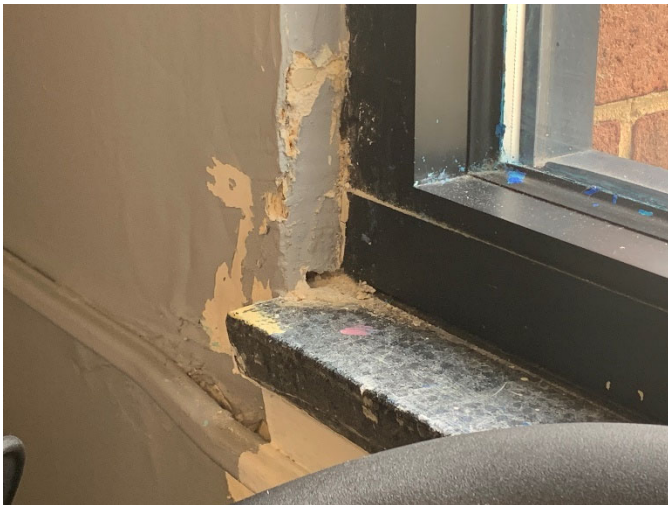
Many classrooms have concrete backer board paneling laminated to the concrete masonry under the windows, which appears to have been done for durability. This paneling is separating in many cases because of thermal issues on this part of the wall. Eventually, this detail should be revised and replaced with a standard furring and insulated system with plaster tape and skim coating finish (Figure 2).

*Figure 8: Paneling under the window pulling apart*

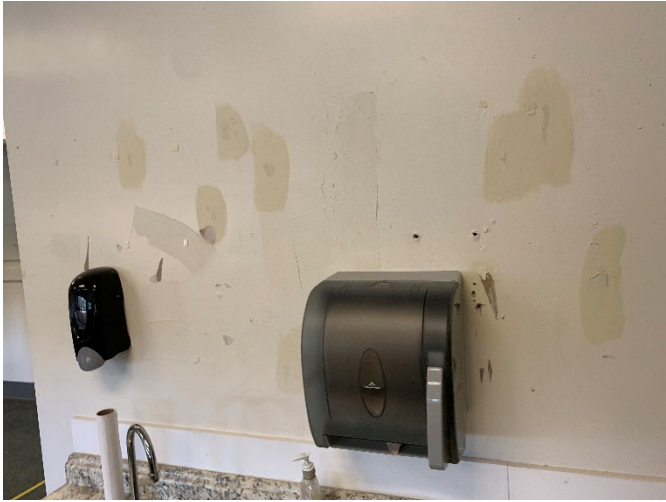
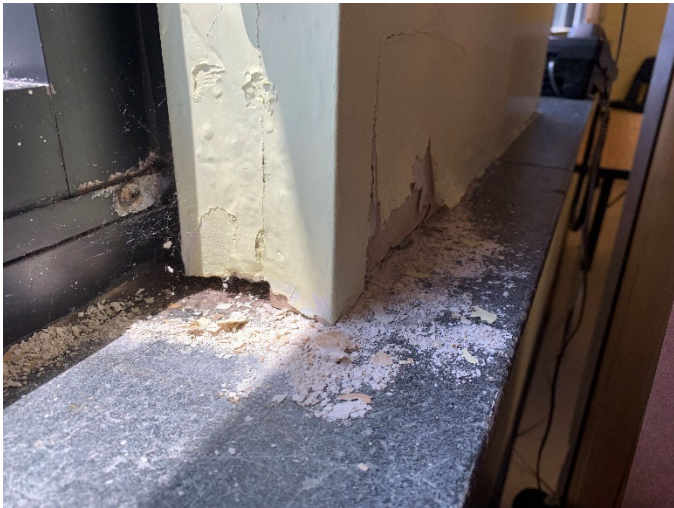
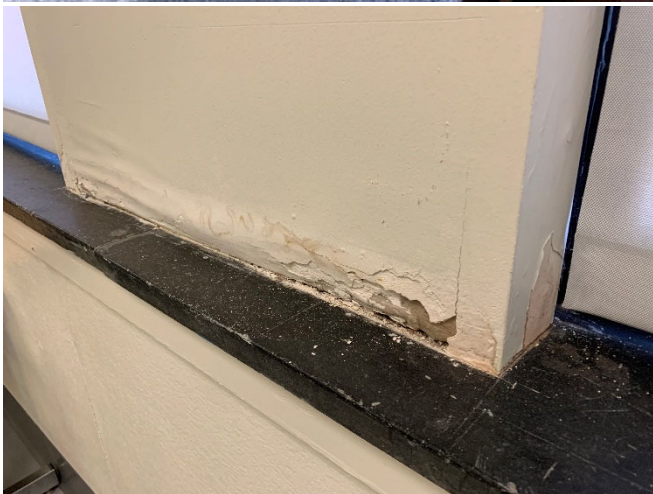
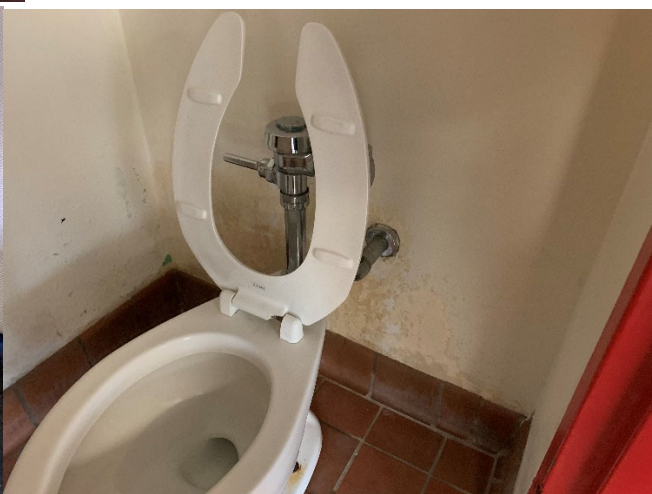
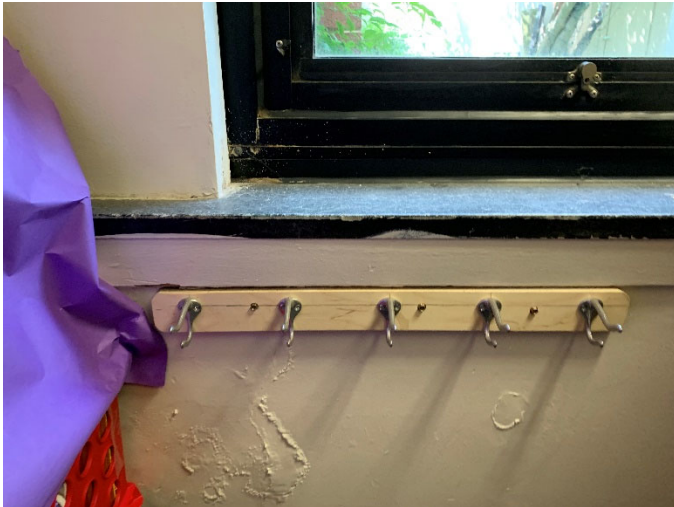
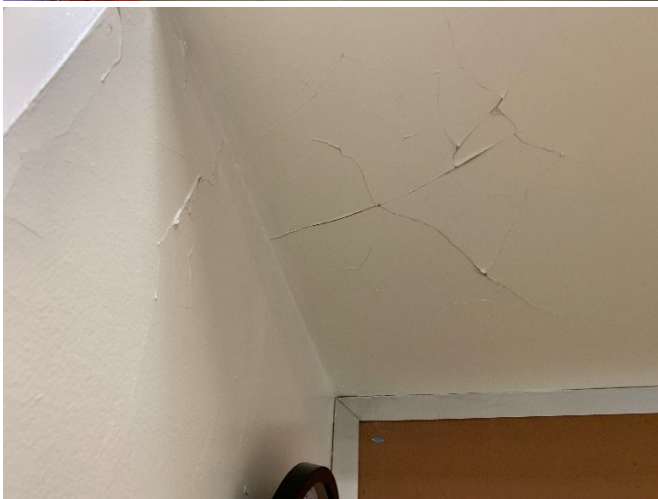
About 37 rooms need minor fixes in the acoustic ceiling panels. There is evidence of past leaks as evidenced by stained ACP in 9 classrooms (Figure 4). Other issues include: many aged carpets that are well beyond their service life; 20 rooms in need of carpet replacement (Figure 5); 22 rooms--including 19 classrooms--have wall finishing issues such as wall and plaster cracks; 9 rooms have issues such as wall peeling and bubbling (Figure 6).

*Figure 9: Wall finish issues*

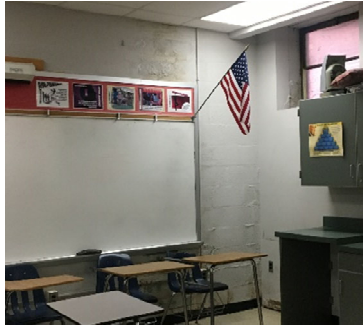
At the cafeteria areas around stair 9 (Figure 5), classroom 002 (Figure 6), and boiler room there have been chronic problems with ground water coming through the basement walls and creating flooding. The building engineer stated that there has been some limited damp-proofing and repairs, but the problem has persisted, suggesting that more significant waterproofing and sub-surface foundation drainage is needed.

Figure 6. Room 002

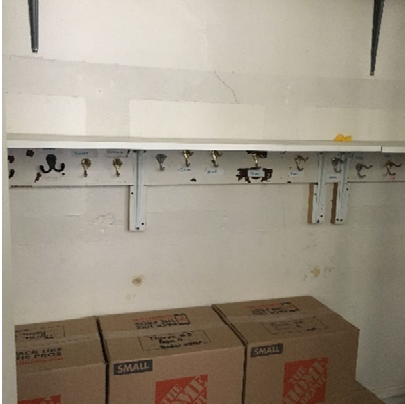
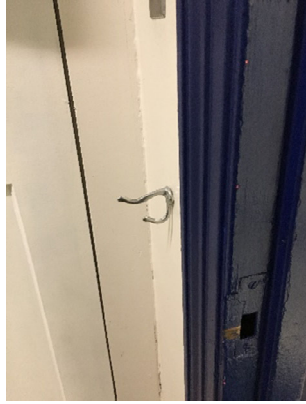
Figure 19 Low Closet and Door Hooks

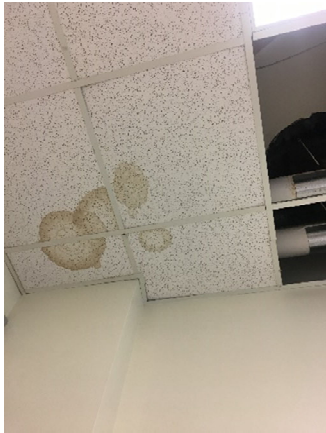
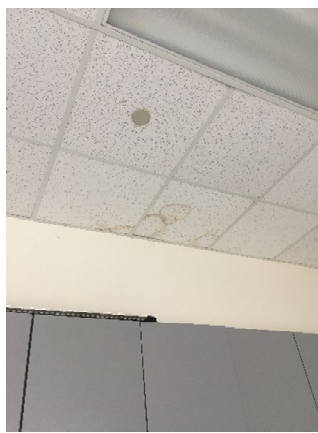
Figure 6 Ceiling Stains

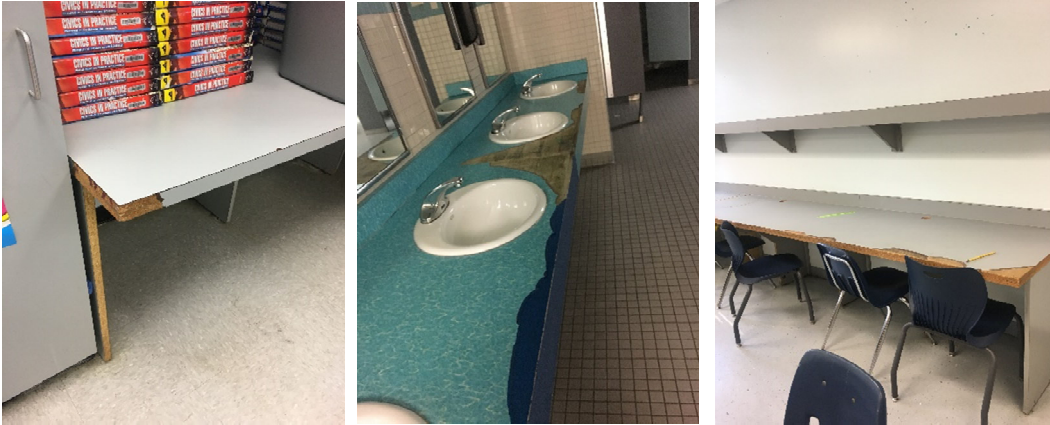
Figure 7 Flooring

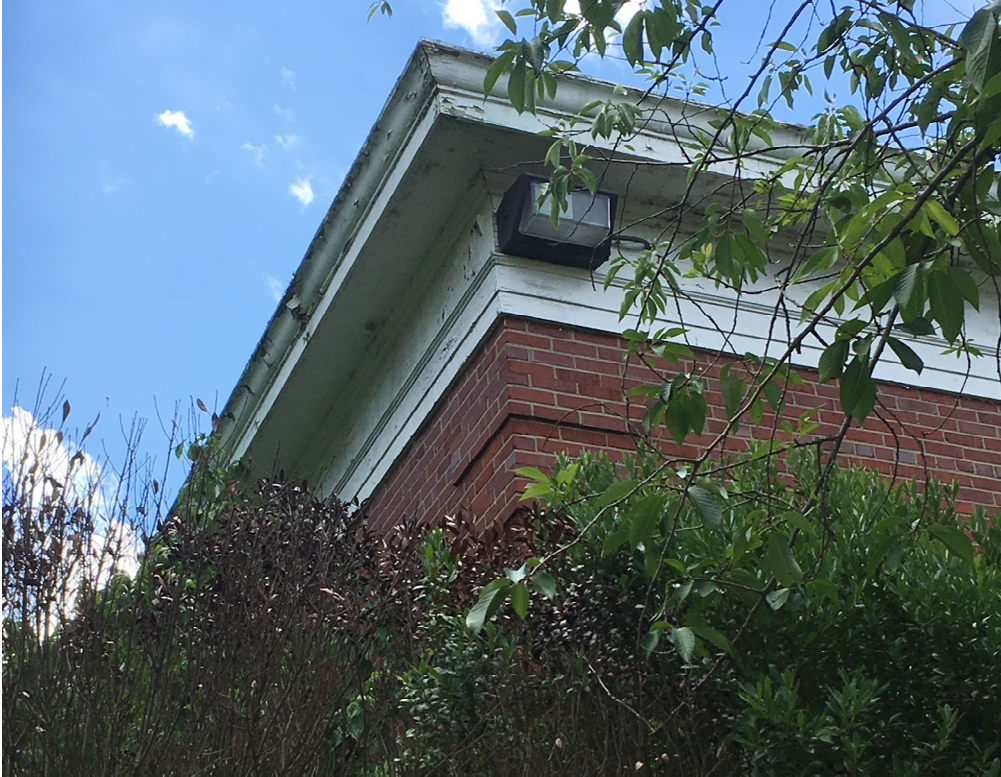
Figure 1: Roof leaks

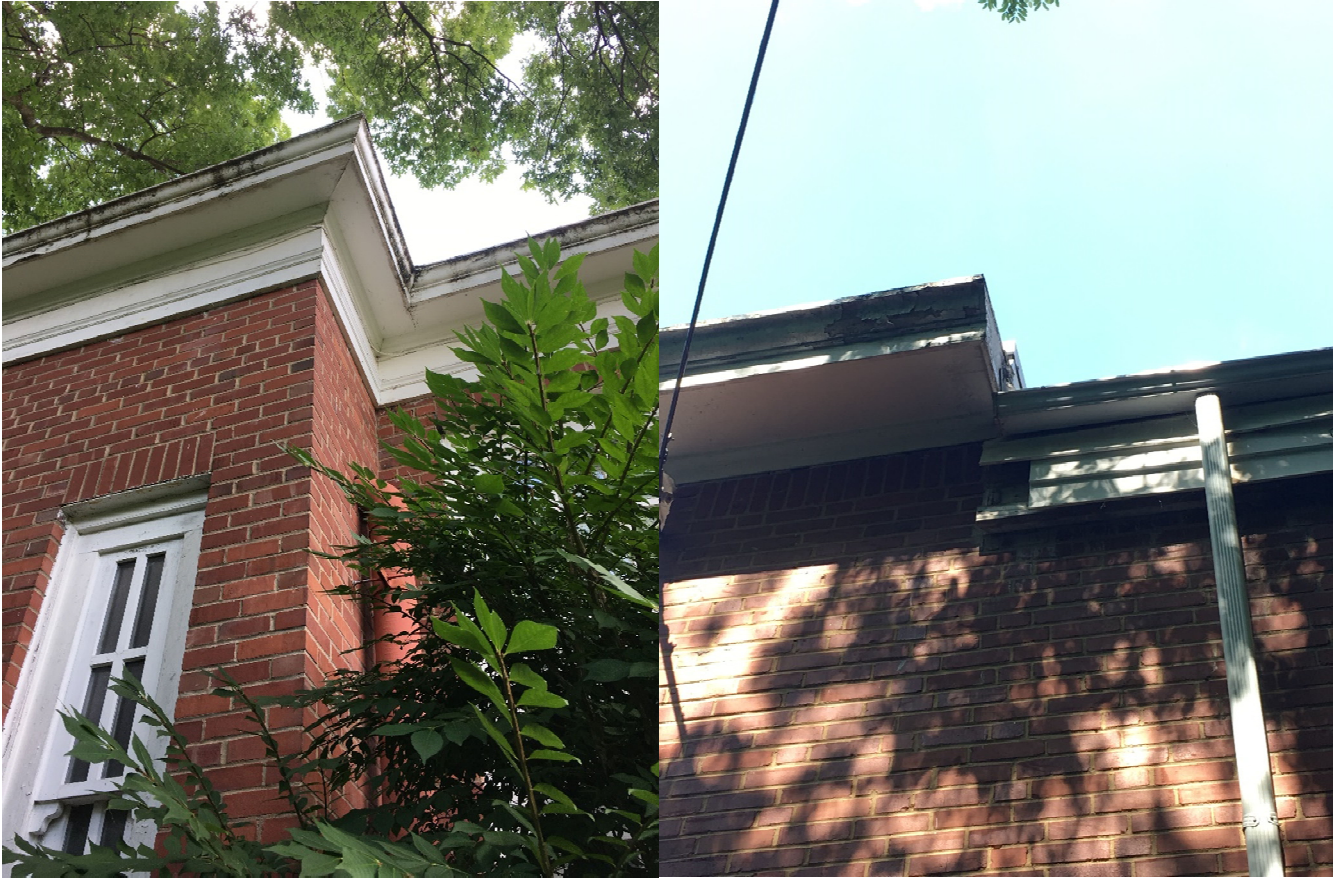
Figure 2: Exterior coping

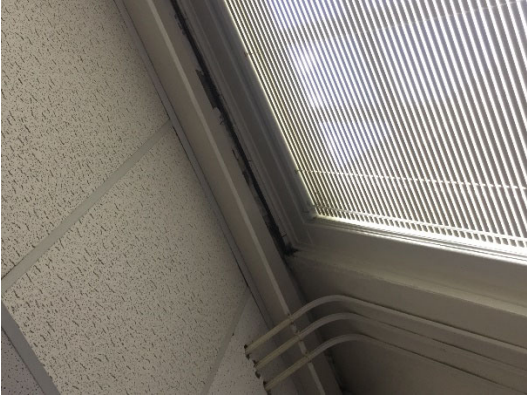
**Figure 4: Window frames**

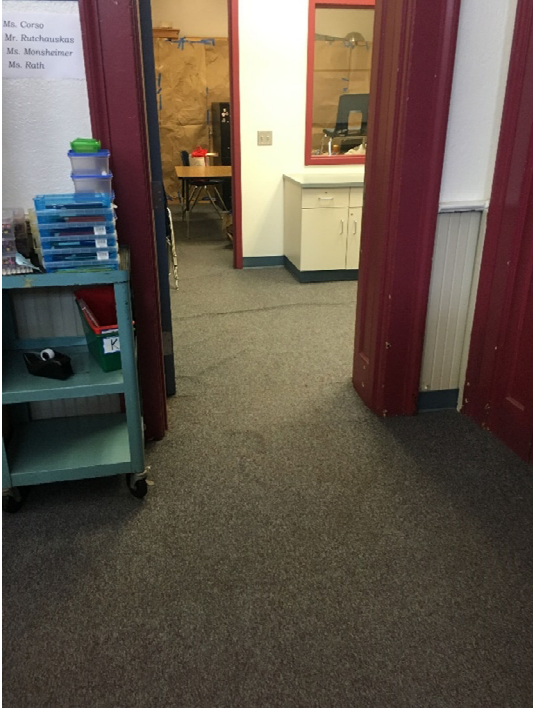
Figure 7: Carpet

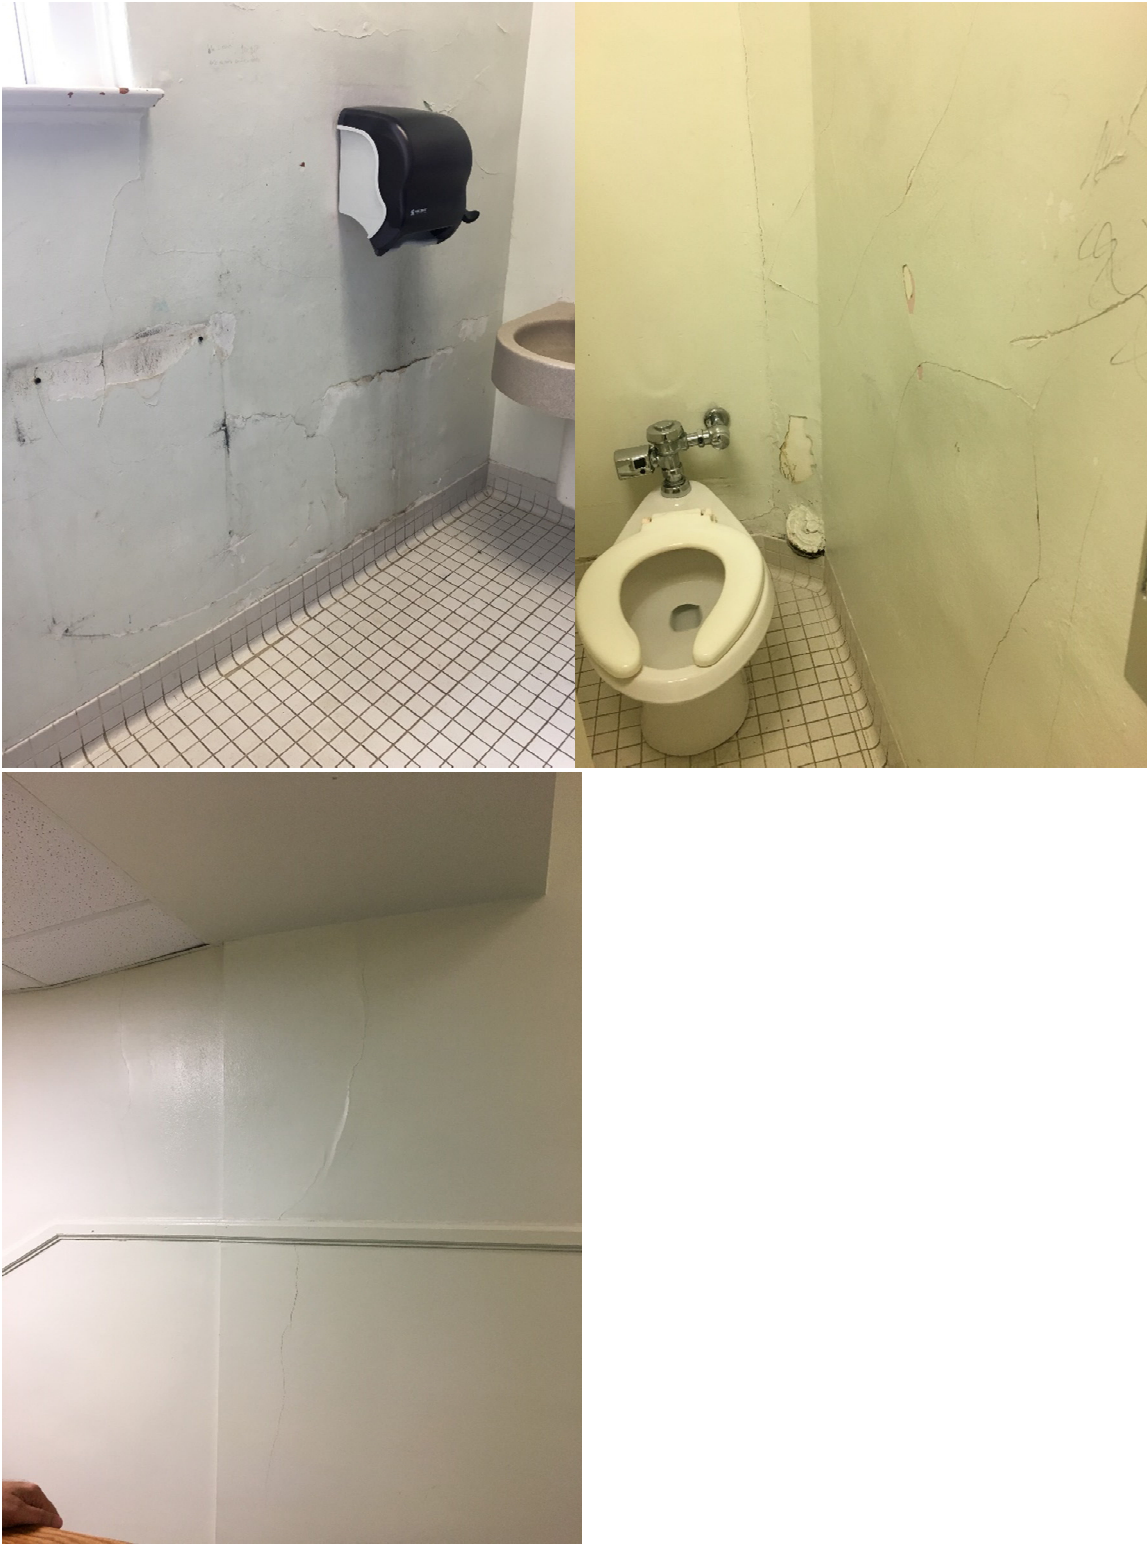
**Figure 8: Wall finishes**

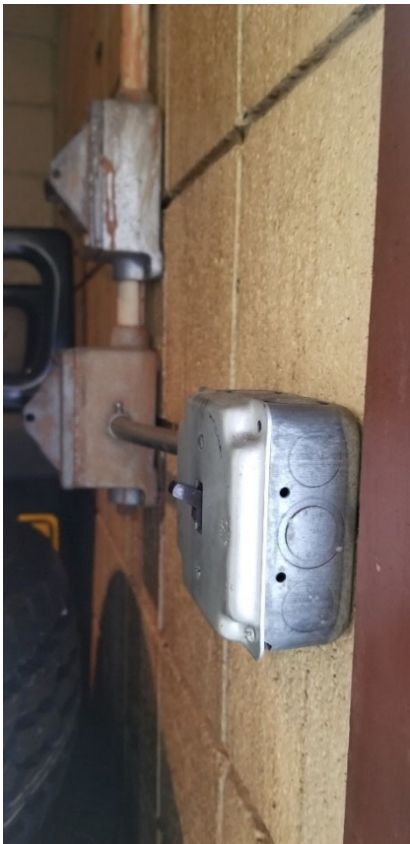
Figure 11: Non-Explosionproof Switch Located In the Battery Storage Space
