ALEXANDRIA CITY PUBLIC SCHOOLS
COMPREHENSIVE CONDITION AUDITS

- CORA KELLY ELEMENTARY SCHOOL
- FRANCIS C. HAMMOND MIDDLE SCHOOL
- GEORGE MASON ELEMENTARY SCHOOL
- GEORGE WASHINGTON MIDDLE SCHOOL
- MATTHEW MAURY ELEMENTARY SCHOOL
- TRANSPORTATION FACILITY

Final Report - DRAFT

August 9, 2019

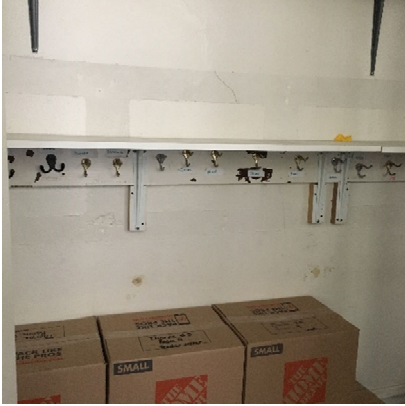
Figure 19 Low Closet and Door Hooks

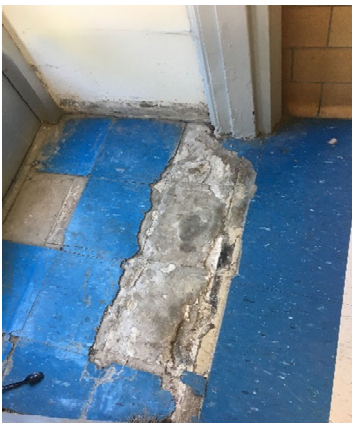
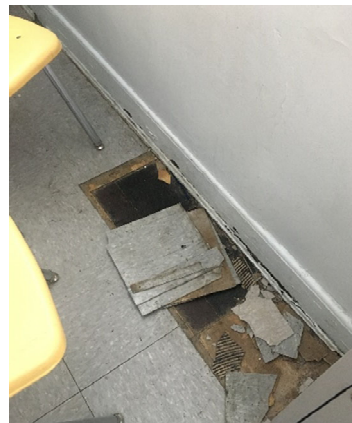
Figure 7 Flooring

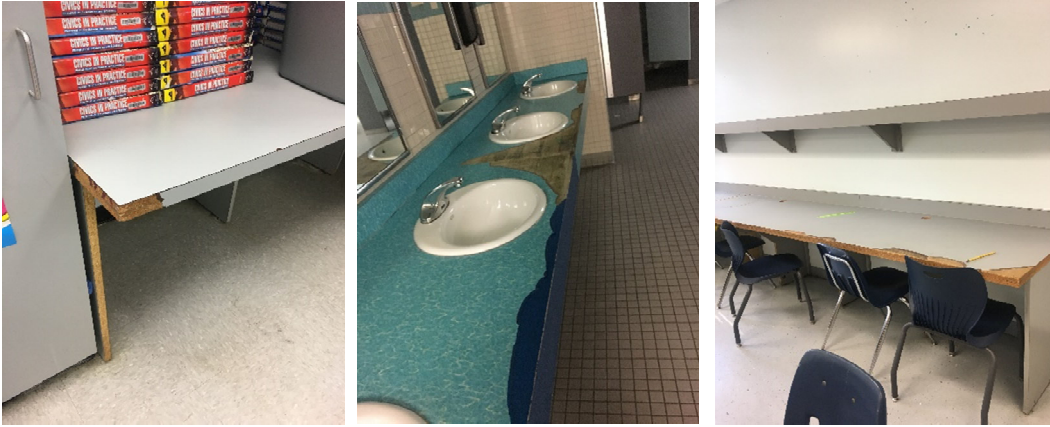
Figure 8 Aged Furniture and Counter Laminate

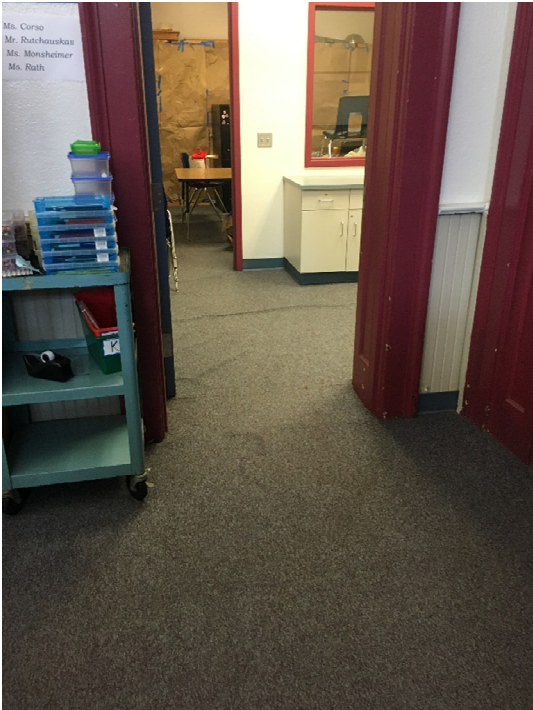
Figure 6: Cracked floor
